Final Reclamation and Stormwater Inspection

Operator: PRIME OPERATING COMPANY - 72118

Location ID: 337340

Inspection Photos
Location Name: EVANS #11-2-1
Location ID: 337340

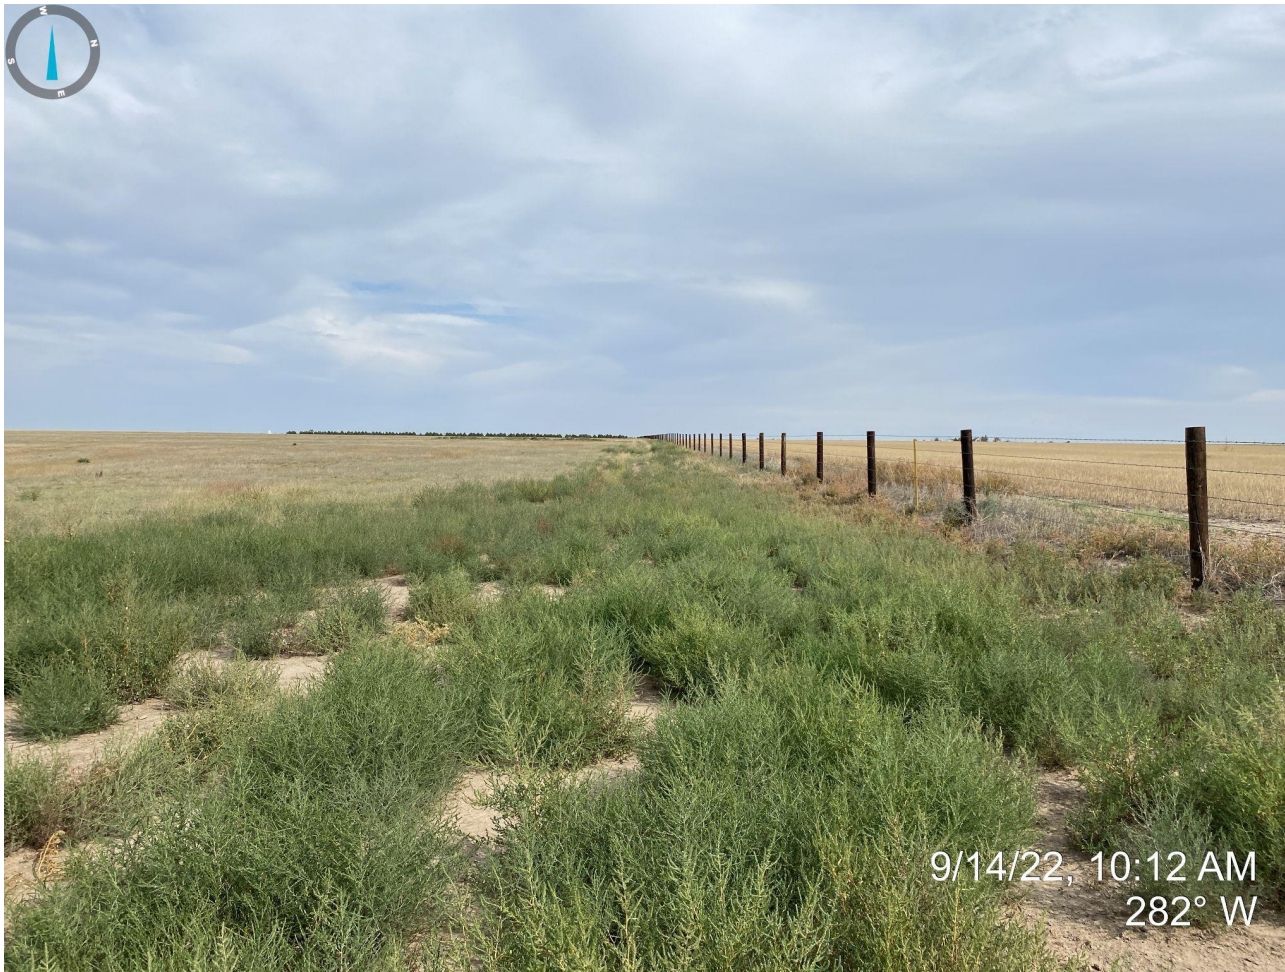
Photo 1. Taken from beginning of access road, facing north. Photo illustrates access road has not been reclaimed or revegetated to reflect reference areas; annual weedy vegetation is predominantly russian thistle.

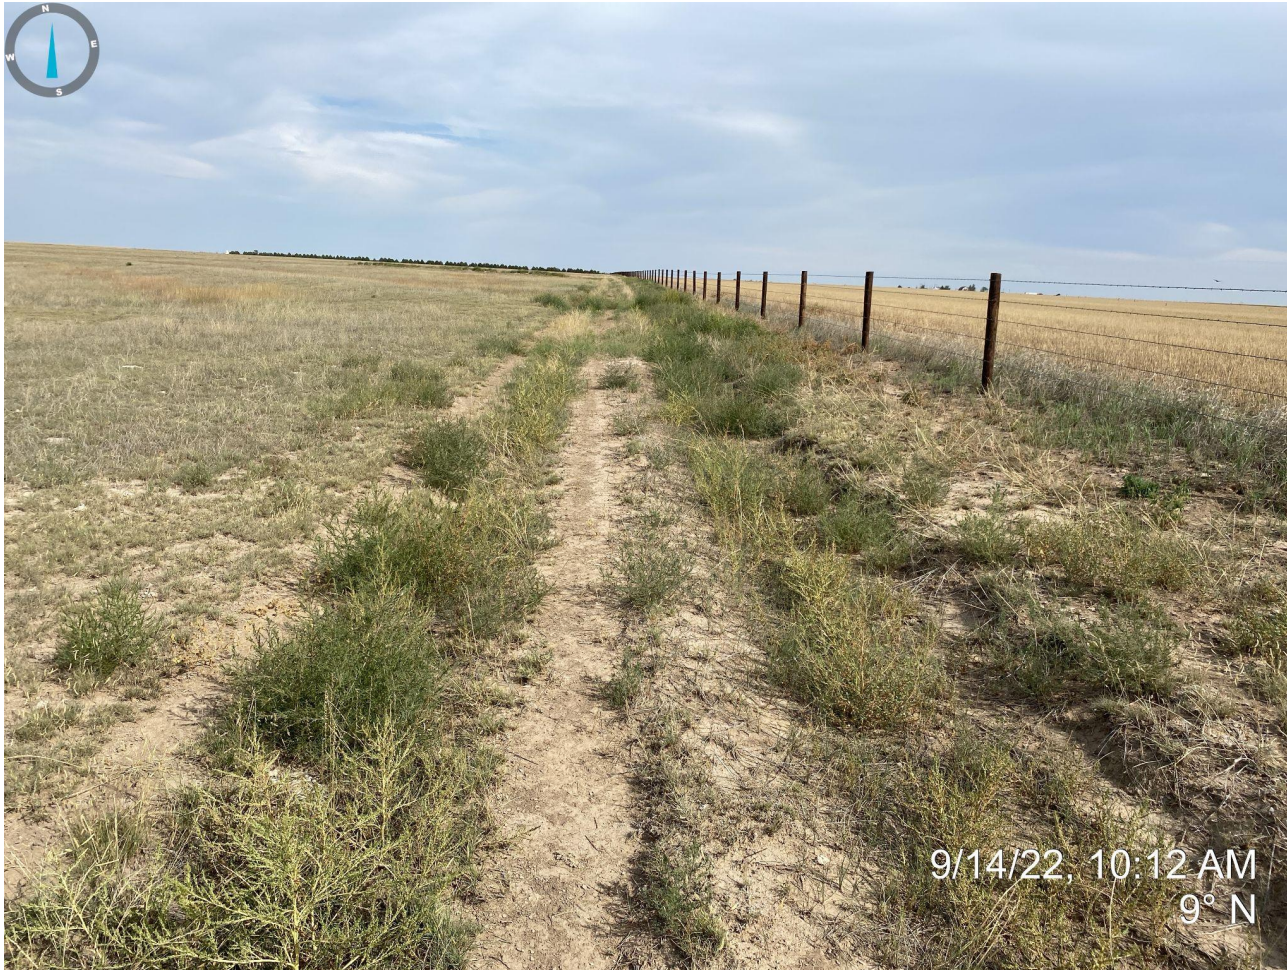
Photo 2. Access road facing north. Photo illustrates road has not been contoured or regraded; heavy rutting and annual weedy vegetation observed.

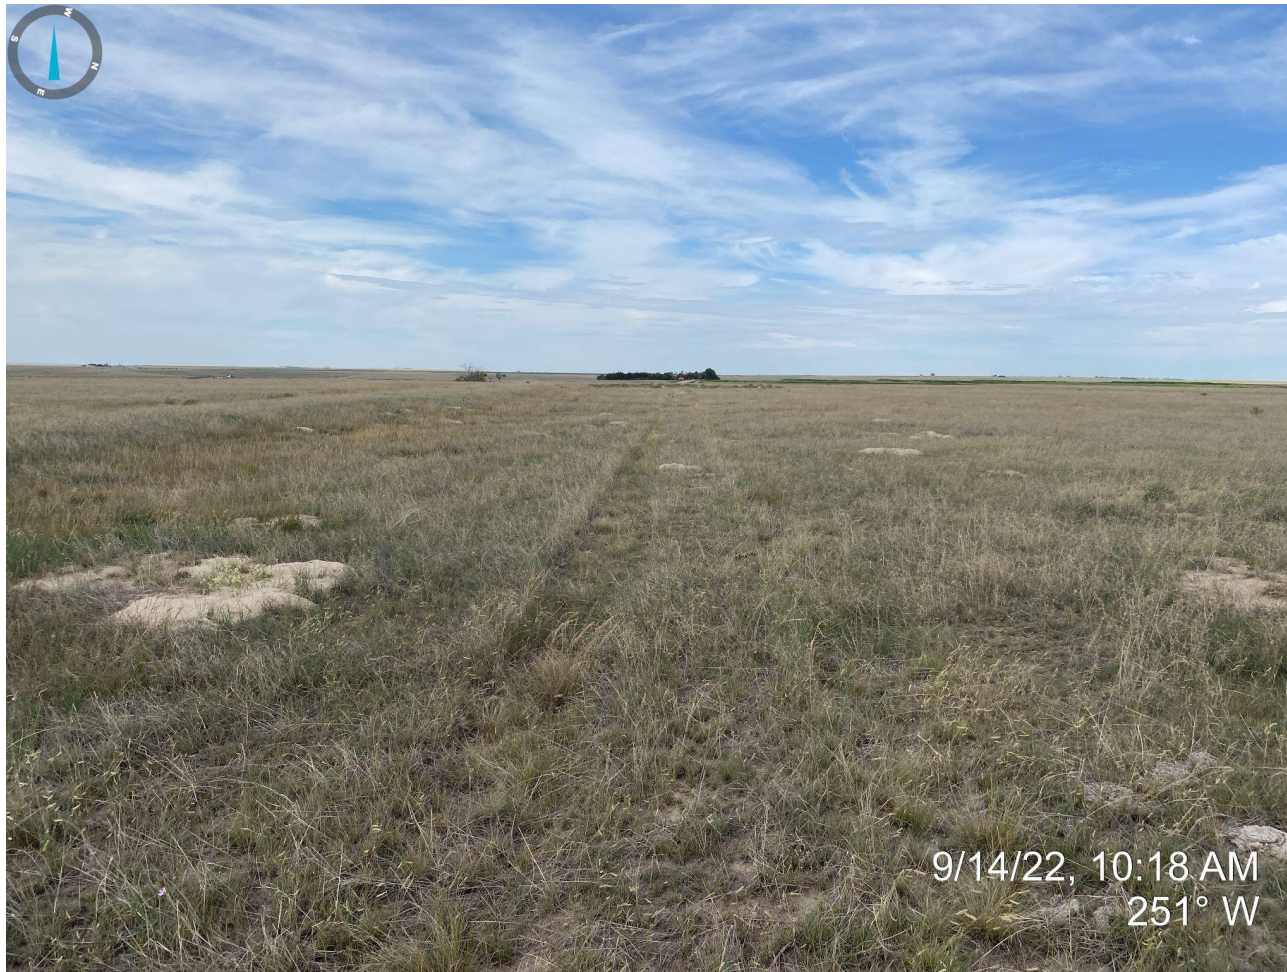
Photo 3. Taken from access road as it turns west towards location. Road has not been contoured or regraded; desirable vegetation observed along this portion of access road (e.g. blue grama, buffalo grass, sand drop seed, etc).

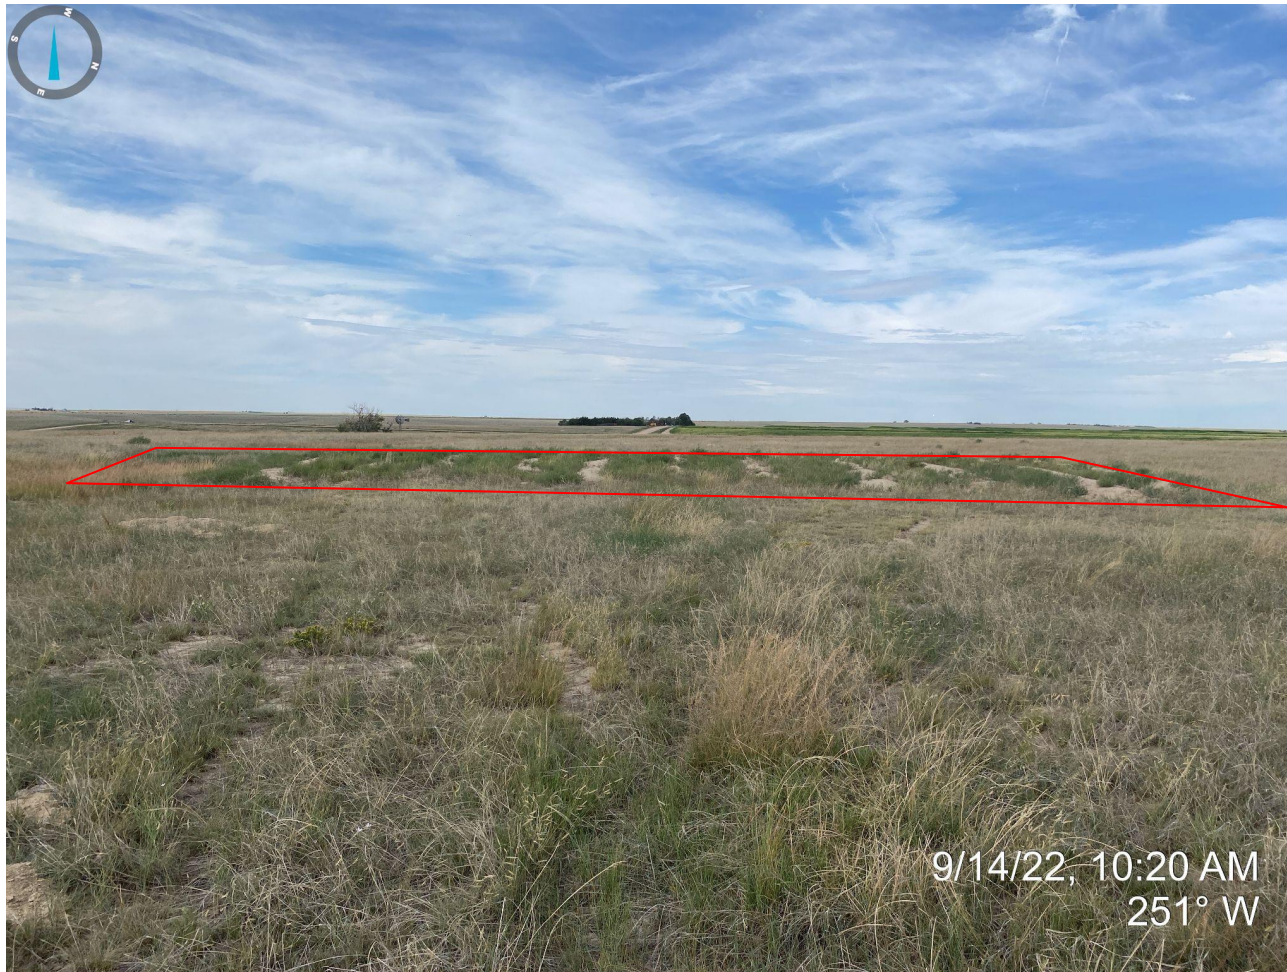
Photo 4. Taken east of location, facing west. Photo illustrates location has not been reclaimed with presence of annual weedy vegetation and soil/dirt that has not been contoured or regraded to reflect reference areas.

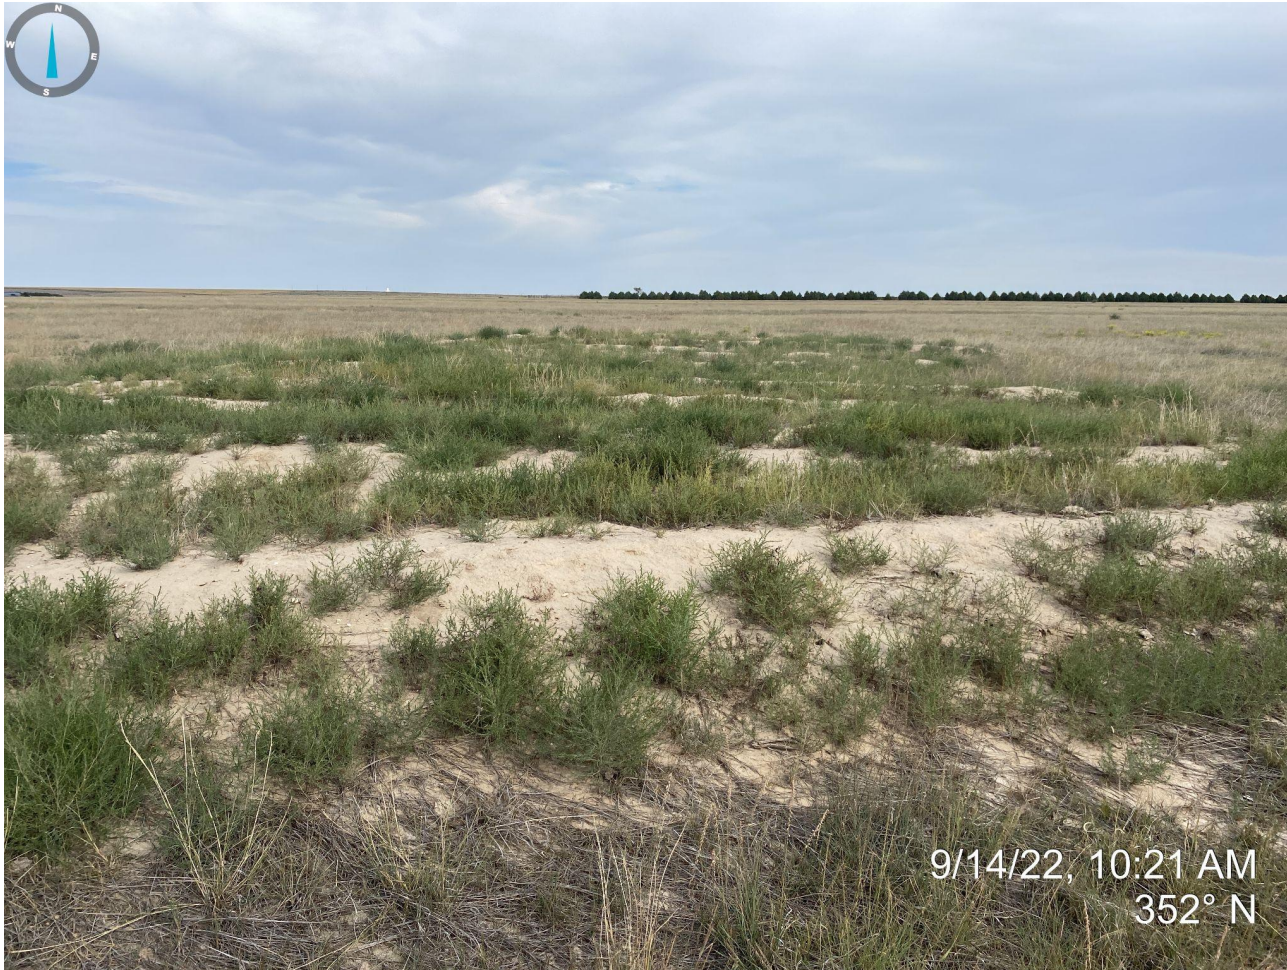
Photo 5. Facing north, see comments in photo 4.

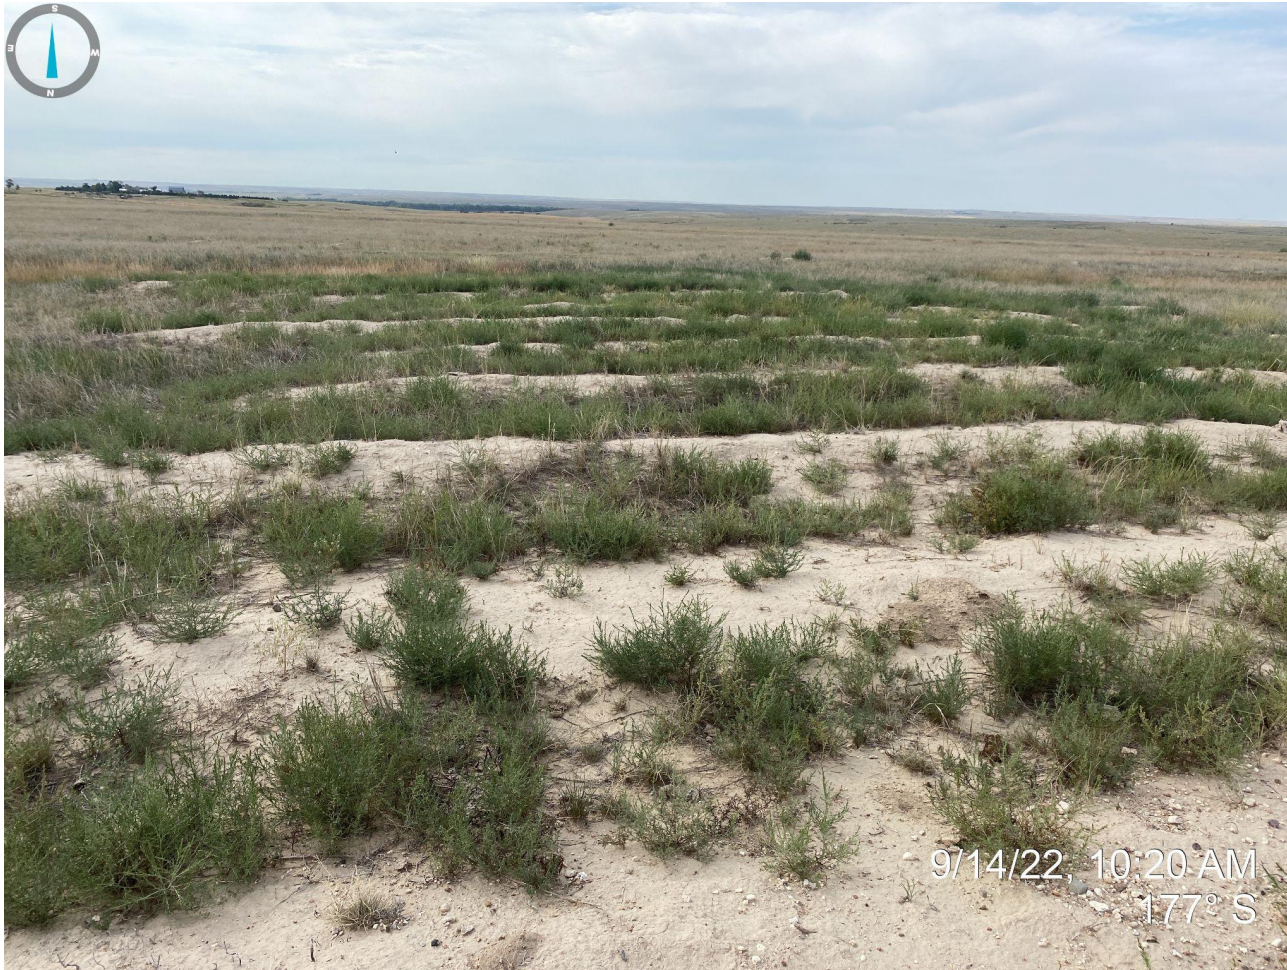
Photo 6. Facing south, see comments in photo 4.

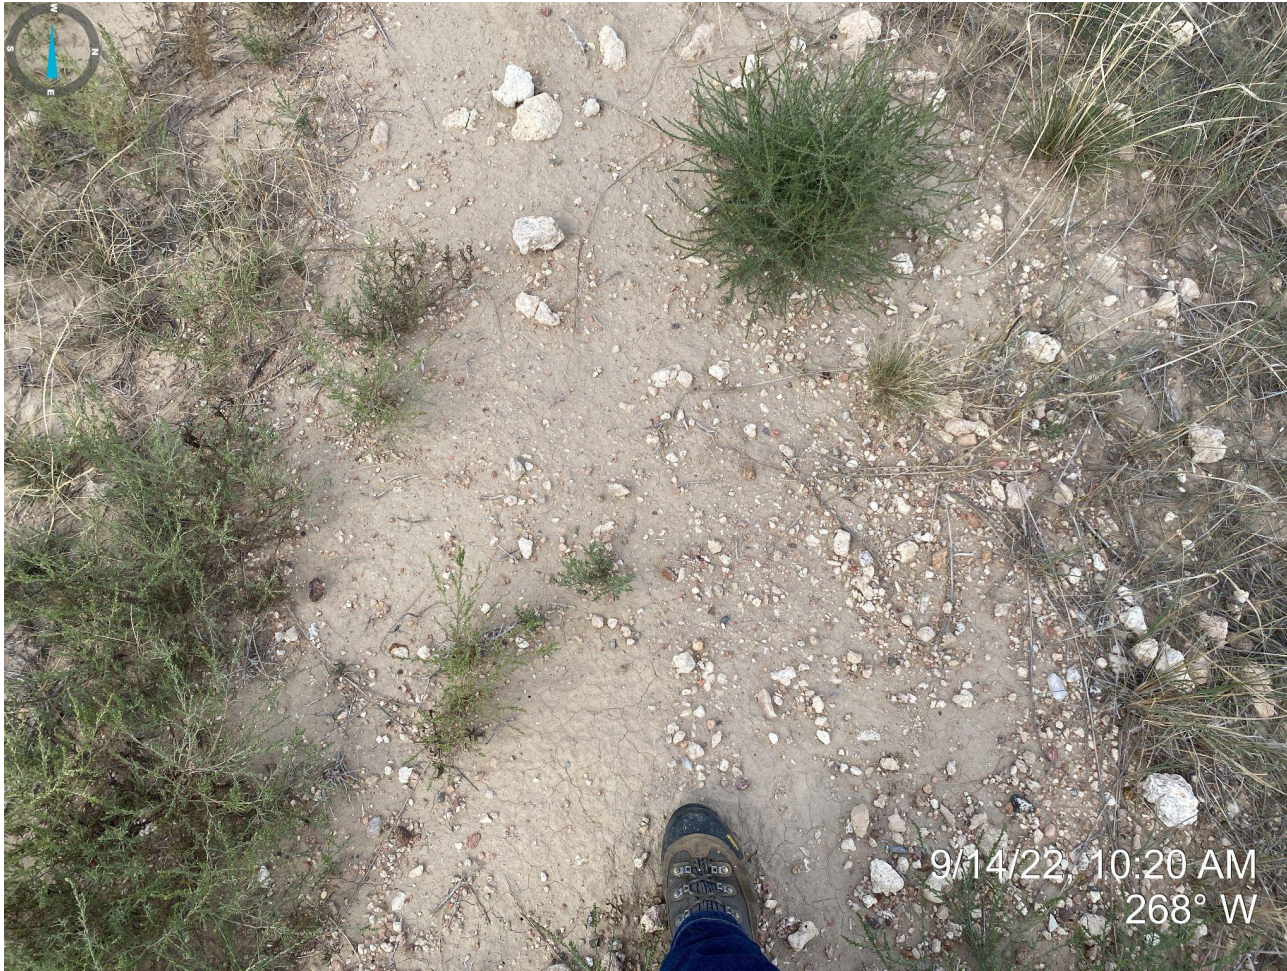
Photo 7. Close up photo showing gravel/road base still on location.

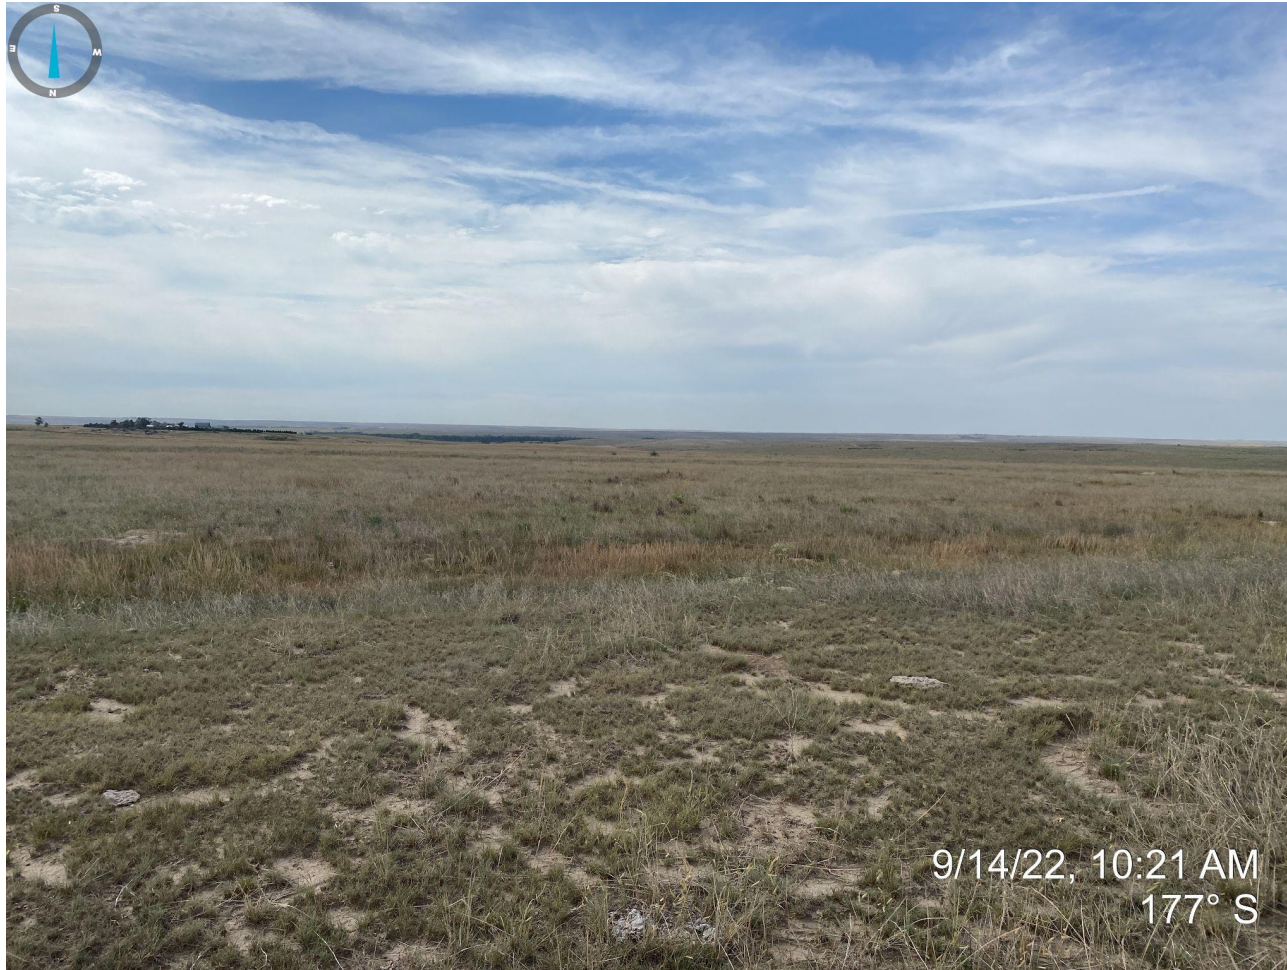
Photo 8. Reference area photo taken south of location, facing south. Area is predominantly buffalo grass, sand drop seed, and blue grama.
