Final Reclamation and Stormwater Inspection

Operator: PRIME OPERATING COMPANY - 72118

Location ID: 303467

Inspection Photos
Location Name: FLEER #13-2
Location ID: 303467

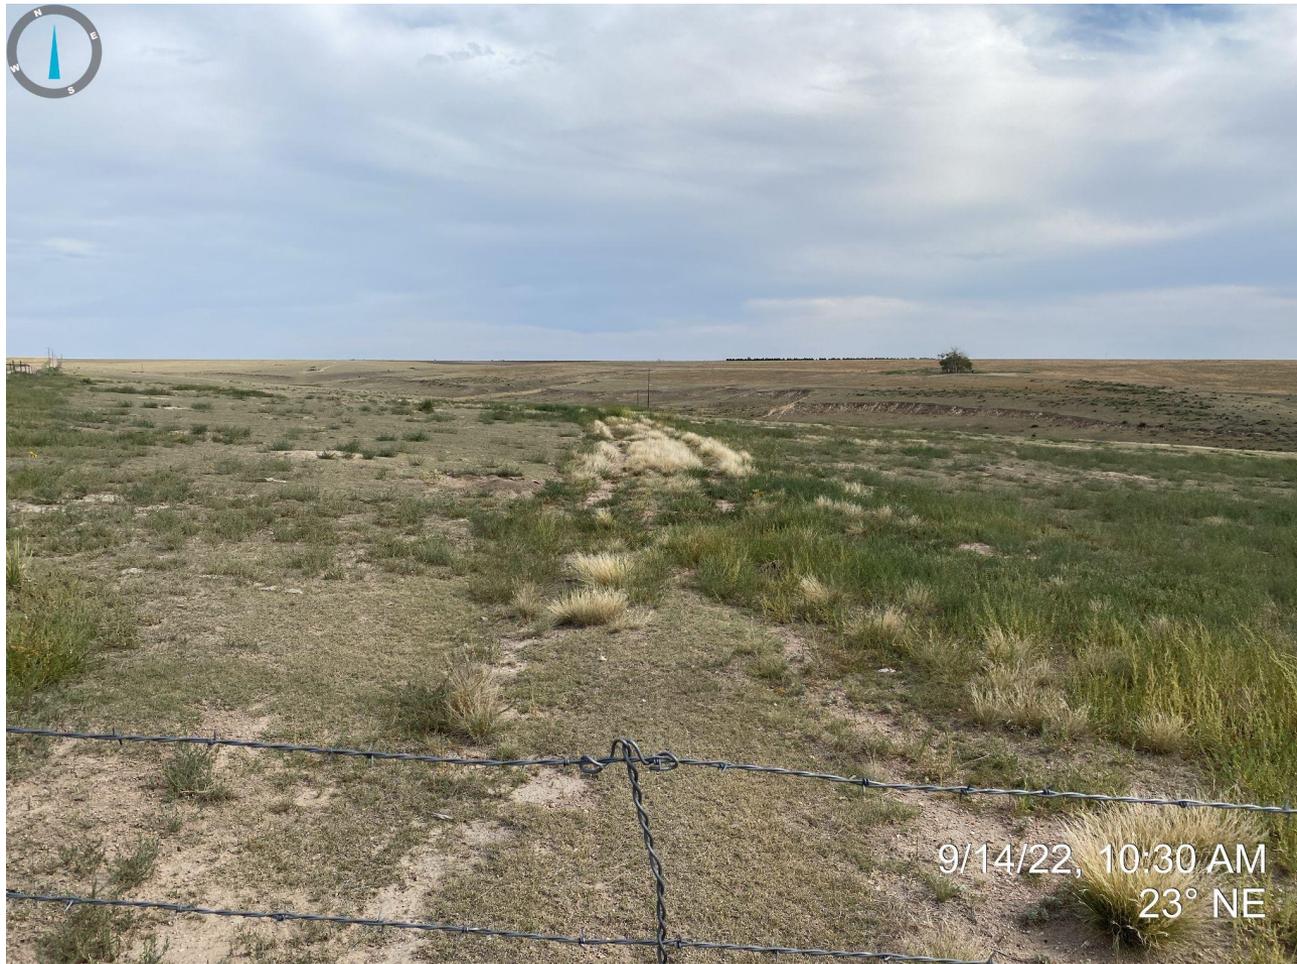
Photo 1. Taken from county road, facing northeast. Photo illustrates access road has not been reclaimed; annual weedy vegetation (predominantly russian thistle) present throughout access road and location.

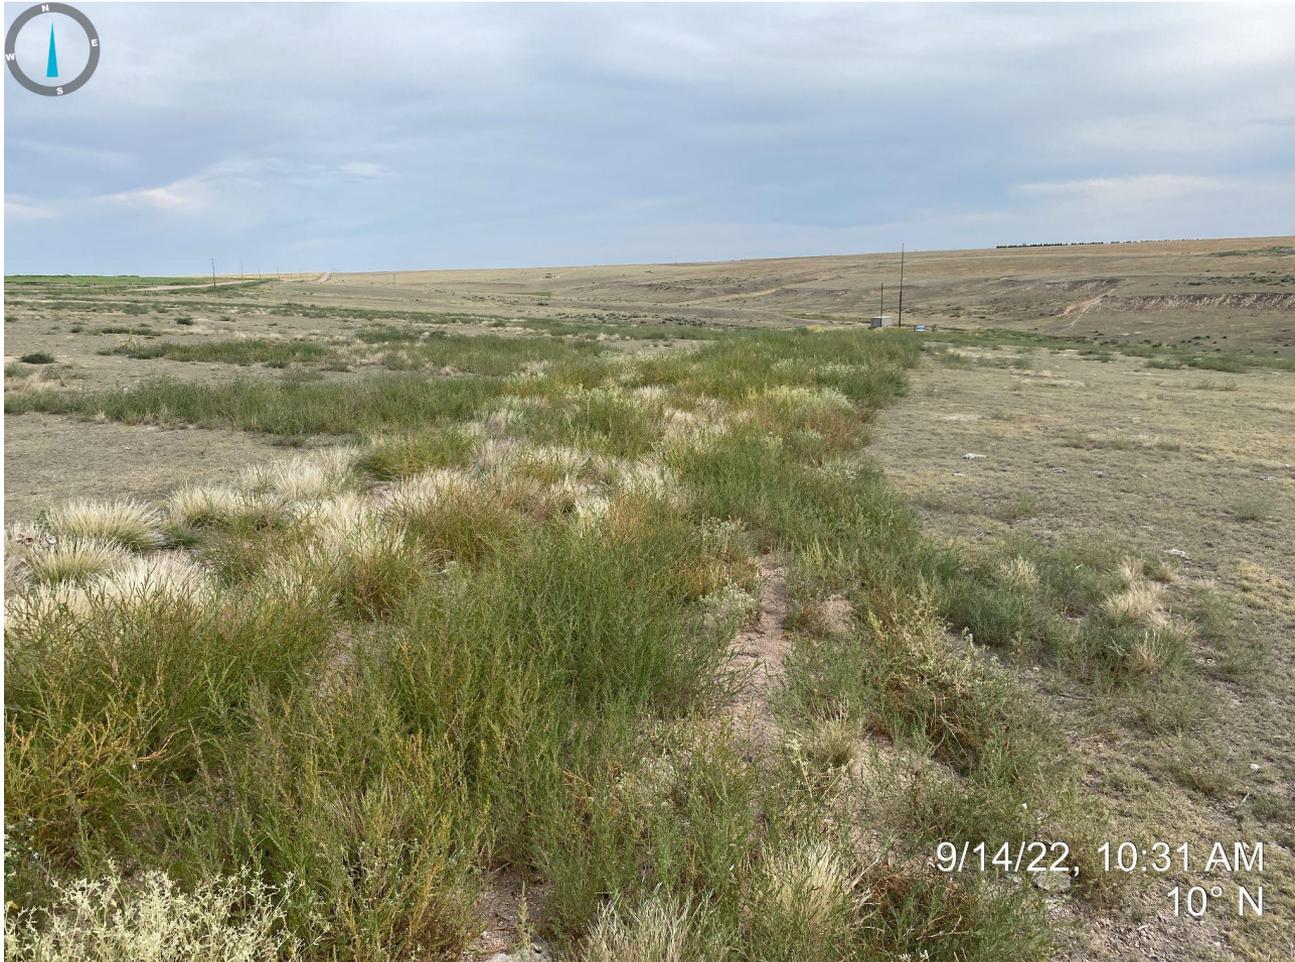
Photo 2. Access road, facing north. See comments in photo 1.

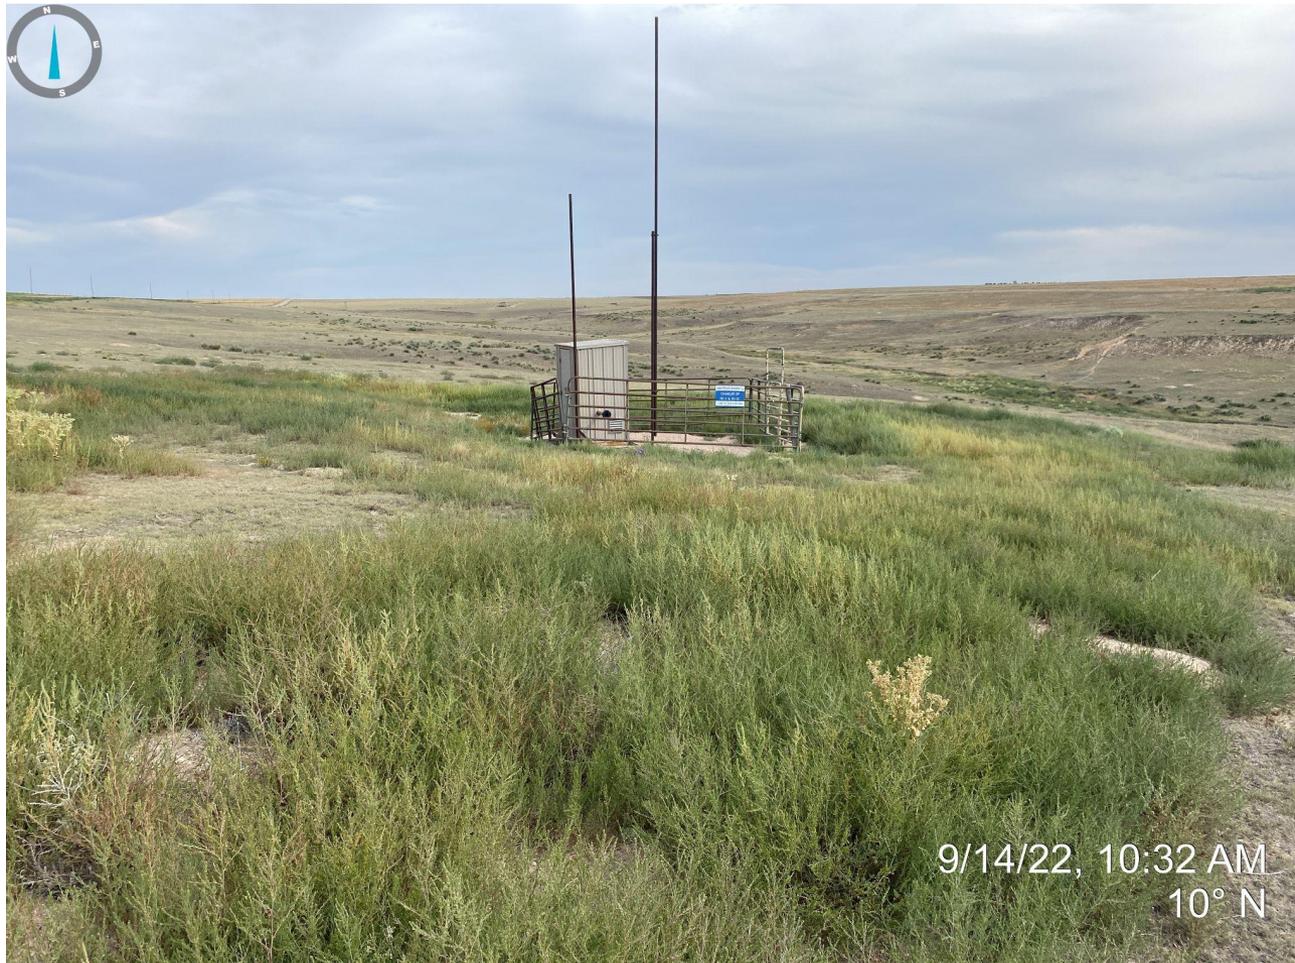
Photo 3. Taken south of location, facing north. Photo illustrates access road and location have not been reclaimed with presence of annual weedy vegetation, access road and location which have not been contoured, regraded, or revegetated. Oil and gas equipment remain on location.

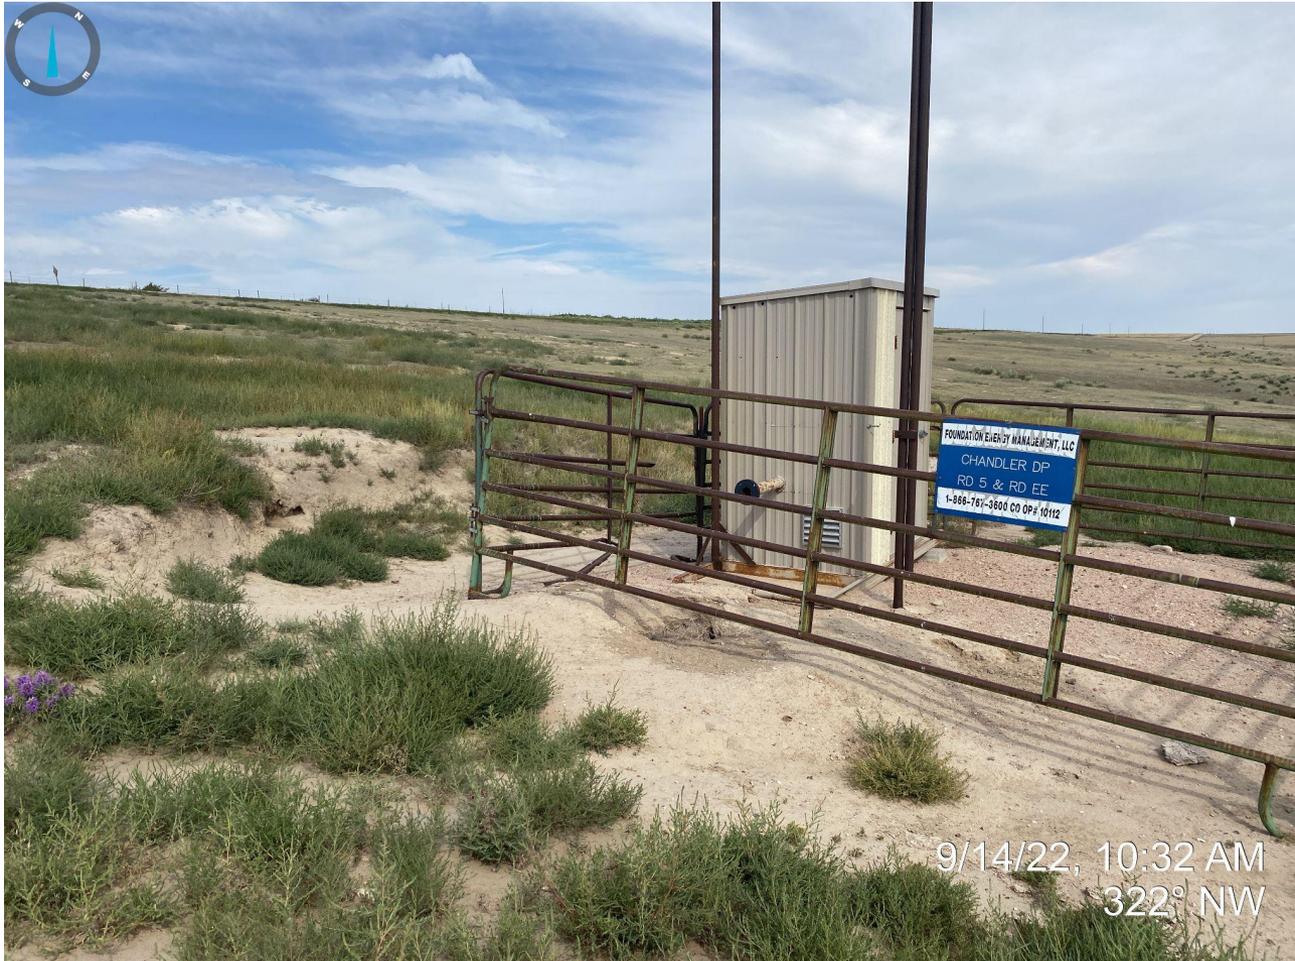
Photo 4. Facing northwest, see comments in photo 3.

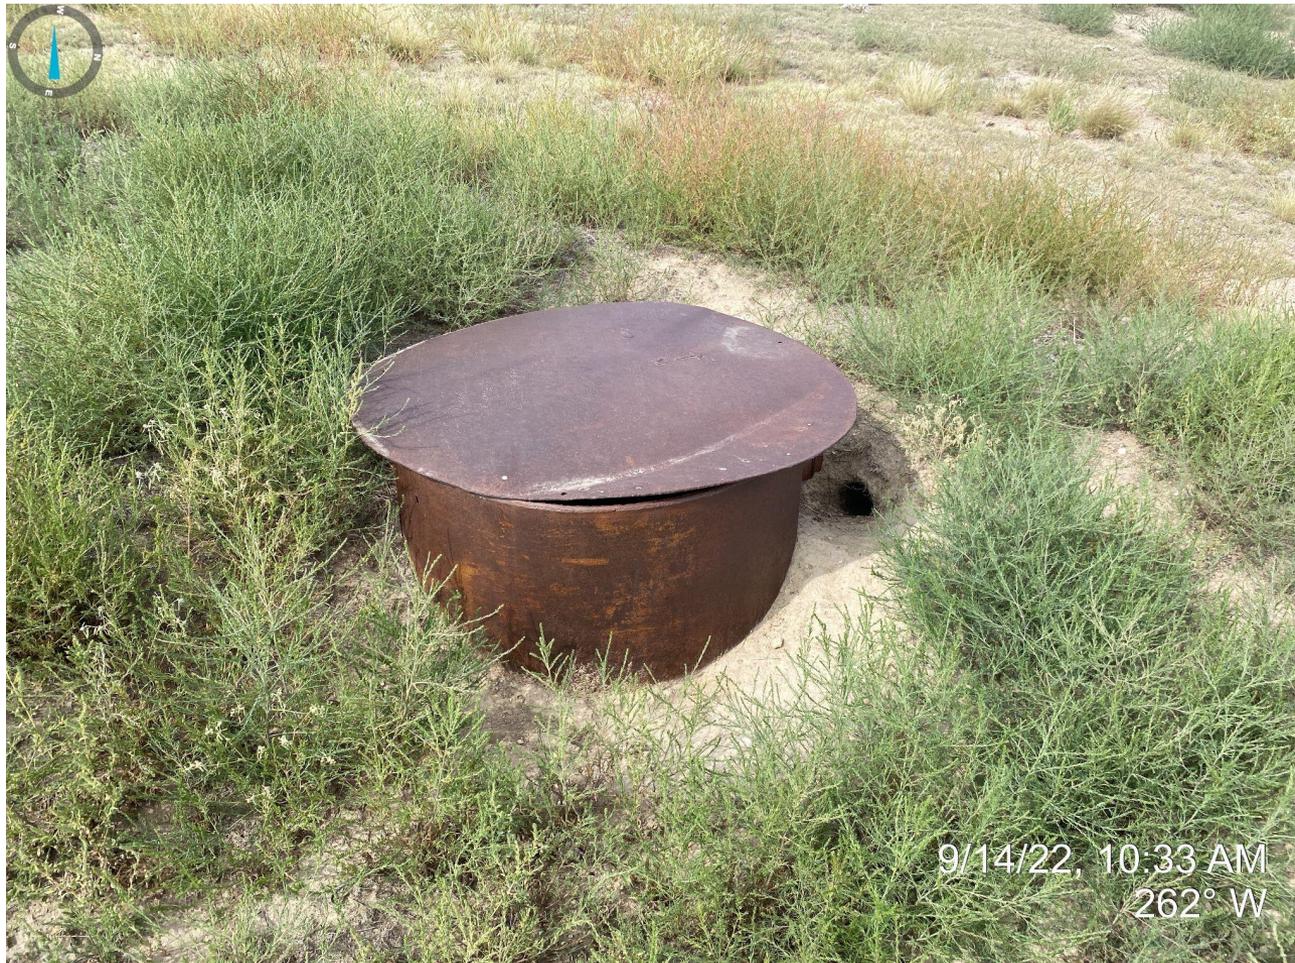
Photo 5. Taken northwest of meter shed, facing west. Unknown buried container.
