Final Reclamation and Stormwater Inspection

Operator: ENERGY QUEST II LLC - 10490

Location ID: 337054

Inspection Photos
Location Name: BRENNER #10-6
Location ID: 337054

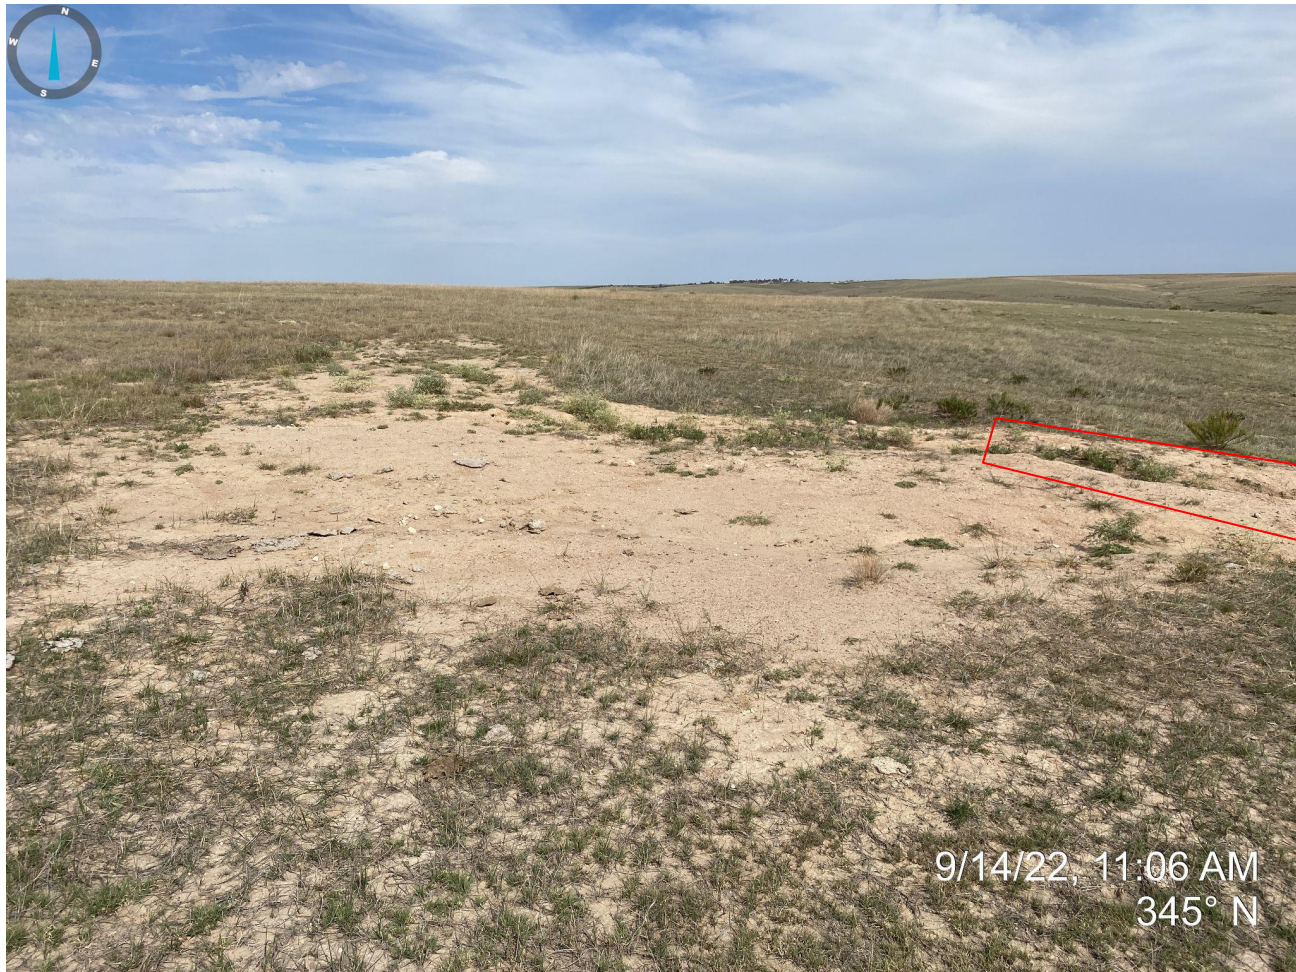
Photo 1. Taken from southern portion of location, facing north. Photo illustrates location has not been reclaimed with presence of annual weedy vegetation (russian thistle), non-uniform vegetation cover resulting in bare soil, and gully erosion on the east side of location (outlined in red).

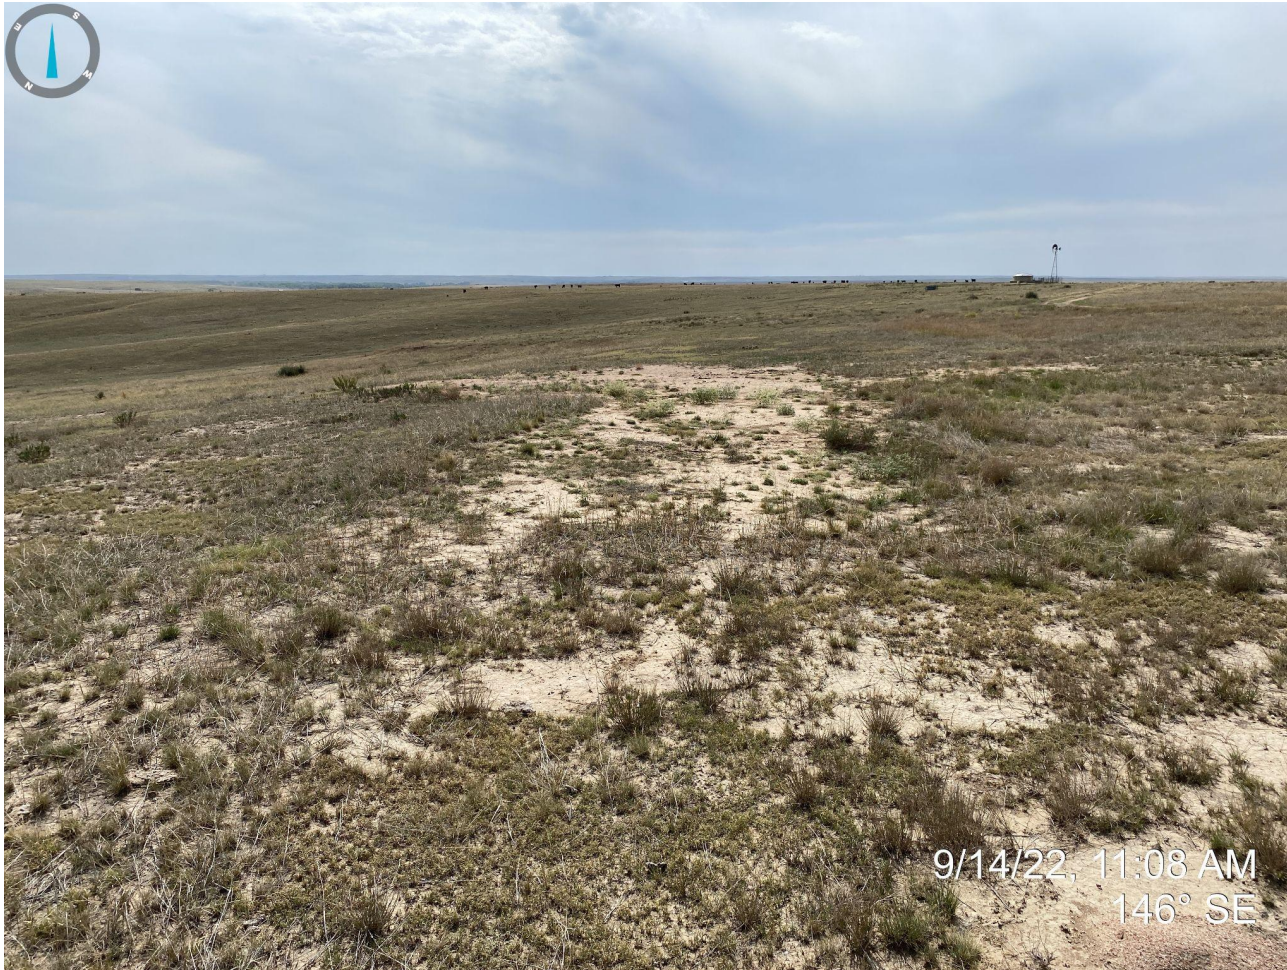
Photo 2. Taken from northern tank battery location, facing southeast. See comments in photo 1.

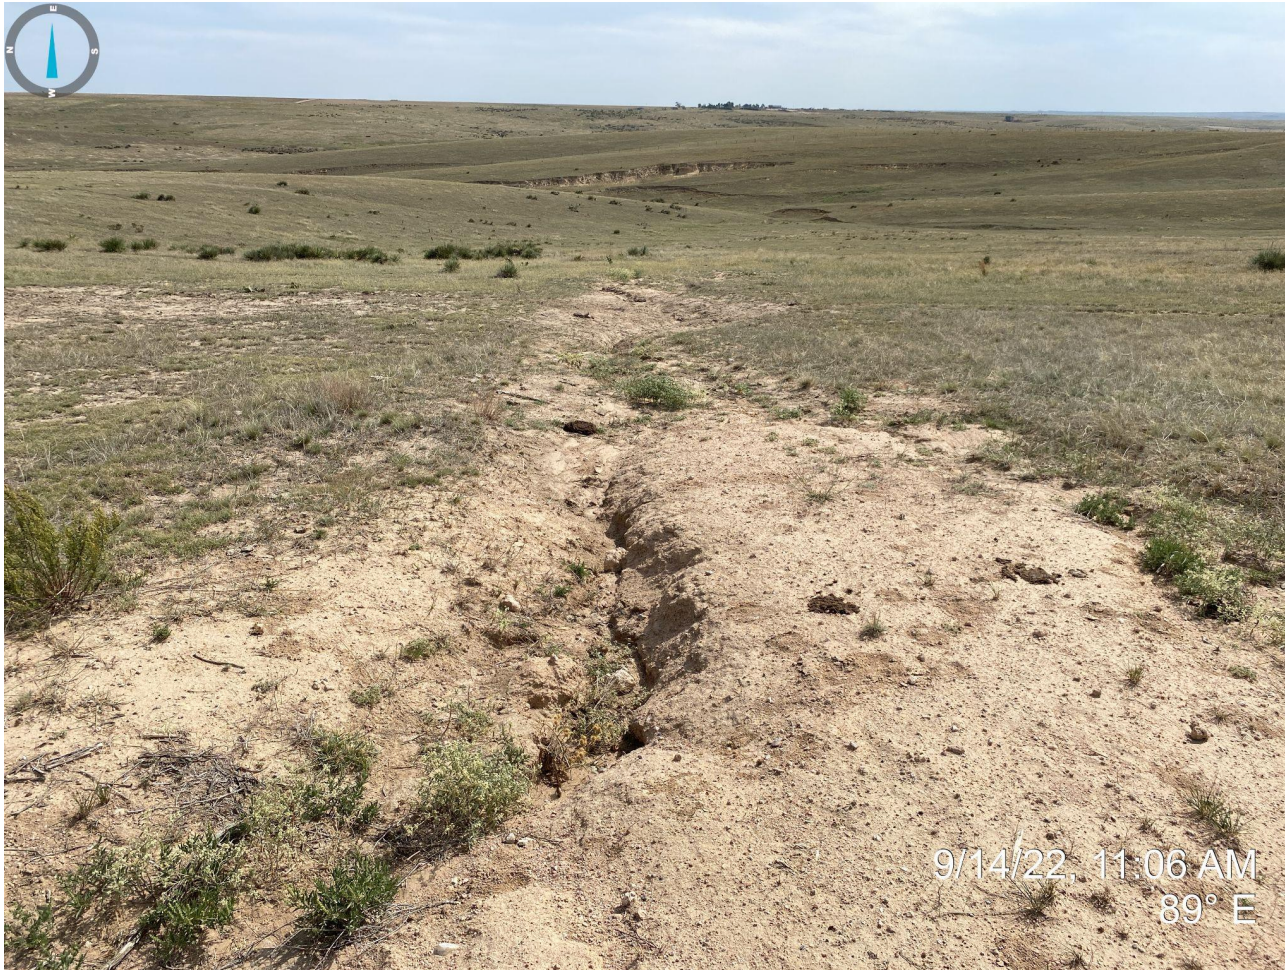
Photo 3. Taken from eastern portion of location, facing east. Photo illustrates gully erosion approximately 1.5' deep x 115' length x 10' wide. Extent of erosion is leaving permitted location and contributing to offsite sediment deposition; no erosion control BMPs observed during inspection.

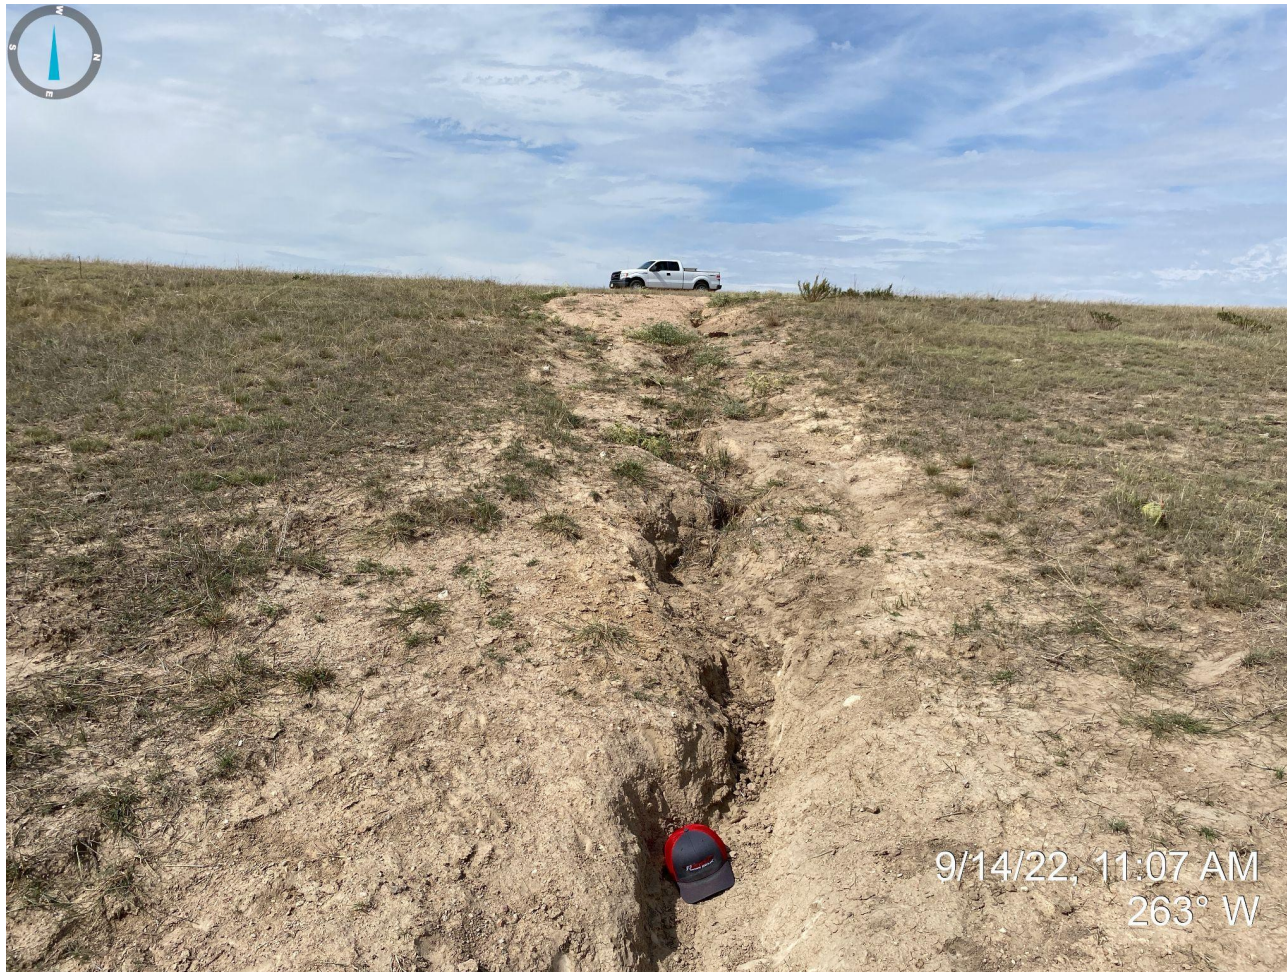
Photo 4. Taken from middle portion, east of location, facing west. See comments in photo 3.

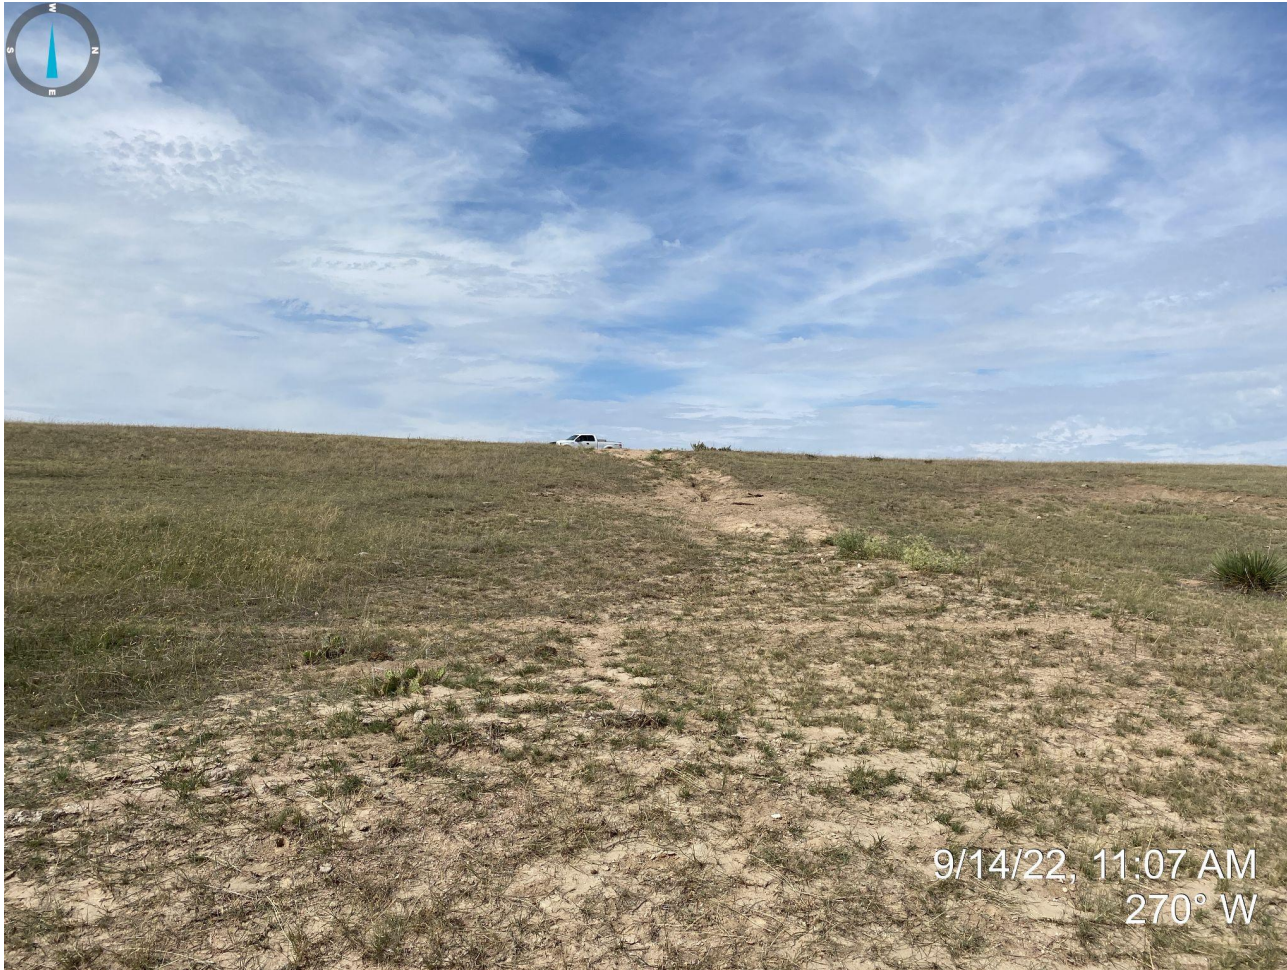
Photo 5. Taken east of location, facing west. See comments in photo 3.

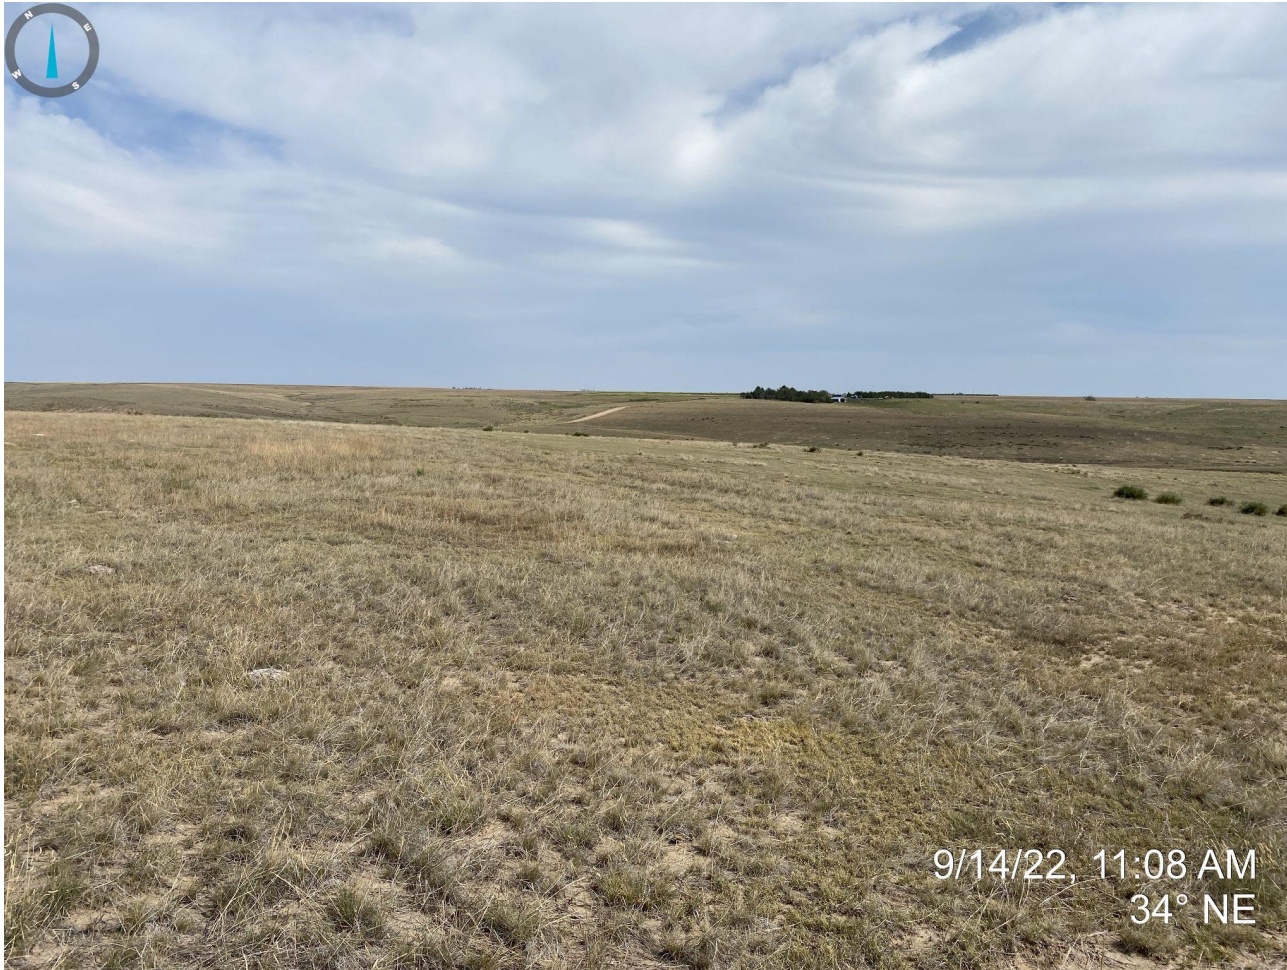
Photo 6. Reference area photo taken northeast of location, facing northeast. Predominantly buffalo grass and sand drop seed, among other desirable vegetation.
