Inspection Photos

Location Name: CAERUS PICEANCE LLC SPECIALITY RESTAURANT-68S96W /7LOT 2

Location ID: 334188

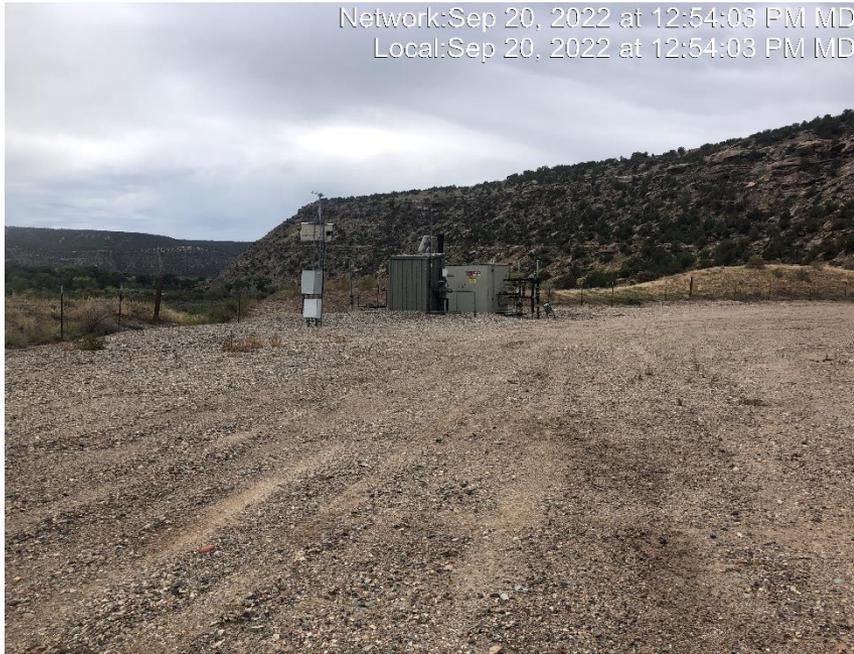
Photo #7755 From entrance to location.

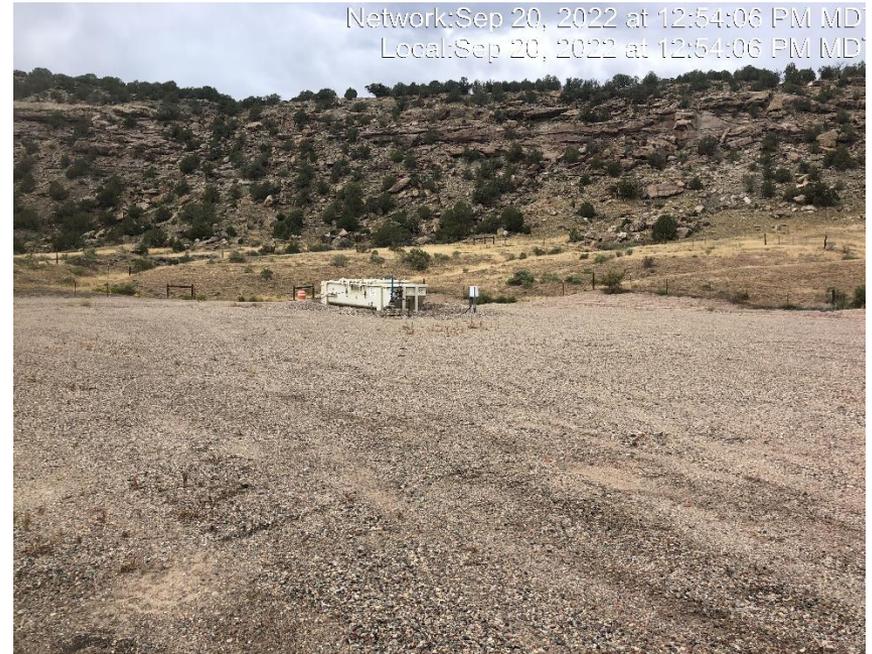
Photo #7756 From entrance to location.

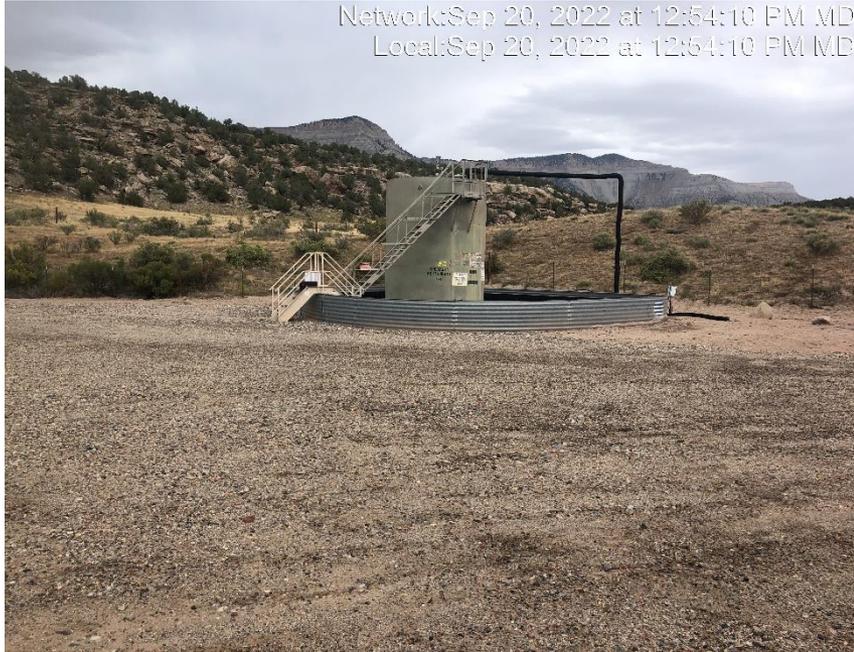
Photo #7757 From entrance to location.

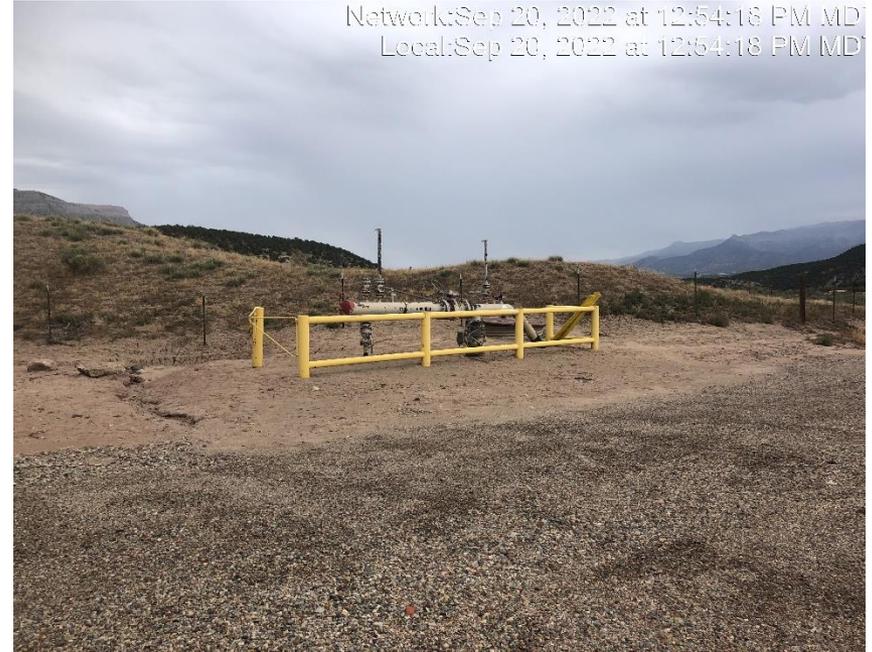
Photo #7758 From entrance to location.

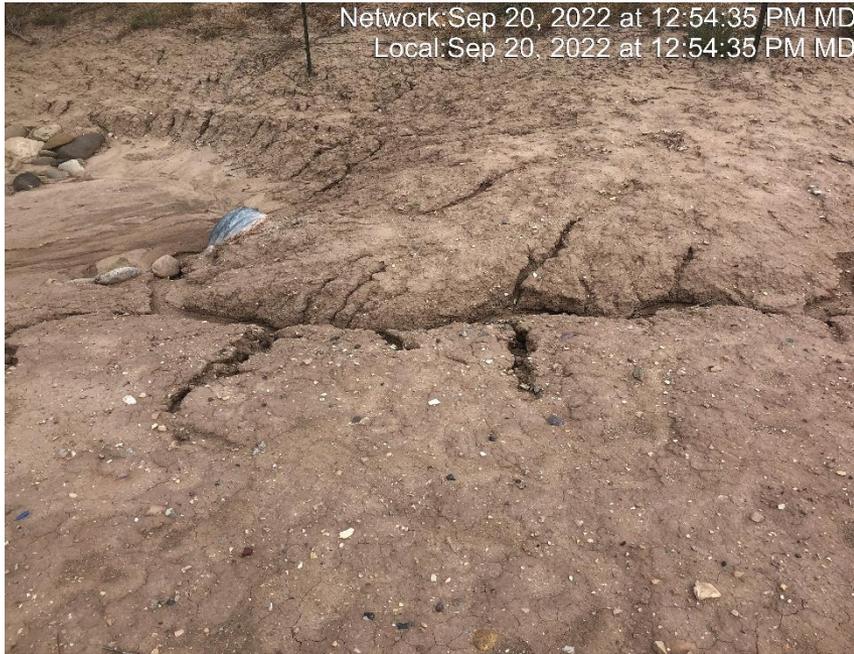
Photo #7759 Rill erosion.

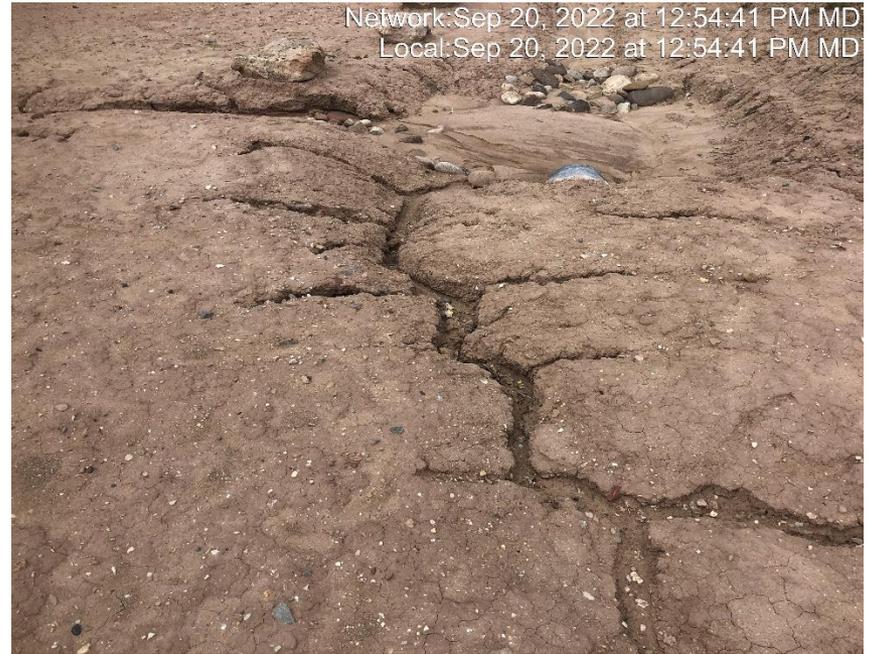
Photo #7760 Rill erosion.

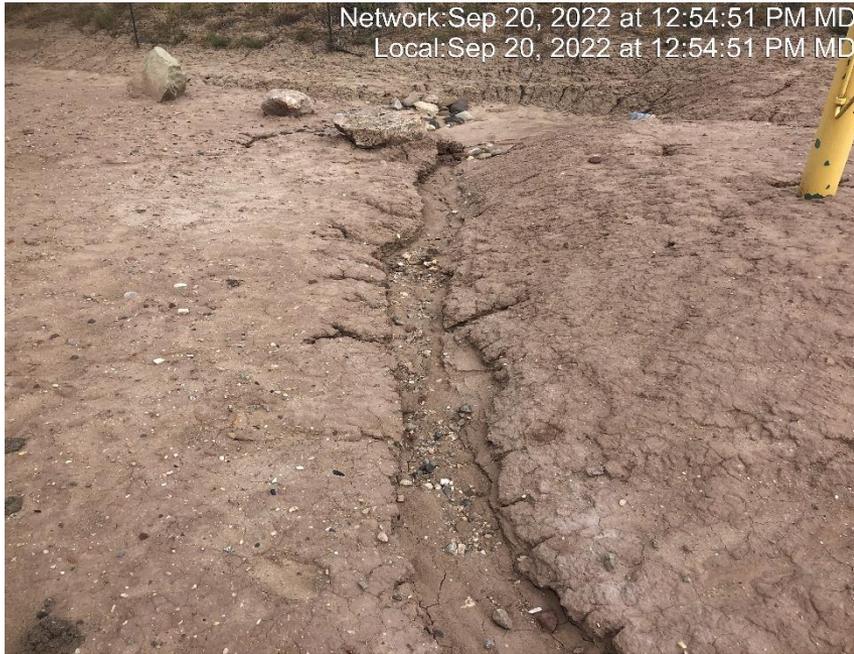
Photo #7761 Gully erosion.

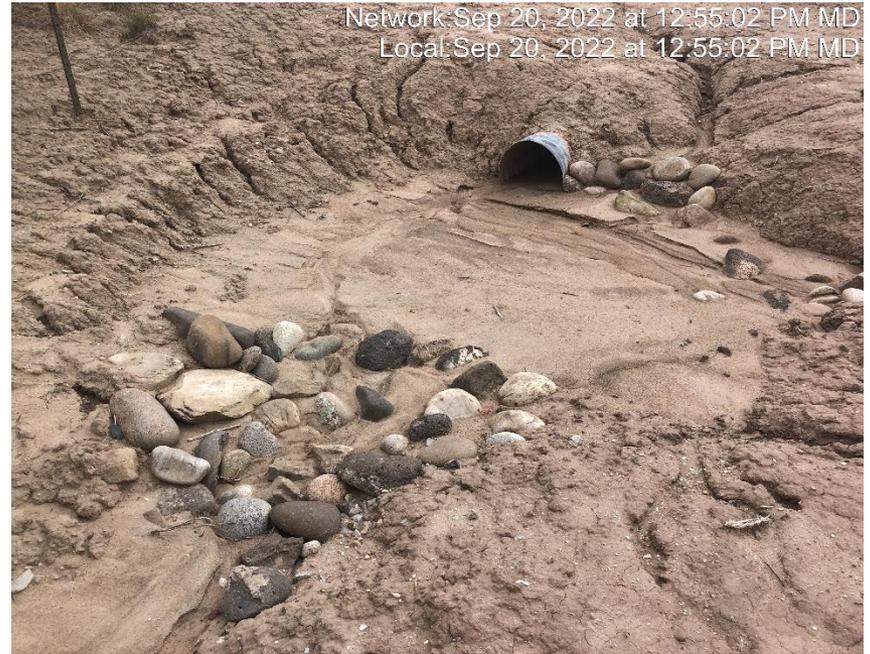
Photo #7762 Sediment trap is full run off of location is not being controlled.

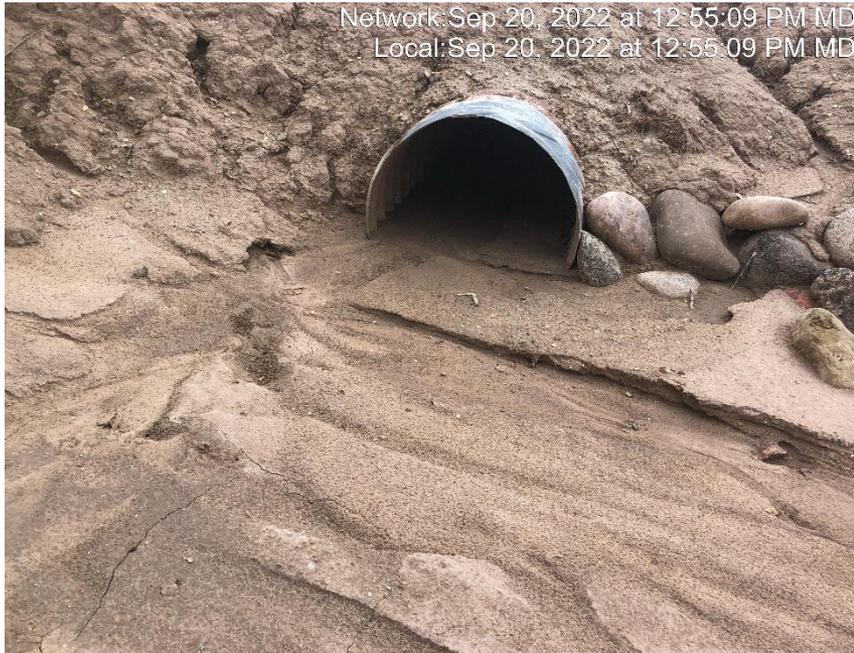
Photo #7763 Culvert capacity has been reduced due to Sediment migration.

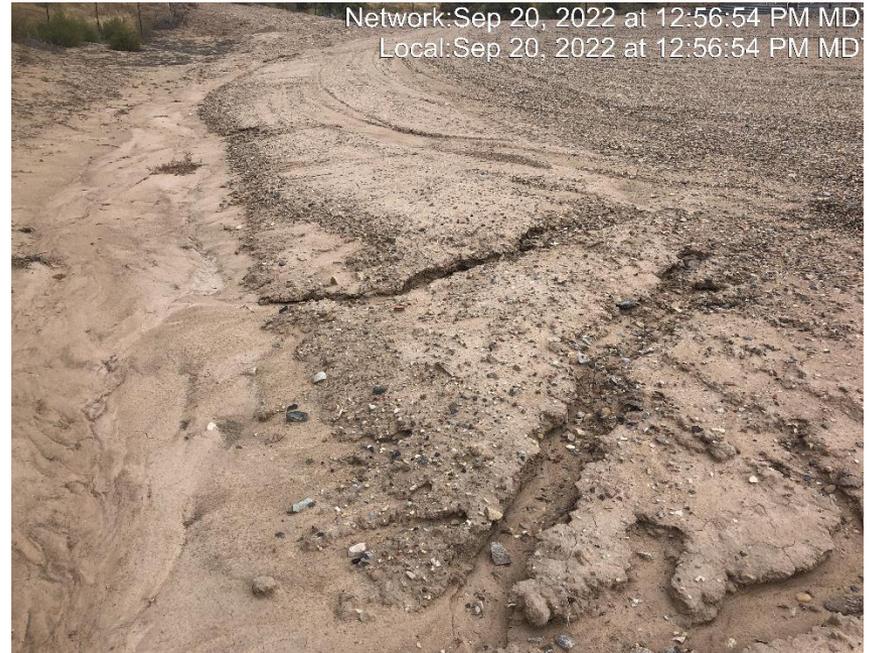
Photo #7767 Rill erosion.
