# Inspection Photos and Issue Report

Operator: TEP ROCKY MOUNTAIN LLC #  
96850

Location #439690  
Rio Blanco County, CO

# TEP, Pitchers Mount WRF, #439690 Annotation Report

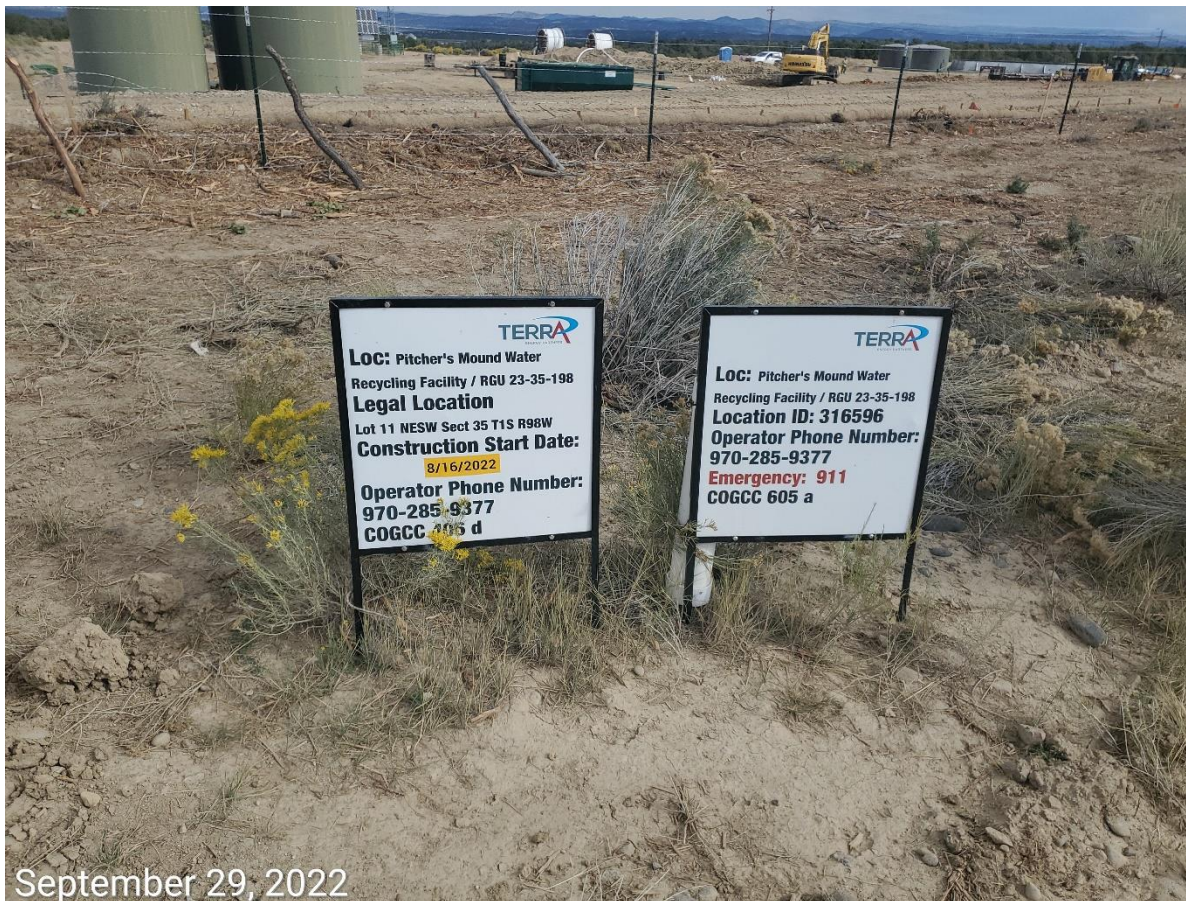
**Photo 1:** Signage at the southern location entrance. Form 2A permit located within PVC tube behind right sign in photo.

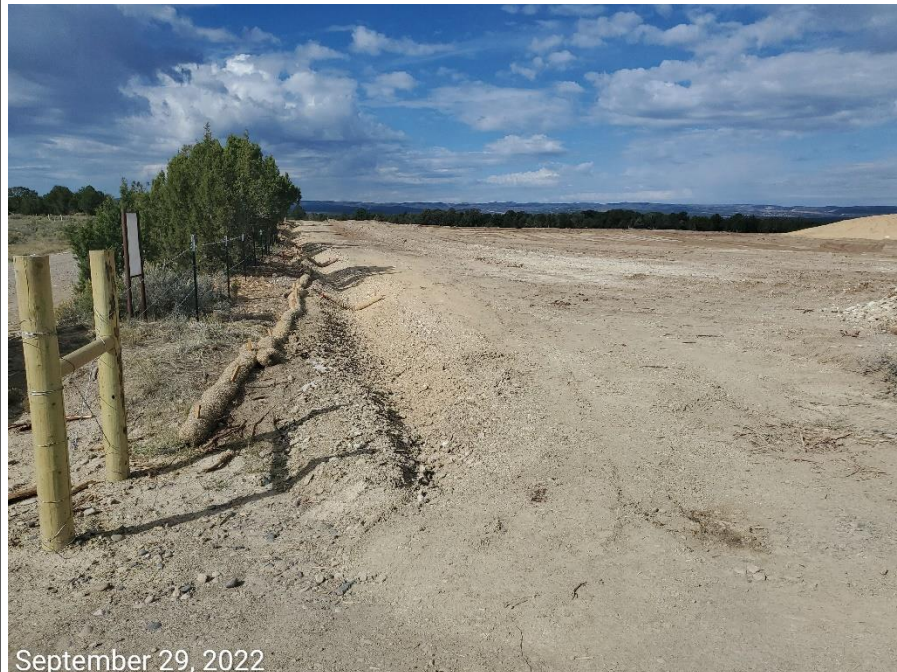
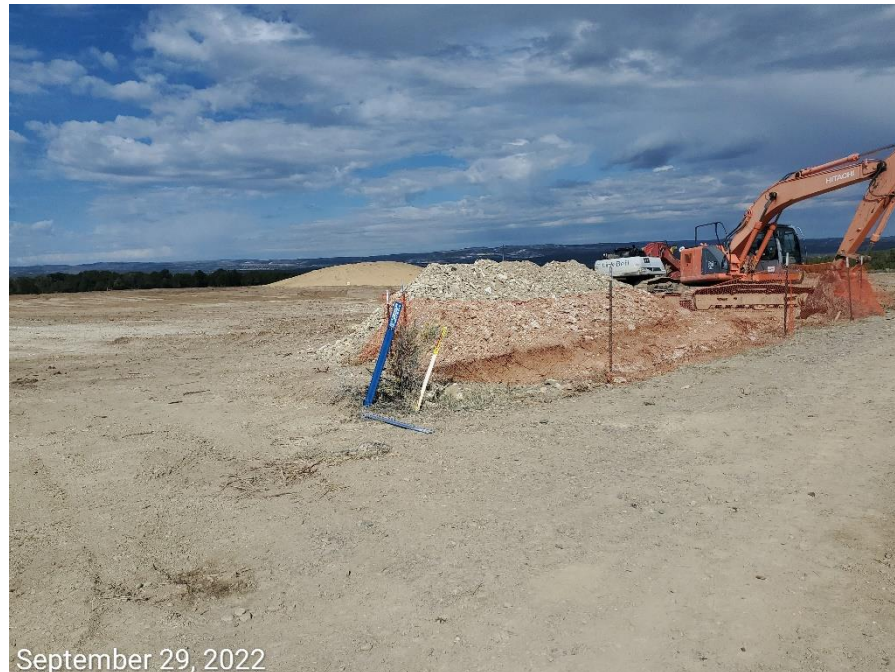
**Photo 2:** Photos 1-2 taken from the southern Location entrance. Photos provide an overview of the Location from west, northwest, northeast to east.

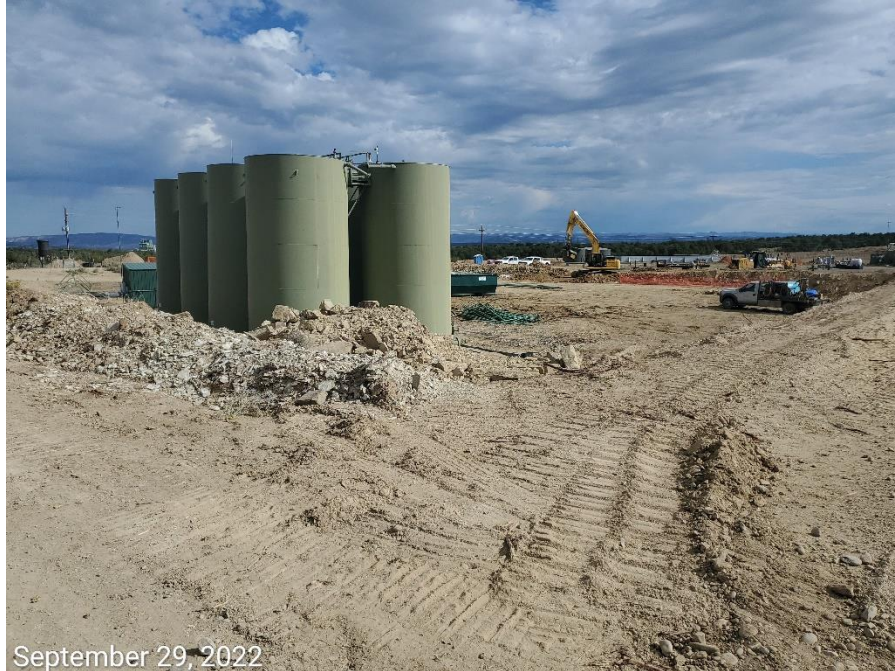
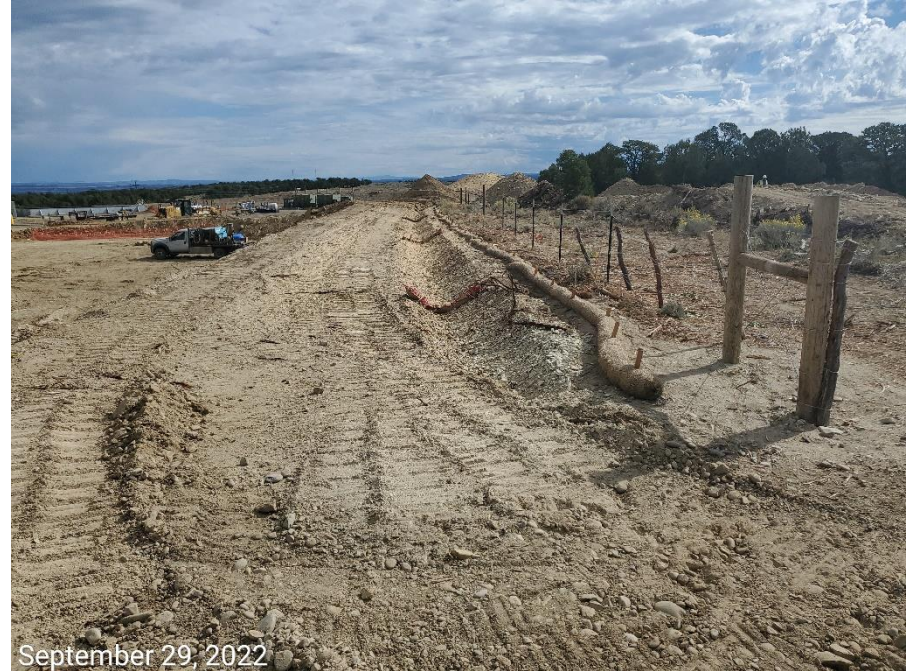
**Photo 3:** See comments under photo 2.

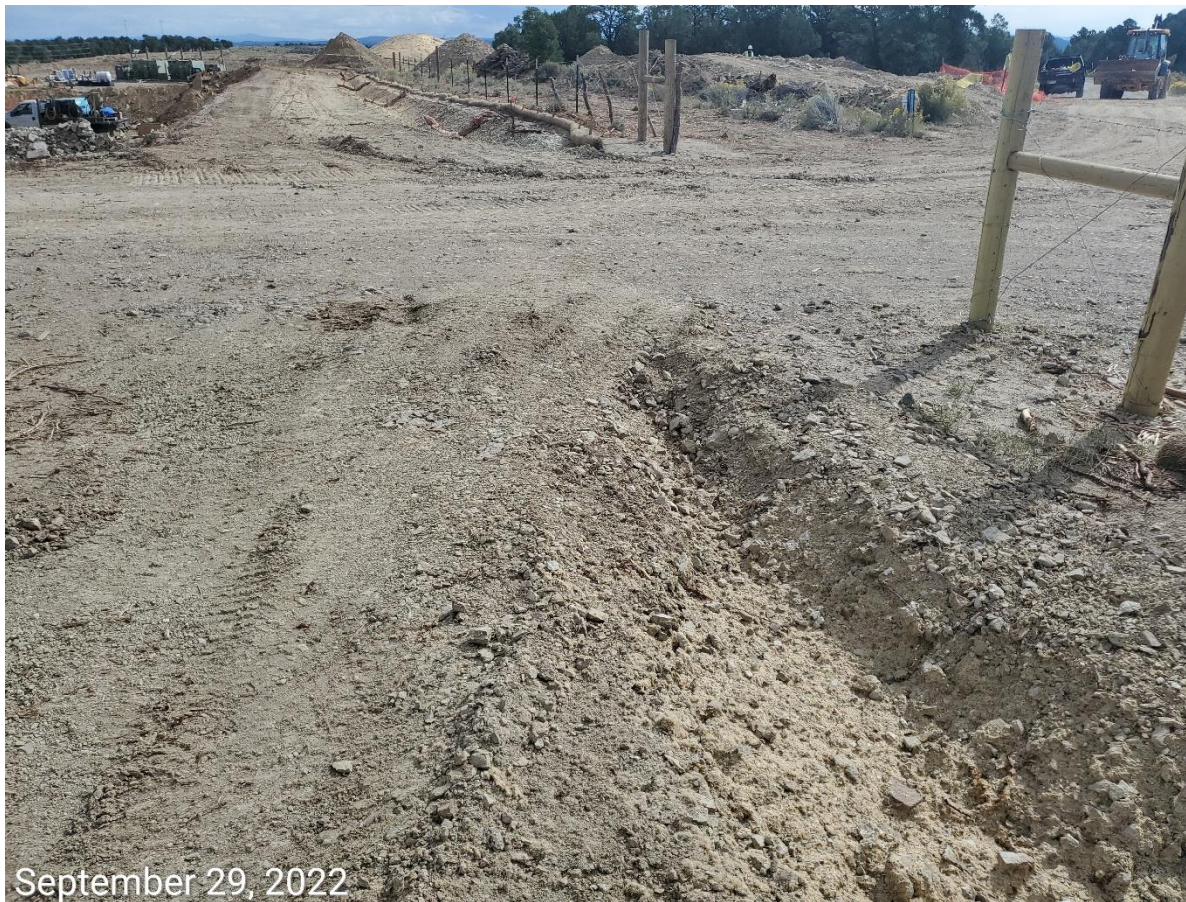
**Photo 4:** Photo shows southern location entrance. BMPs such as a culvert, have not been installed at this entrance. SWMP #402895189 does not identify that a culvert will be installed at this entrance. Topography within area may not warrant need for a culvert at this entrance.

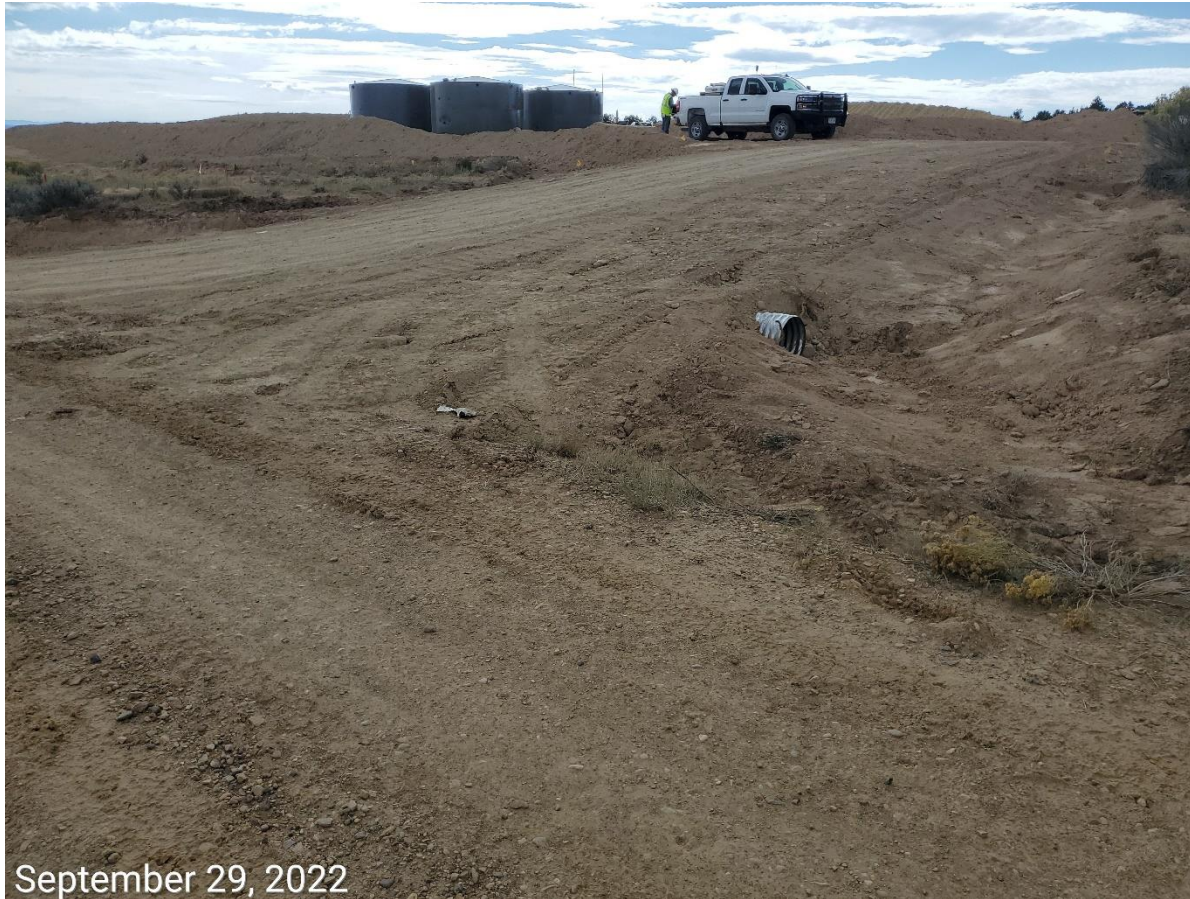
**Photo 5:** Photo shows northeastern Location entrance.

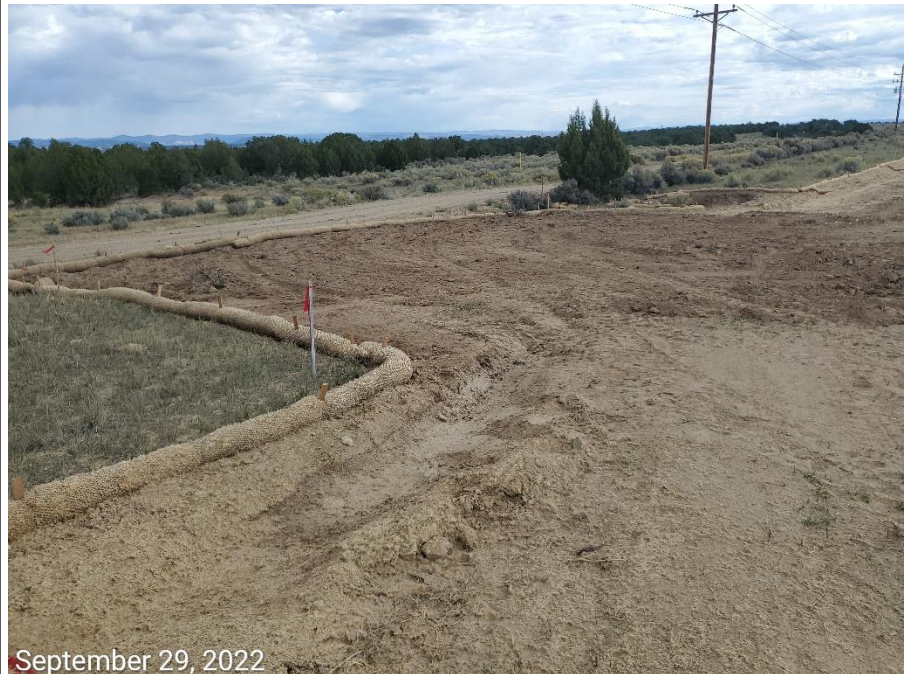
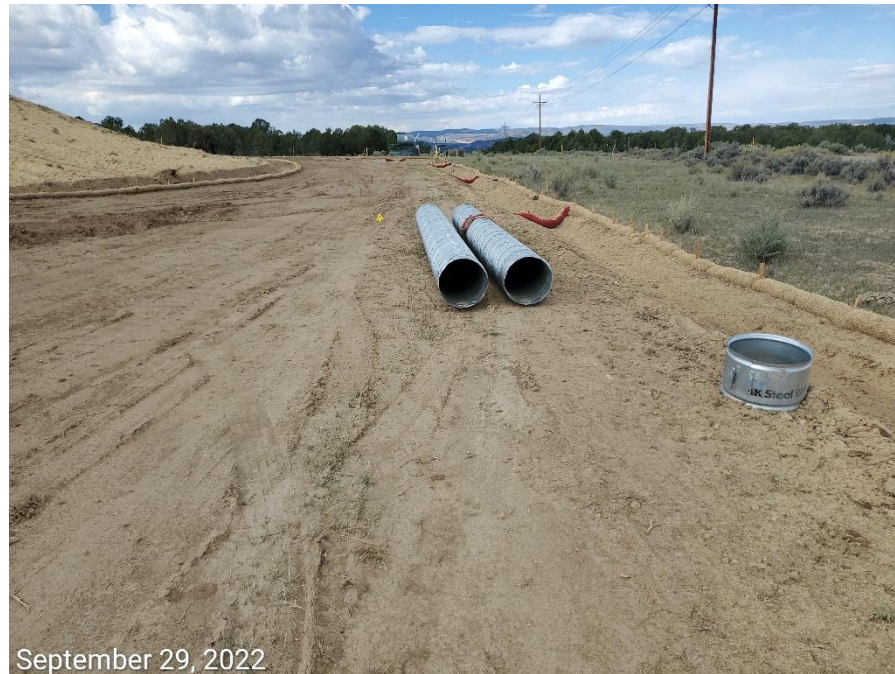
**Photo 6:** Photos show northwestern location entrance. Entrance not yet constructed, and culvert BMPs not yet installed.

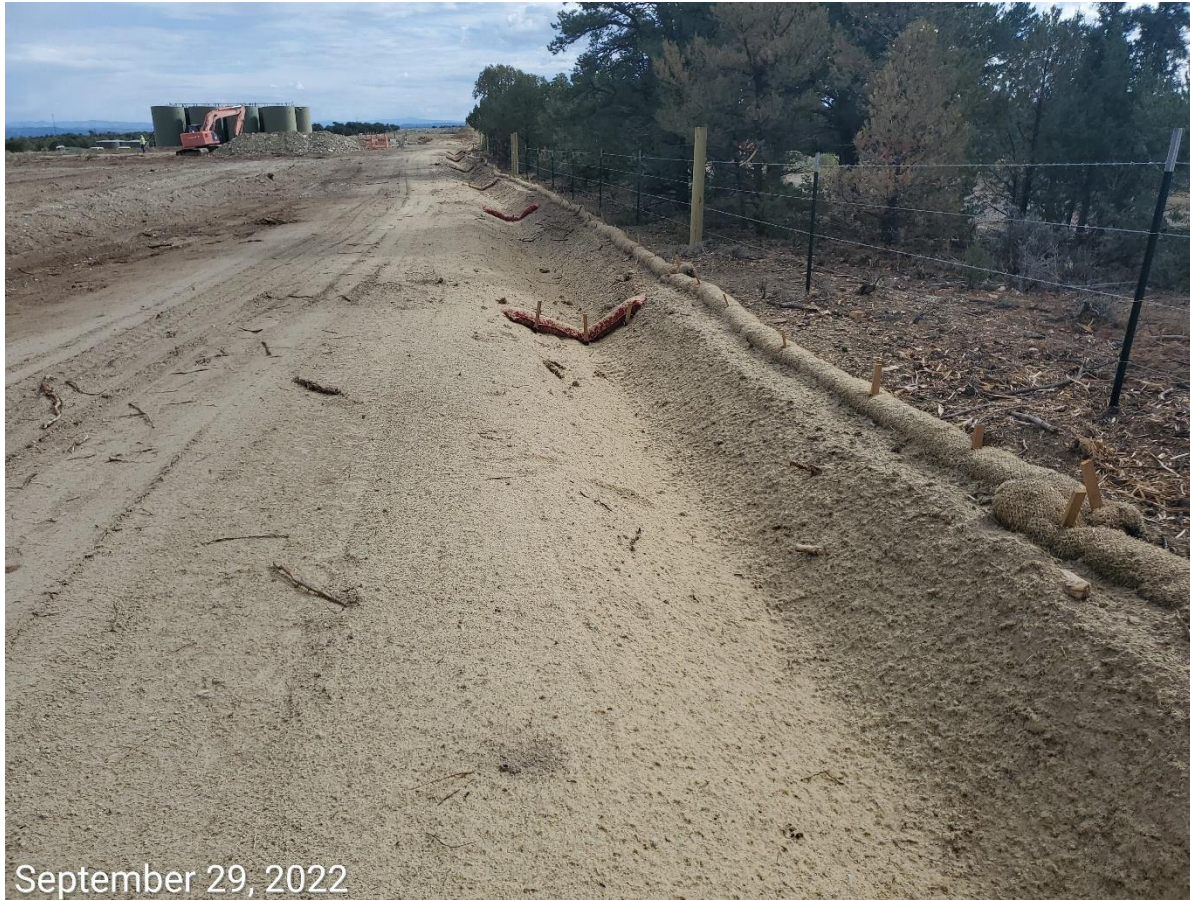
**Photo 7:** Photo provides example of the stormwater diversion ditch constructed along perimeter of the Location. BMP has been constructed with an appropriate grade and consolidation. Erosion logs implemented as velocity checks within ditch. Other controls such as hydromulch, and erosion log berms have been implemented in conjunction with the ditch; BMPs in proper functioning condition at time of inspection.

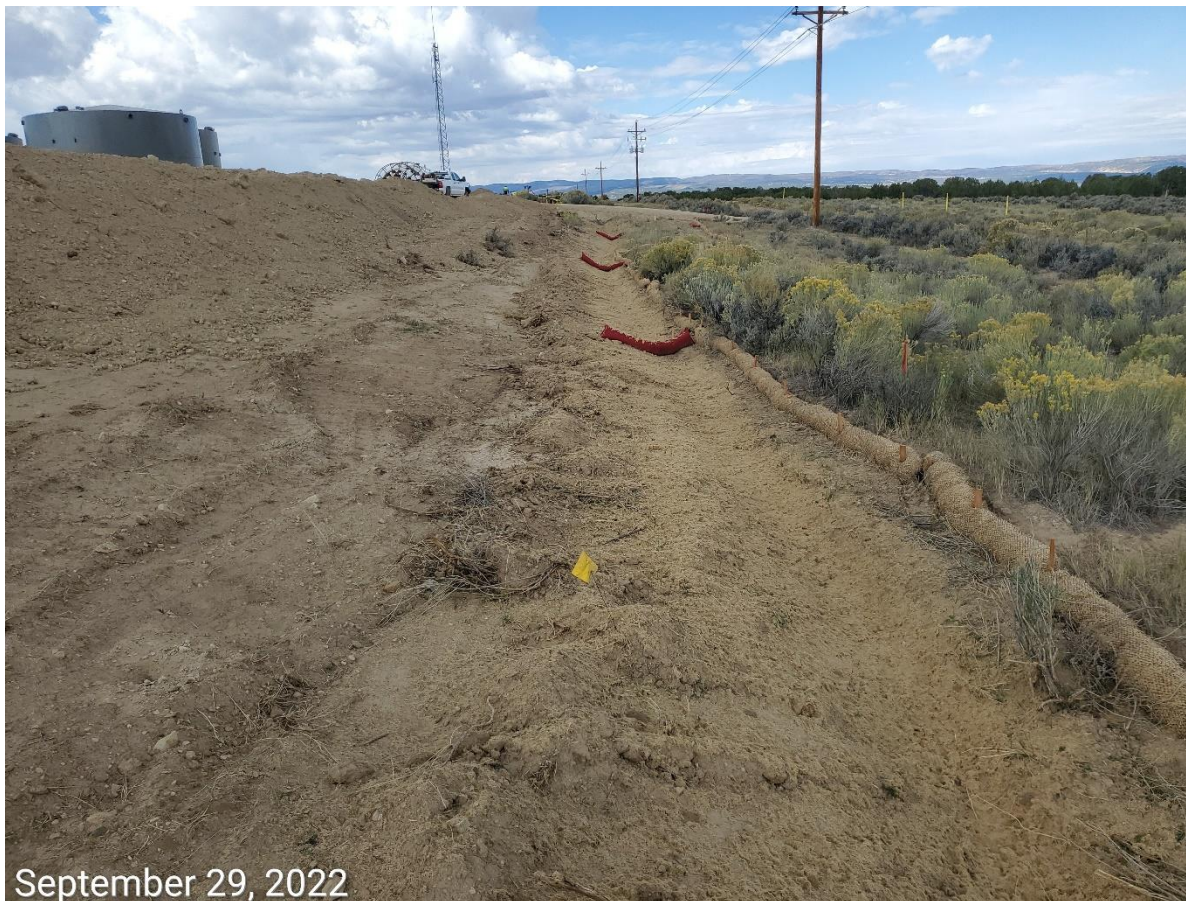
**Photo 8:** Photos 8-9 taken from the stormwater diversion ditch on the northeast end of the Location. Photos show areas where ditch does not appear to be deep enough, and may be unintended points of stormwater discharge.

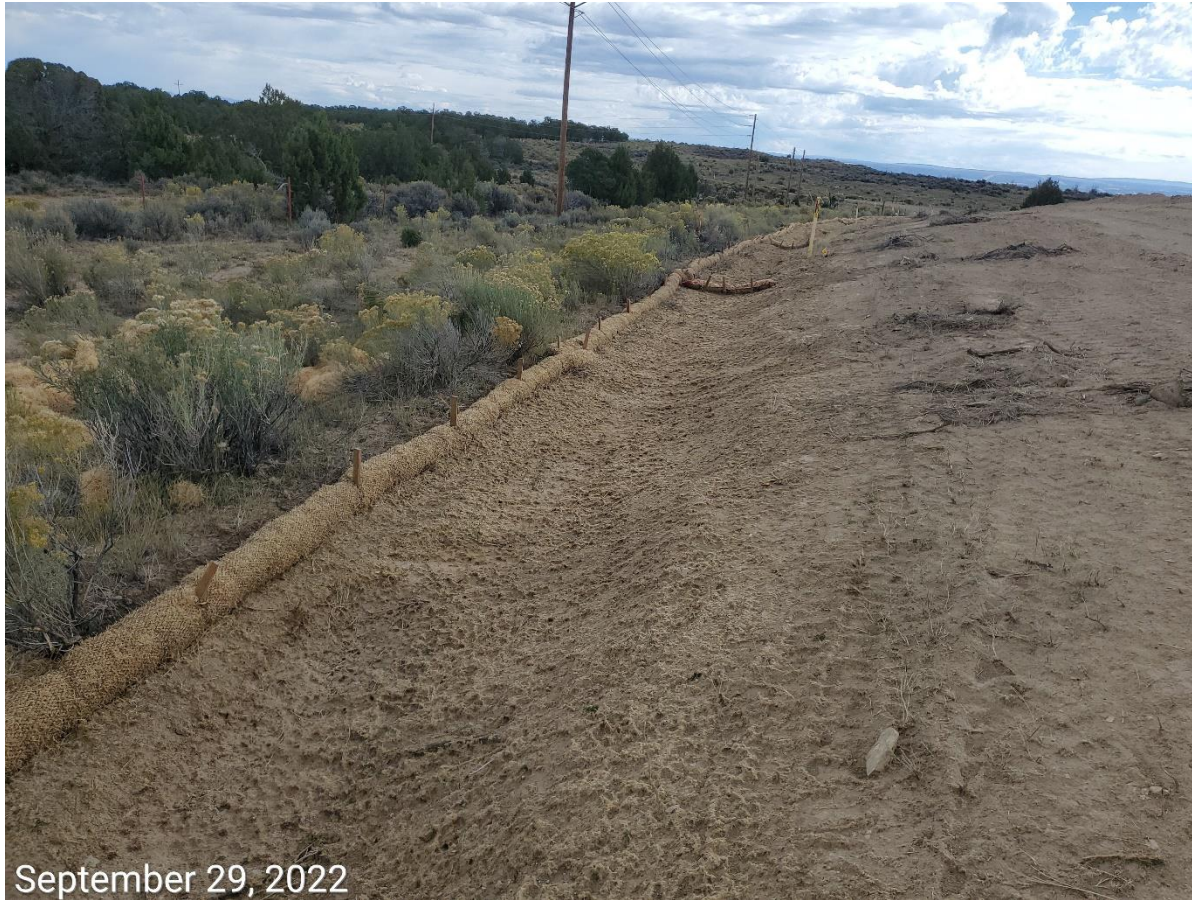
**Photo 9:** See comments under photo 8.

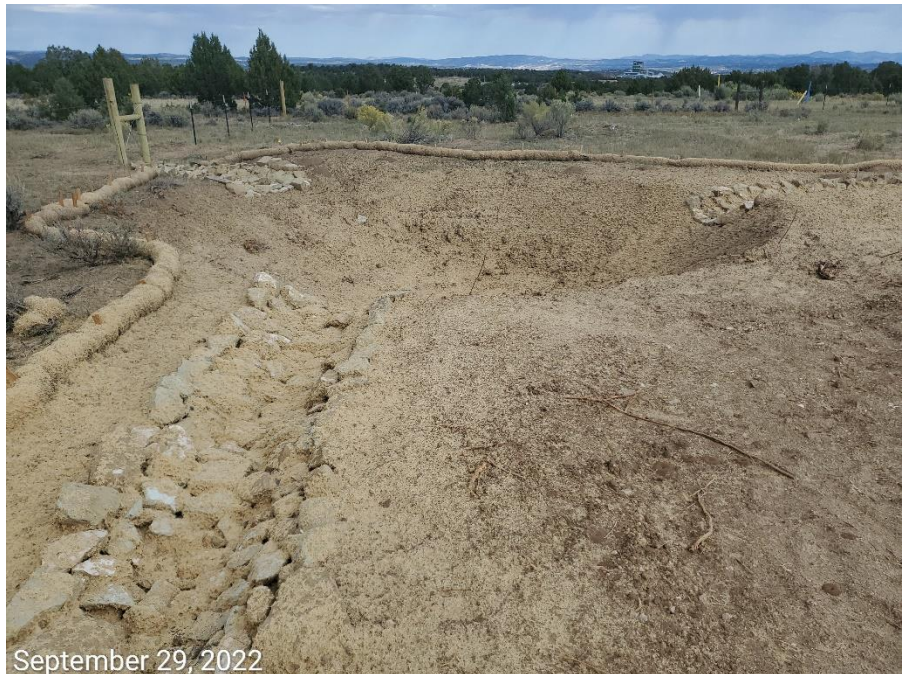
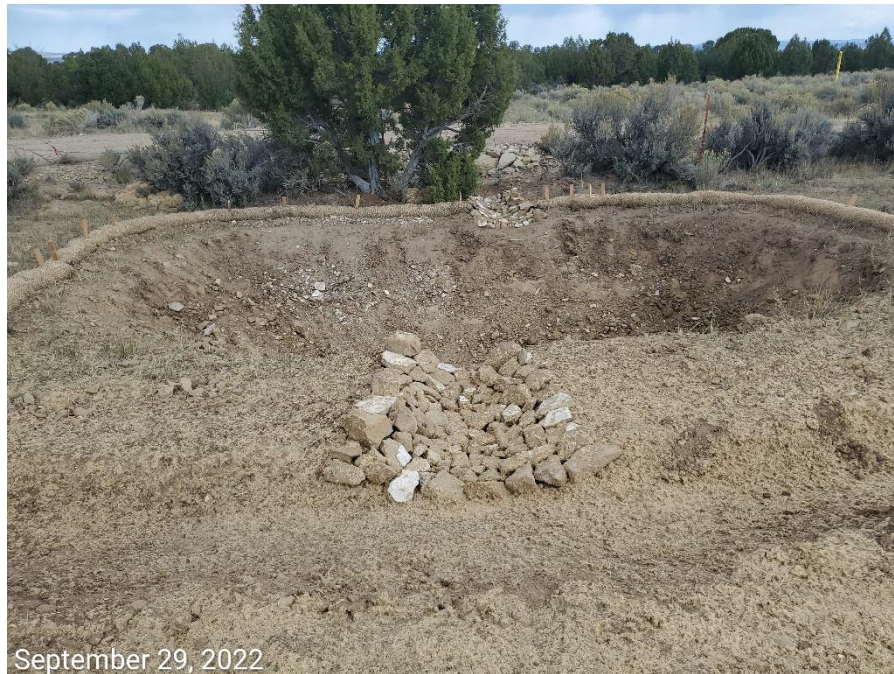
**Photo 10:** Photos 10-11 show sediment traps constructed on the northwest, northern, northeast and southeast ends of the Location.

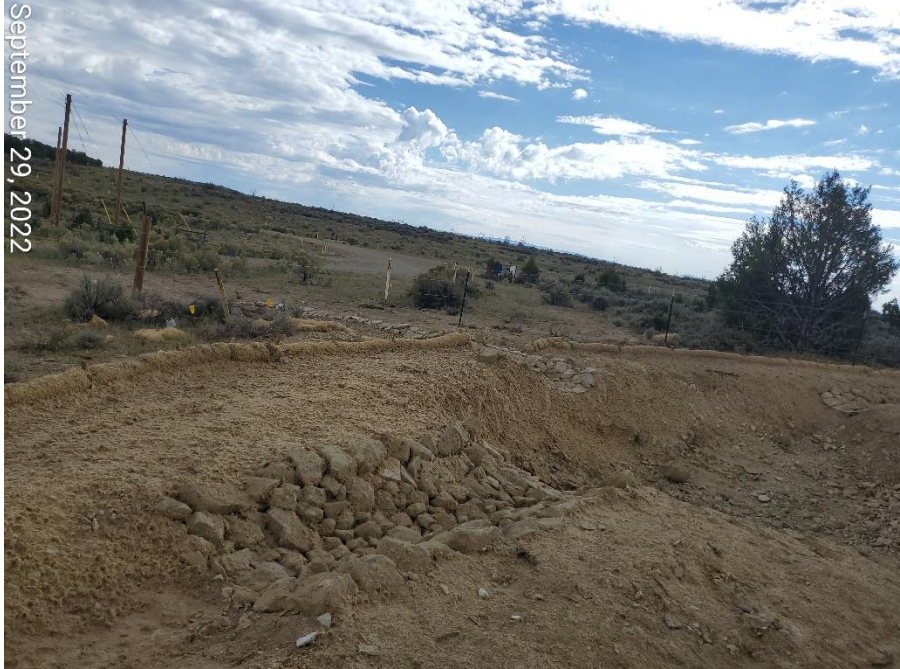
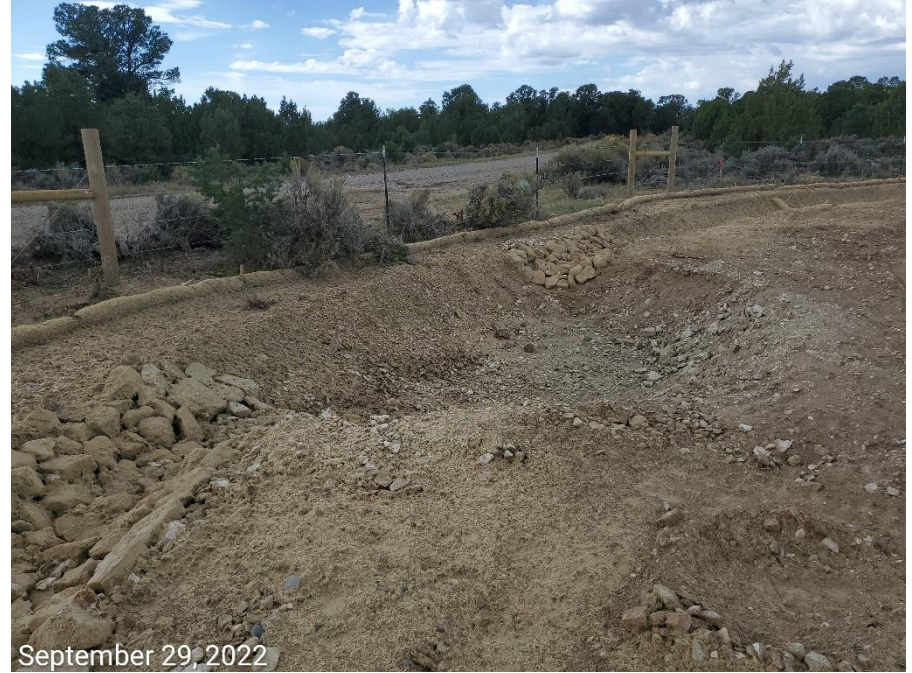
**Photo 11:** See comments under photo 10.

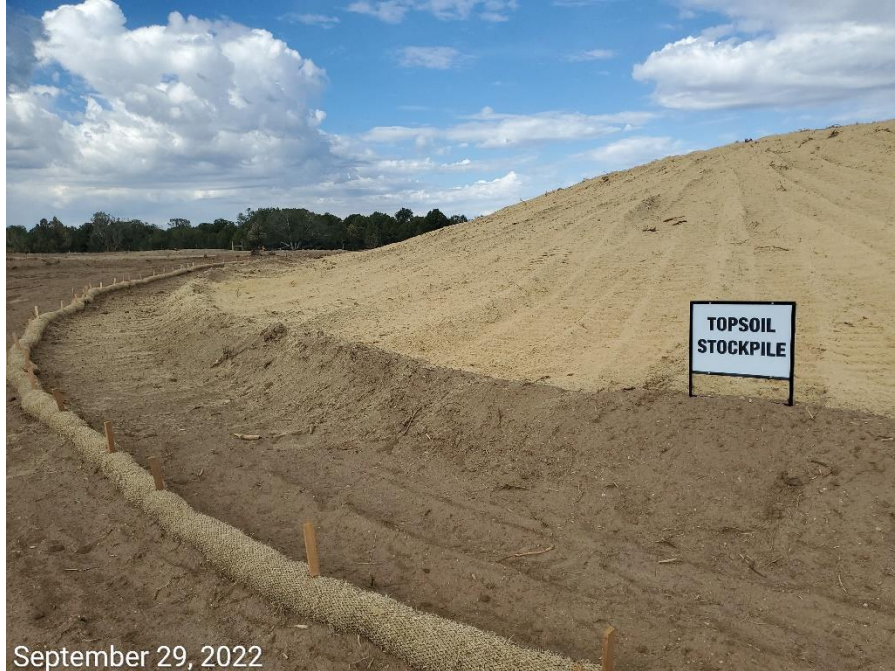
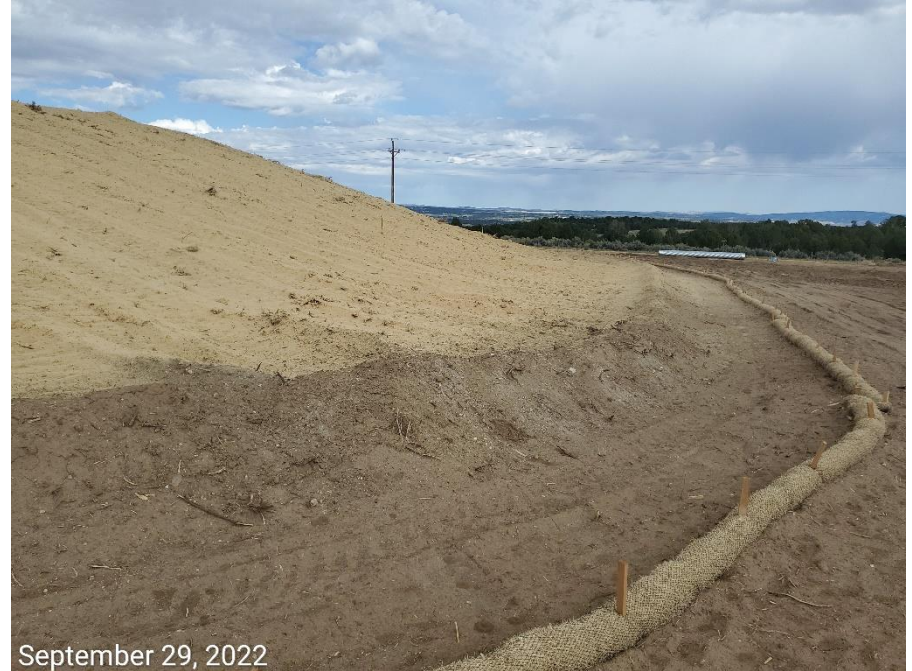
**Photo 12:** Photos show topsoil stockpile on the northwest end of the Location. BMPs (hydromulch, erosion logs, berm) to protect the topsoil stockpile, as well as to minimize erosion and sediment transport appear to be adequate, and in proper functioning condition at time of inspection.

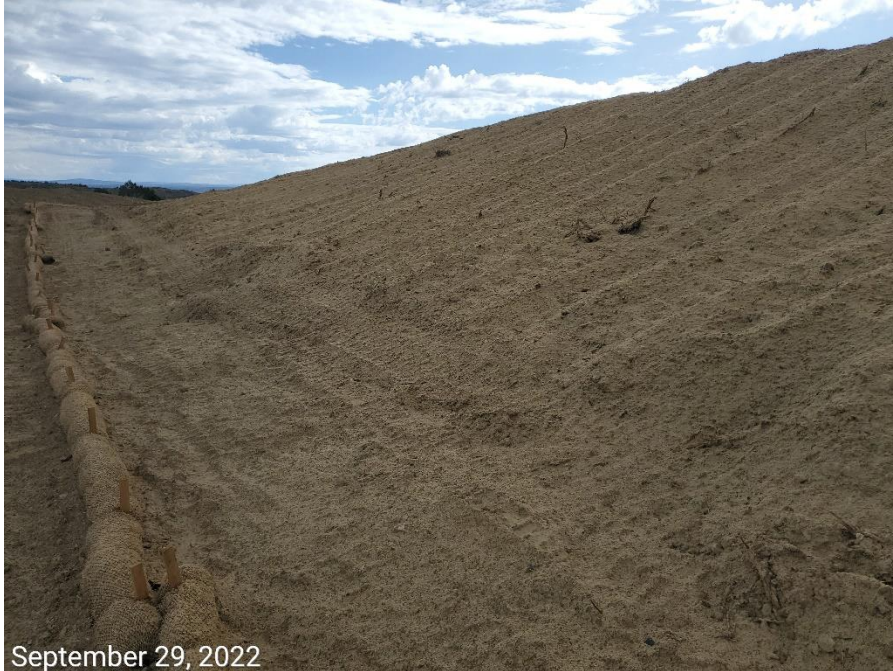
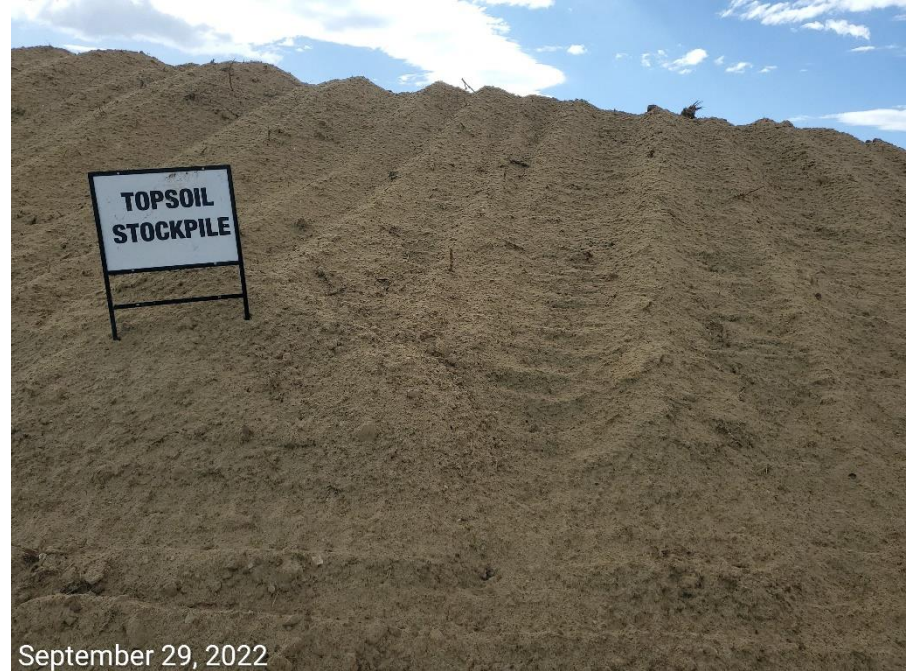
**Photo 13:** Photos show topsoil stockpile on the southeast end of the Location. See comments under photo 12.

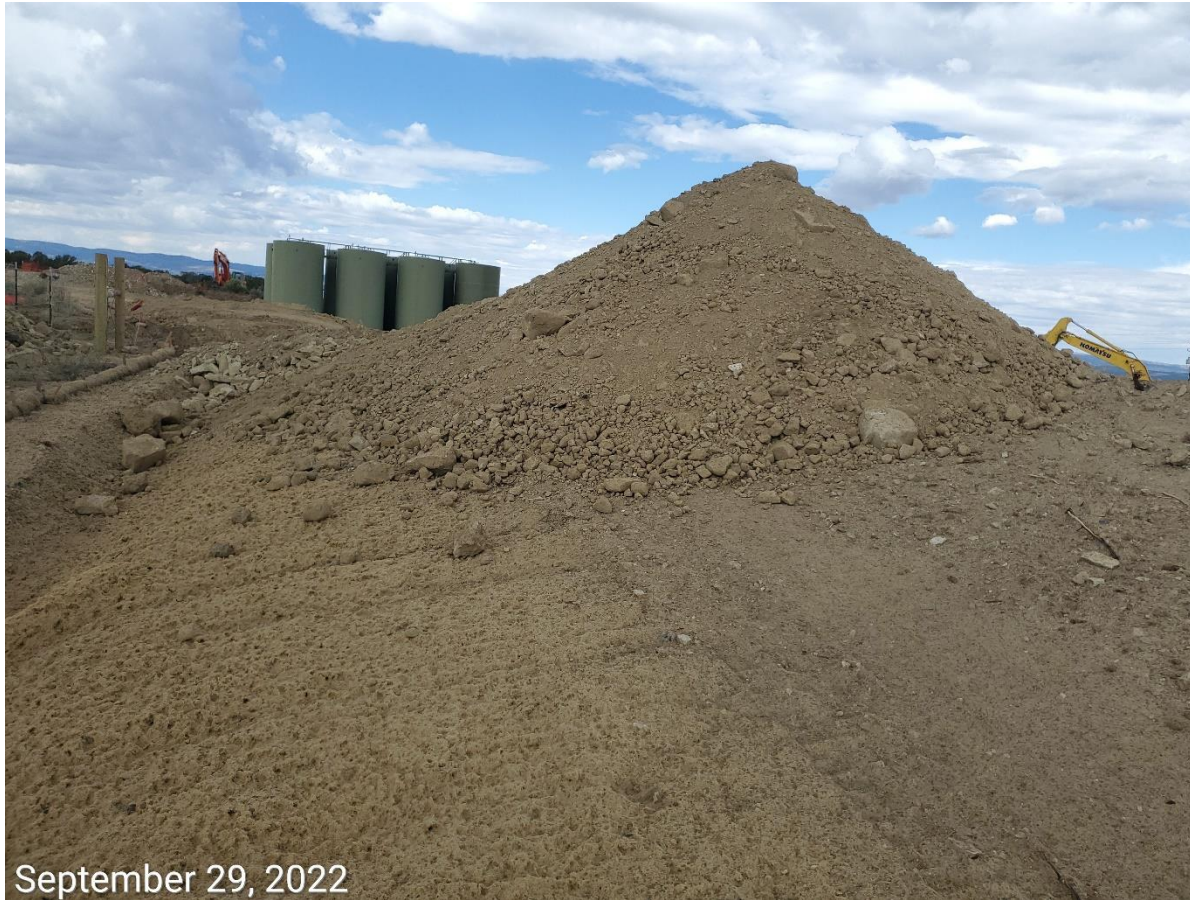
**Photo 14:** Photos 14-18 provide examples of soil stockpiles observed throughout the location missing BMPs to protect the stockpiles, and minimize erosion, degradation and sediment transport.

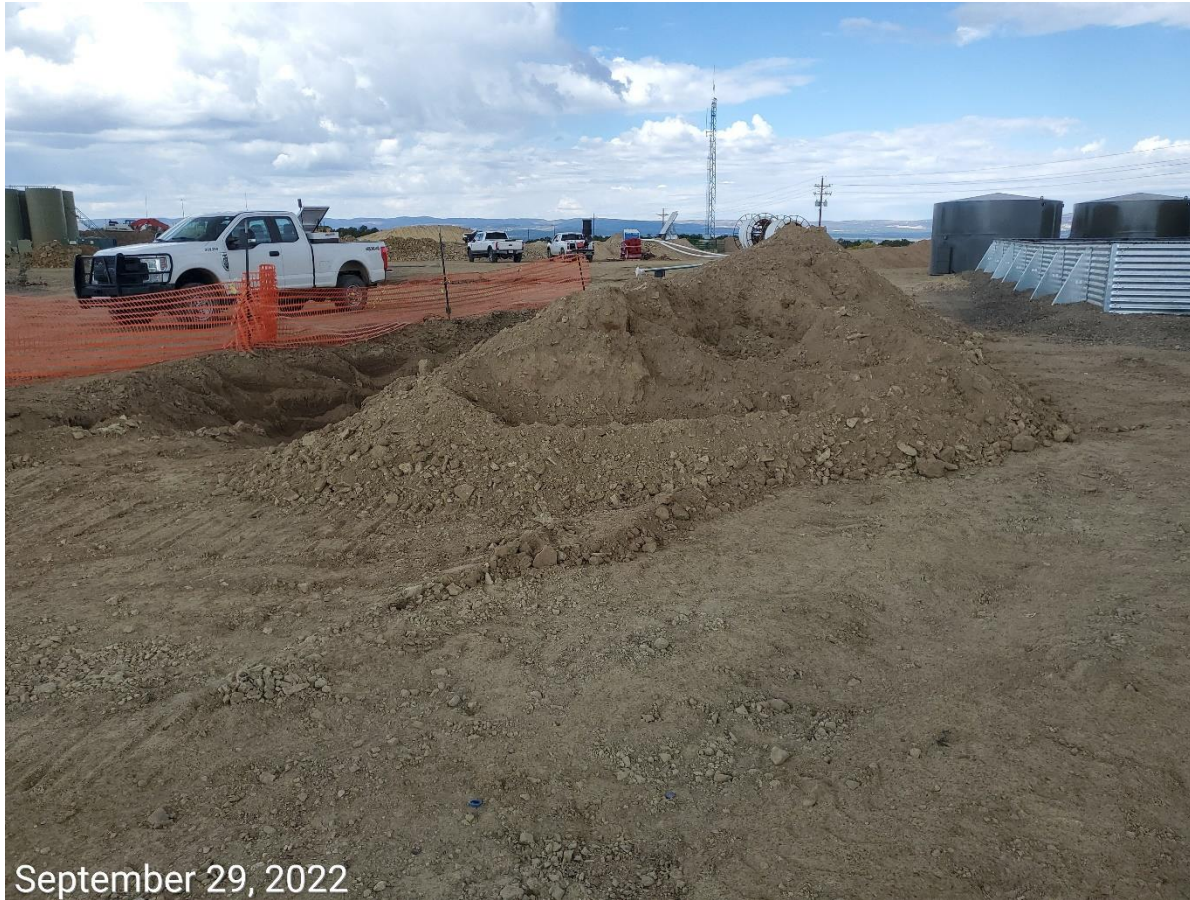
**Photo 15:** See comments under photo 14.

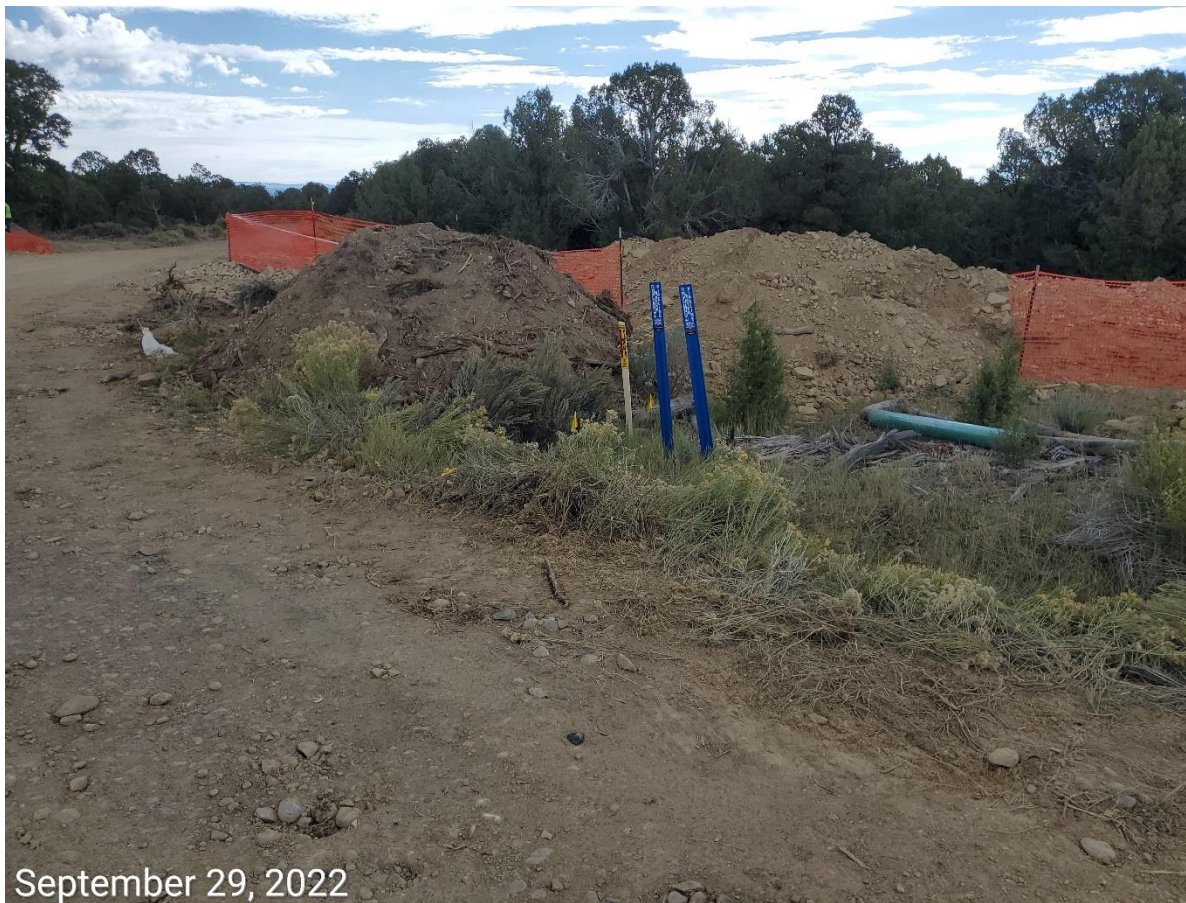
**Photo 16:** Photos 16-18 taken from the pipeline operations on the north end of the Location, and adjacent to the access road adjacent to the Location. See comments under photo 14. Photos examples of soil stockpiles observed missing BMPs to protect the stockpiles, and minimize erosion, degradation and sediment transport. Photos also show topsoil has been salvaged and segregated during excavation operations.

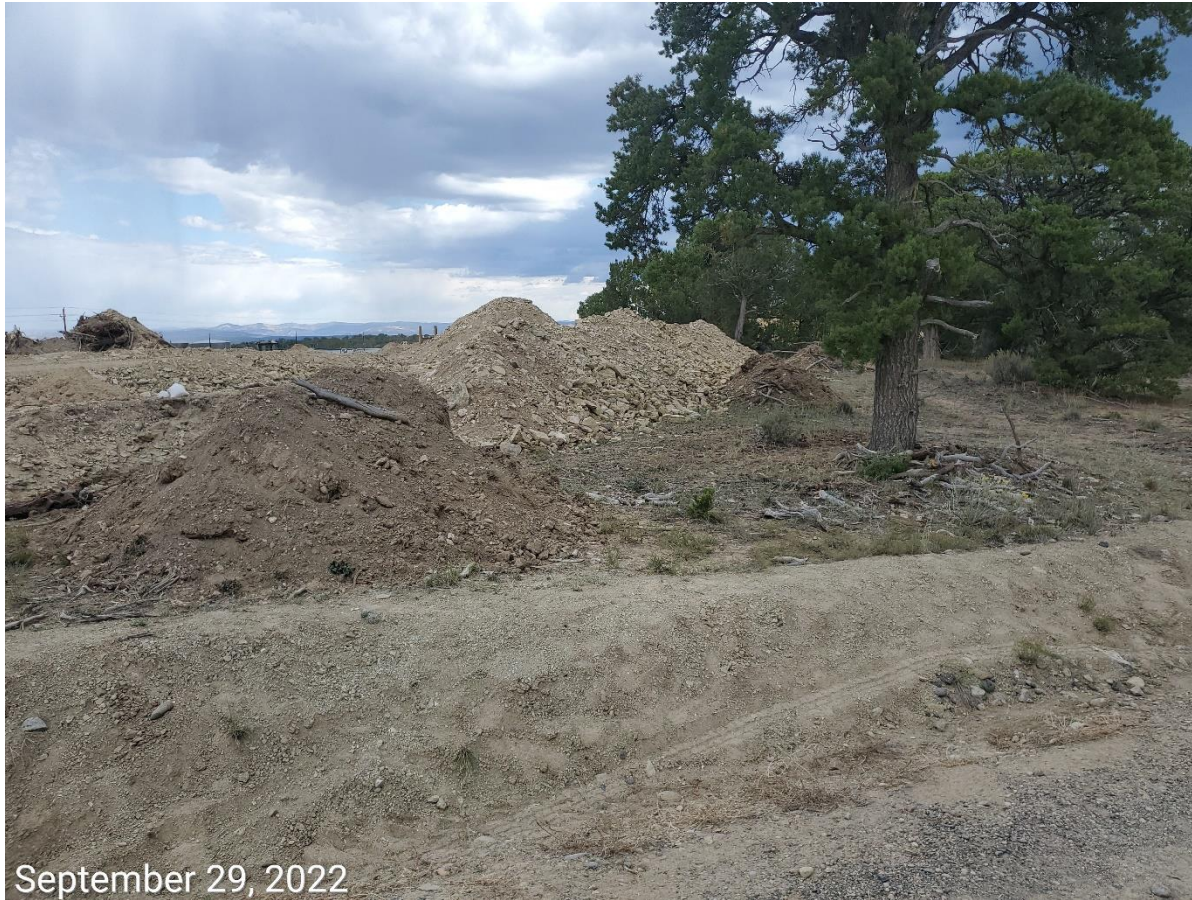
**Photo 17:** See comments under photo 16.

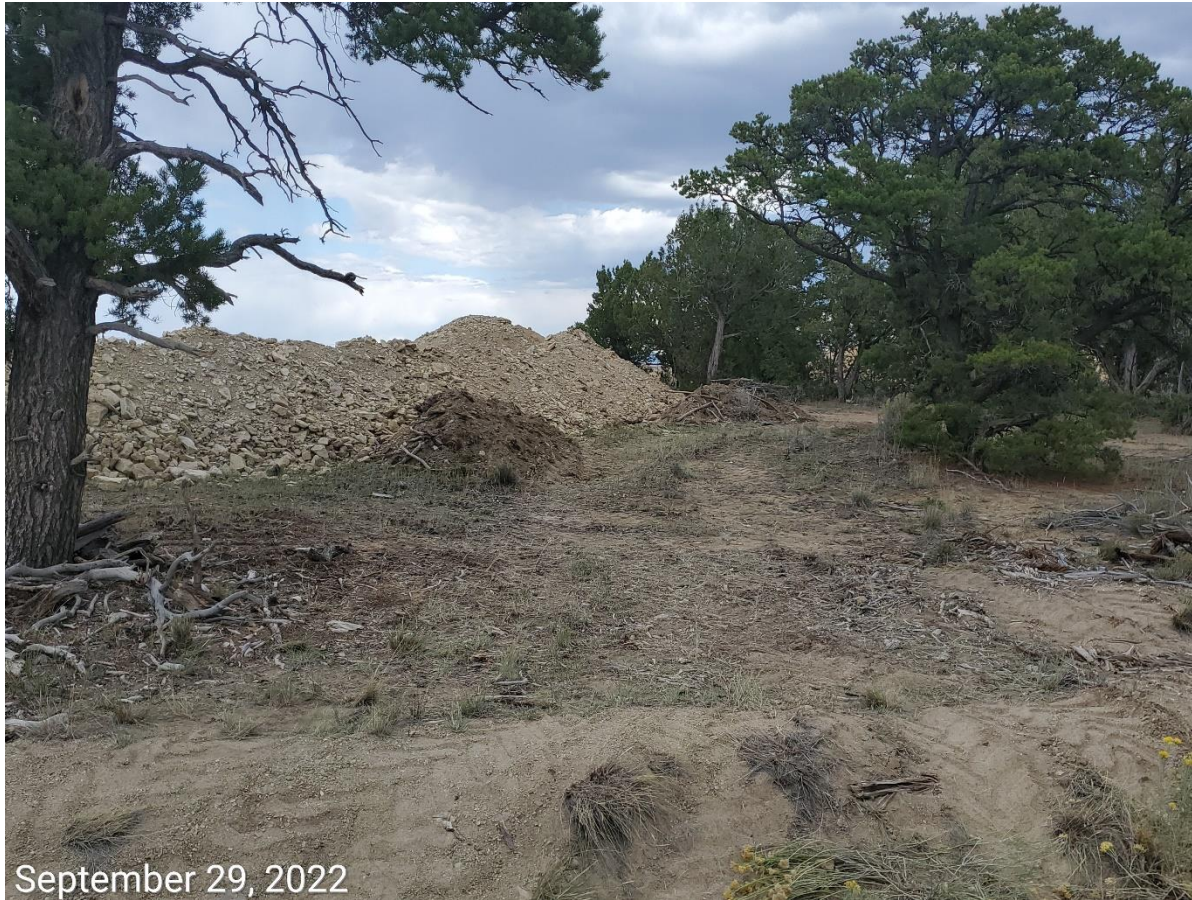
**Photo 18:** See comments under photo 16..

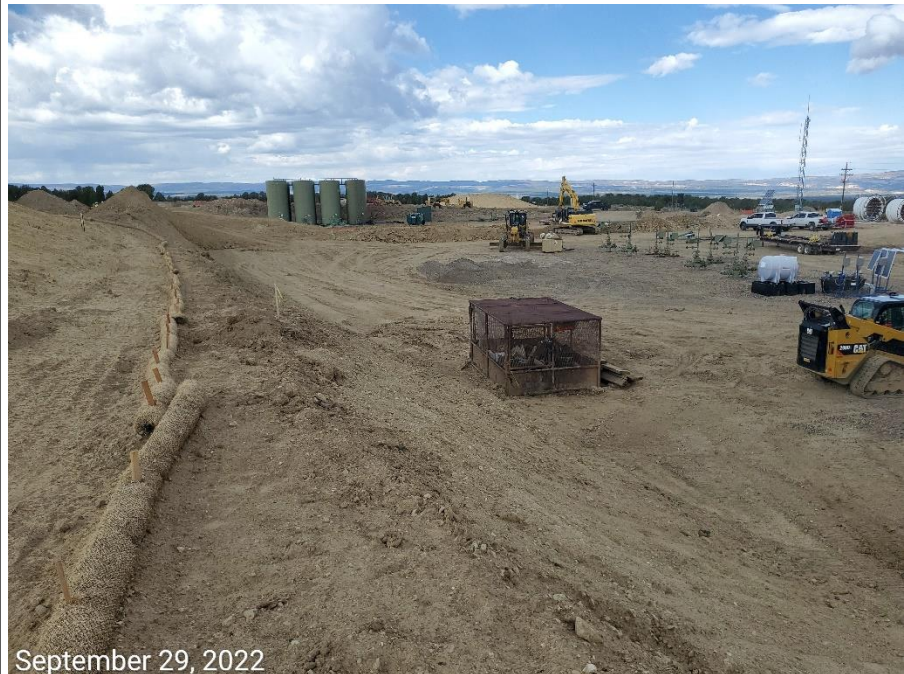
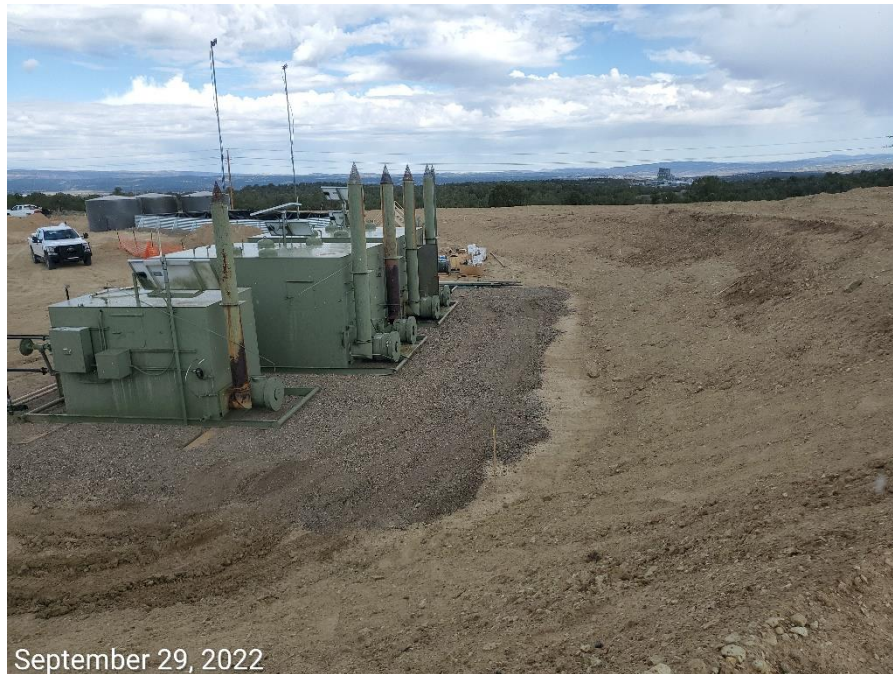
**Photo 19:** Photos taken from the southeast of the current production area. Photos provide an overview from west to north. Photos also show separator equipment have been moved to the east end of the Location.
