# Inspection Photos and Issue Report

Operator: TEP ROCKY MOUNTAIN LLC #  
96850

Location #439690  
Rio Blanco County, CO

# TEP, Pitchers Mount WRF, #439690 Annotation Report

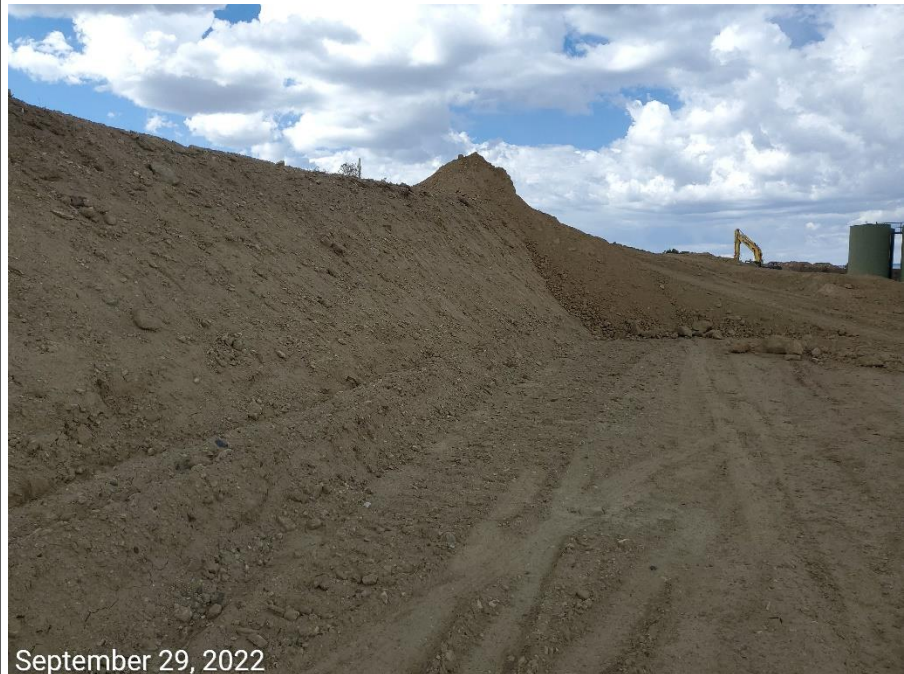
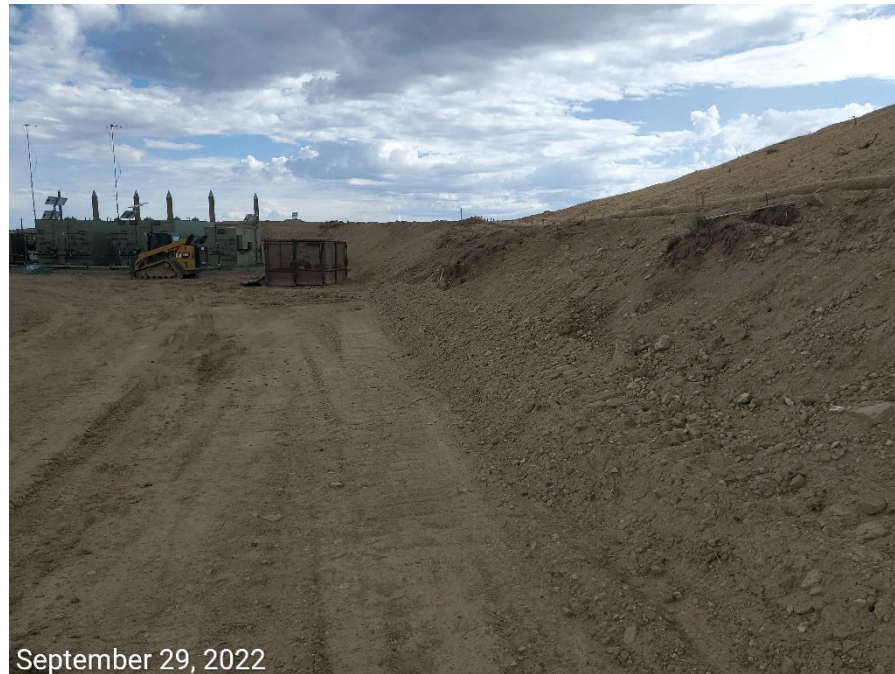
**Photo 20:** Photos example of current cut slopes of the Location. Construction operations currently in-pricess; BMPs to protect and stabilize slopes will be required.

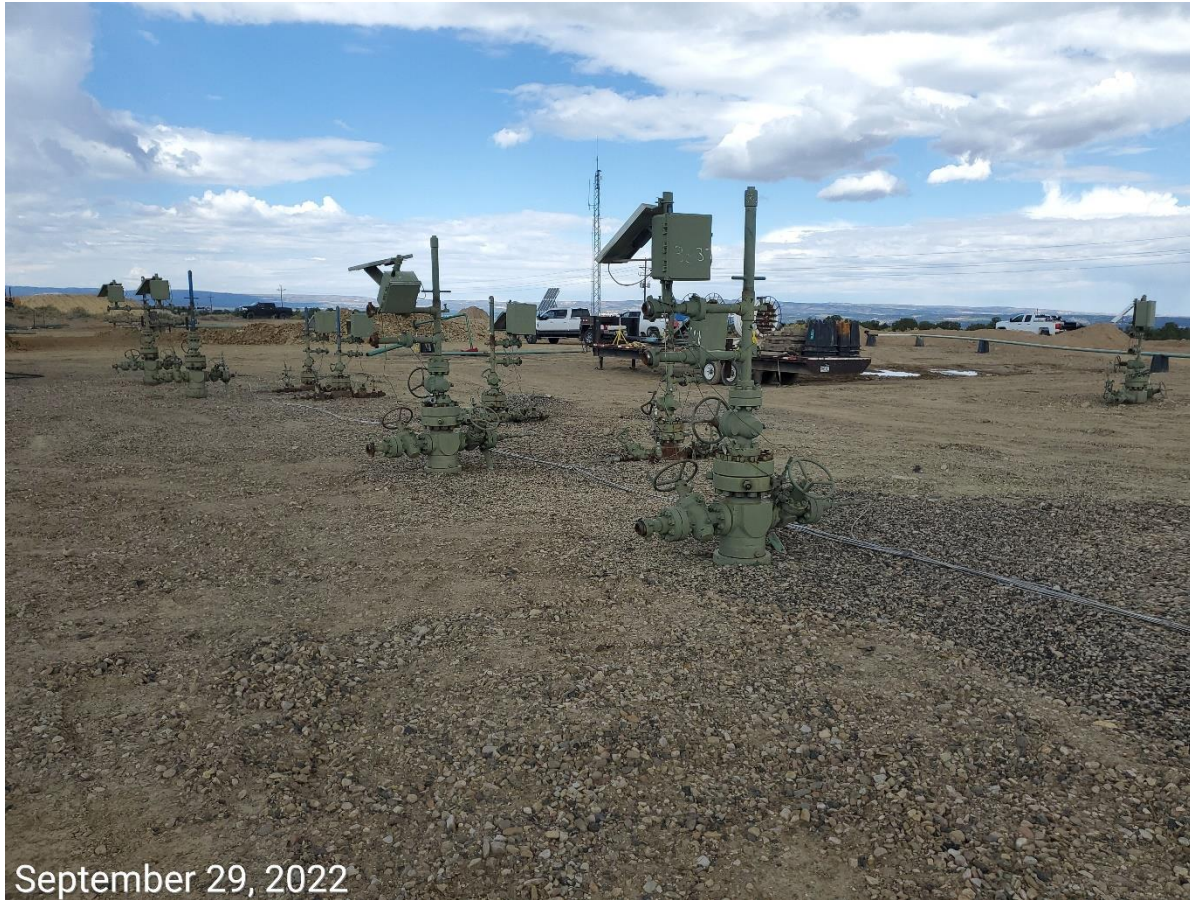
**Photo 21:** Photo shows permanent signage missing from the wells on the Location.

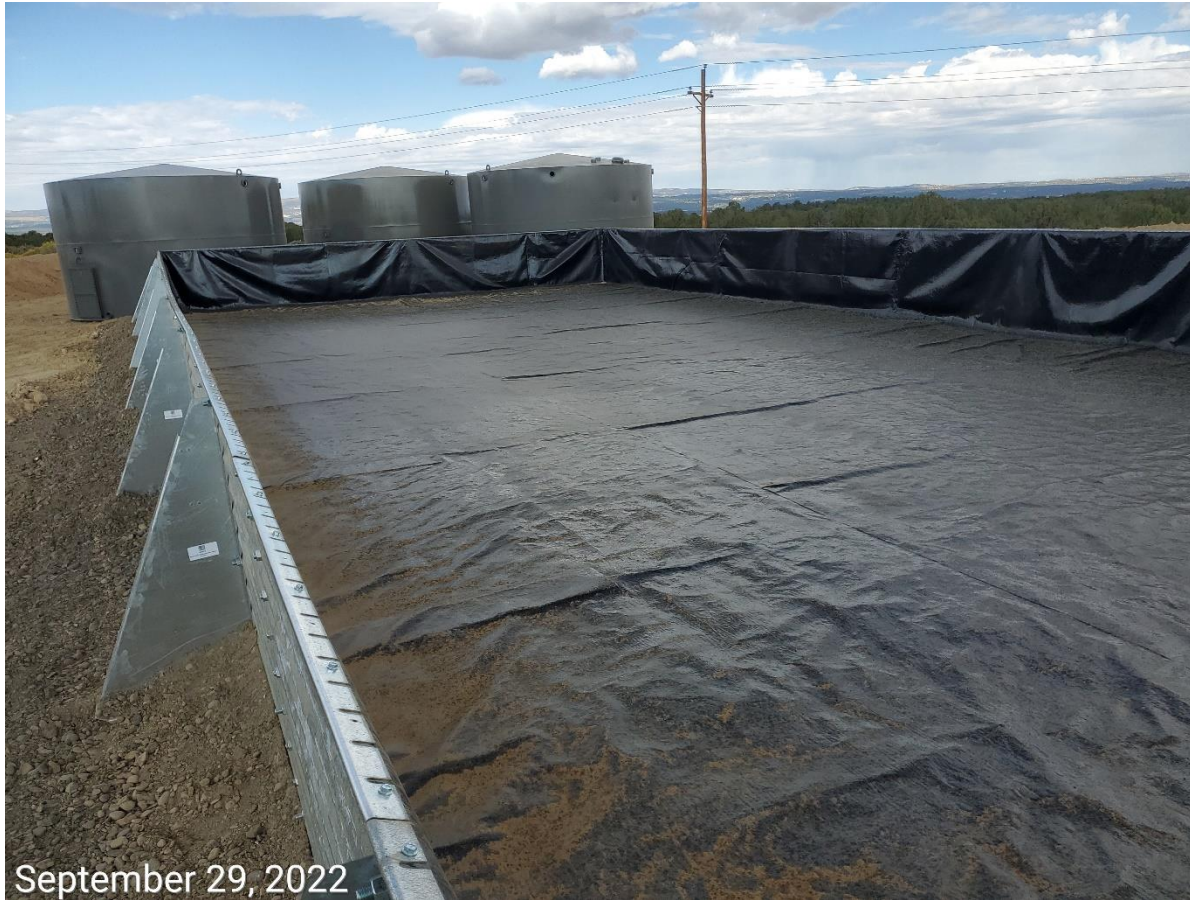
**Photo 22:** Photo shows tank facility being installed on the northeast end of the Location.

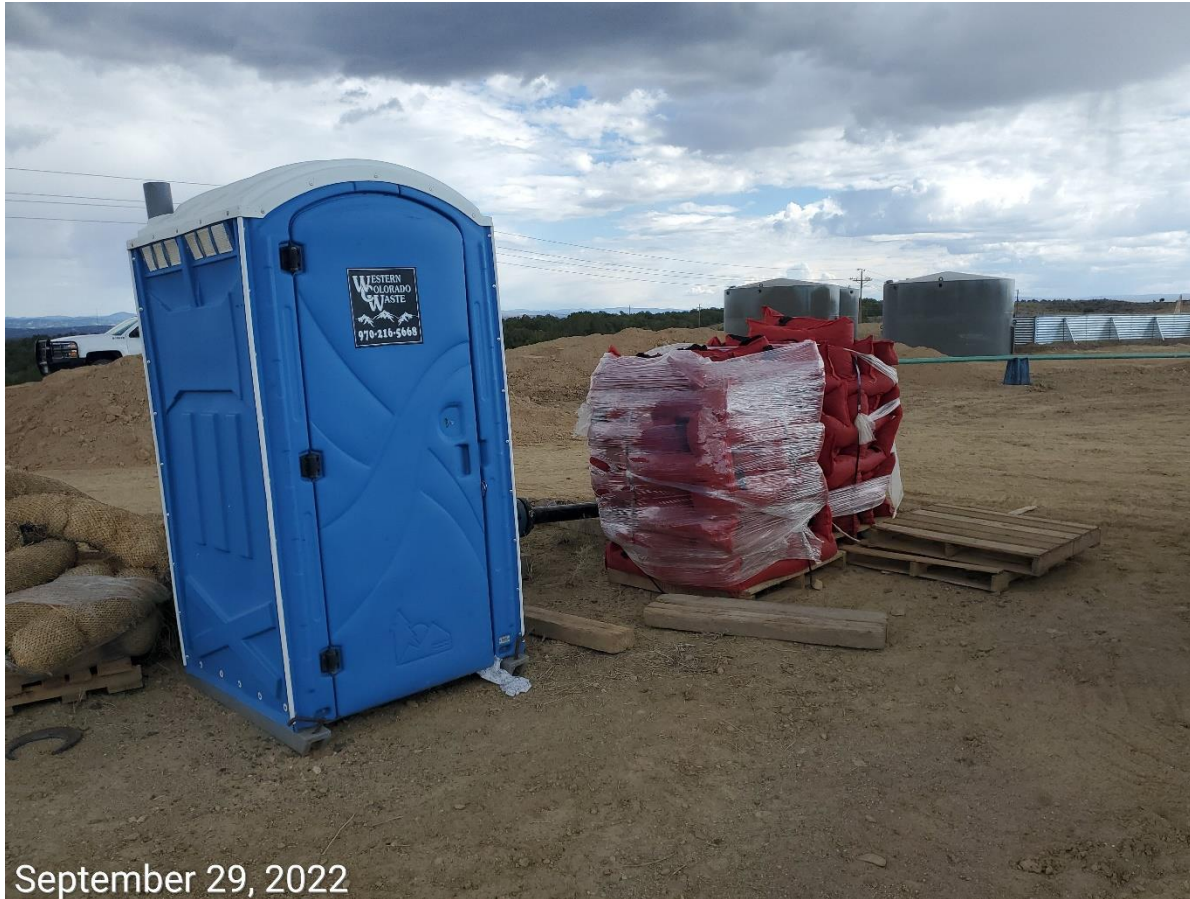
**Photo 23:** Porta-john on location with spill prevention BMPs; unit has been staked and secured.
