Inspection Photos
Location Name: Pine River 04-32 1
Location ID: 325489

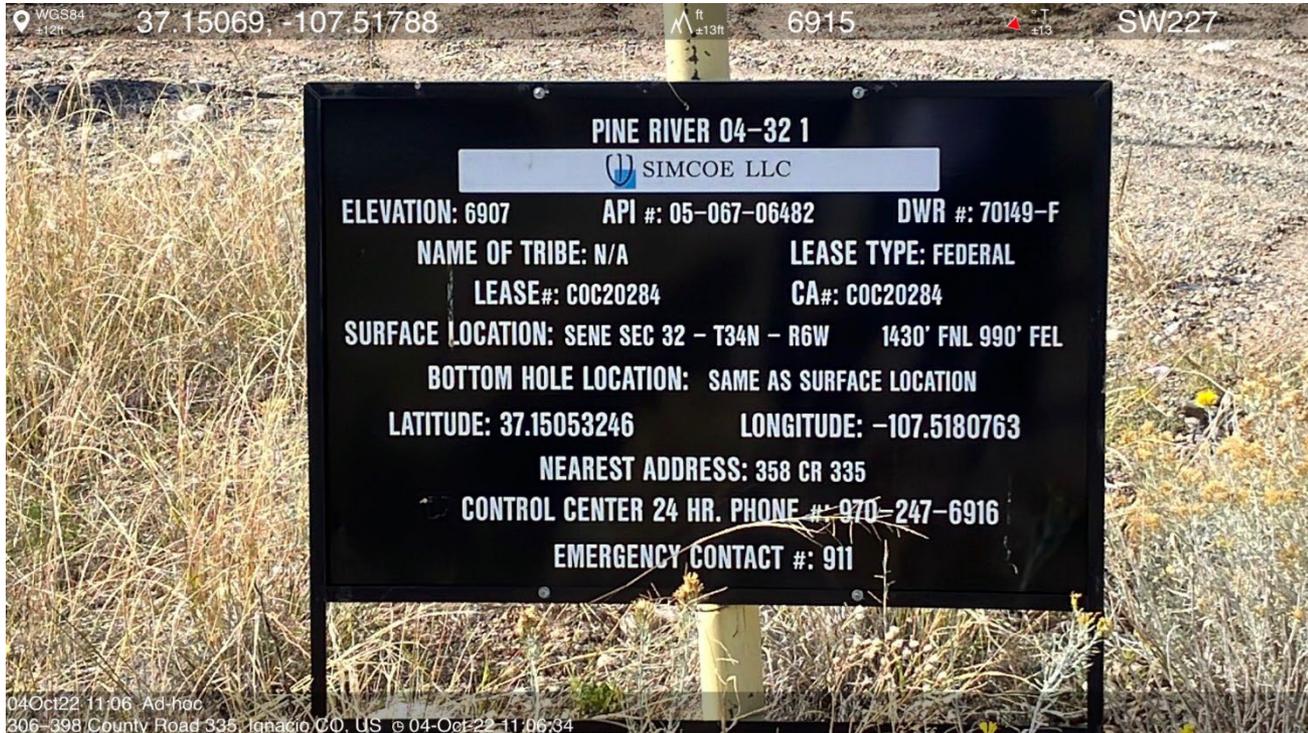
IMG 01
Well sign

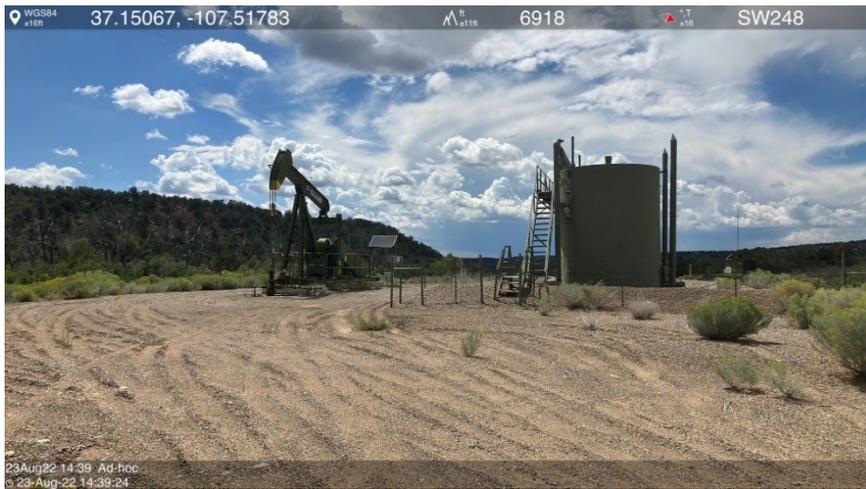
IMG 03
Location overview 8/23/22

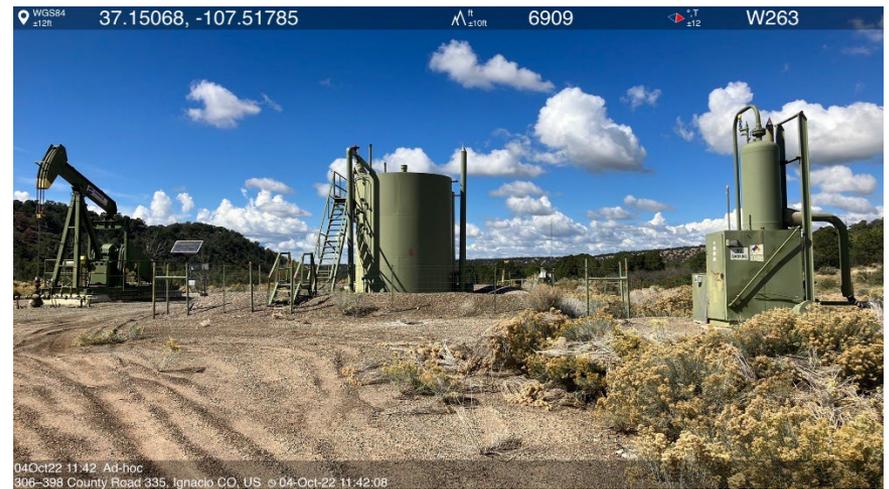
IMG 04
Location overview 10/4/22

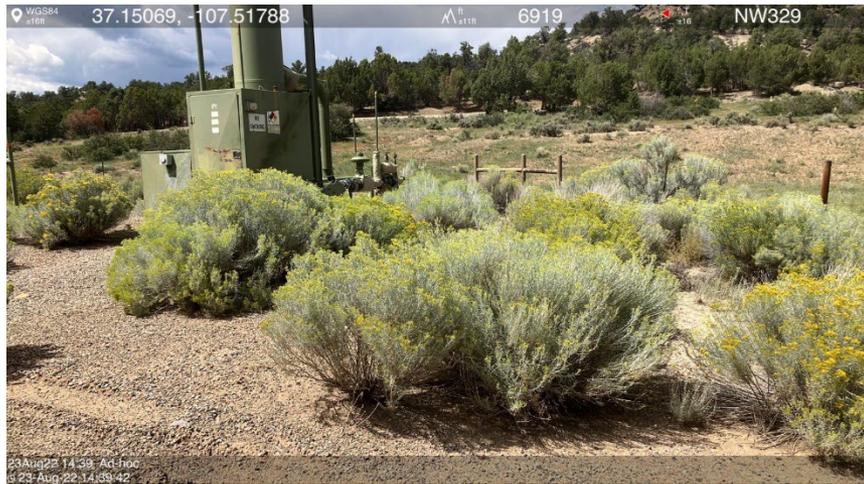
IMG 05
Weeds on 8/23/22

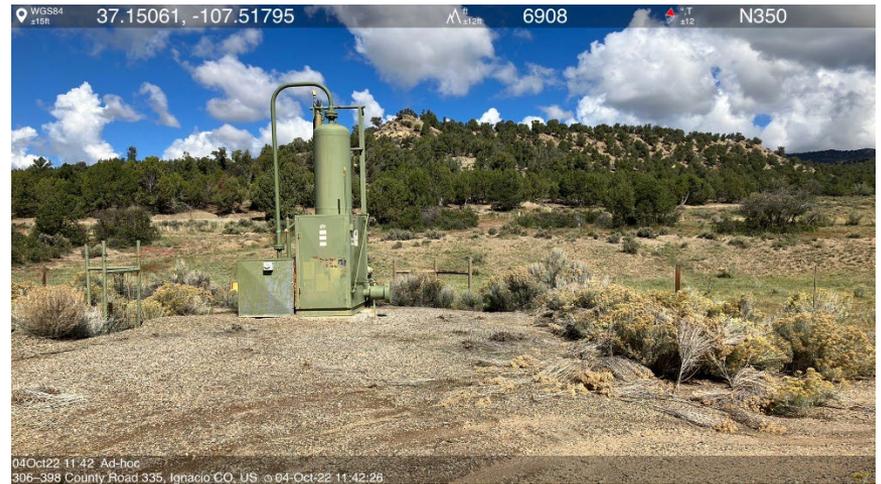
IMG 06
Weeds within 25' of separator, 10/4/22

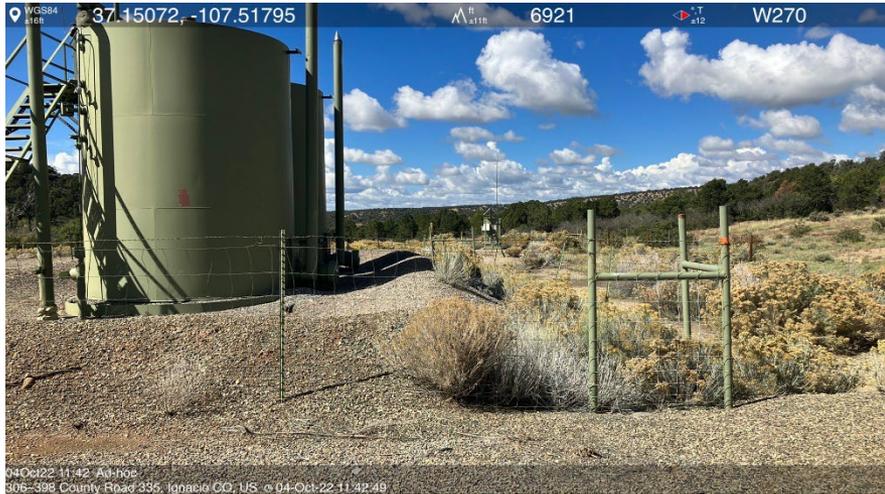
IMG 07

Weeds within 25' of produced water tanks

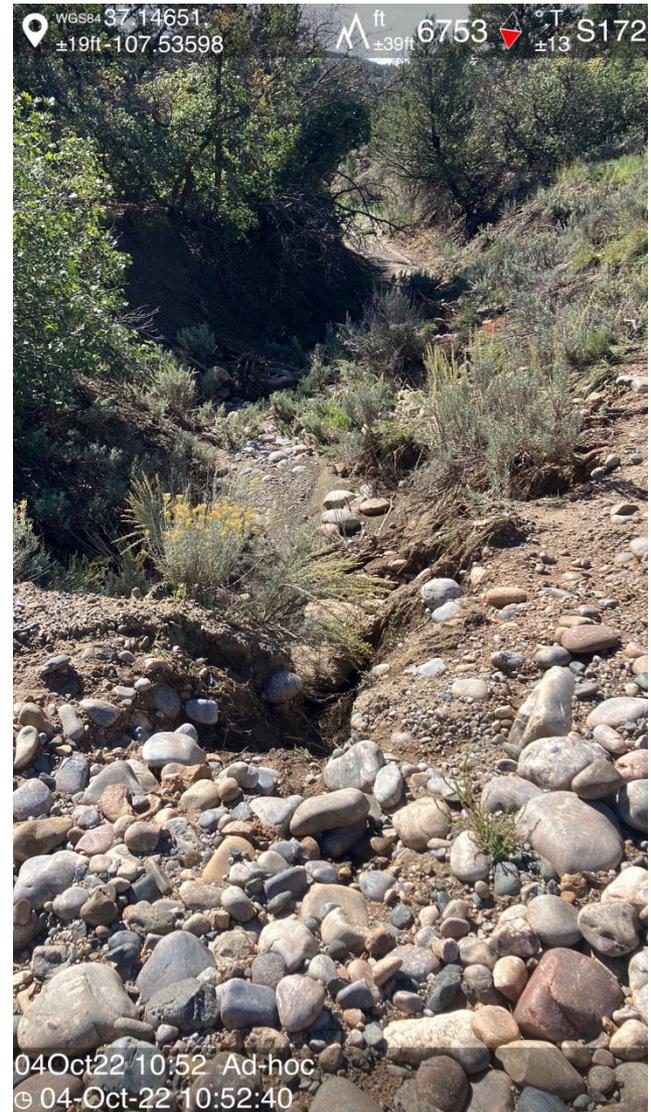
IMG 08

Erosion channel off of access road

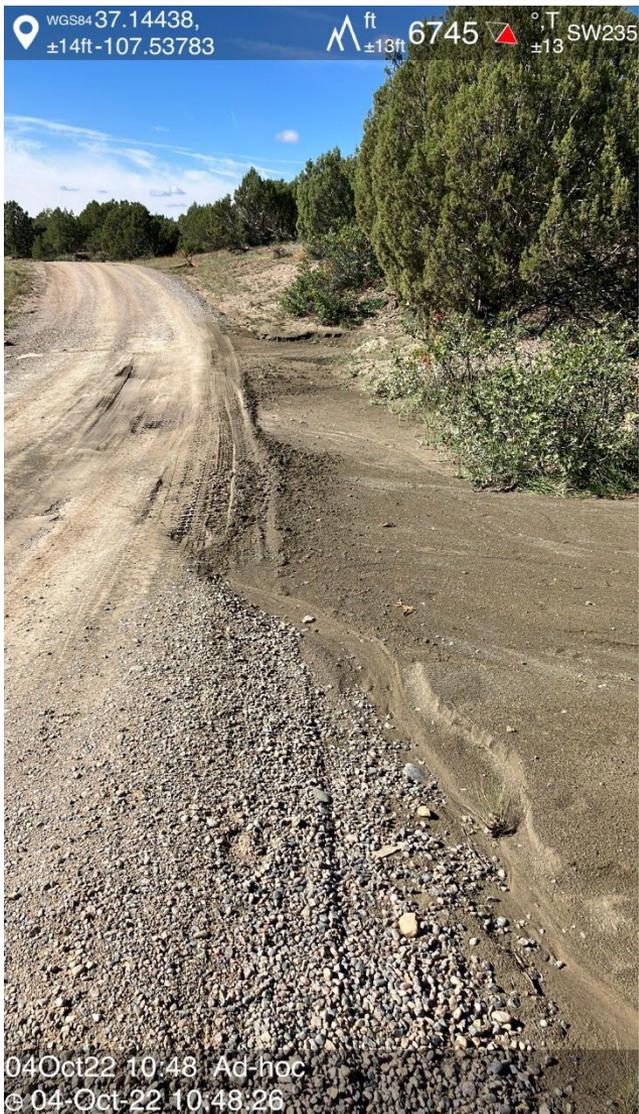
IMG 09

Sediment on access road, ditch is filled, requires post event BMP maintenance

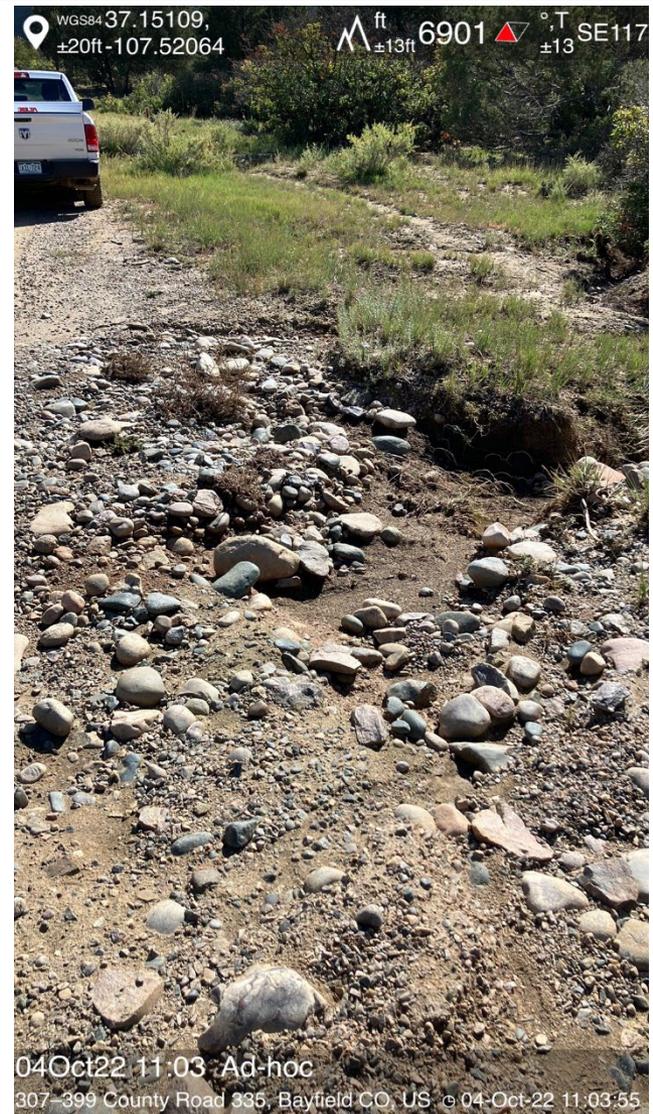
IMG 10

Erosion off of access road

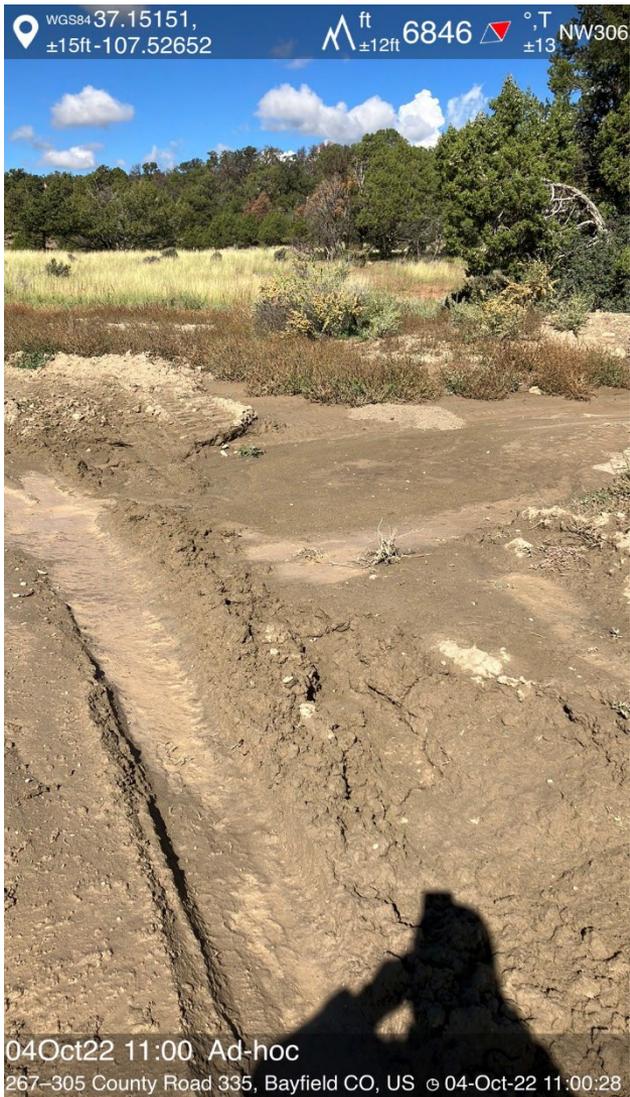
IMG 11

Sediment on access road, culvert inlet is buried, requires post event BMP maintenance

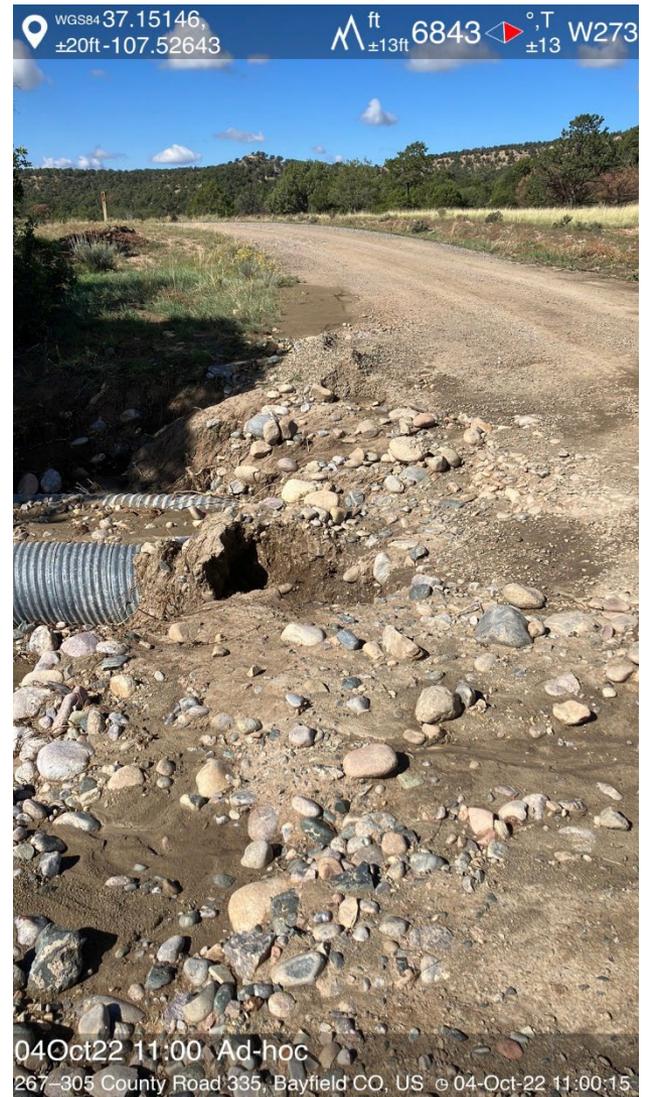
IMG 12

Erosion near culverts

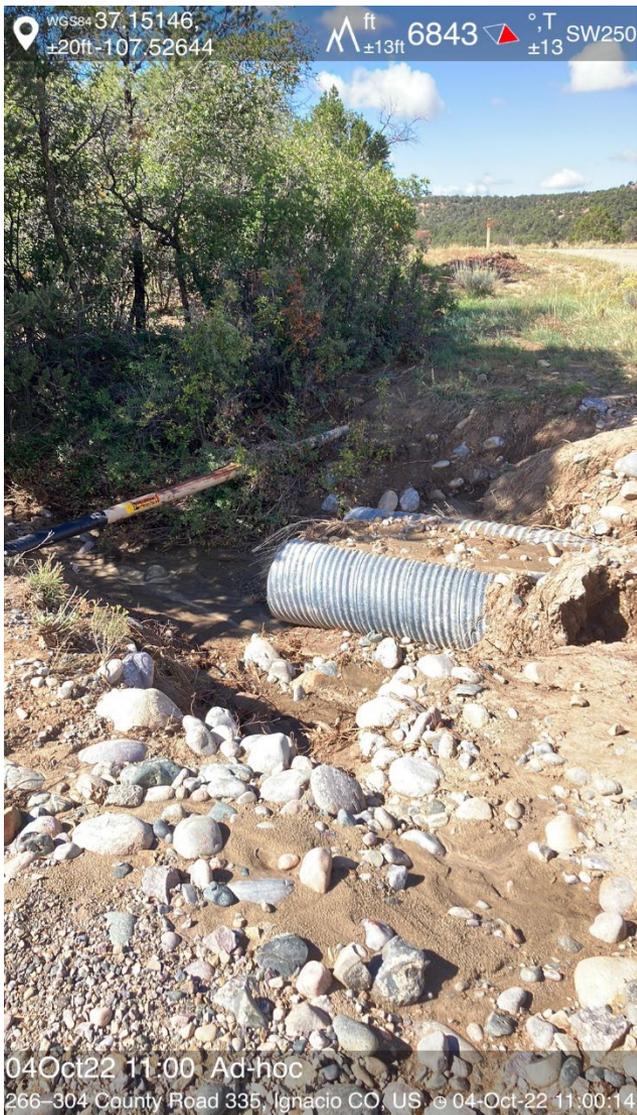
IMG 13

Erosion near culvert. Culvert outlet is unprotected

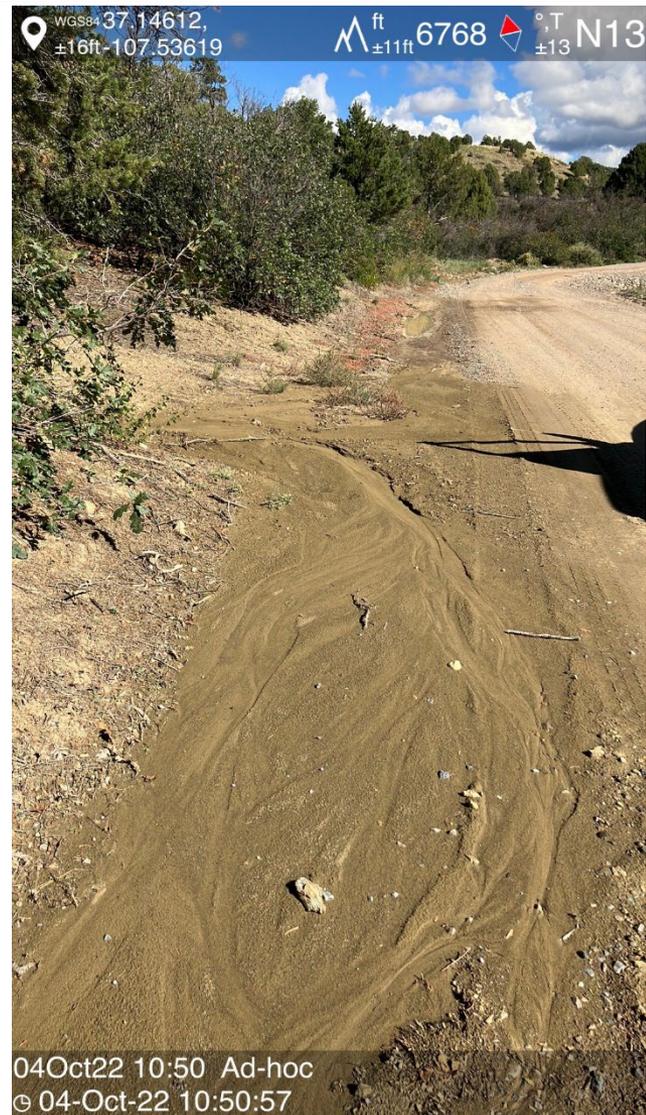
IMG 14

Sediment on access road, ditch requires post event BMP maintenance

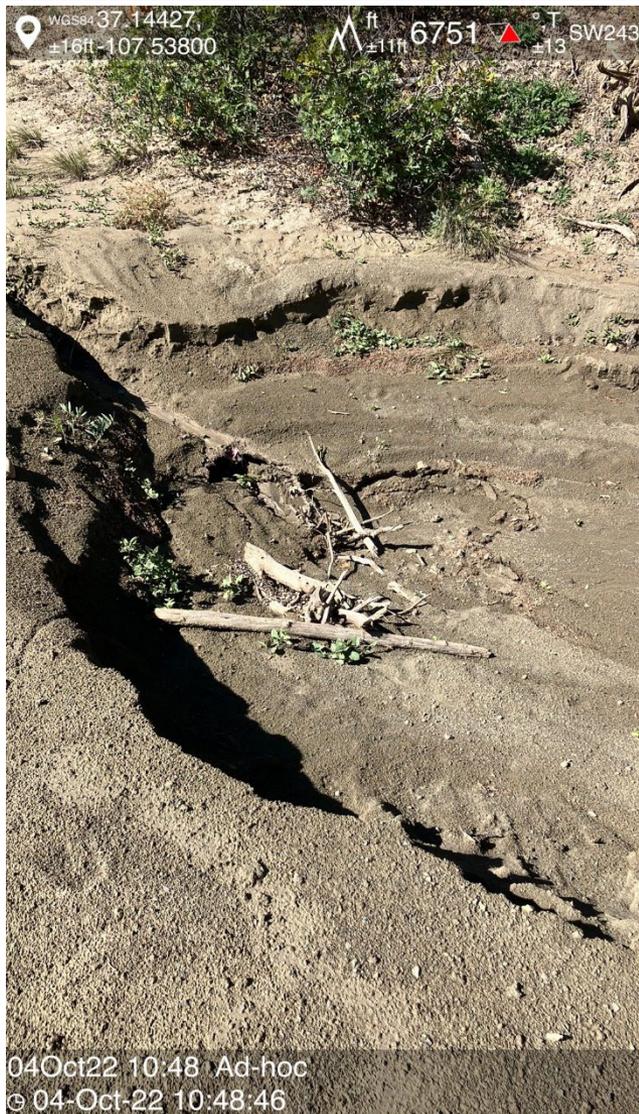
IMG 15

Culvert Inlet is buried, ditch requires post event BMP maintenance

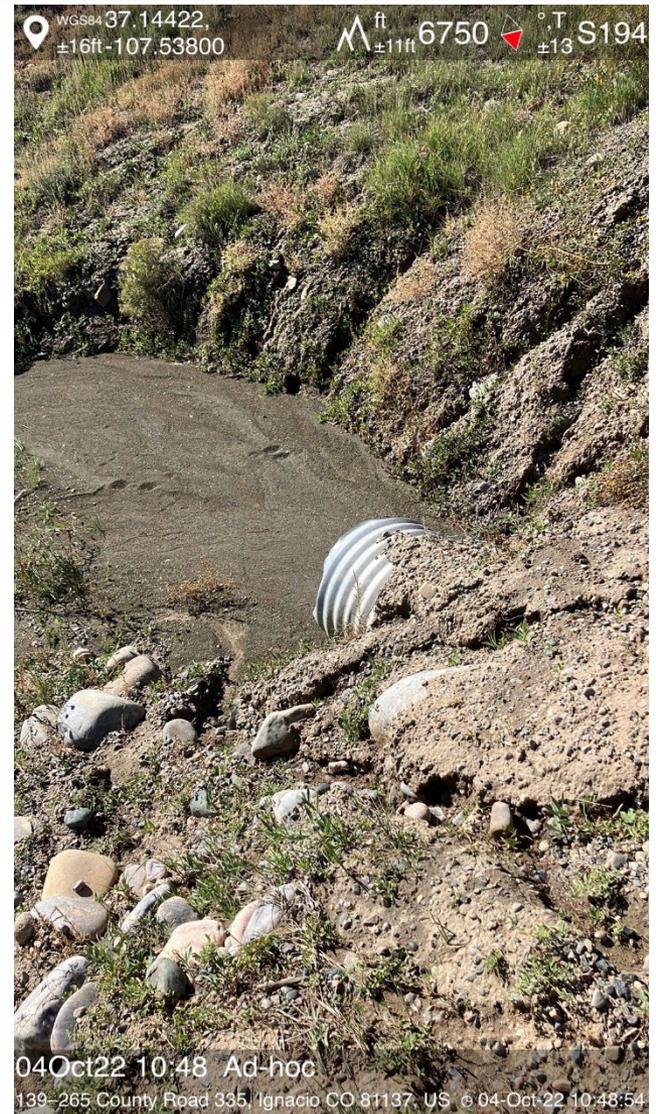
IMG 17

Culvert with no outlet protection
