Inspection Photos

Location Name: CAERUS PICEANCE LLC COUEY-66S92W /30NWSE

Location ID: 335358

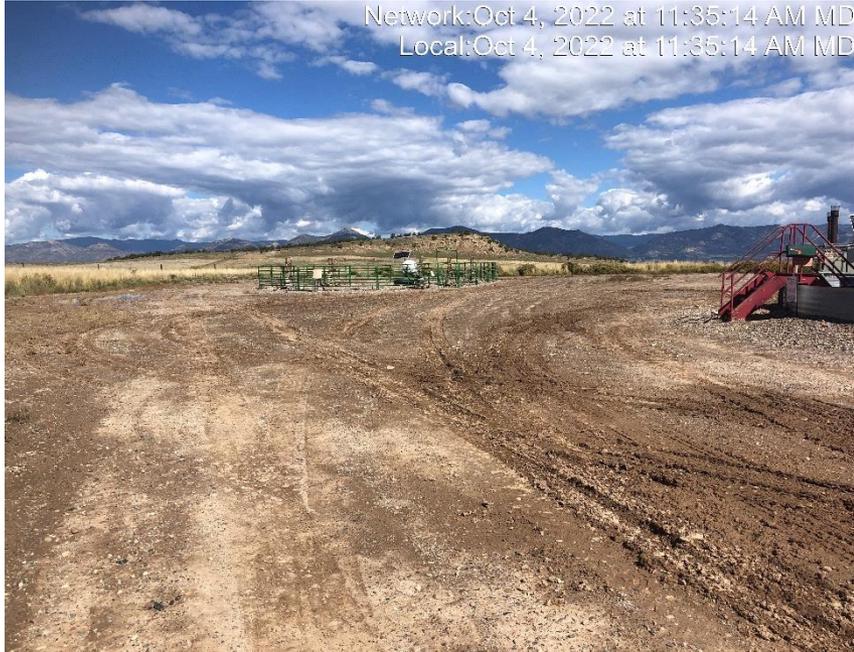
Photo #7907 From entrance to location.

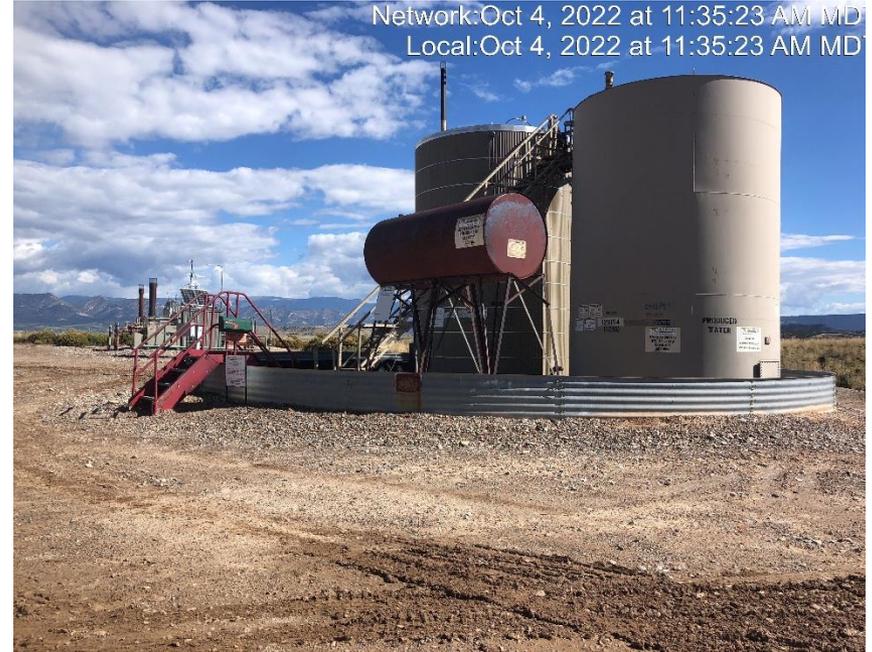
Photo #7908 From entrance to location.

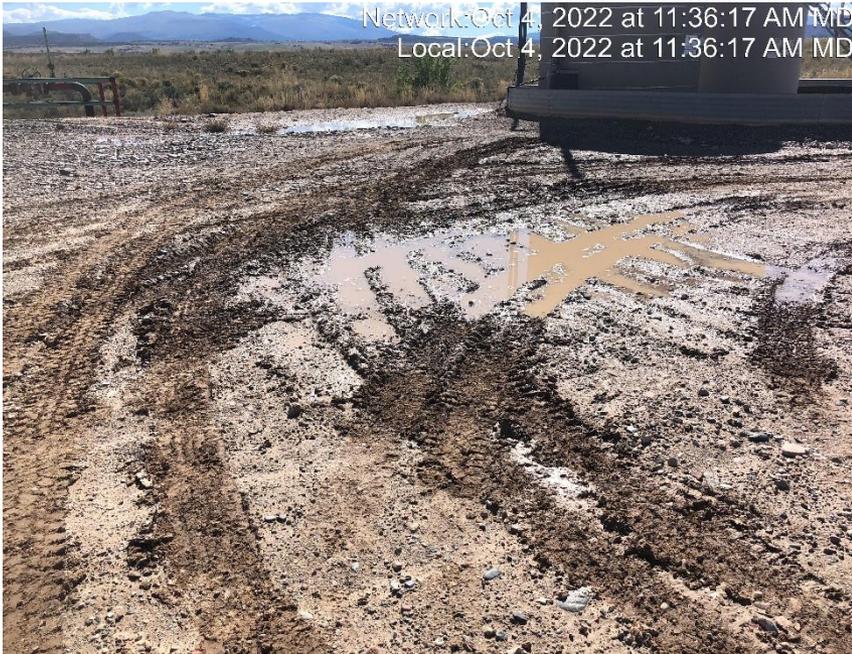
Photo #7910 Location lacks stabilization.

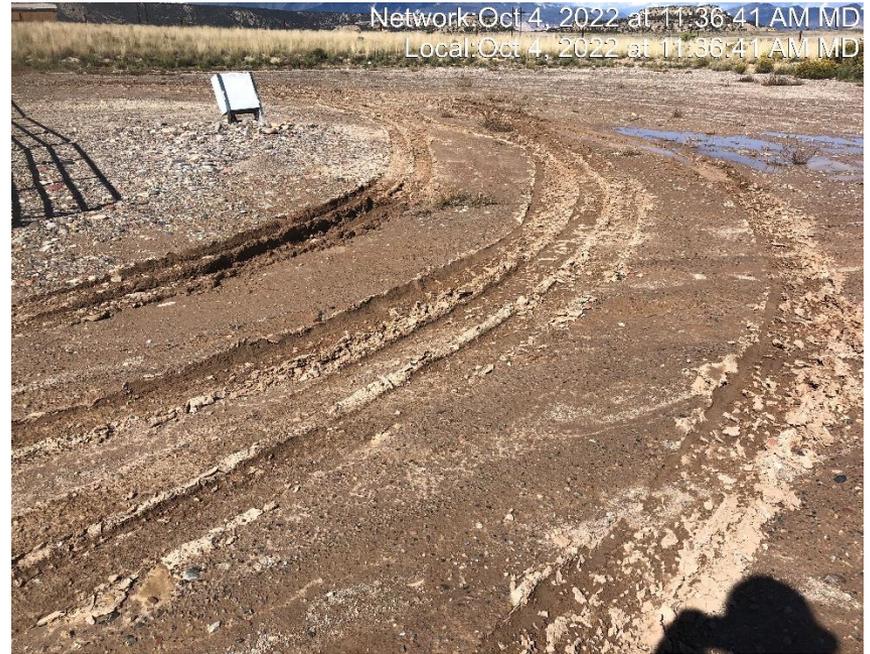
Photo #7911 Location lacks stabilization.

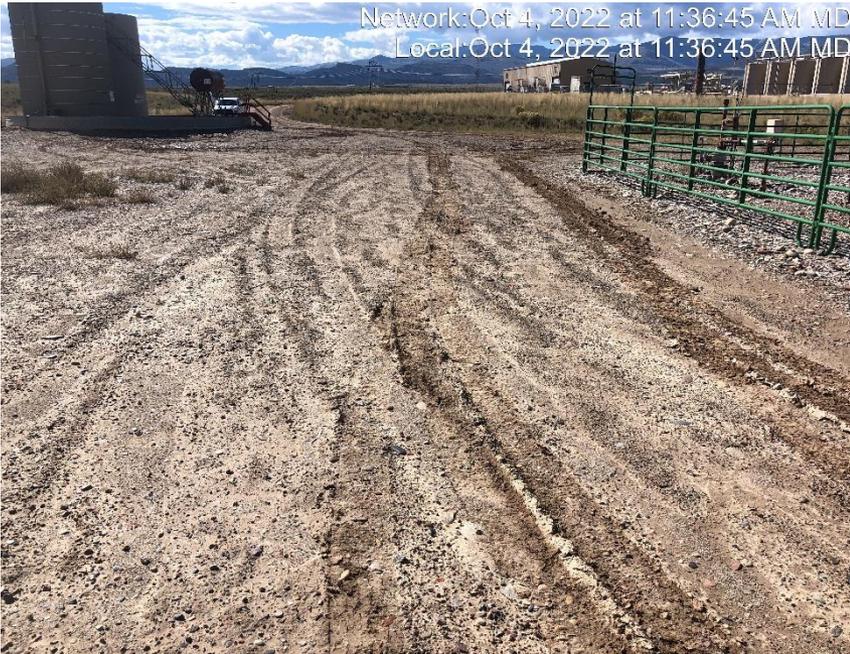
Photo #7912 Location lacks stabilization.

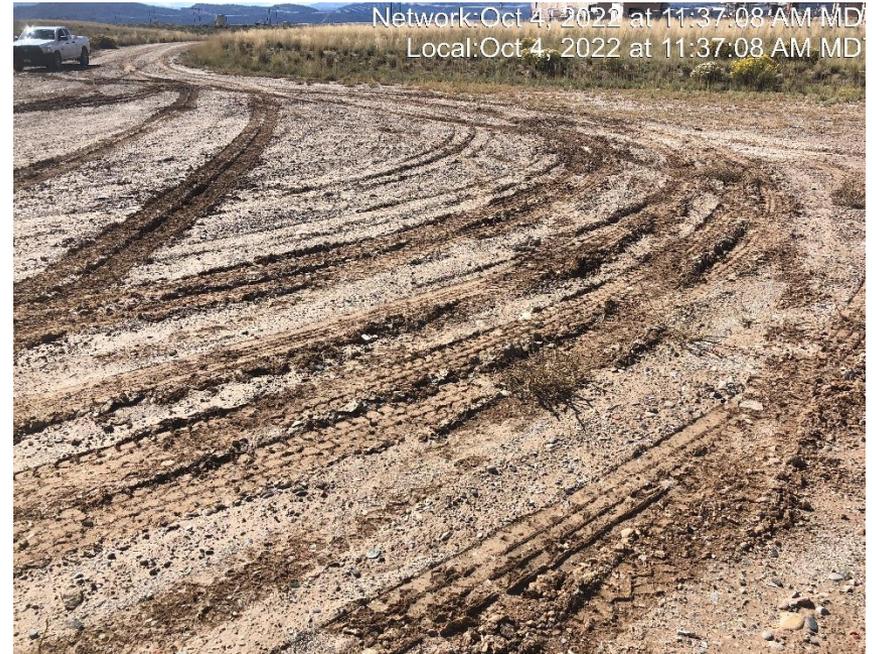
Photo #7913 Location lacks stabilization.

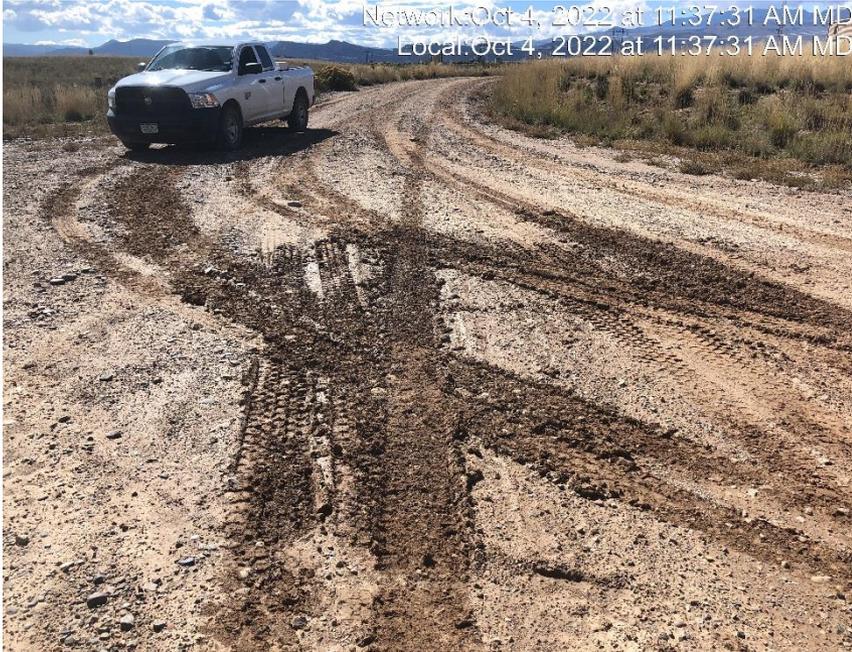
Photo #7915 insufficient tracking BMP's at entrance to location.
