Inspection Photos

Location Name: CAERUS PICEANCE LLC COUEY-66S92W /32NWNW

Location ID: 335301

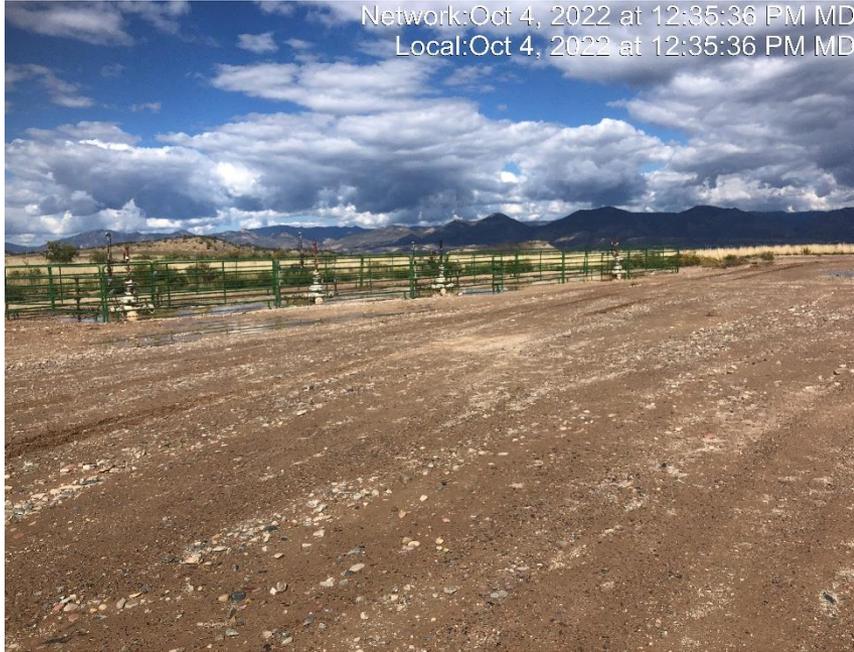
Photo #7915 From entrance to location.

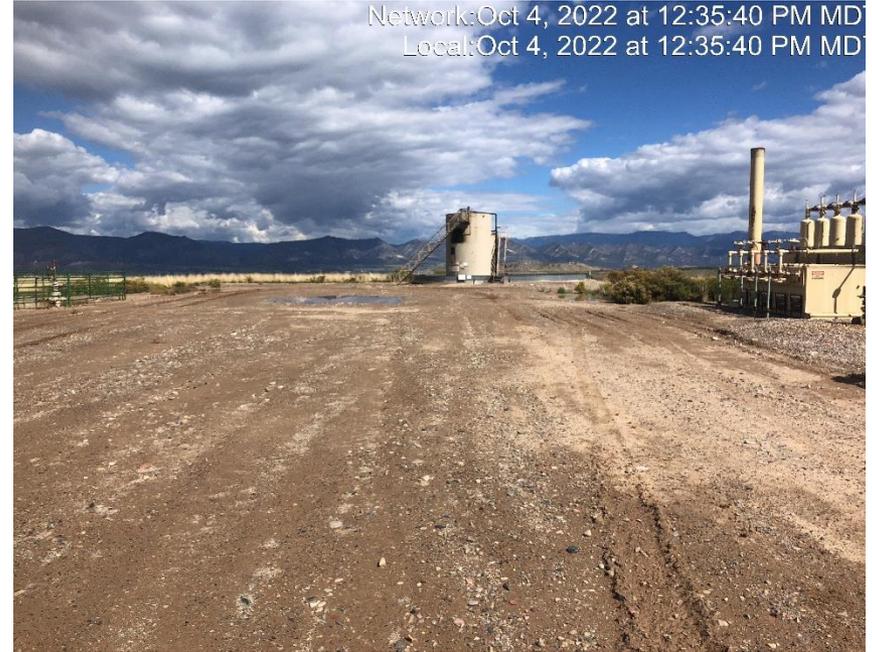
Photo #7916 From entrance to location.

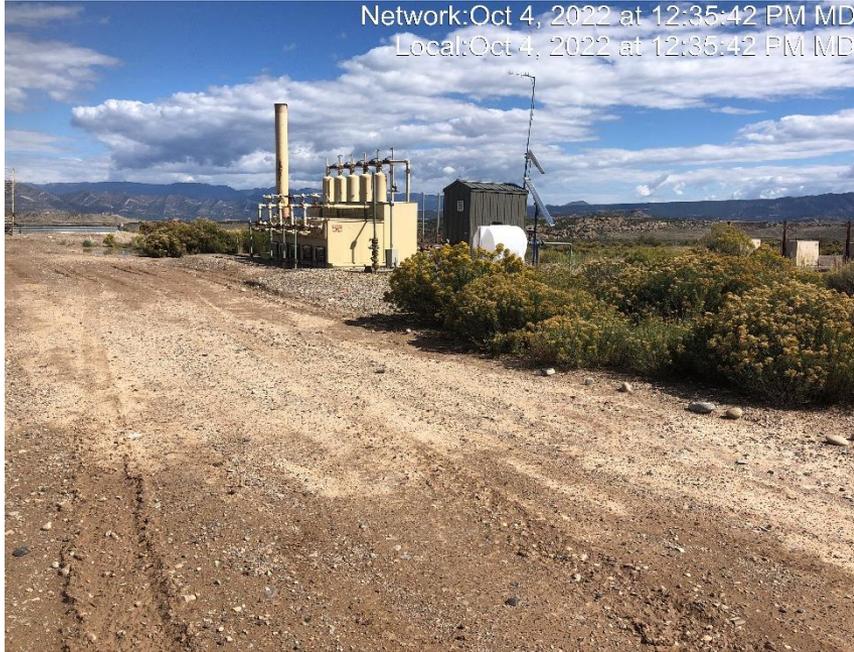
Photo #7917 From entrance to location.

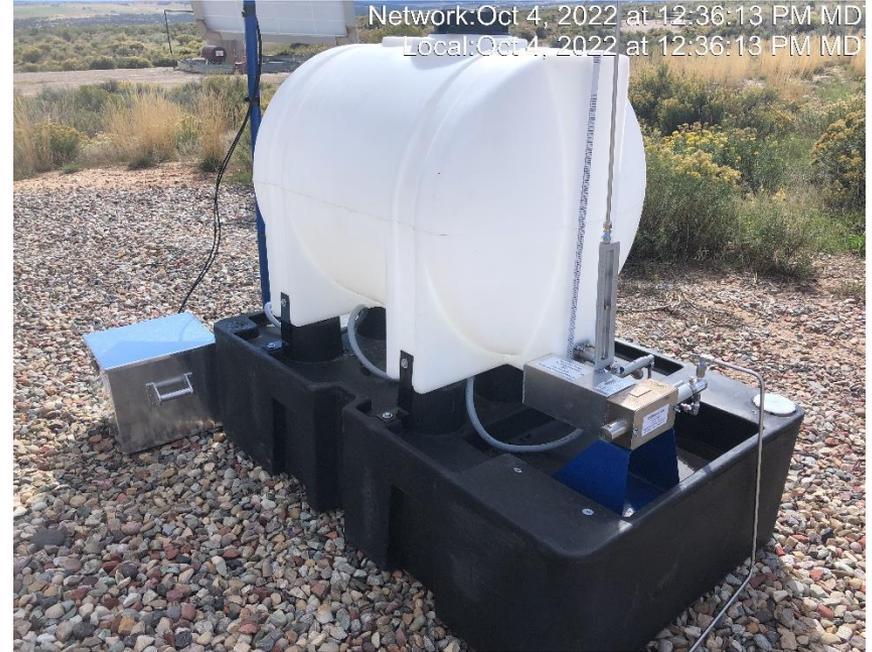
Photo #7918 Chemical tank missing required information.

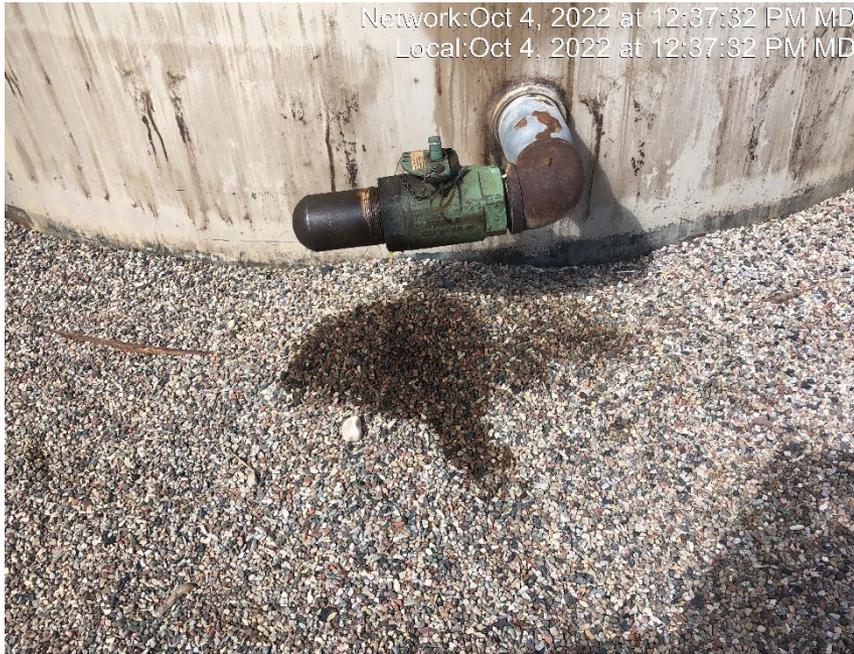
Photo #7923 Stained soils in containment.

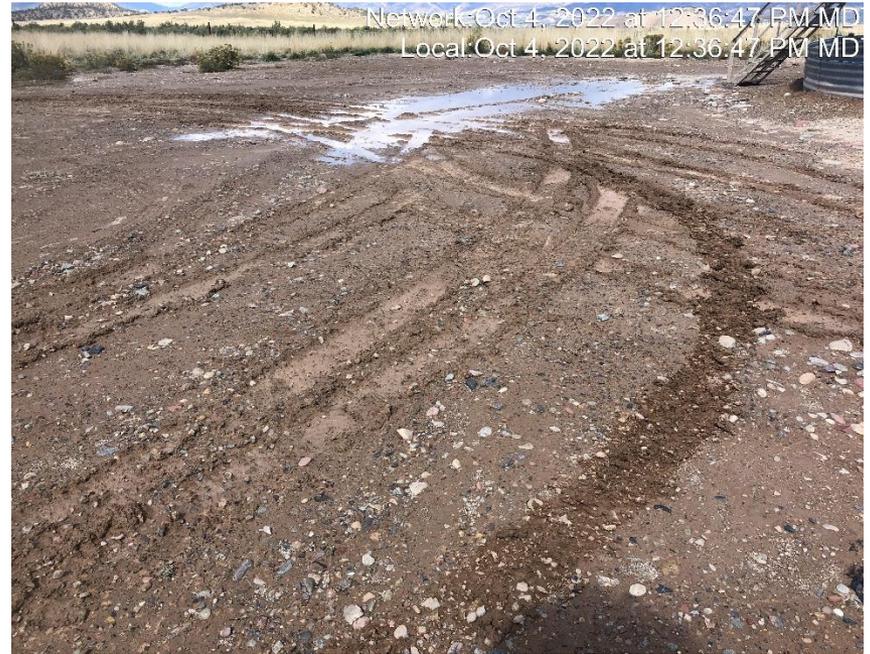
Photo #7919 Location lacks stabilization.

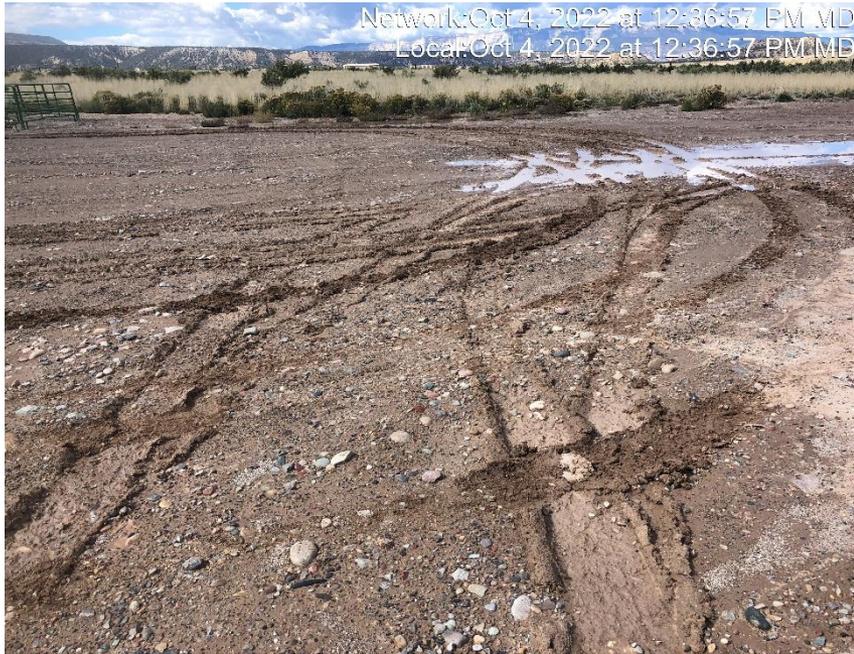
Photo #7920 Location lacks stabilization.

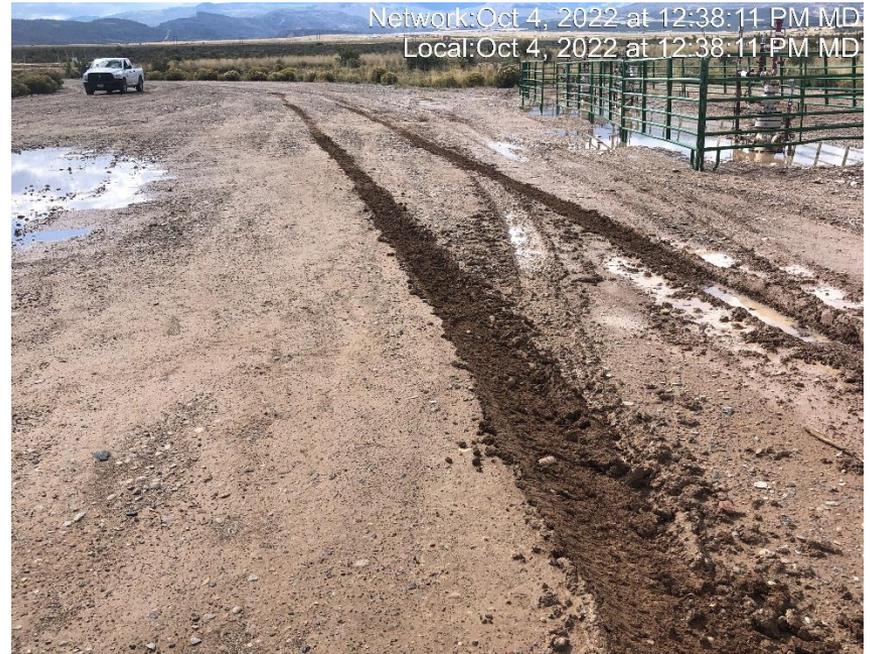
Photo #7224 Location lacks stabilization.

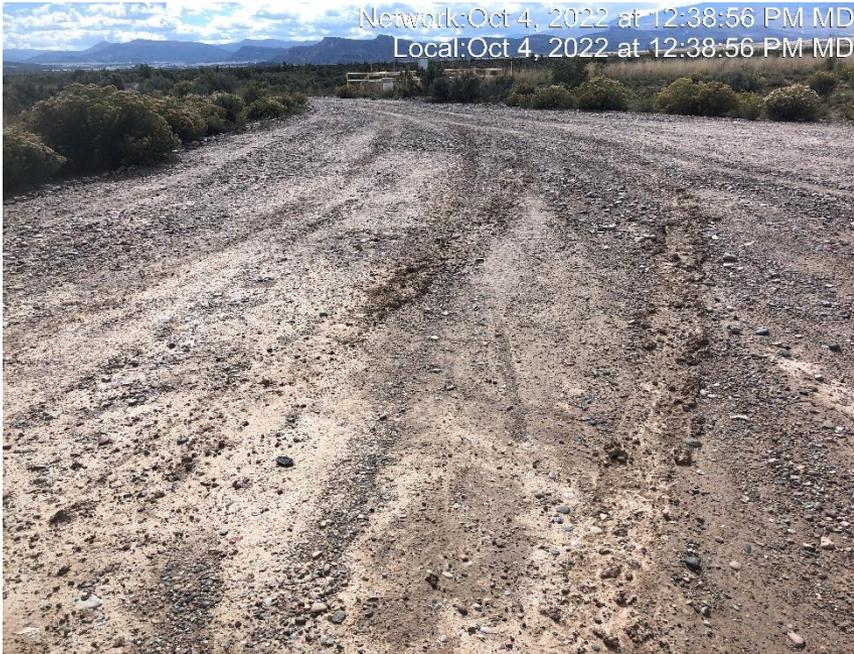
Photo #7925 Insufficient tracking BMP at entrance to location.
