Inspection Photos

API: 055-06067

Operator: OXY USA INC

Inspection Date: 10/6/2022

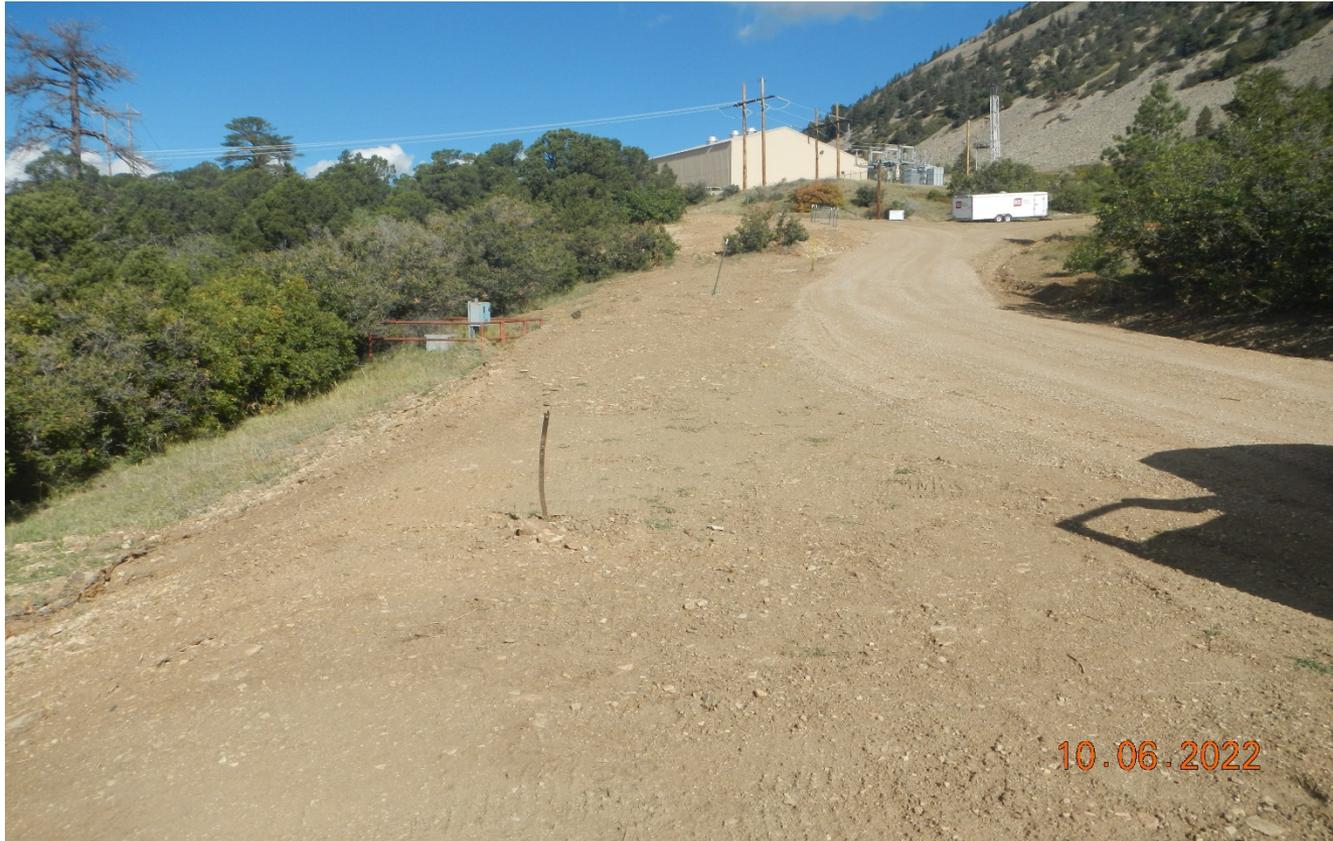
Photo 1. Facing north along the access road. The disturbance from the flowline along the road needs to be reclaimed and stabilized.

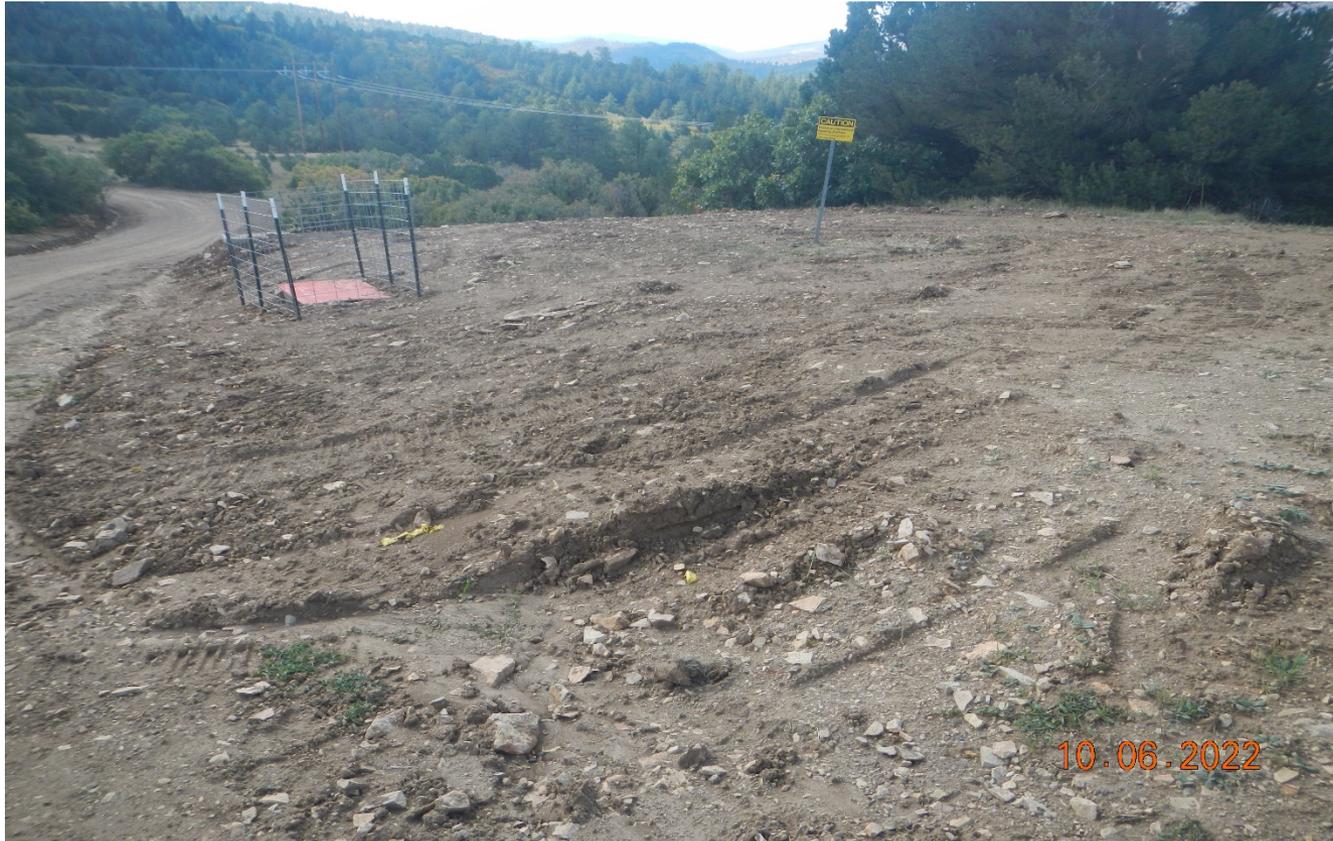
Photo 2. The disturbance from the flowline along the road needs to be reclaimed and stabilized.

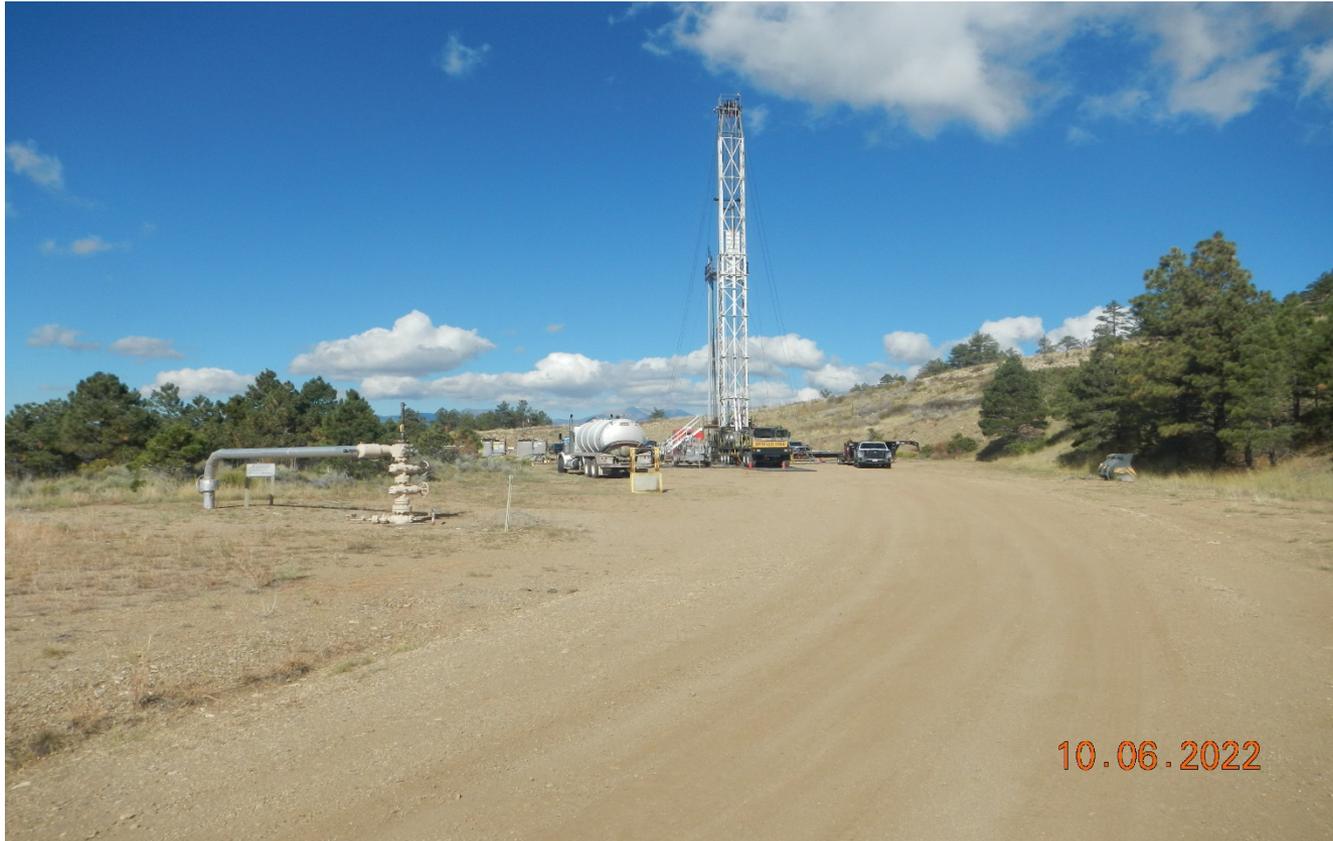
Photo 3. Facing northwest toward the location.
