# Inspection Photos

API: 055-06041

Operator: OXY USA INC

Inspection Date: 10/6/2022

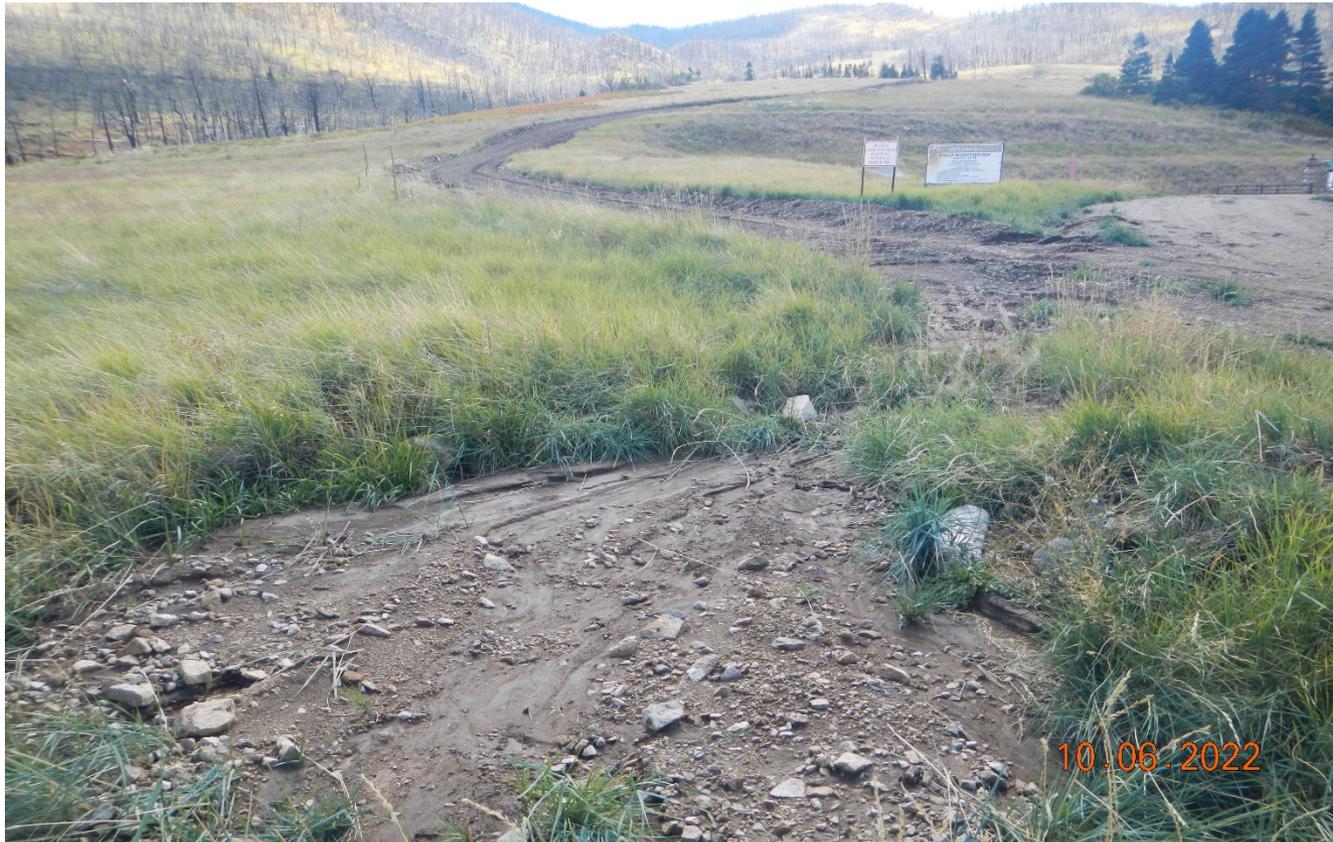
**Photo 1.** Facing southwest along the access road near the SMU #1-12-B . There is sediment from the road depositing in this area. BMP's such as a sediment trap should be installed in this area.

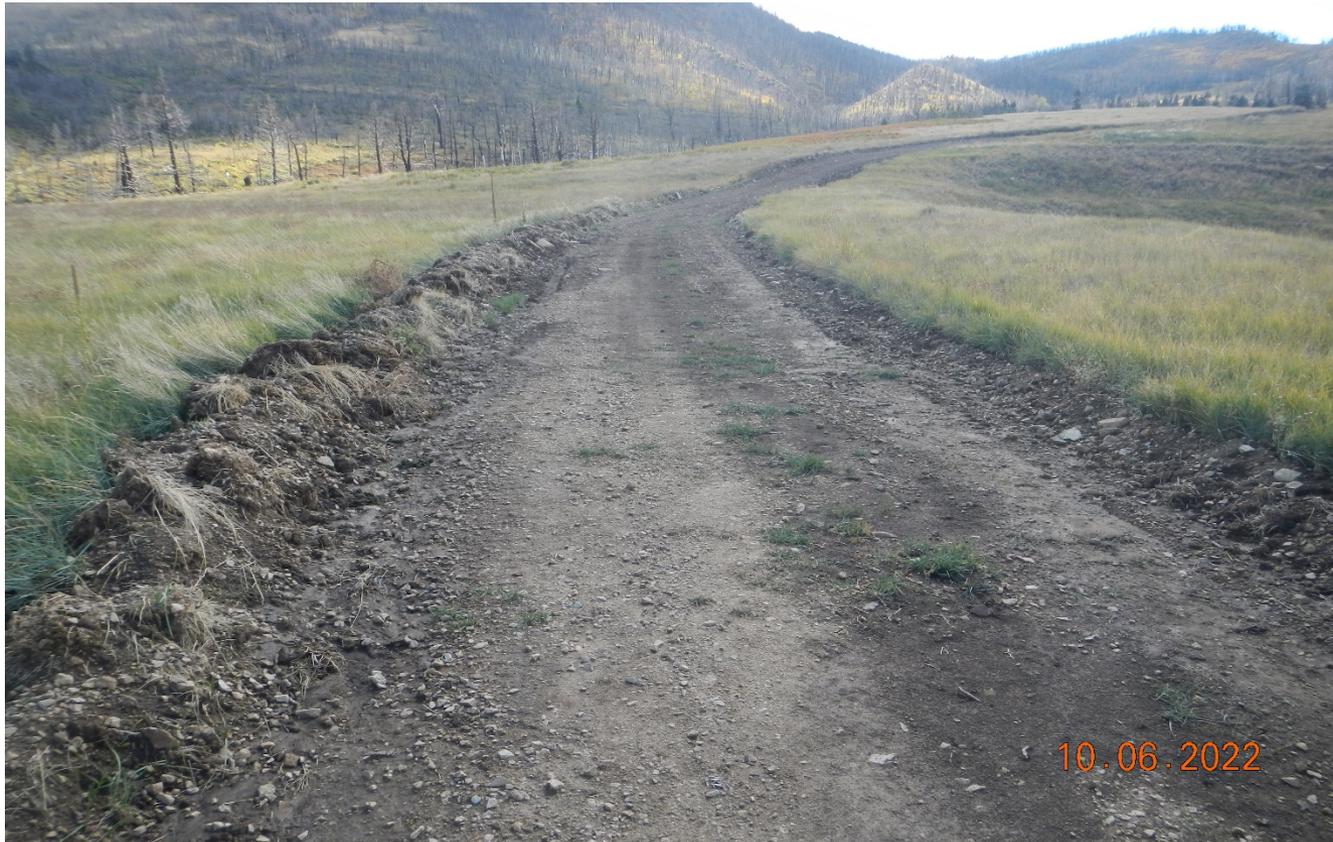
**Photo 2.** Facing southwest along the access road near the SMU #1-12-B . The road was graded along a portion of the road. The concern now is lack of BMP's on this long stretch or road which will direct stormwater and create more erosion.

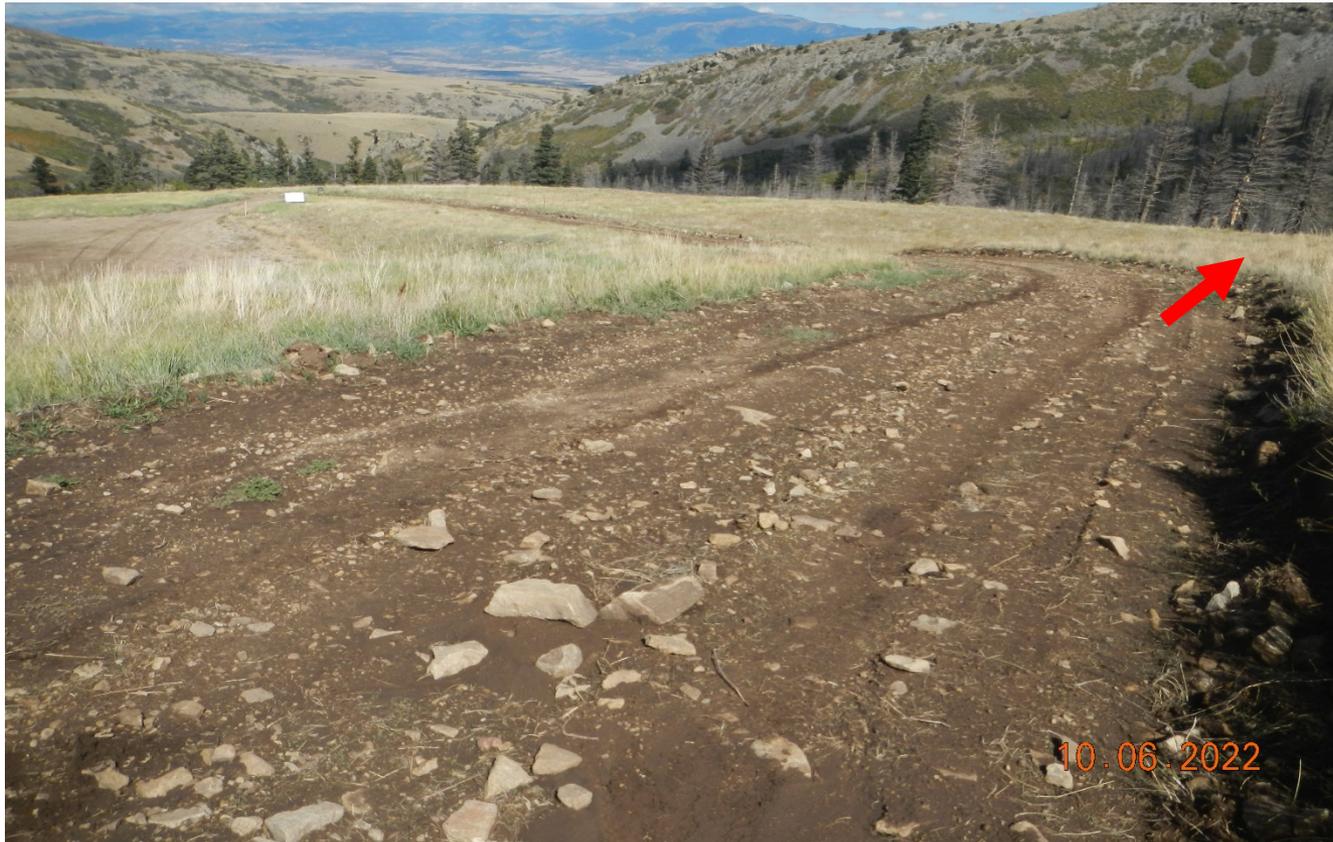
**Photo 3.** Facing northeast. The road will direct stormwater all the way down the road creating erosion. BMP's need to be installed to direct stormwater off the road and reduce stormwater concentration along the road. A diversion ditch would be helpful at the red arrow along with water bars, sediment traps, check dams, ect.

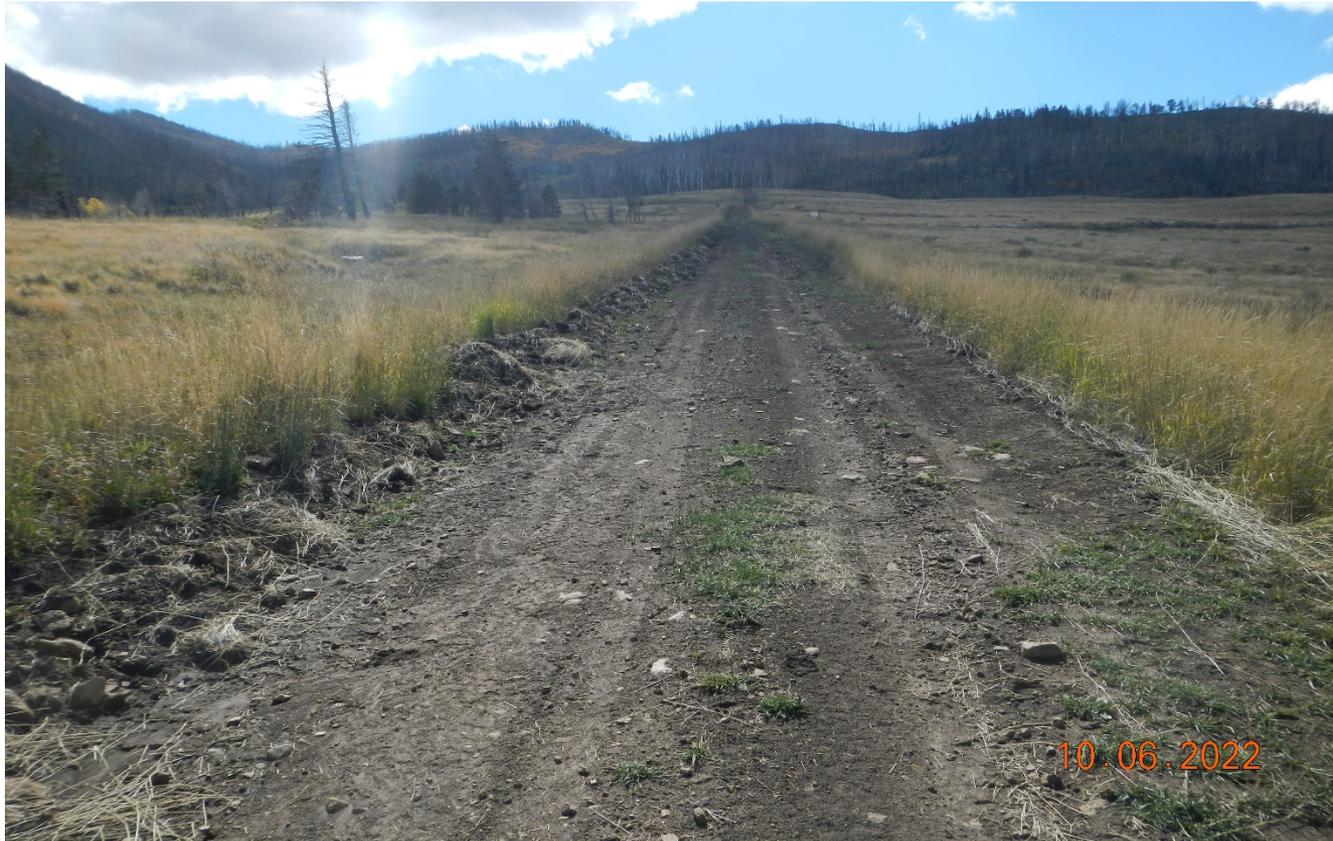
**Photo 4.** Facing southwest along the graded road. There are no BMP's installed along this portion of road.

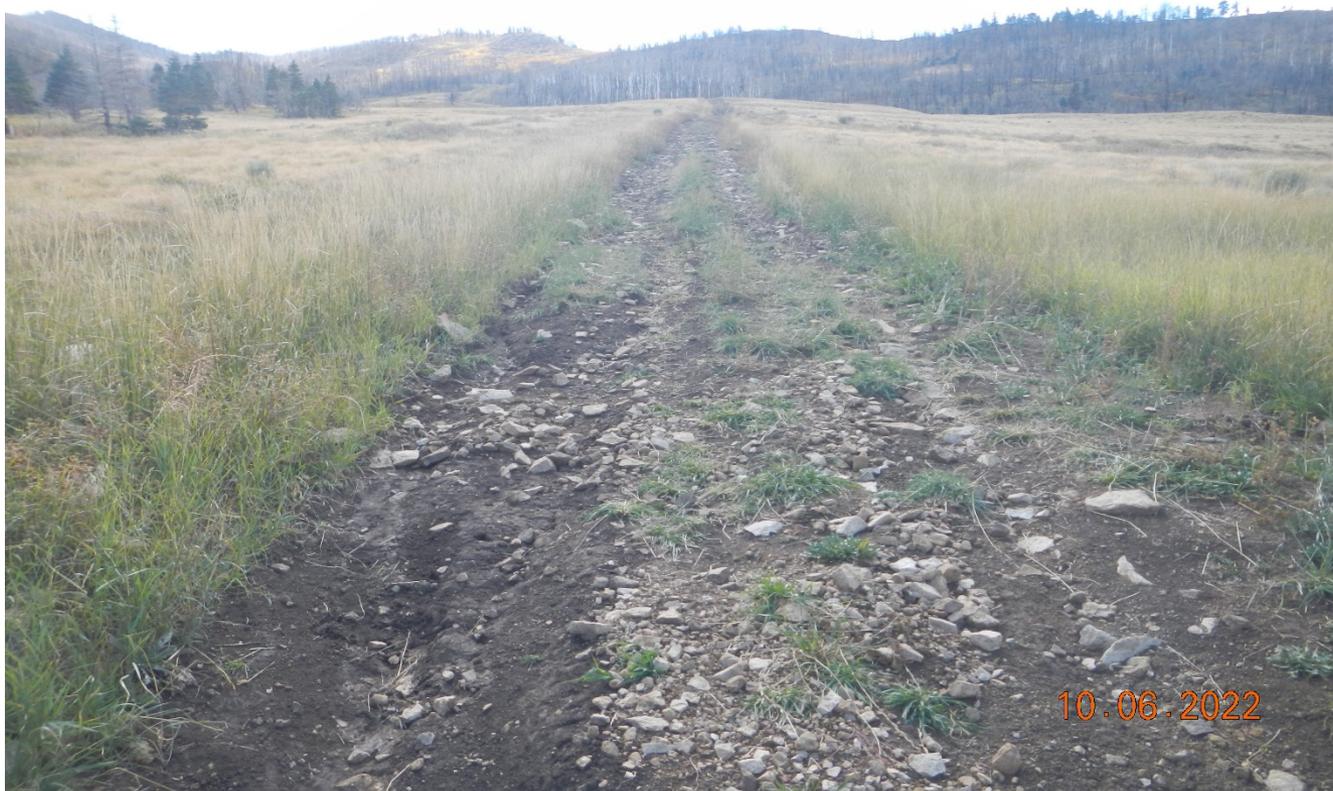
**Photo 5.** Facing southwest. The grading ended at this point which appears to be more stabilized with vegetation. Did not inspect any further due to wet soil conditions.
