Final Reclamation Inspection

Operator: PDC ENERGY INC - 69175

Location ID: 327580

Inspection Photos
Location Name: Billings 43-21
Location ID: 327580

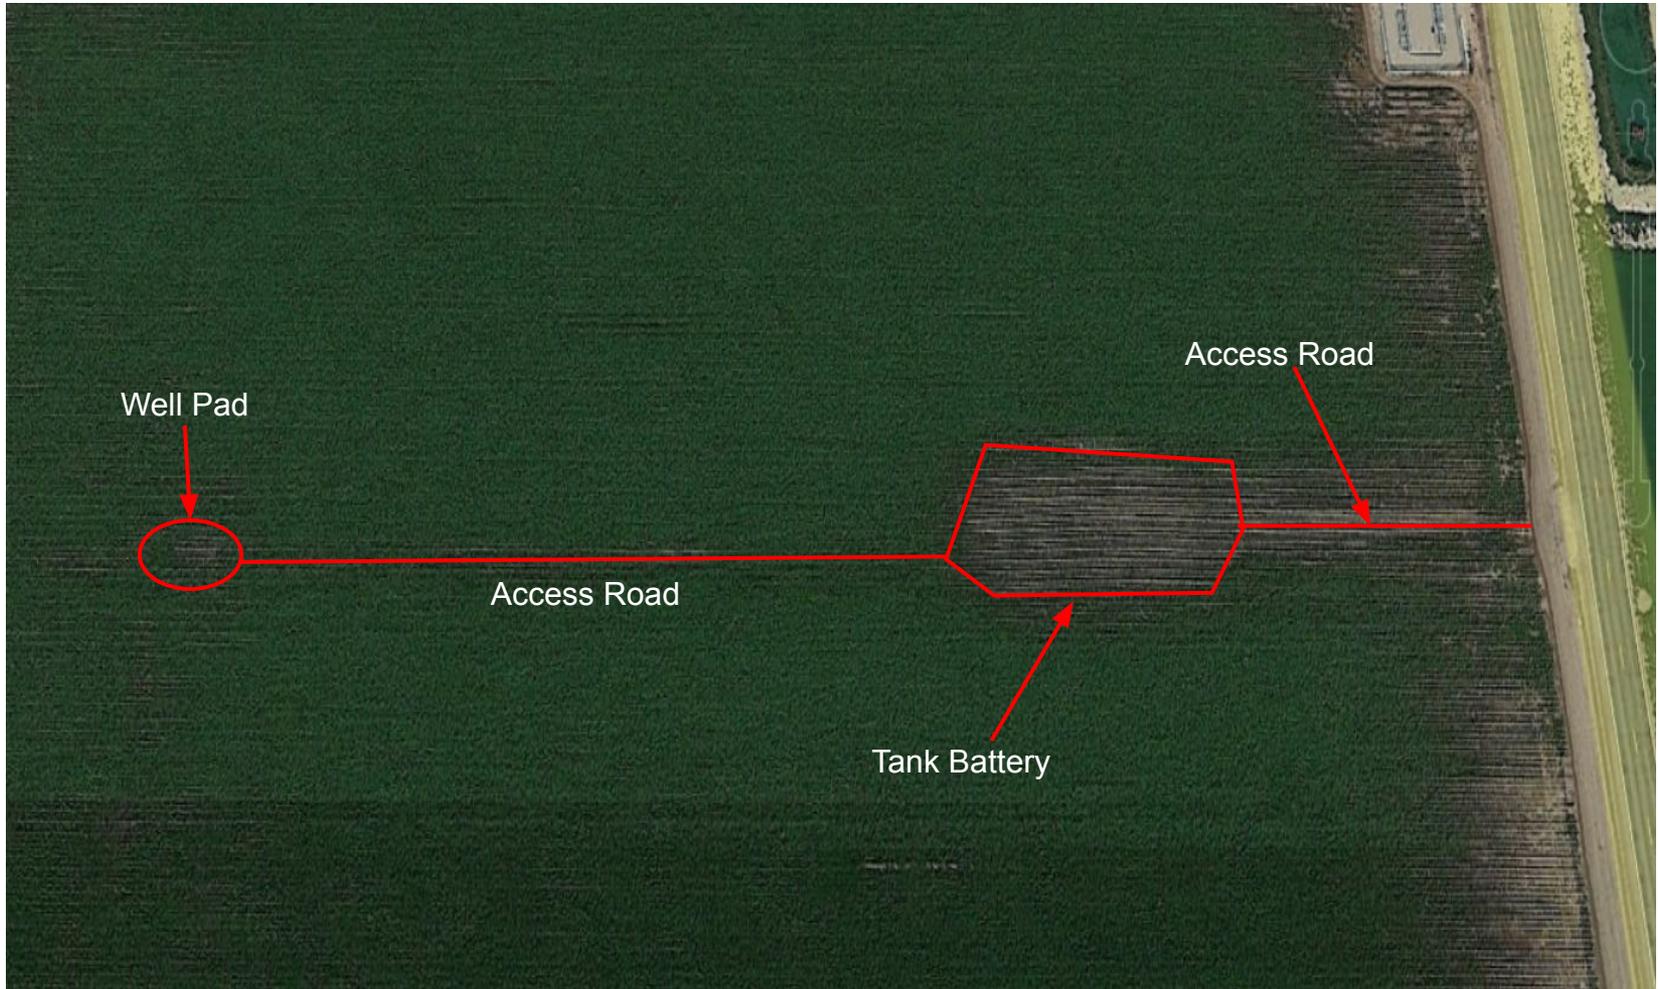
Photo 1. 2019 aerial imagery of the well pad, access road and tank battery.

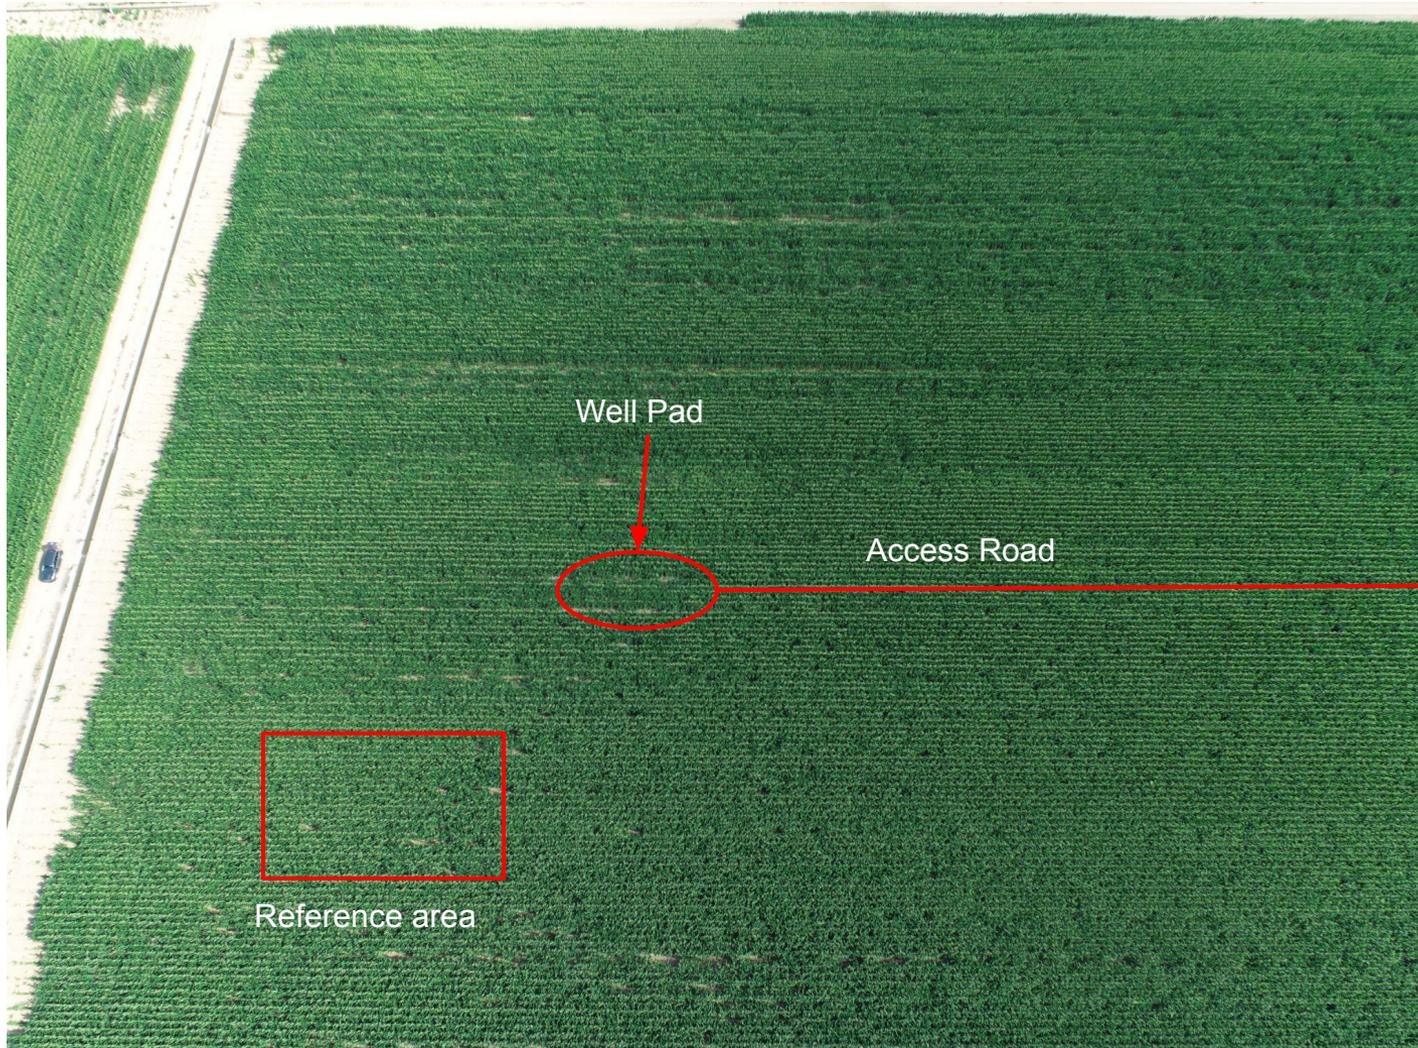
Photo 2. Overview photo of the well pad and access road taken from the southern edge facing north using a drone. Note: well pad and access road appear consistent with the adjacent crop reference area.

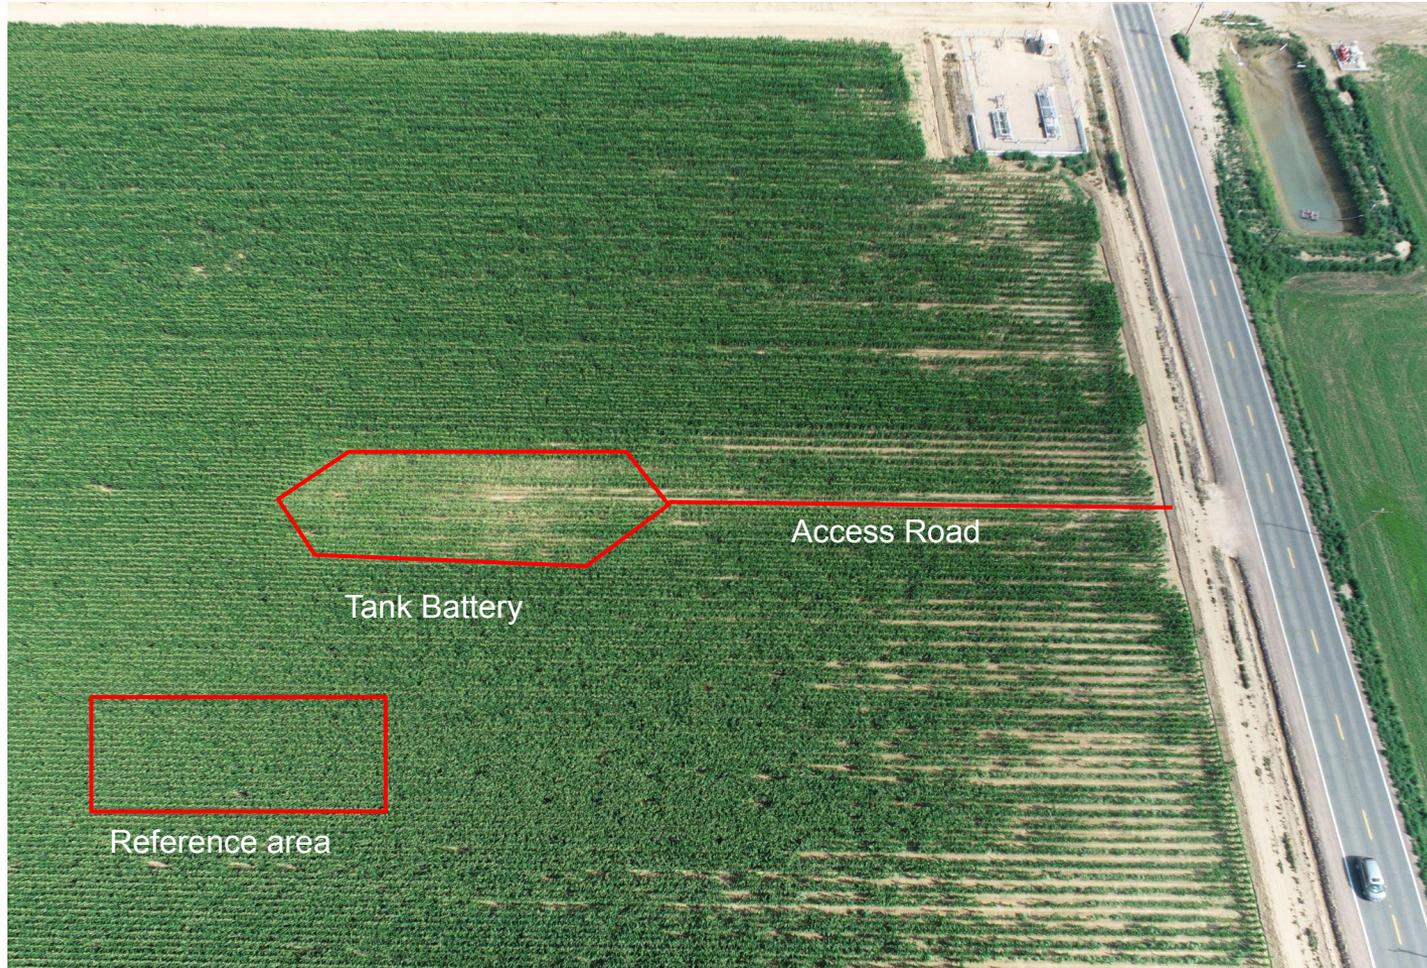
Photo 3. Overview photo of the tank battery, access road and reference area taken from the southern edge facing north using a drone. Note: tank battery does not appear consistent with adjacent crop reference area.

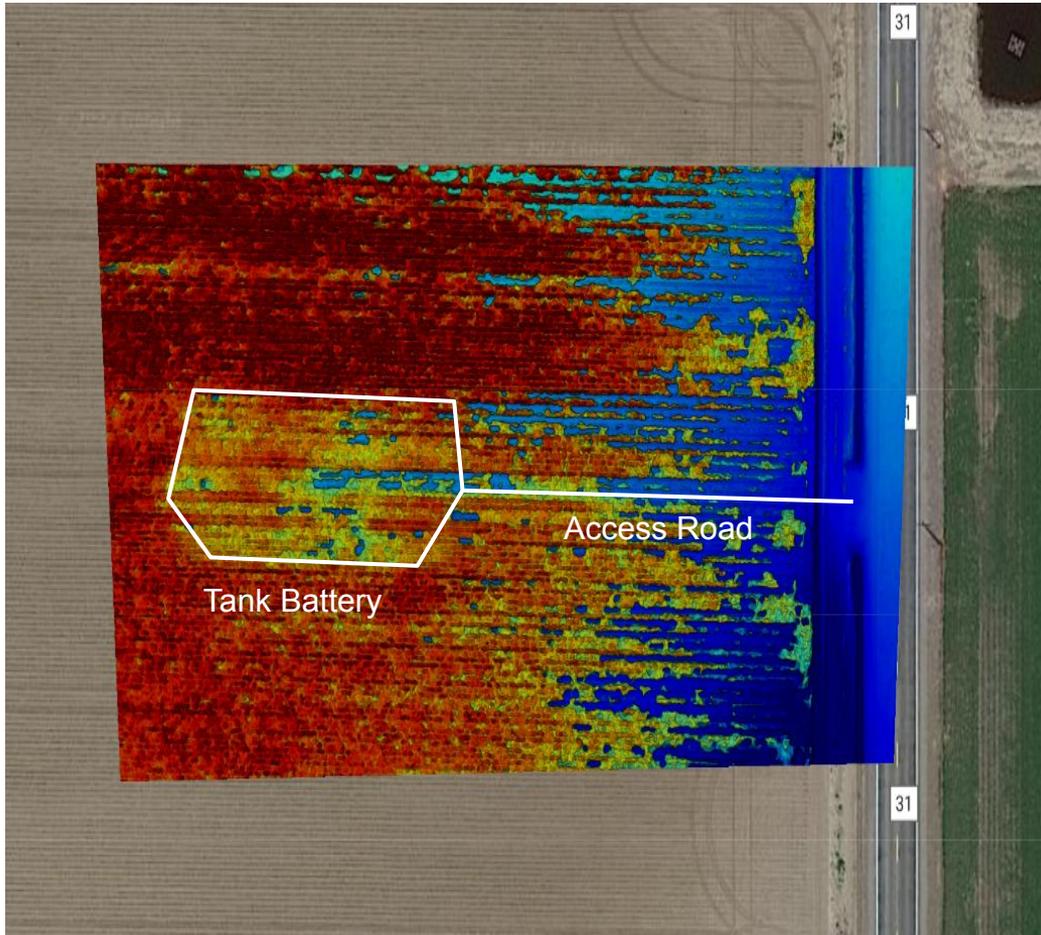
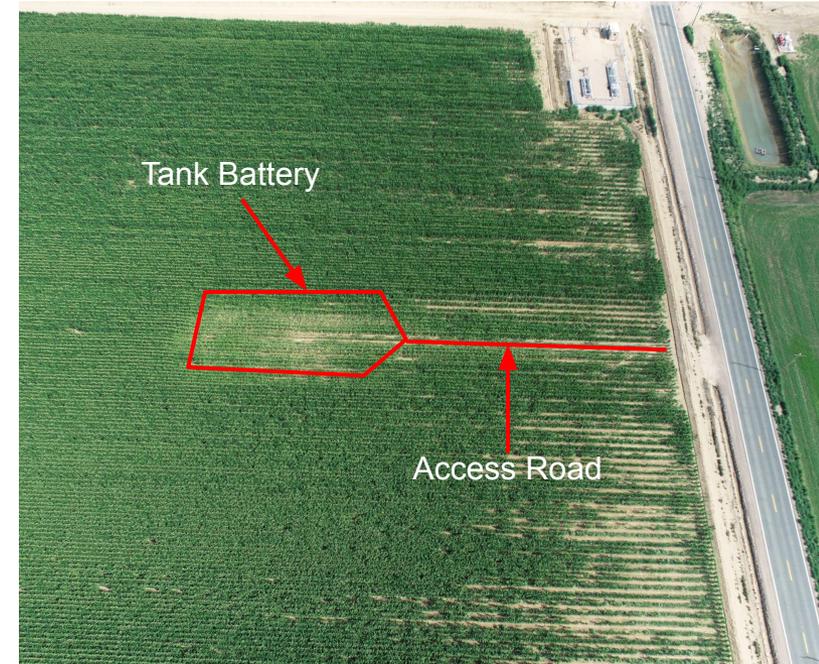
Overview photo of the tank battery taken with a drone on the day of the inspection.

Photo 4. Overview photo shows crop heights at the tank battery and associated access road using a drone (up is north). Blue/green indicates crop heights at 0-3 feet, yellow/orange indicates crop heights at 5-6 feet and red indicates crop heights at 7-8 feet. Model shows stunted growth with average heights of 0-3ft feet appear throughout a majority of the access road while heights at 5-6 feet dominate most of the tank battery.

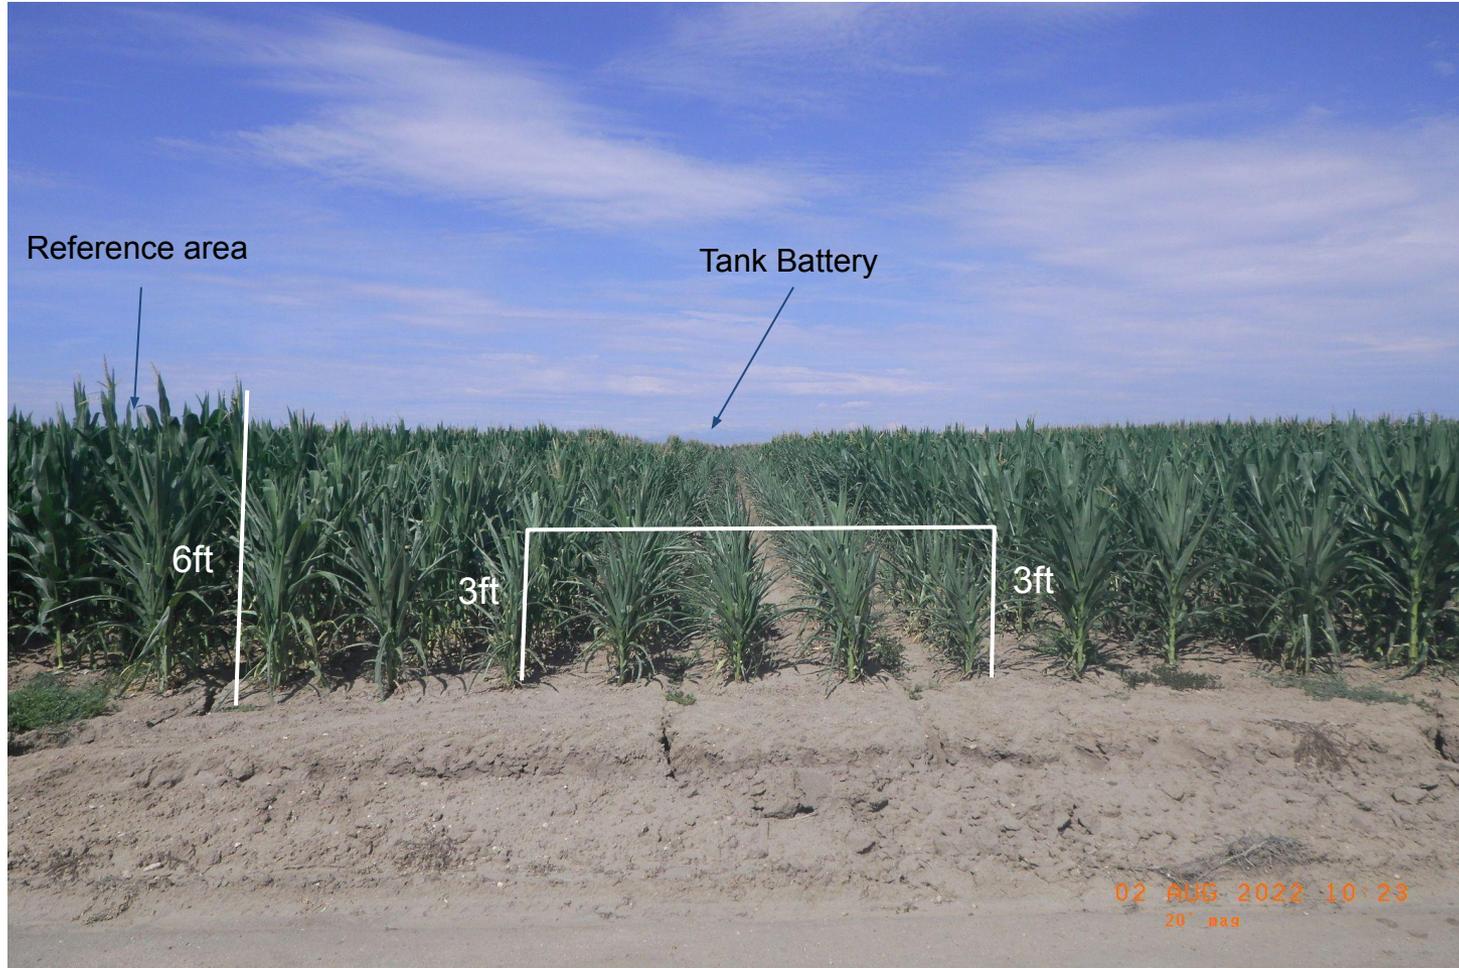
Photo 5. Photo of the access road taken at ground level from the eastern edge of the crop field looking west. Photo shows crop growth along access road is not reflective of adjacent reference area.
