Inspection Photos

API: 061-06179

Operator: ENERVEST OPERATING LLC

Inspection Date: 10/12/2022

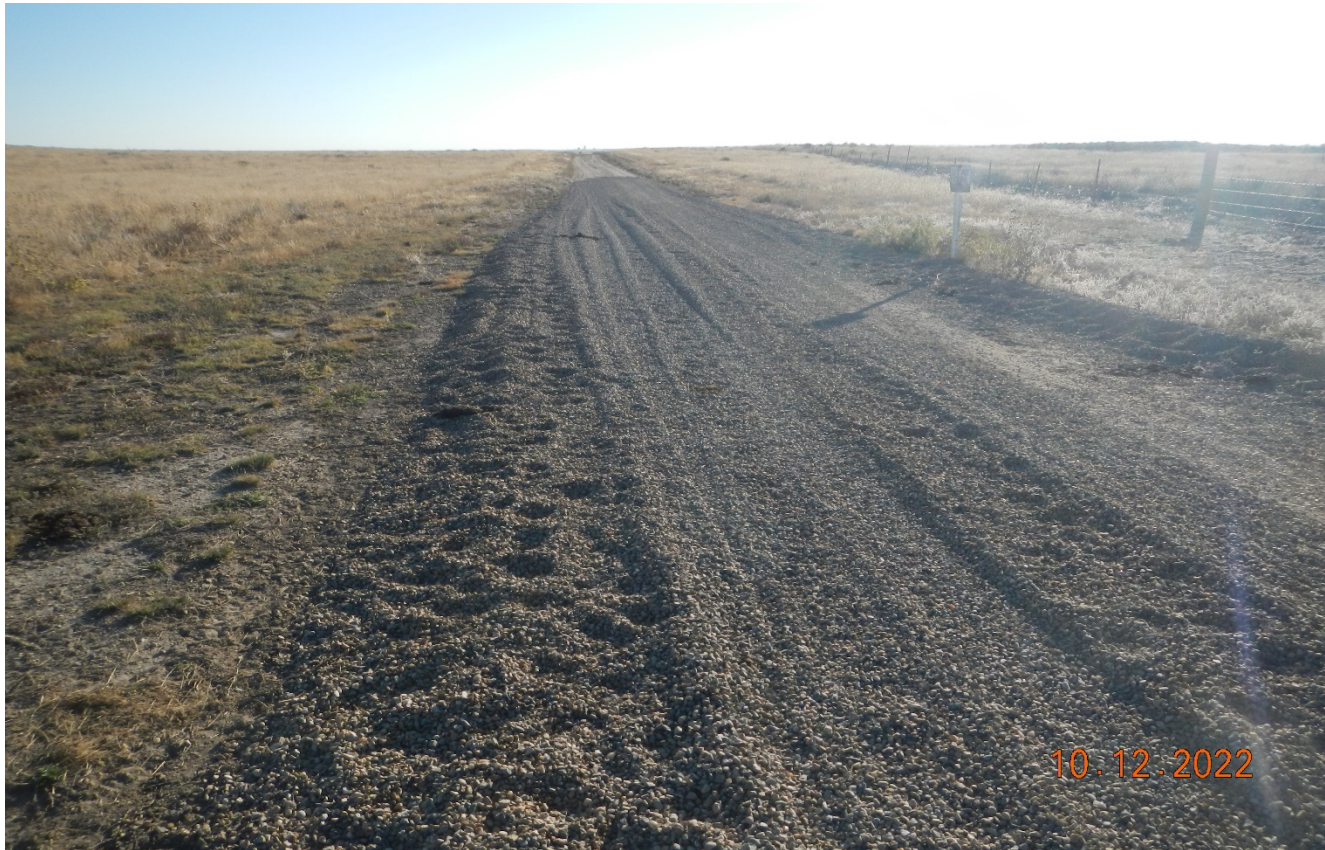
Photo 1. Facing east along the access road. There has been gravel spread along areas of the road. Some areas may have excess gravel that may need to be spread out better.

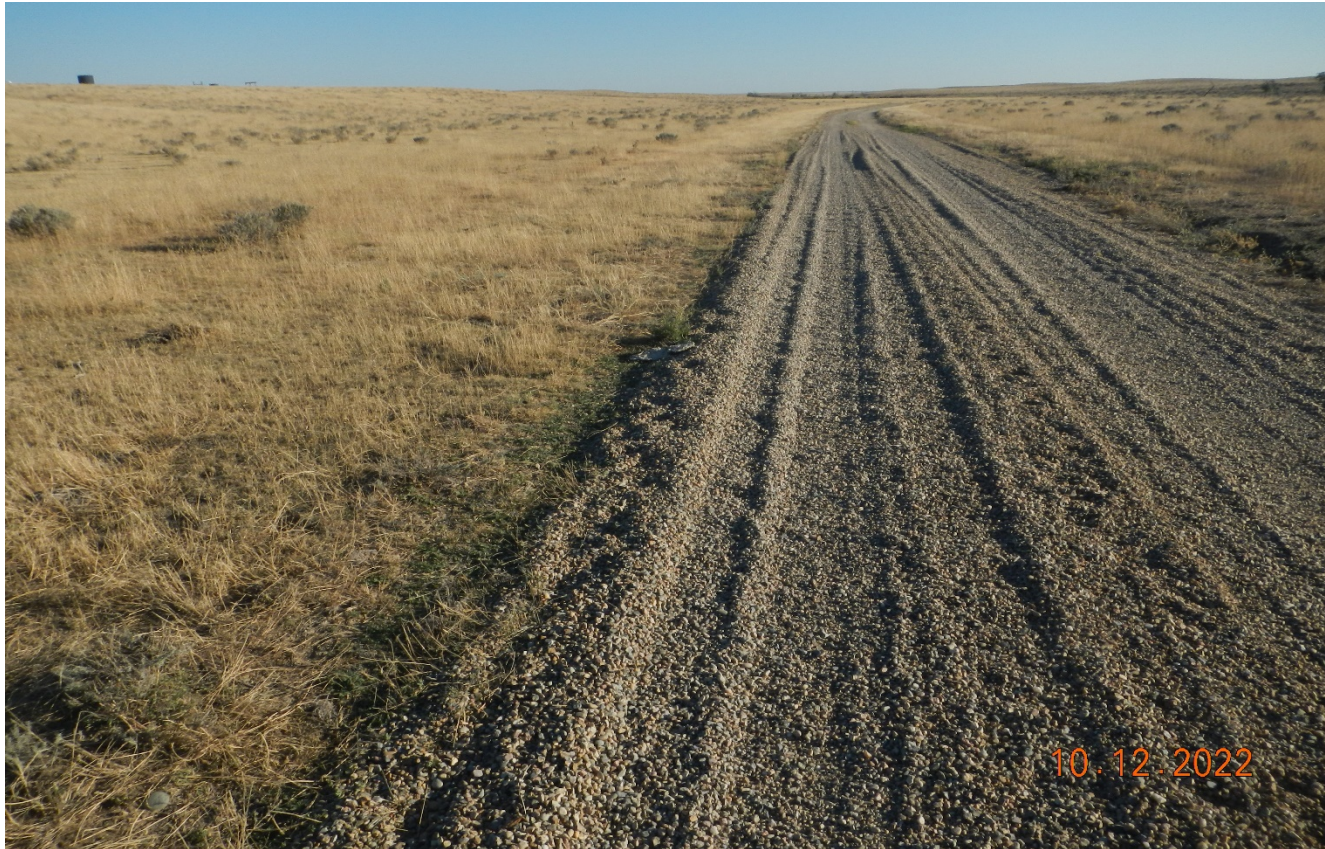
Photo 2. Facing northeast along the access road. There has been gravel spread along areas of the road for stabilization where water was pooling on the road.

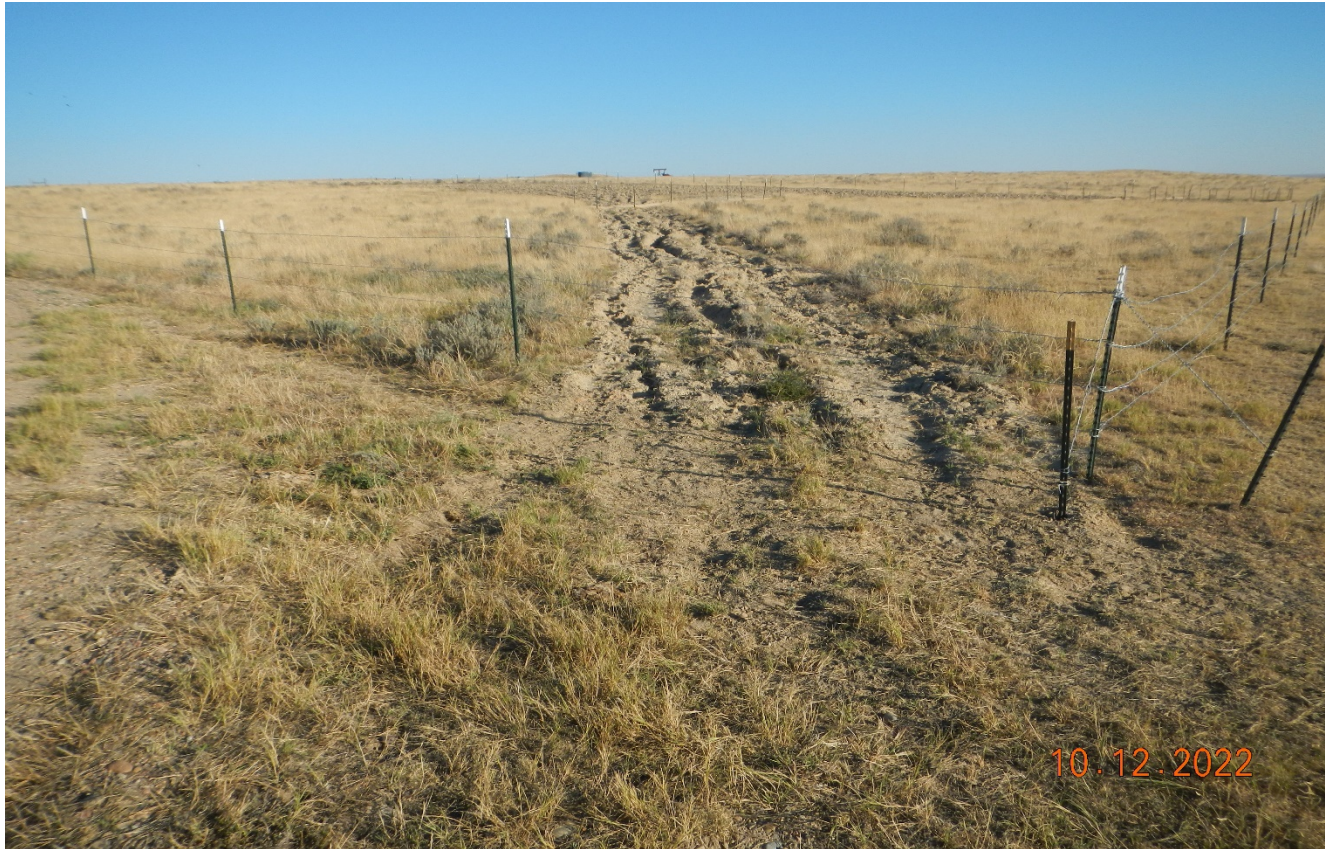
Photo 3. Facing north toward the location. There is a remediation project # 19874 in process. Soils have been recontoured at the location and the location has been fenced.

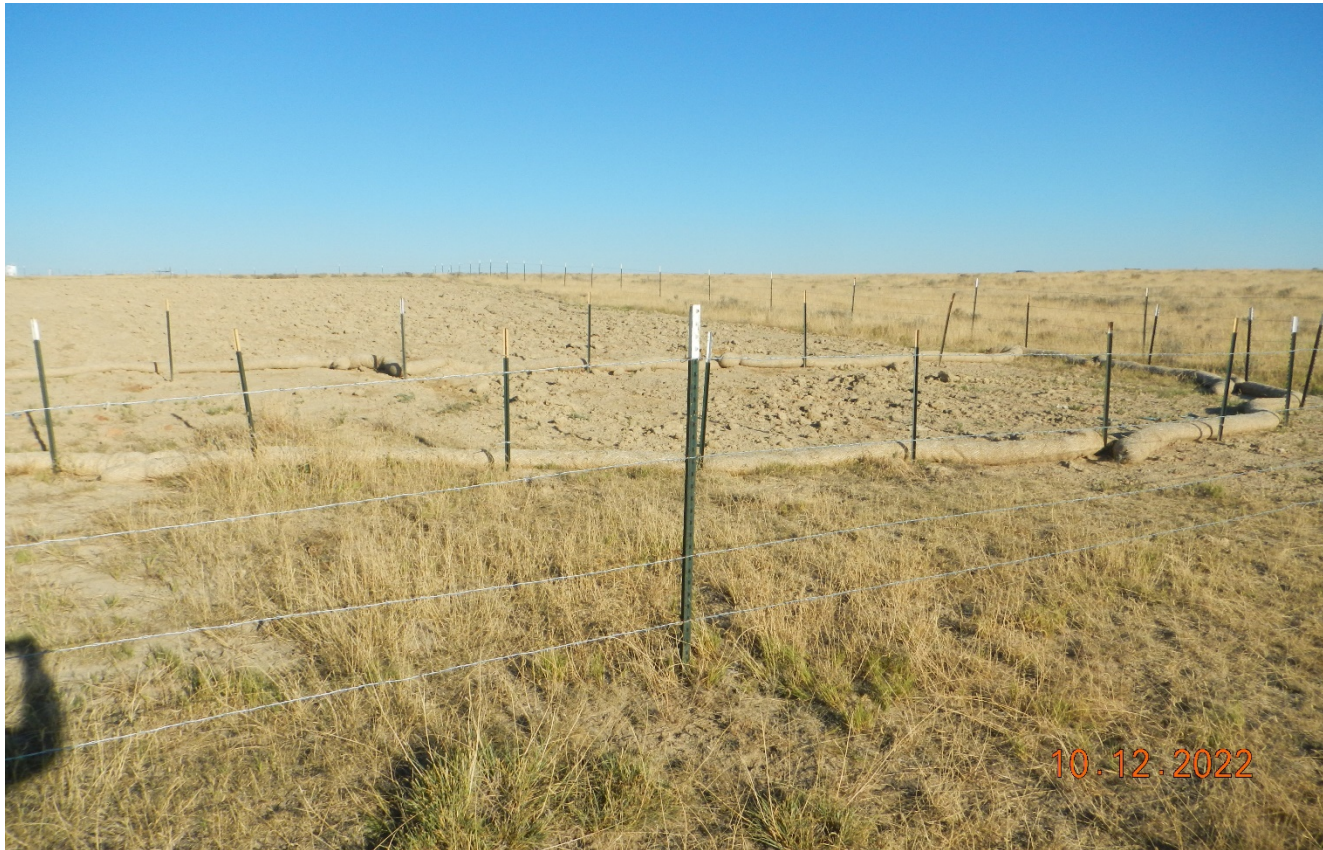
Photo 4. Facing northwest at the location. There are wattles installed at the down gradient side of the location however, wattles are not properly staked down. T-post are being used to hold wattles in place which is not adequate.

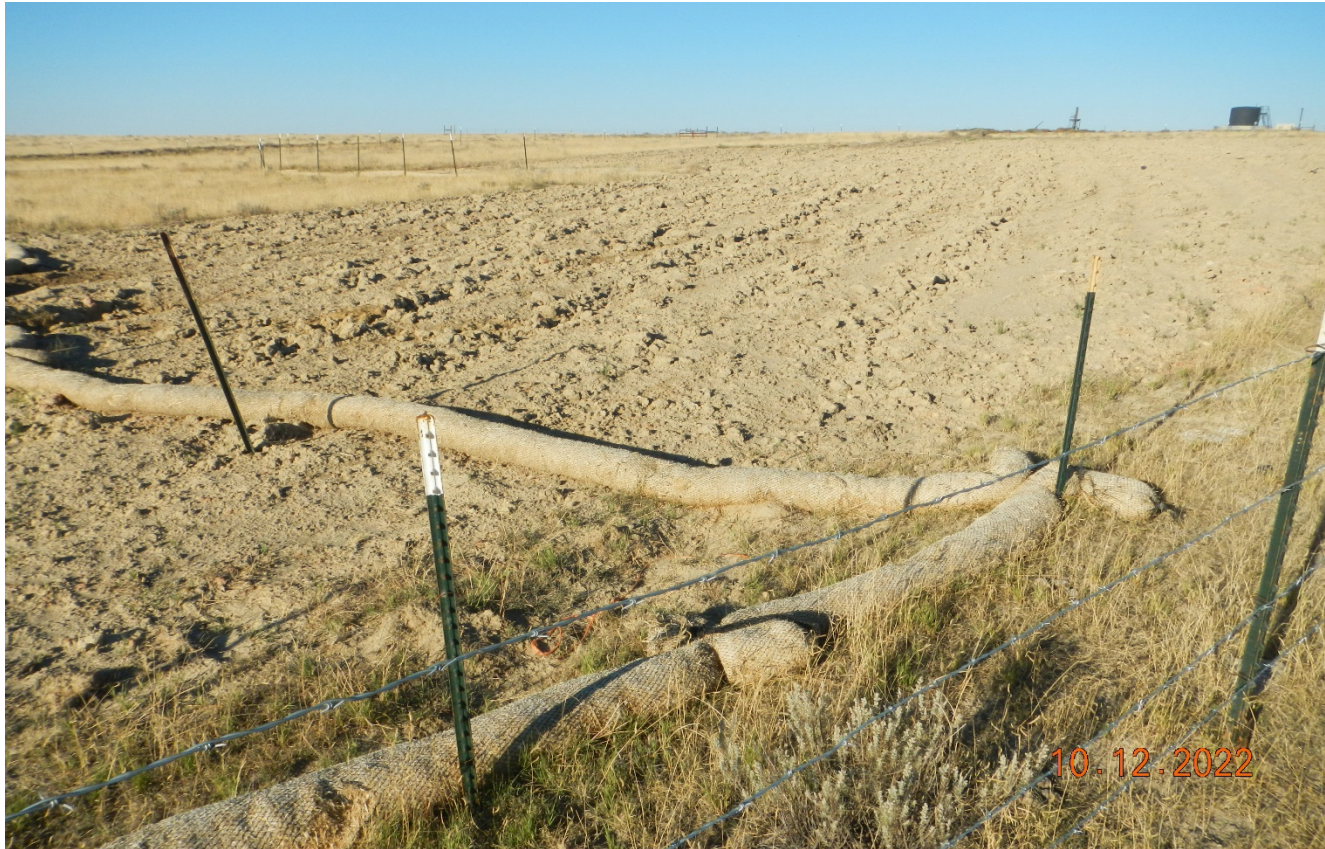
Photo 5. Facing west toward the location. The wattles will need to be properly staked down once the location is seeded and reclaimed.

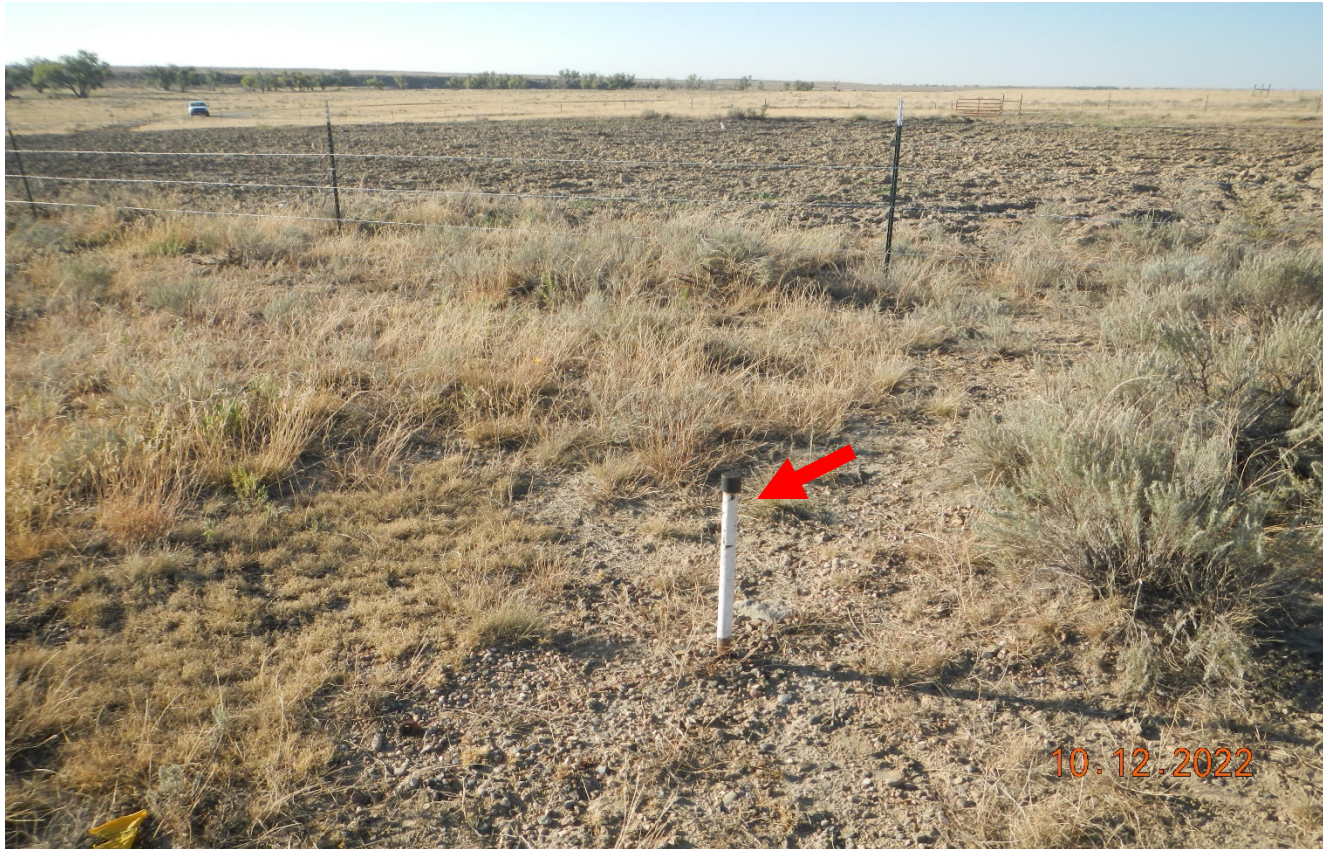
Photo 7. North side of the location facing southeast. There is a metal pipe riser shown at red arrow that needs to be removed.

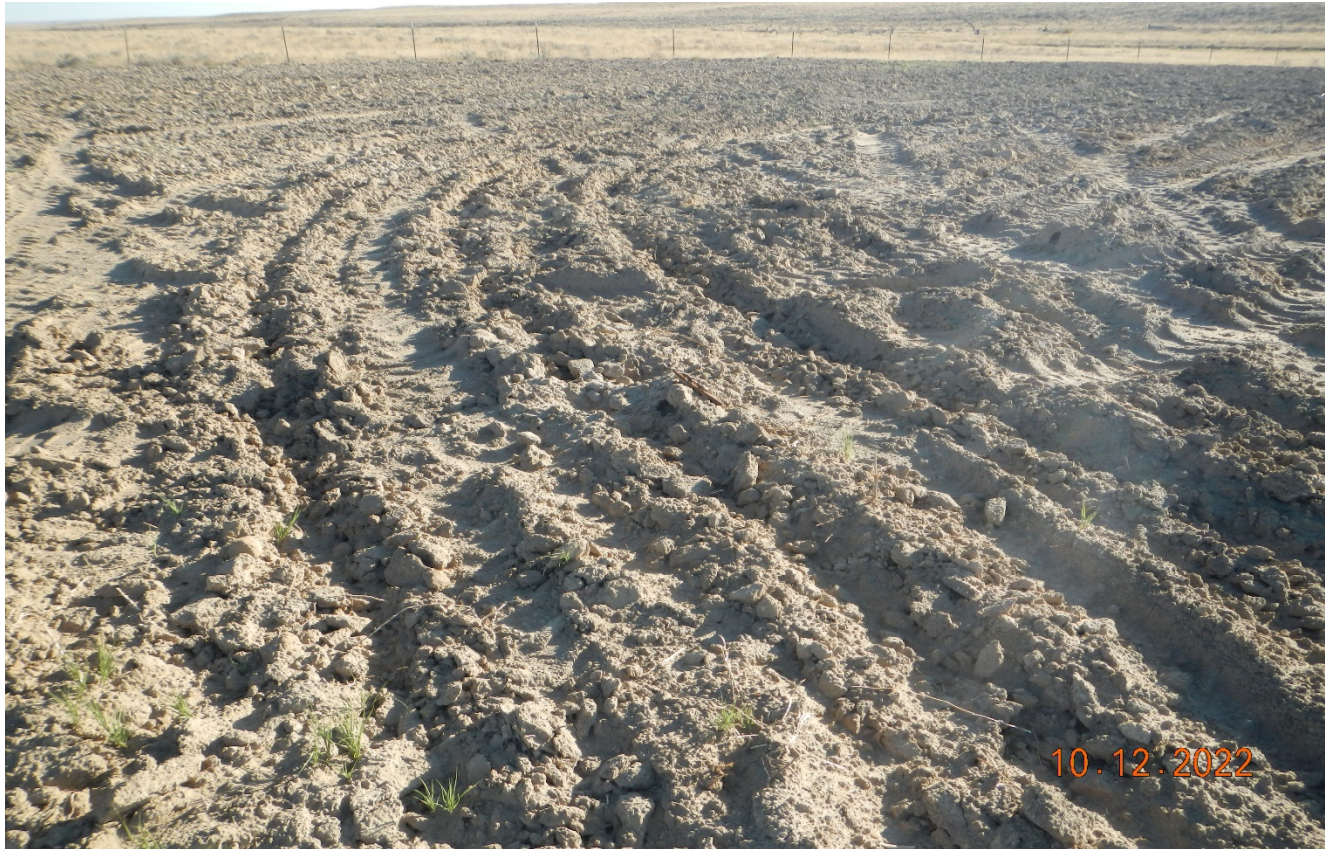
Photo 8. Facing north at the location. It appears soils have been decompacted. It does not appear that seeding has been performed yet.
