Inspection Photos

Location Name: CAERUS PICEANCE LLC SHAEFFER-67S93W /12SWSE

Location ID: 334650

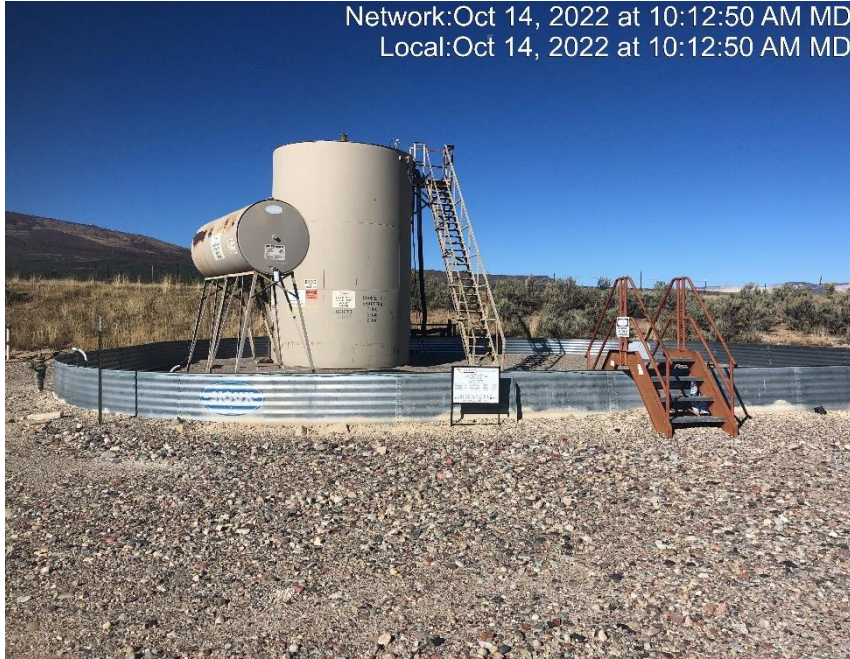
Photo #8065 From entrance to location.

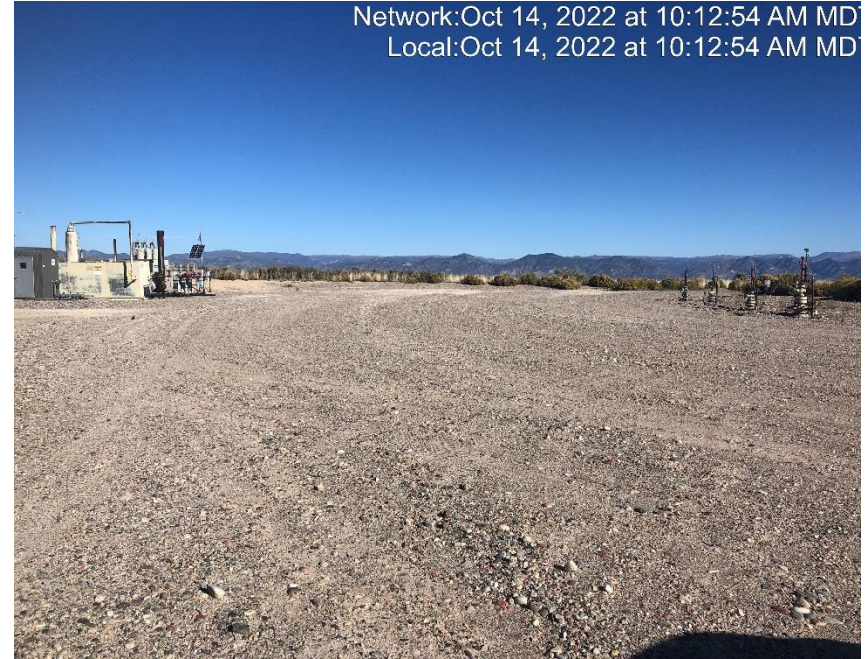
Photo #8066 From entrance to location.

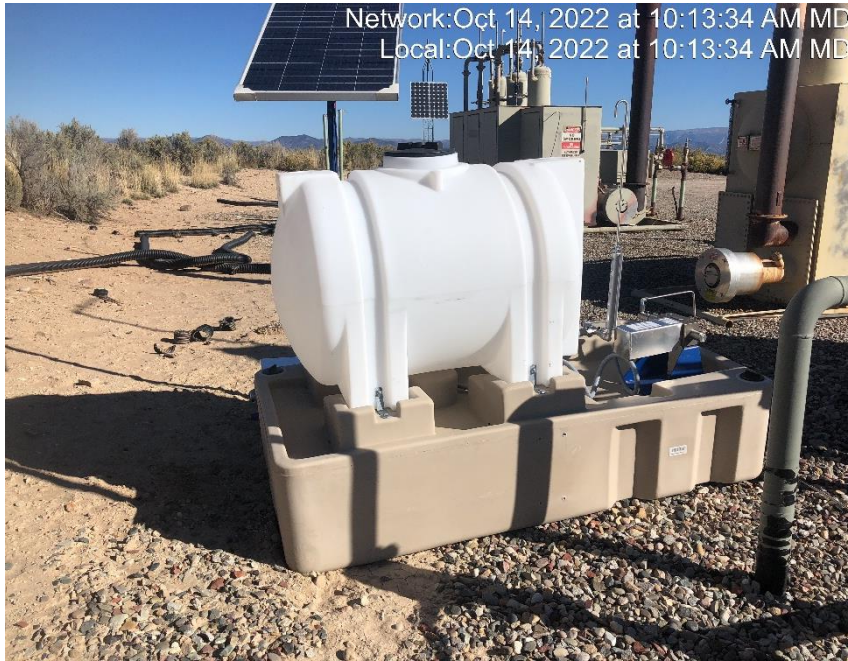
Photo #8068 Chemical tank missing required information.

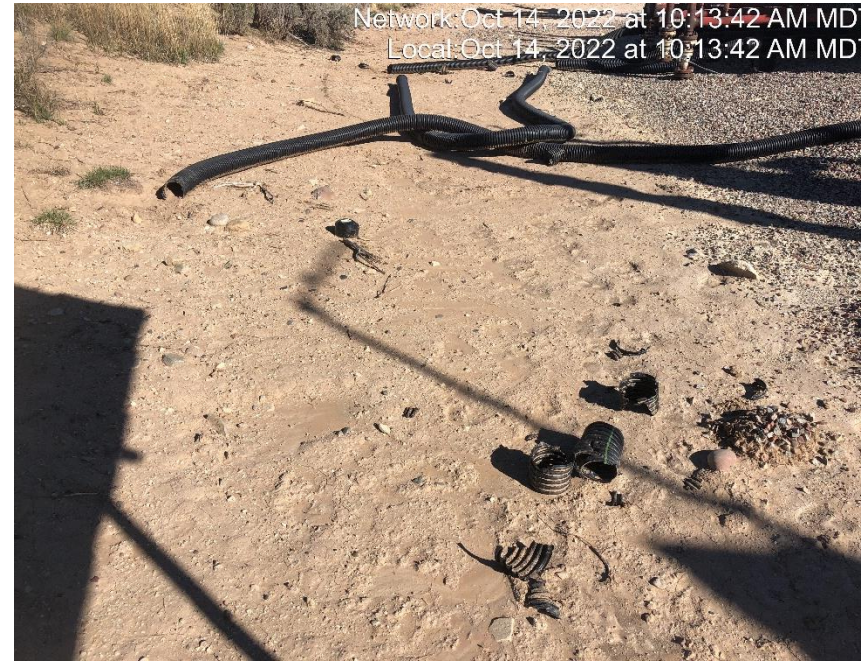
Photo #8069 Debris on location.

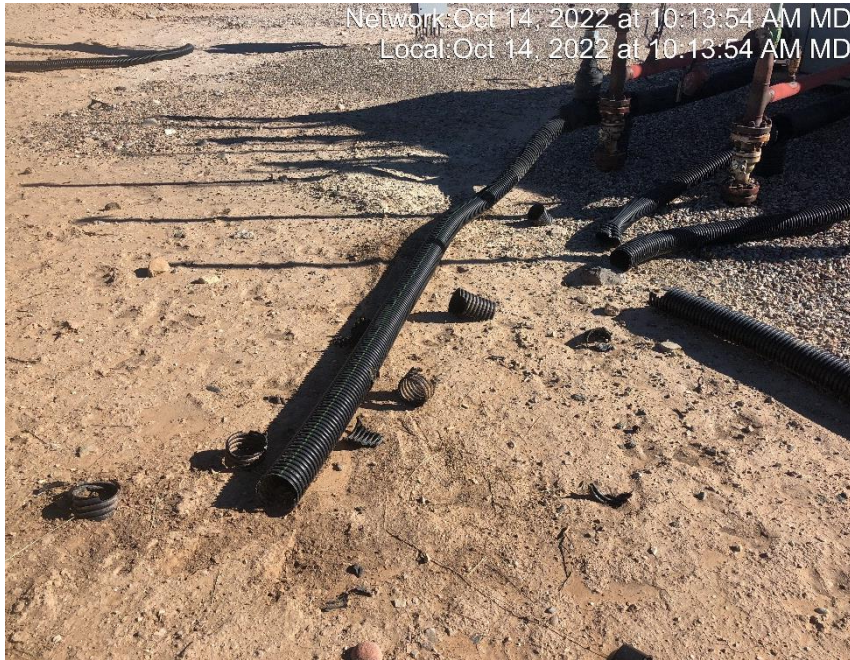
Photo #8070 Multiple heating insulation open ended and not capped.

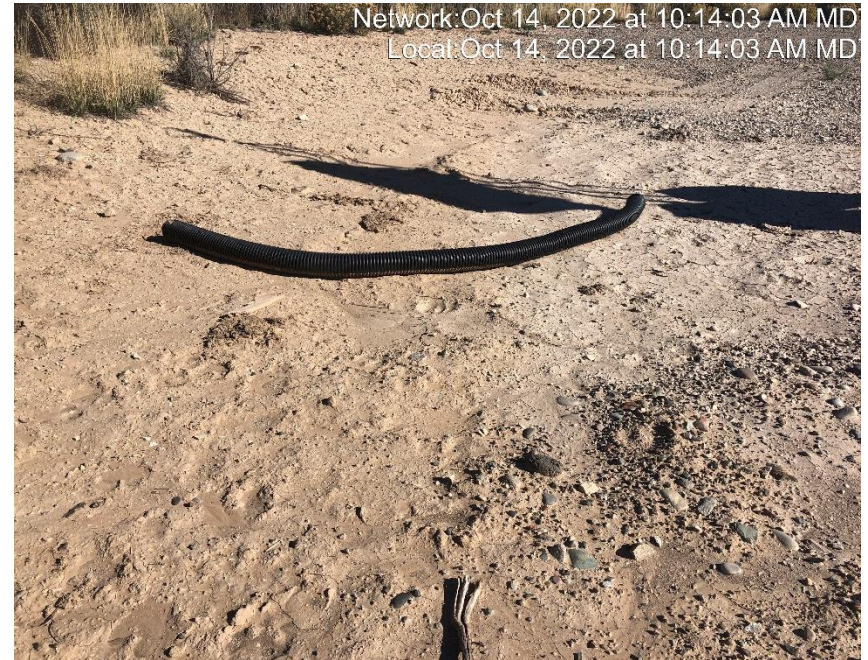
Photo #8071 Debris on location.

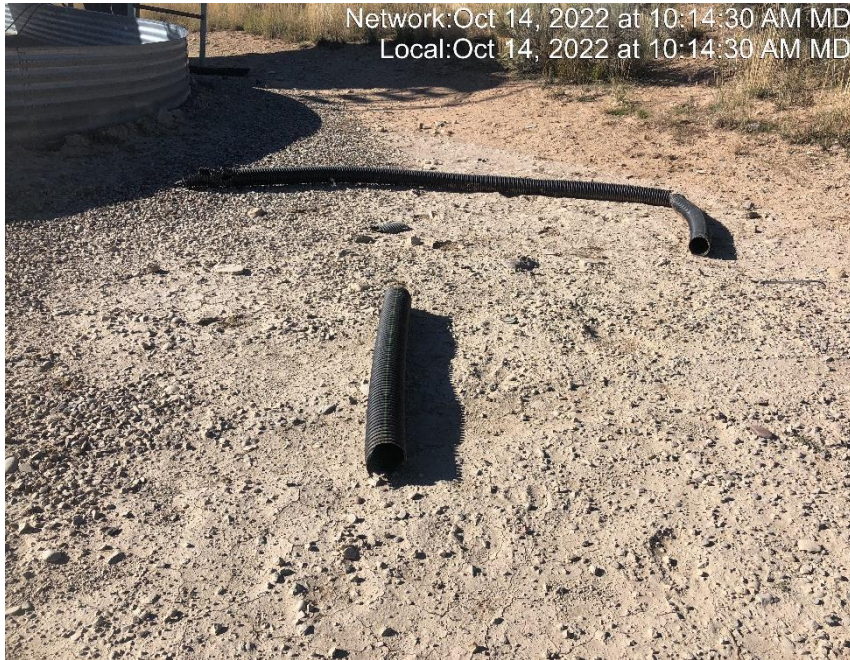
Photo #8072 Debris on location.
