Inspection Photogs
Location Name: Miller Mesaverde Unit 1
Location ID: 325165

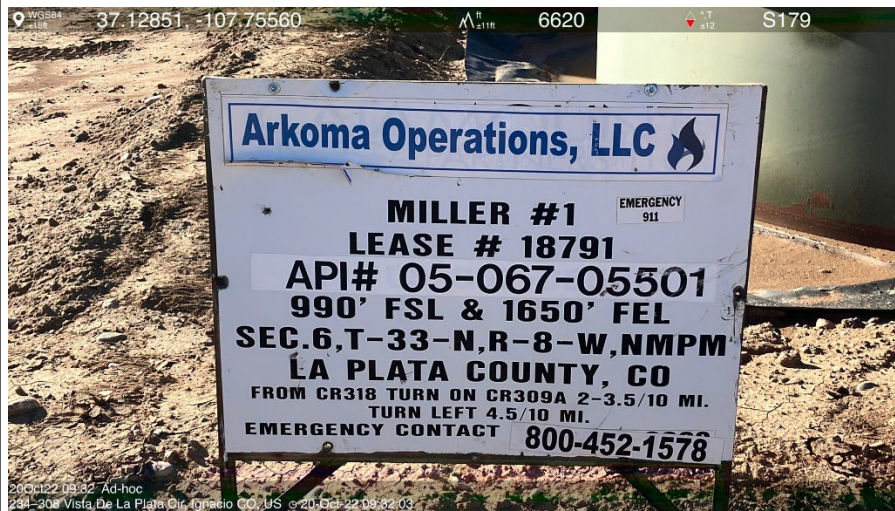
IMG 01
Well sign

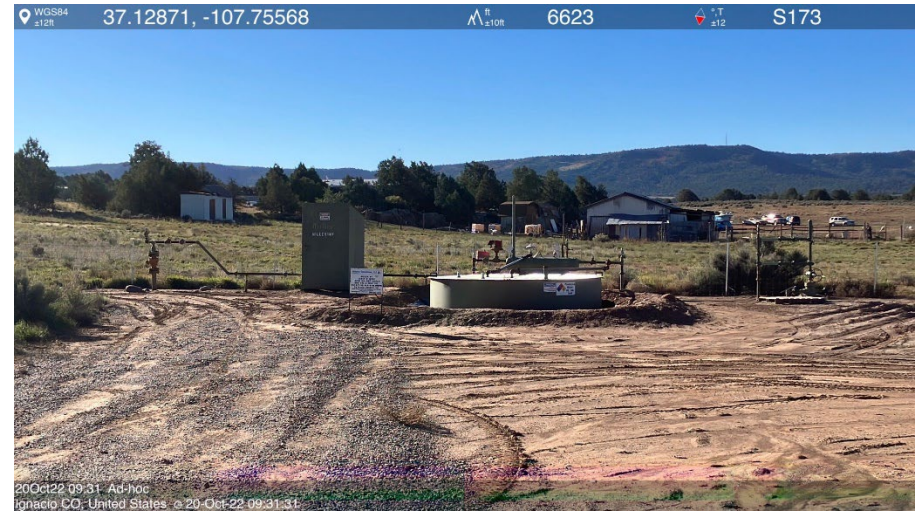
IMG 02
Location overview

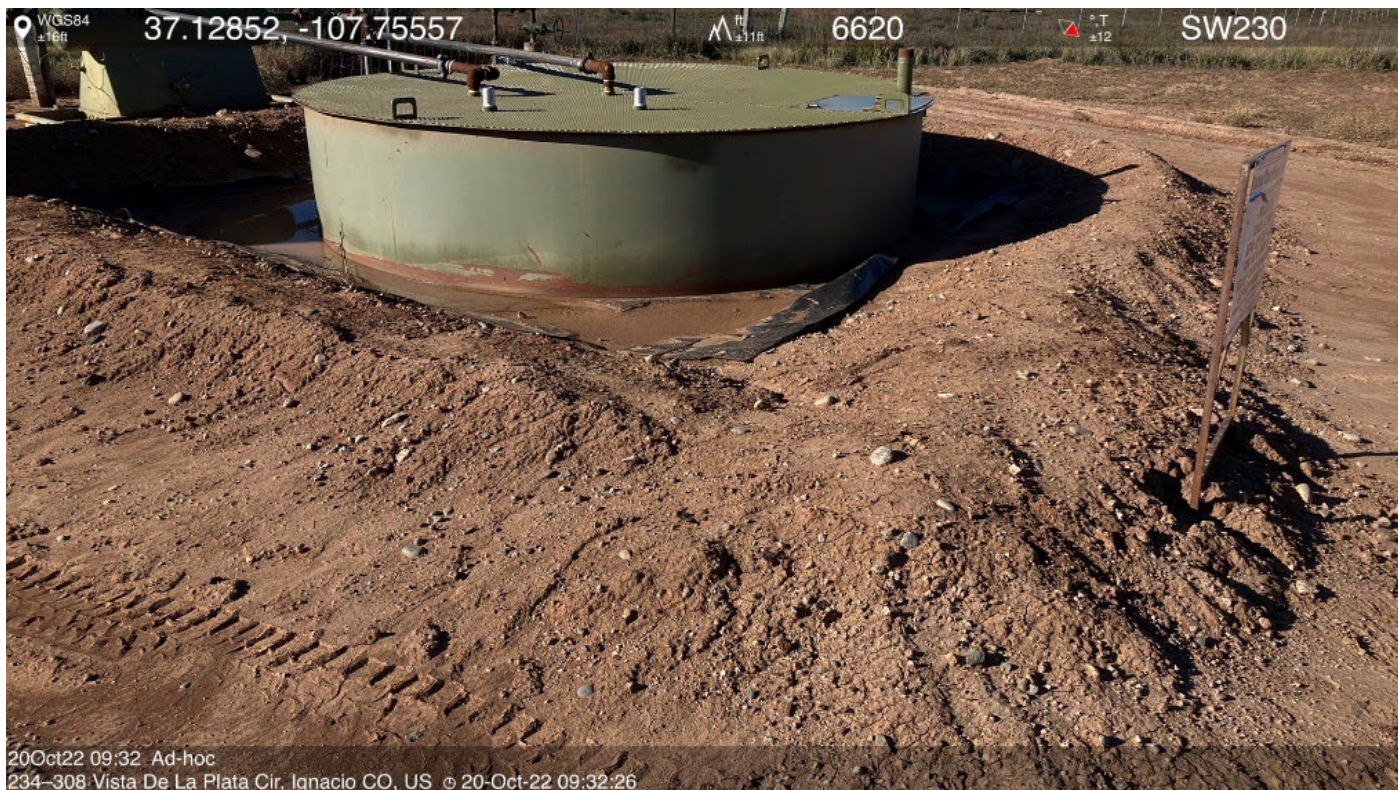
IMG 03
Berm height
