Inspection Photos

Location Name: LARAMIE ENERGY LLC Blackman /14-12 Pad

Location ID: 334544

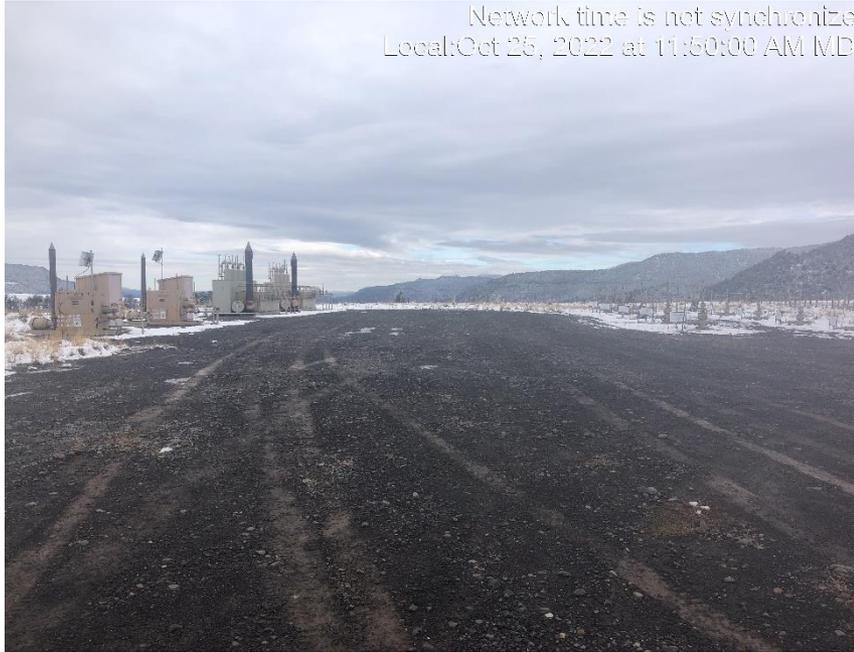
Photo #8154 From entrance to location.

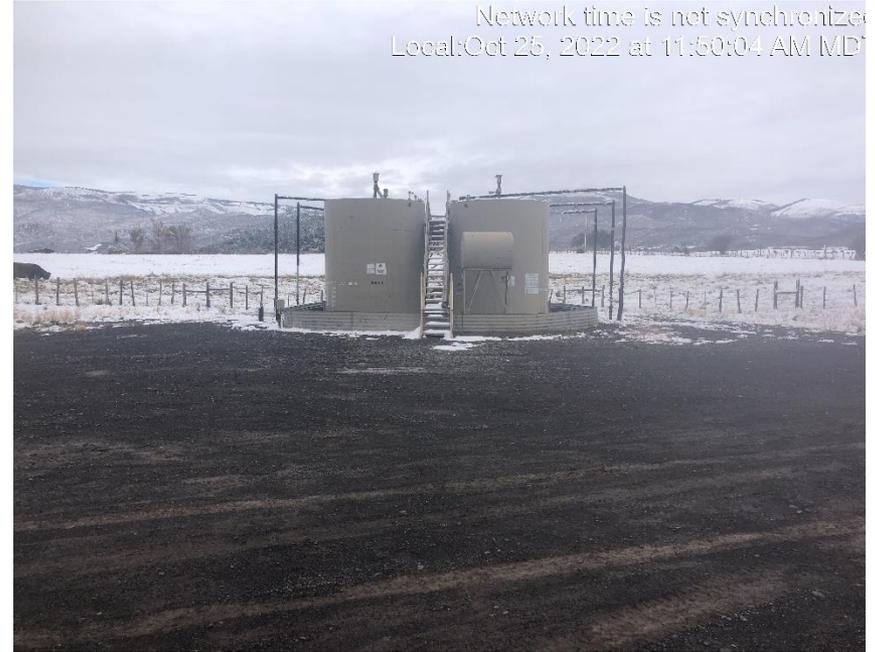
Photo #8155 From entrance to location.

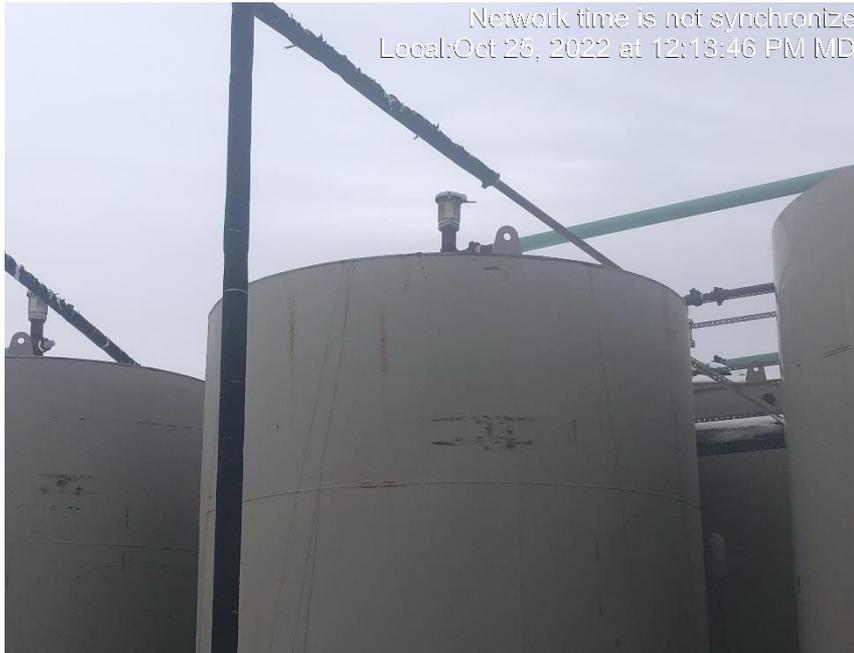
Photo #8156 Pressure relief valve leaking. Refer to OGI video.

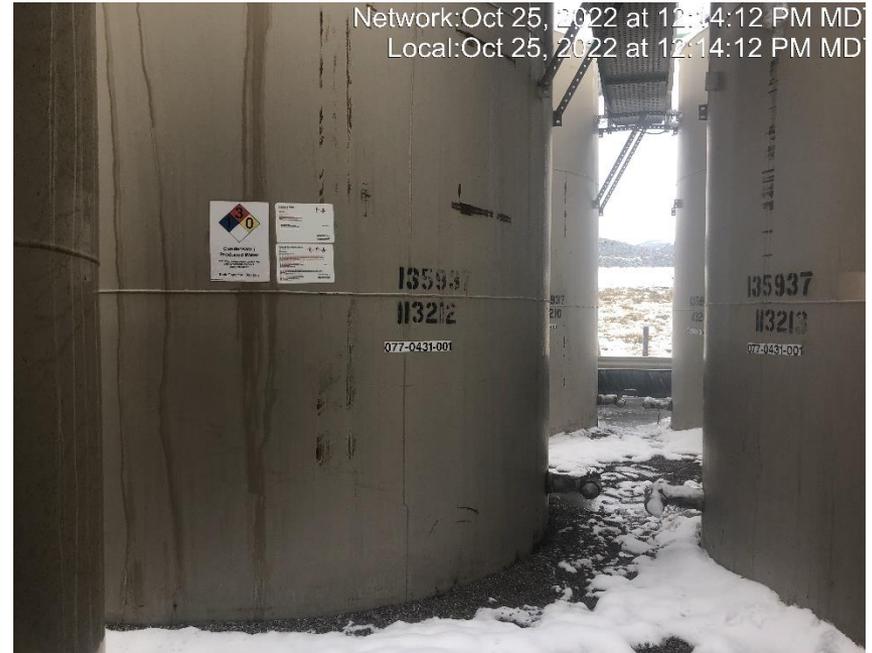
Photo #8157 Leaking pressure relief valve located on Tank #113212
