Inspection Photogs
Location Name: Mary Catherine 33-7-3 3B
Location ID: 311955

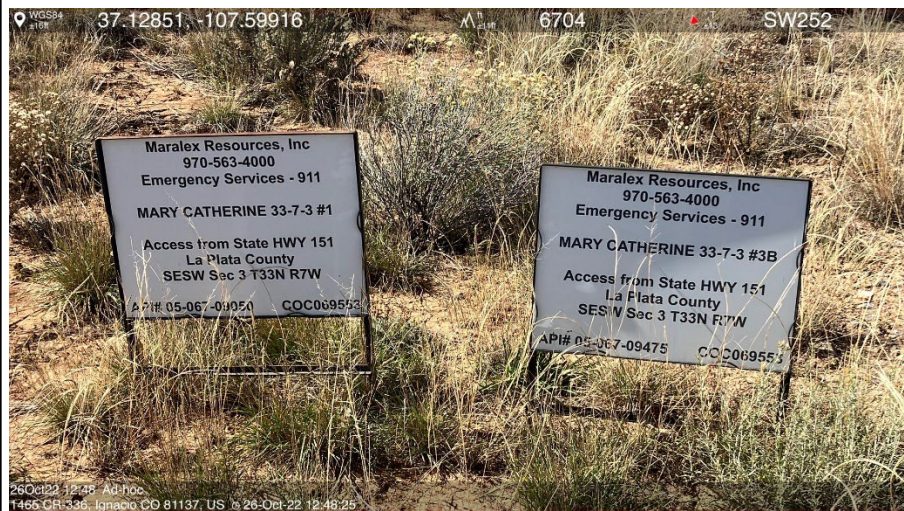
IMG 01
Well sign

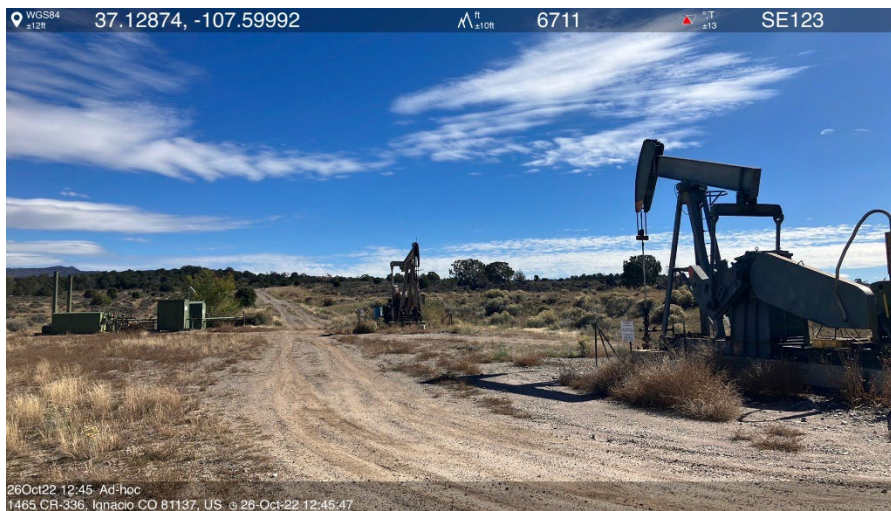
IMG 02
Location overview

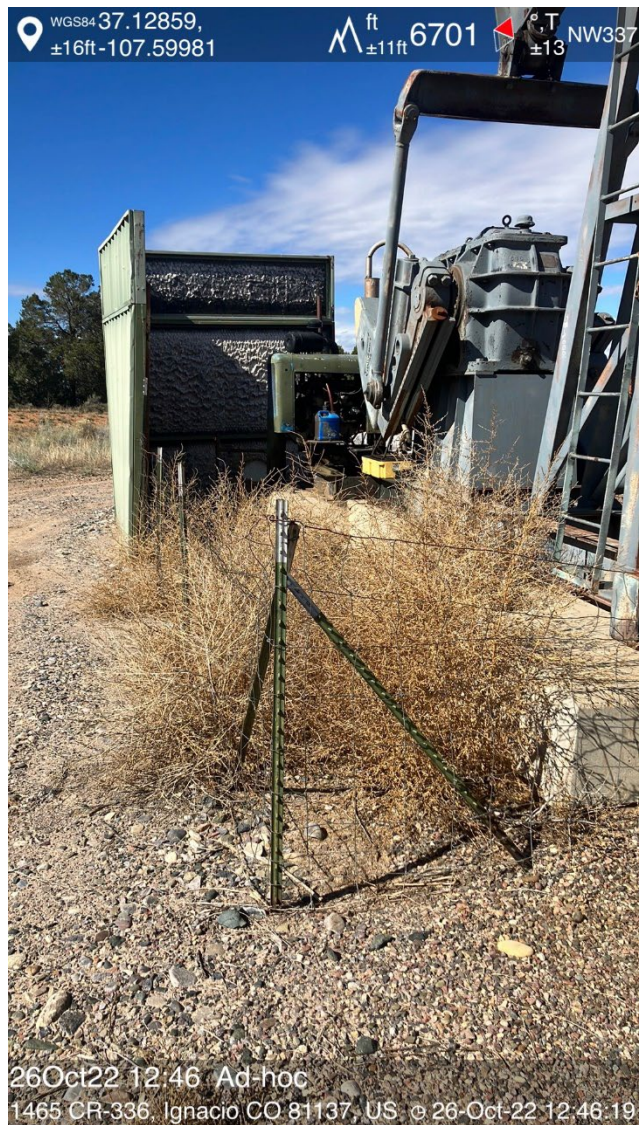
IMG 03
Weeds at pump jack

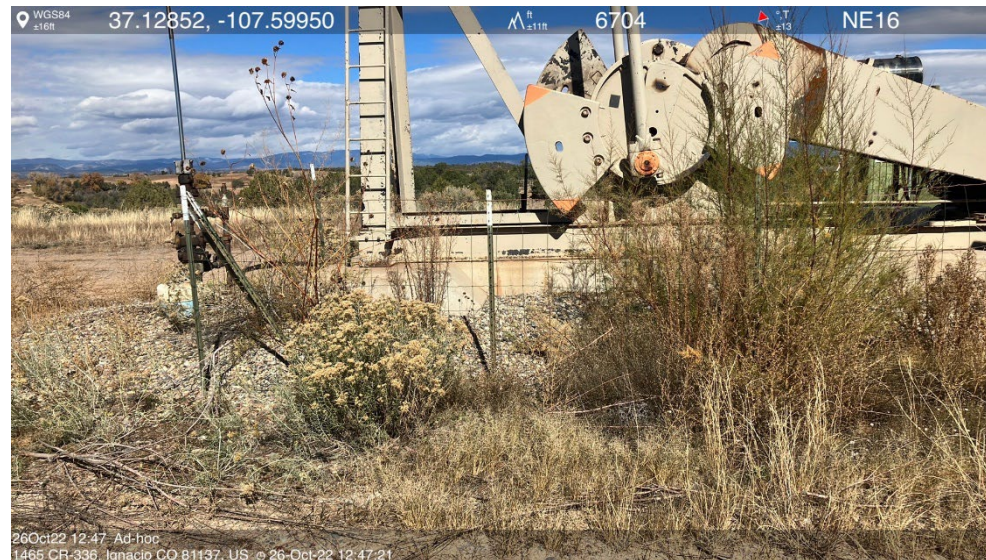
IMG 04
Weeds at pump jack

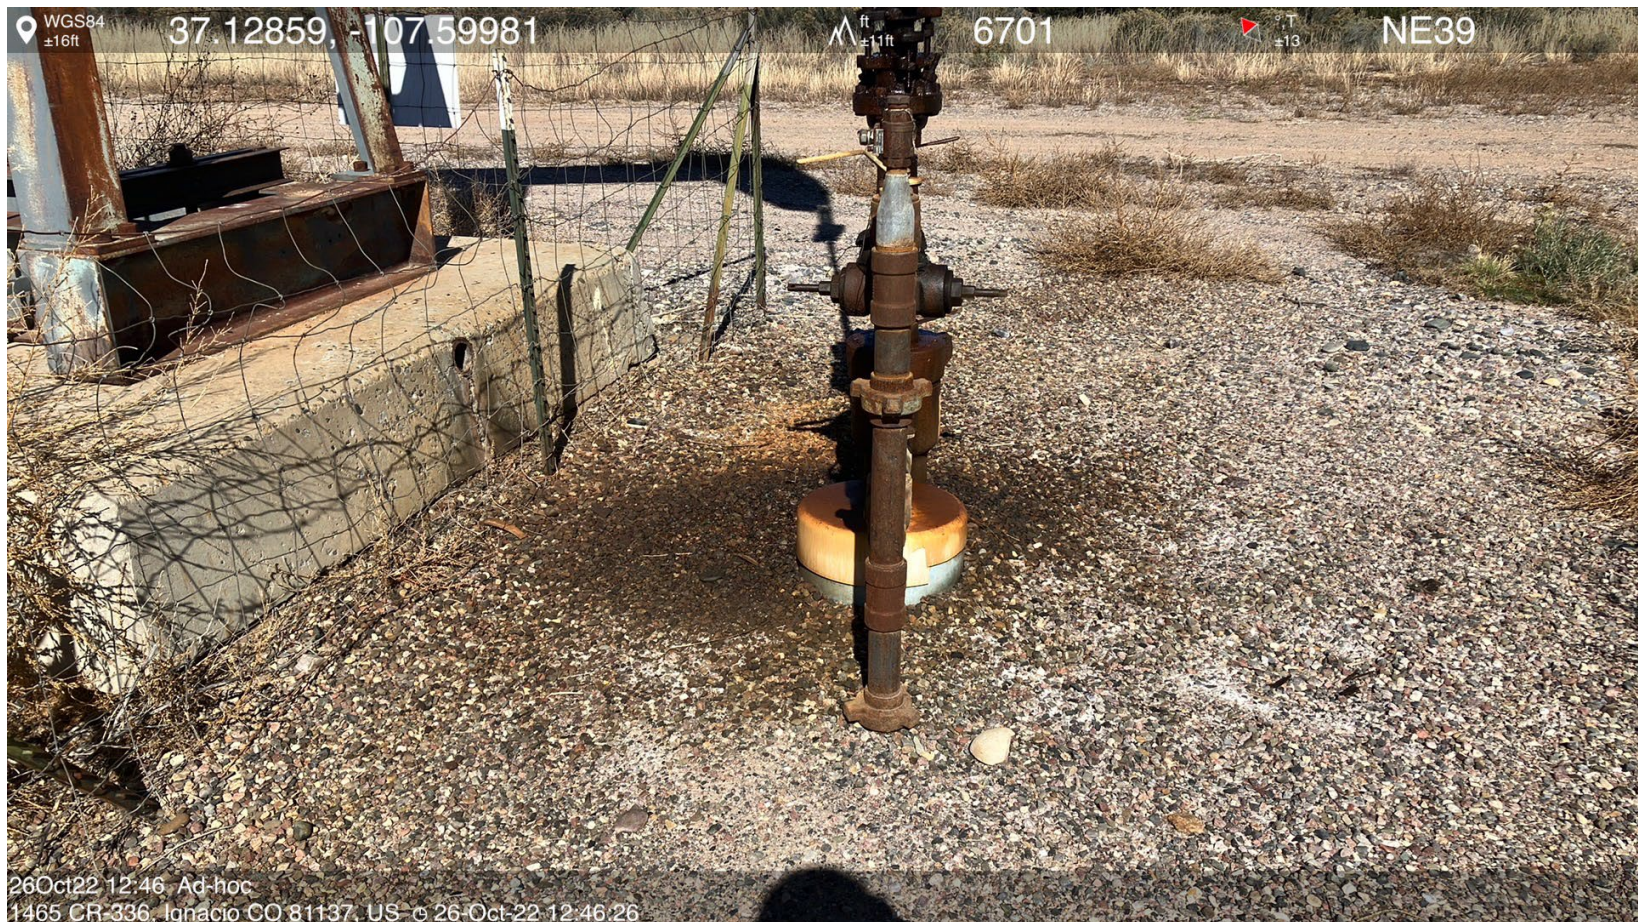
IMG 05

Lube oil has impacted surface material
