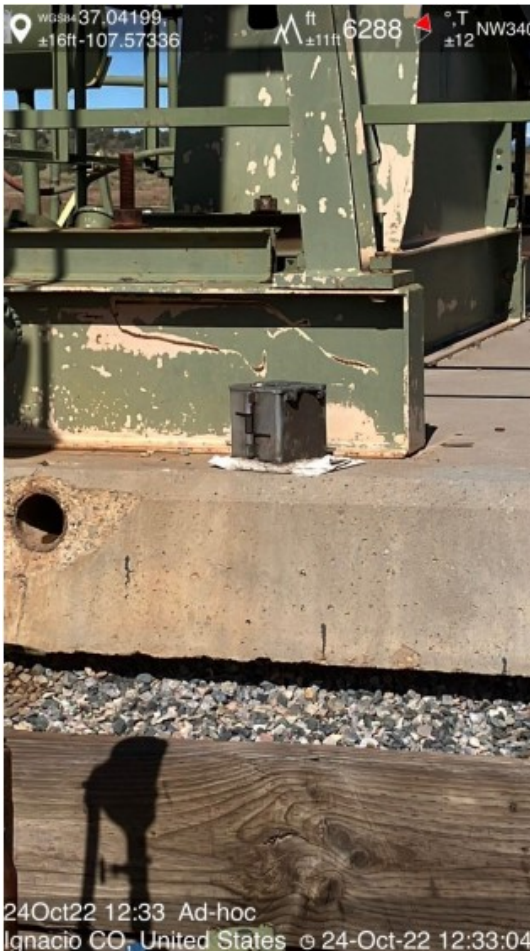
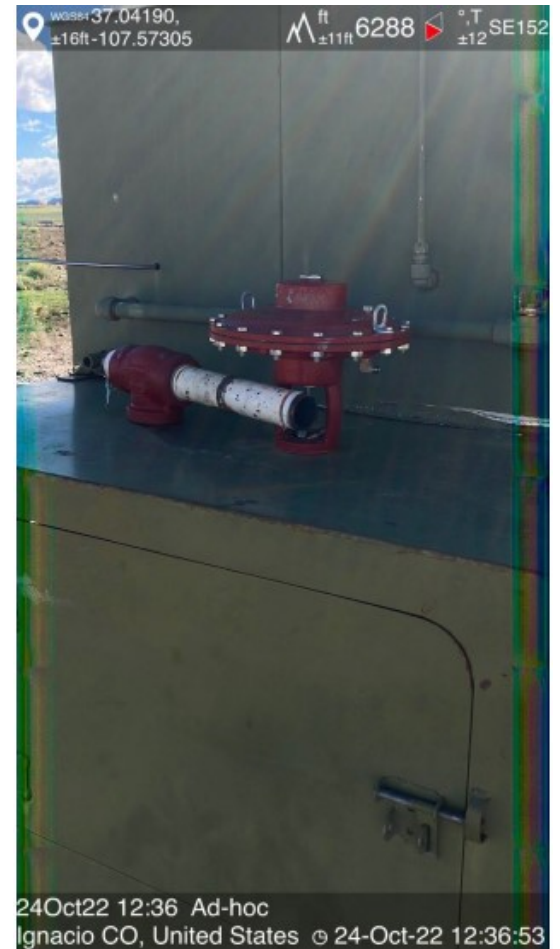
: Pump packing box at pump jack (IMG 04), valve and pipe fittings at separator (IMG 06) are unused.

Pictures from INC showing the unused equipment on the location.

Corrective Action: All unused equipment must be returned to use or stored off location per rule 606. **Date: 11/02/2022**

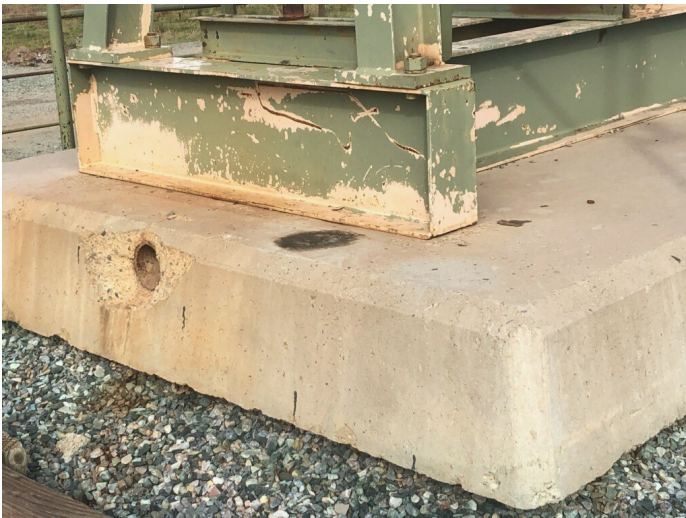
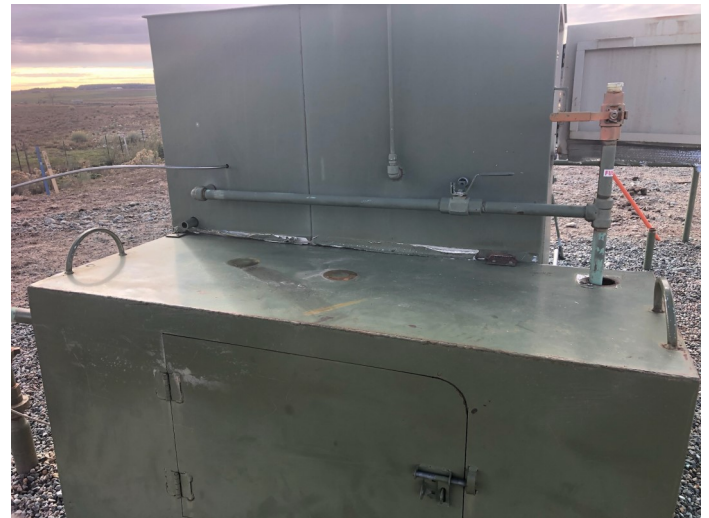
Pictures showing that all unused equipment has been removed from the site.

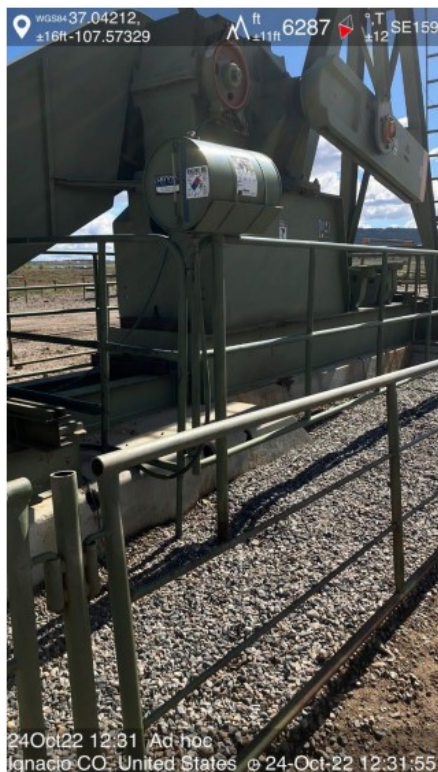
Lube oil. Lube oil at #2 3 wellhead does not have spill prevention (IMG 03).

Picture from INC showing the missing containment around the lube oil day tank.

Corrective Action: Implement or modify BMPs for improved material handling and spill prevention per rule 1002.f.(2)B.

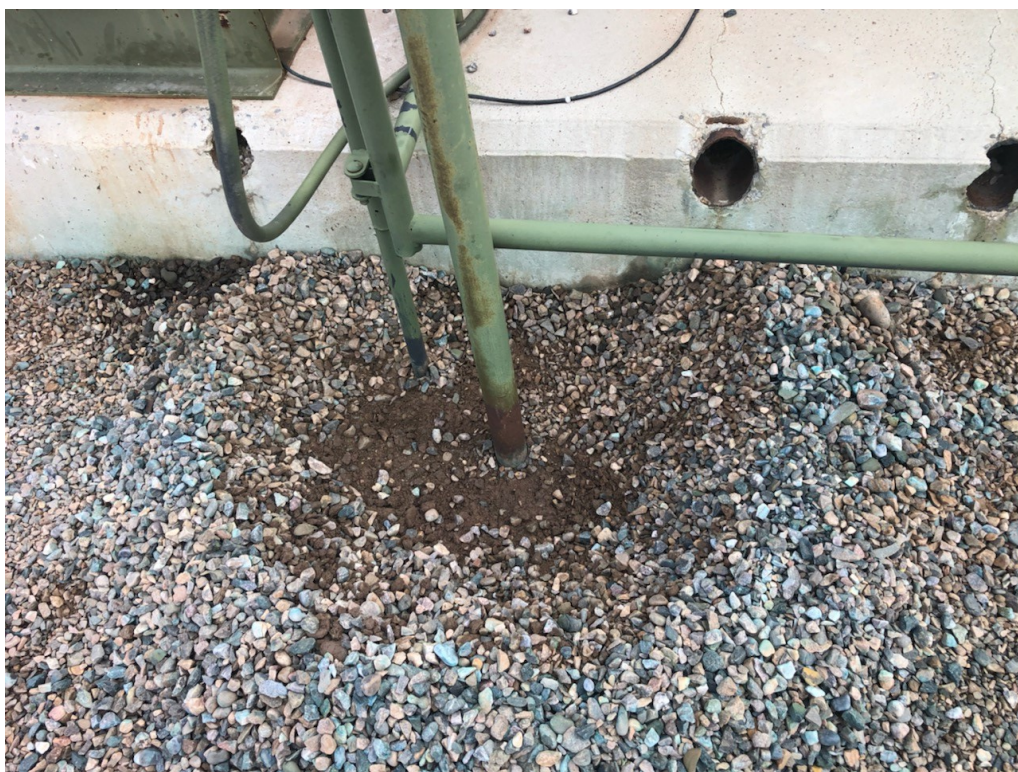
Containment berm was built around the lube oil tank .

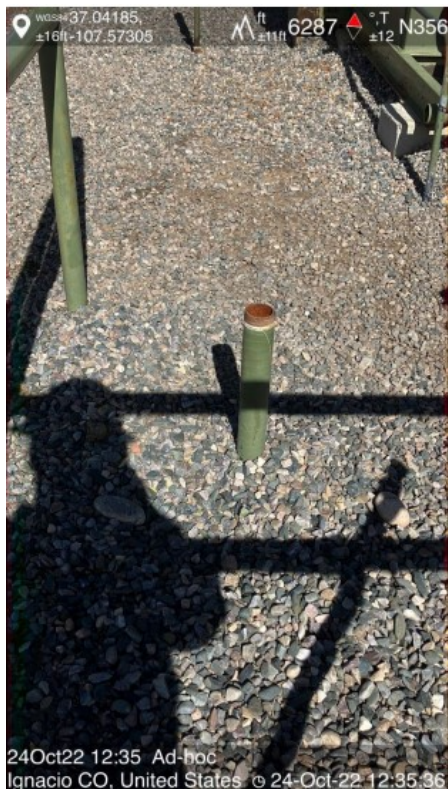
: 3" and 4" line from #2 3 wellhead to separator, 2 3" lines from C #1 to separator, 4" produced water line from separator to off location, 2 1" gas supply lines at separators. 2" line at C #1 separator is not in use and not locked out (IMG 05).

Picture from INC showing the unused flow line near the separator.

Corrective Action: Apply Out of Service Locked and Tagged on unused flow line per rule 1101.a(3) **Date: 10/27/2022**

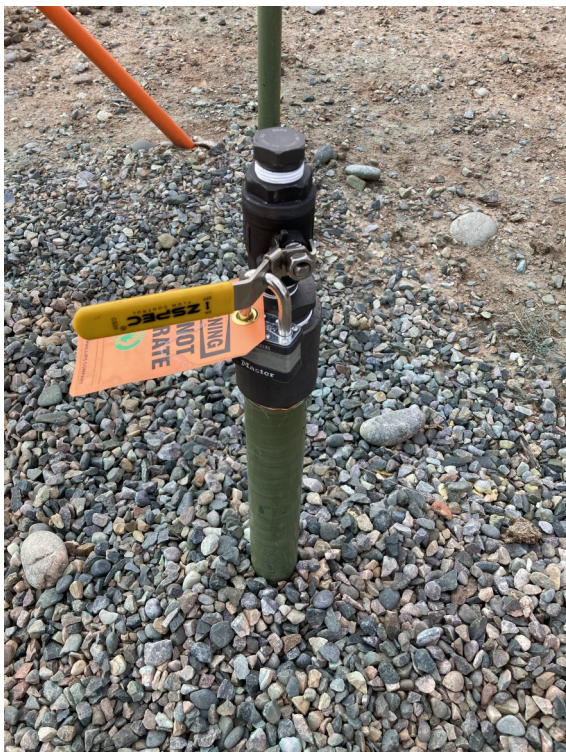
Installed valve on unused flow line and locked and tagged out.

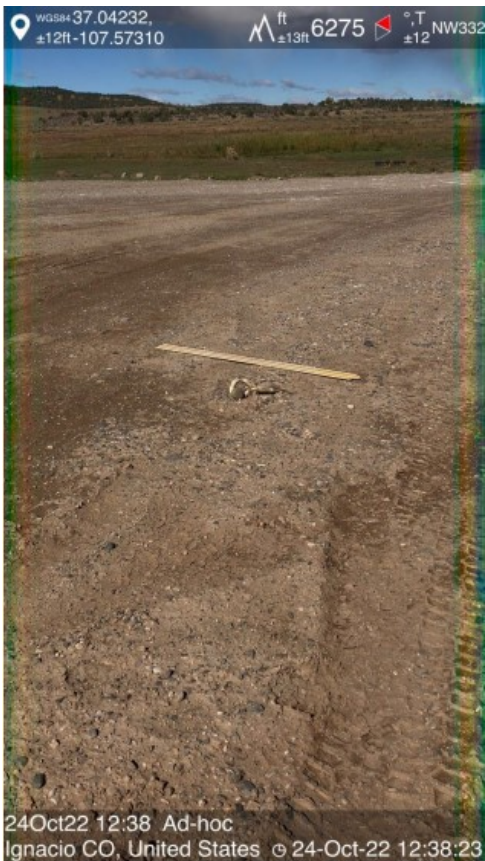
: Rig anchors not secured properly (IMG 07).

Picture of downed rig marker from the INC.

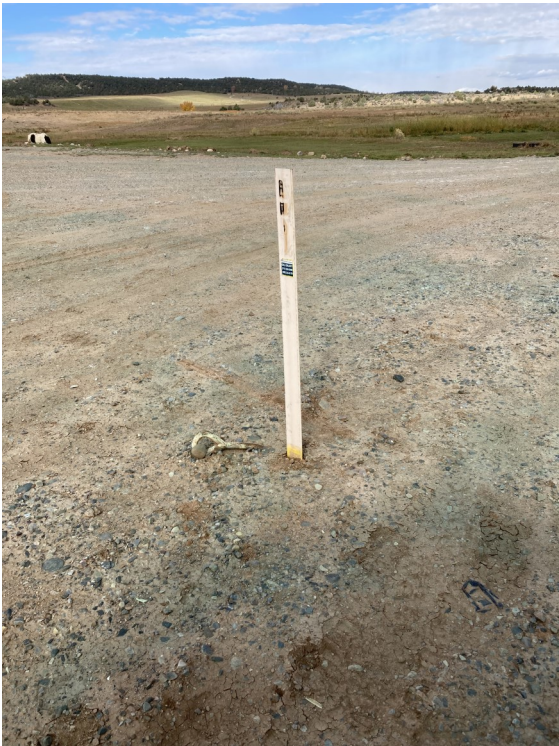
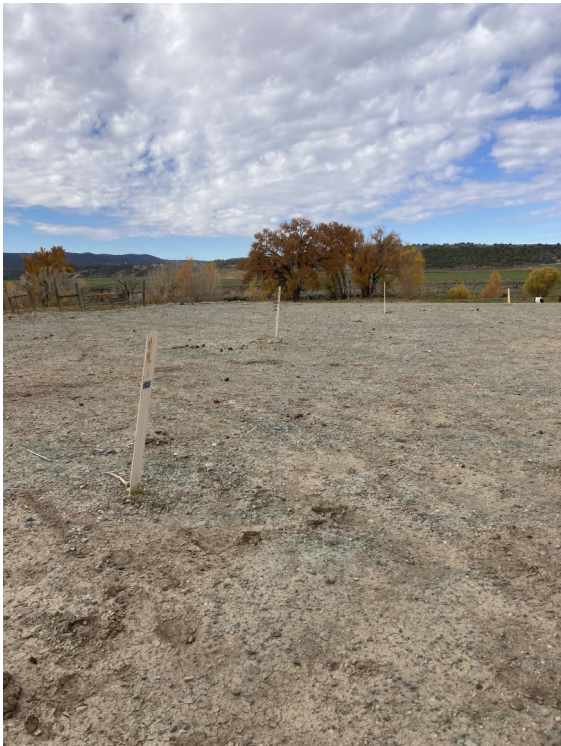
Replaced all of the damaged rig anchor markers on the location.
