Inspection Photos
Location Name: Albert Martinez 1A
API: 007-06256

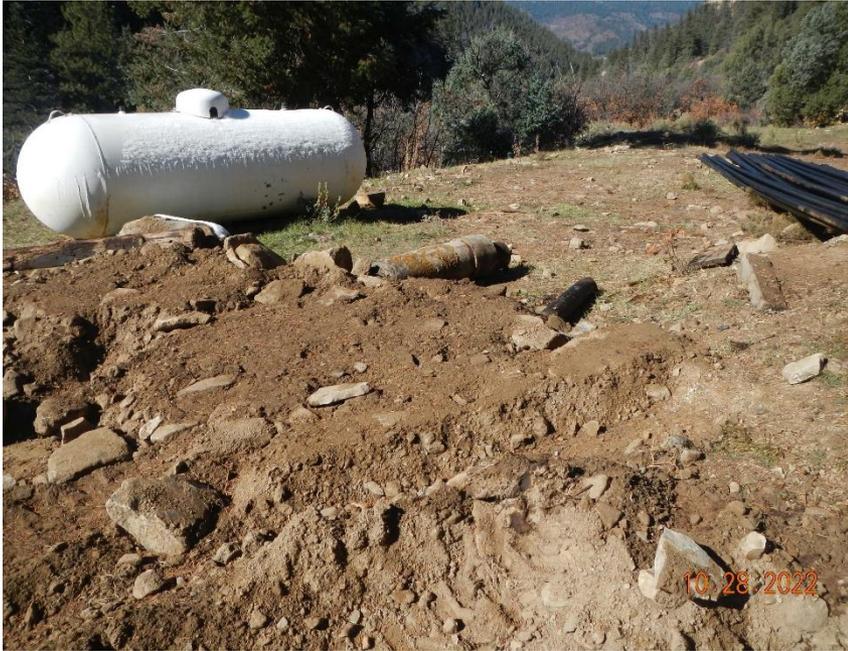
Cut-off stub and backfilled wellhead and propane tank

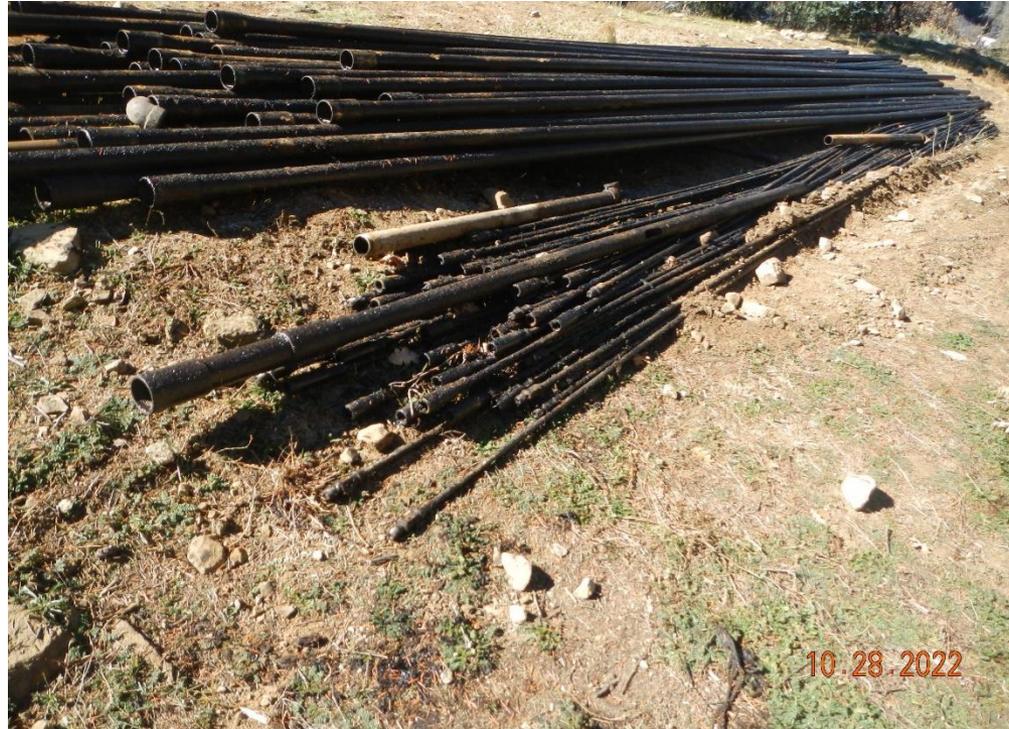
Tubing and rods coated in oily waste still stored on bare ground

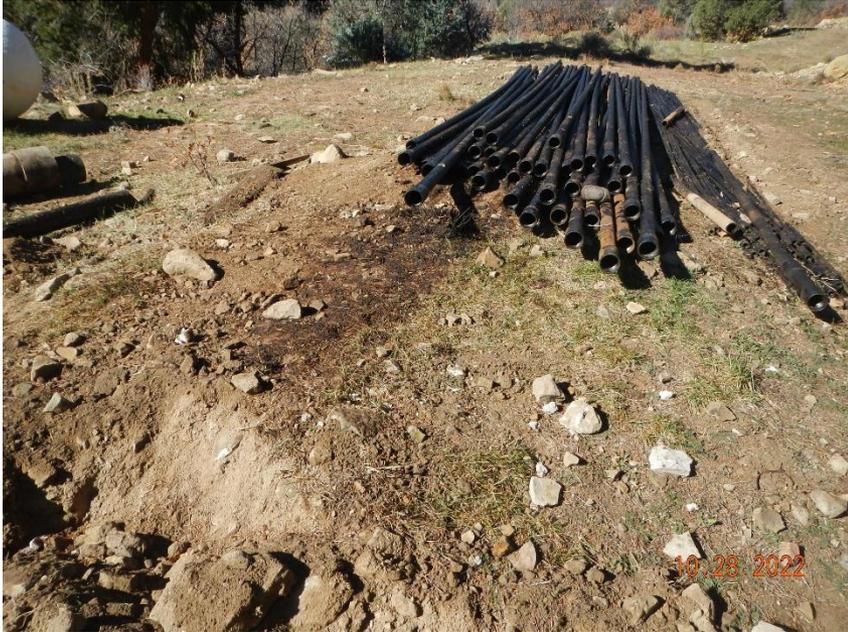
Oily waste on ground, no spill response approx. 18x40"

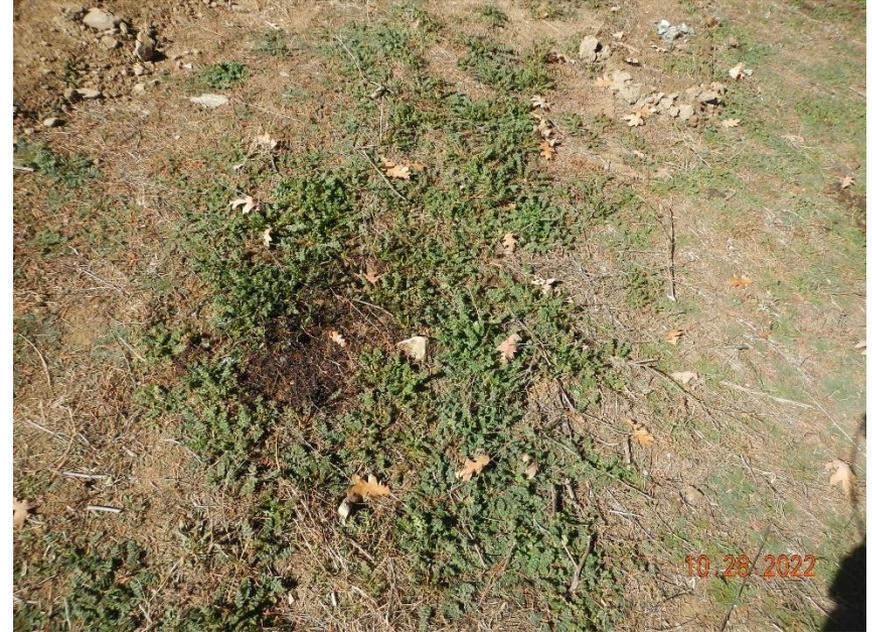
Oily waste 10-12" diameter
