Stormwater Inspection Report

Operator:	Laramie Energy, LLC
Project:	Cascade Creek
Location:	Shell 797-03A Pad
Date:	Wednesday, November 2, 2022
Weather:	Partly Cloudy, Windy, 64°, Lo 46°

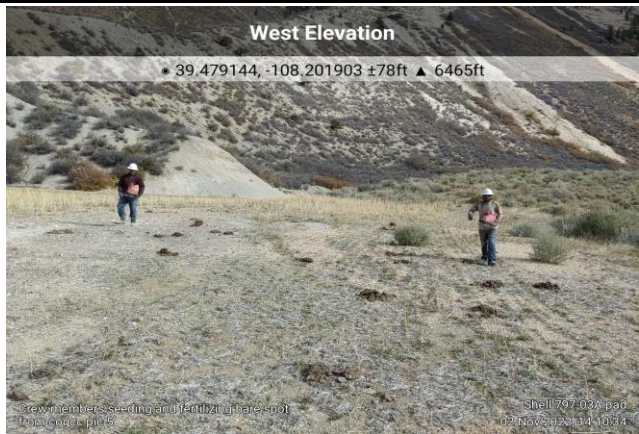
Photo 3

Seeding Bare Areas Identified as Photo #5
