Inspection Photos

Location Name: CAERUS PICEANCE LLC DUNN-67S92W /4NWSW

Location ID: 323955

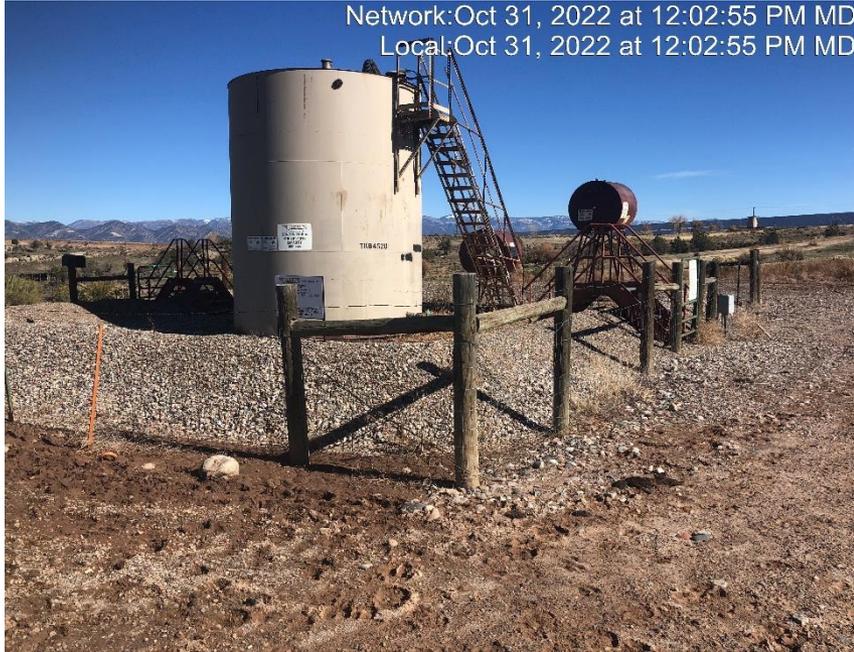
Photo #8255 From entrance to location.

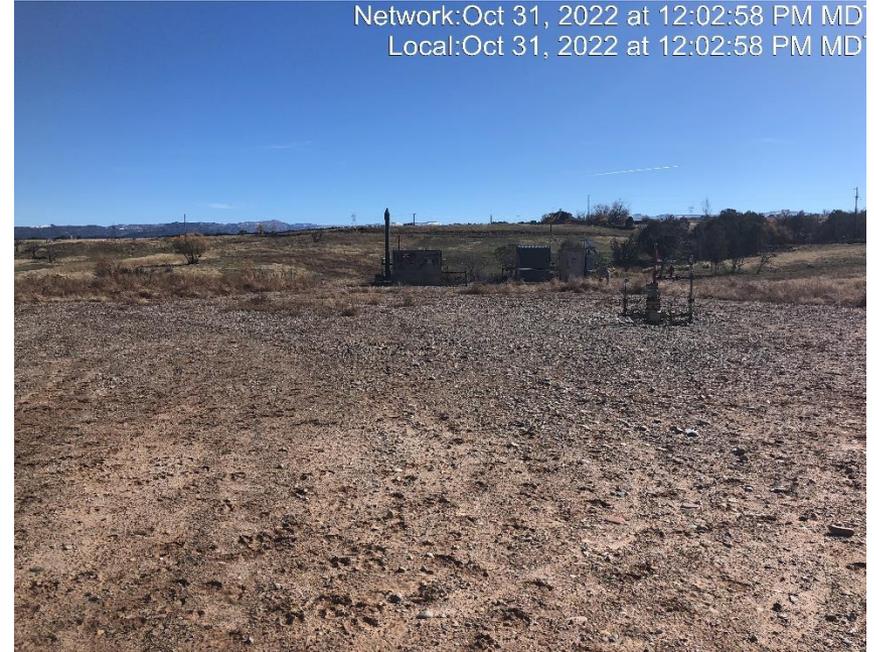
Photo #8256 from entrance to location.

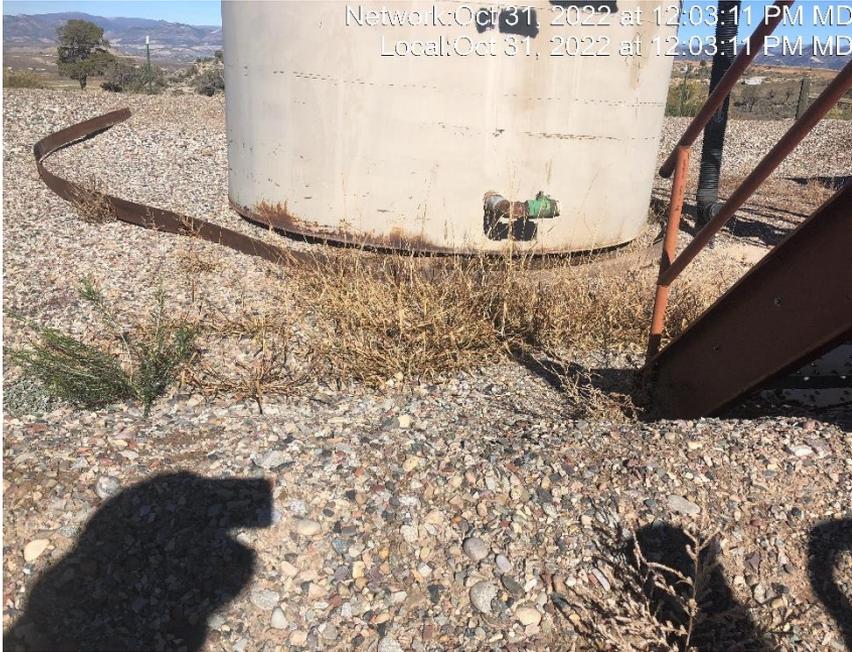
Photo #8257 Undesirable plant species in tank containment.

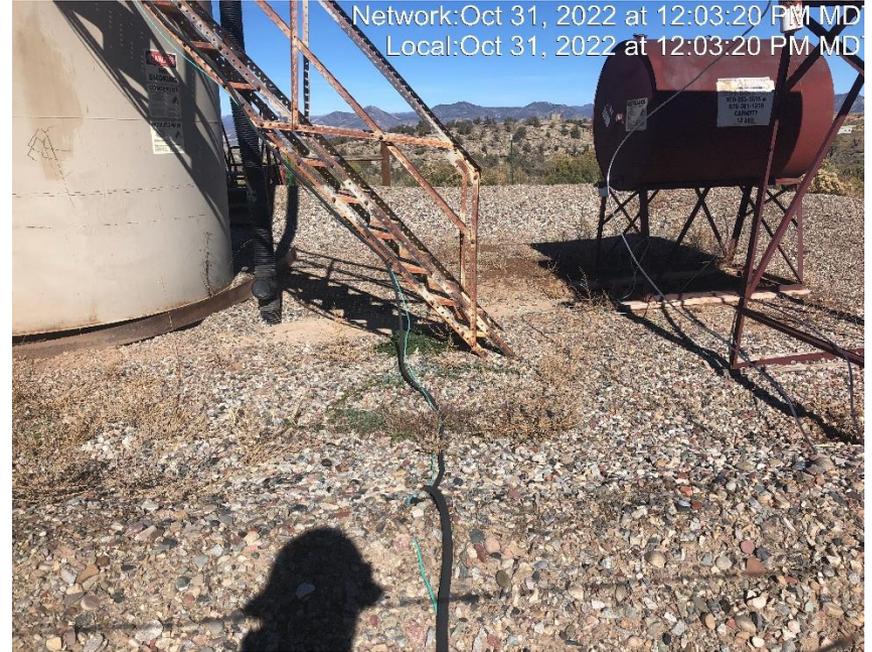
Photo #8258 Undesirable plant species in tank containment

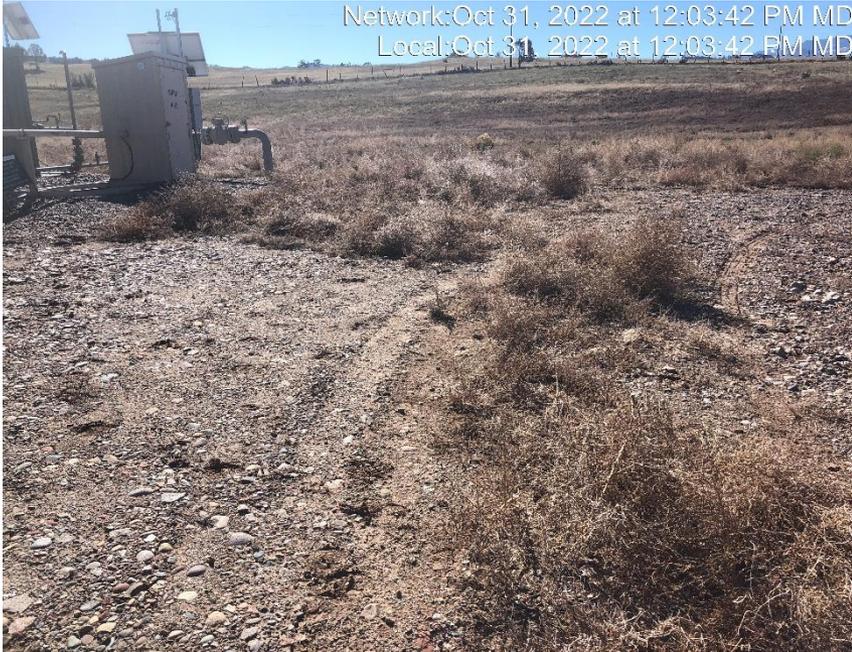
Photo #8259 Undesirable plant species in tank containment

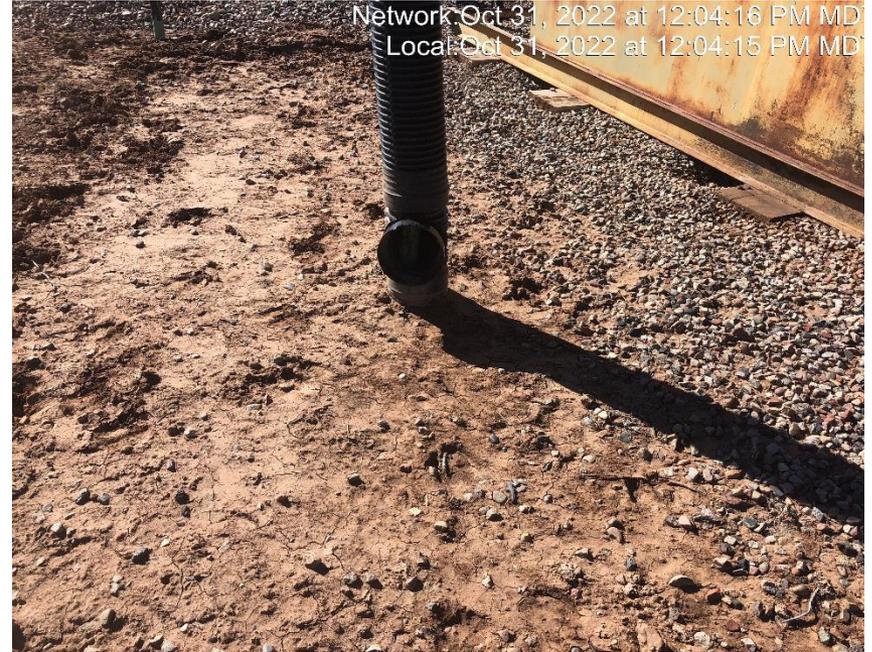
Photo #8260 Flowline heating insulation open ended and not capped.
