Inspection Photos

Location Name: CAERUS PICEANCE LLC GRAHAM-66S92W /32SWSW

Location ID: 334885

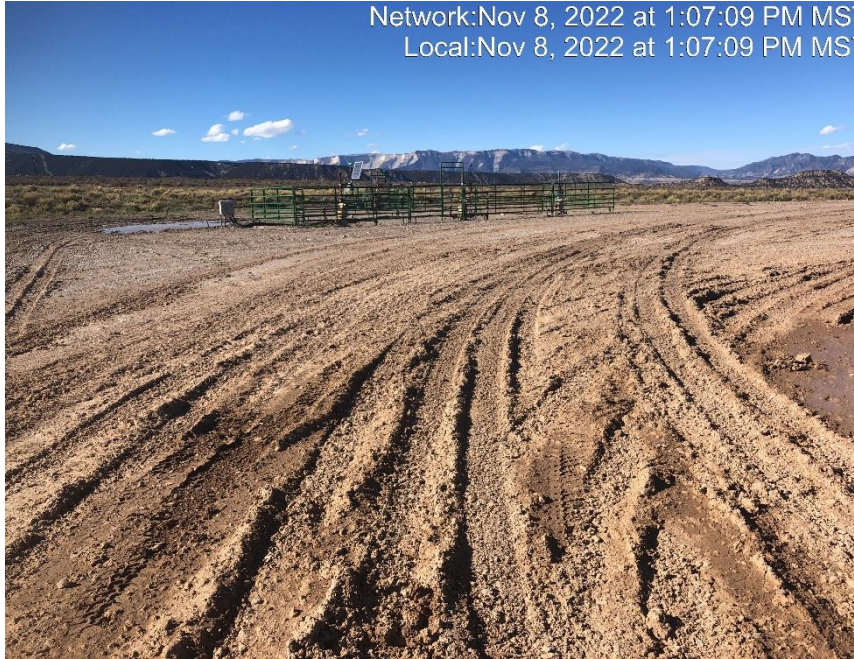
Photo #8342 From entrance to location.

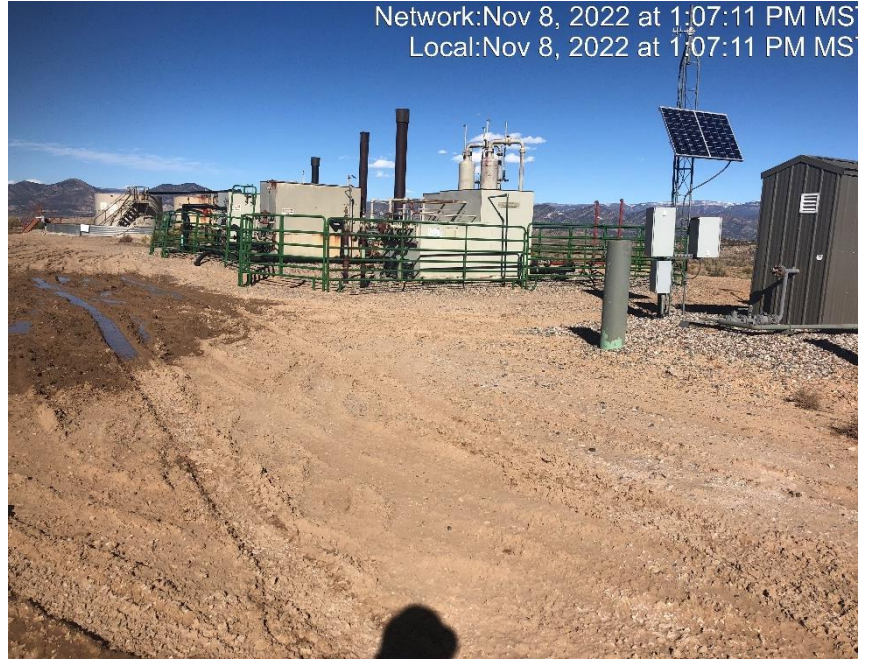
Photo #8343 From entrance to location

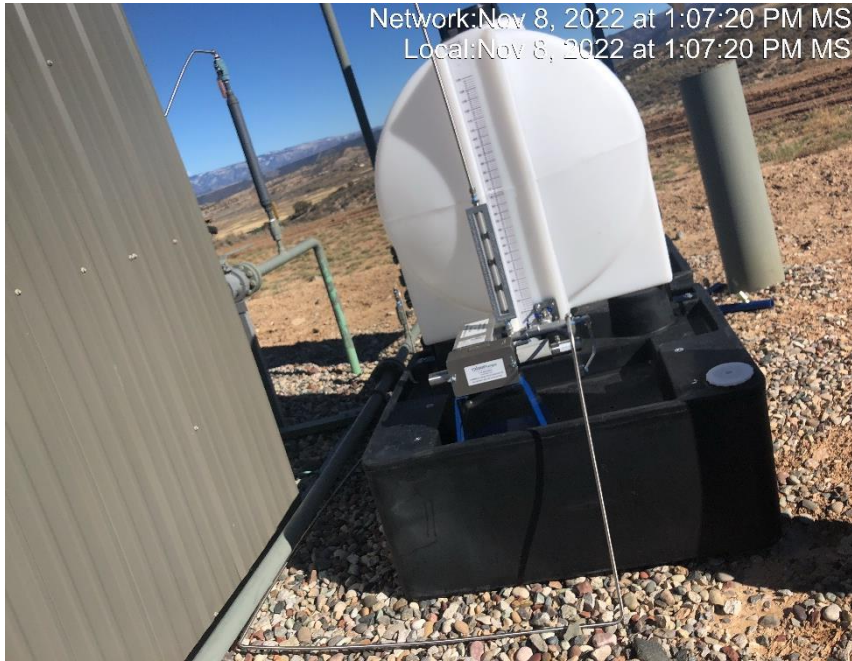
Photo #8344 Chemical tank missing required information.

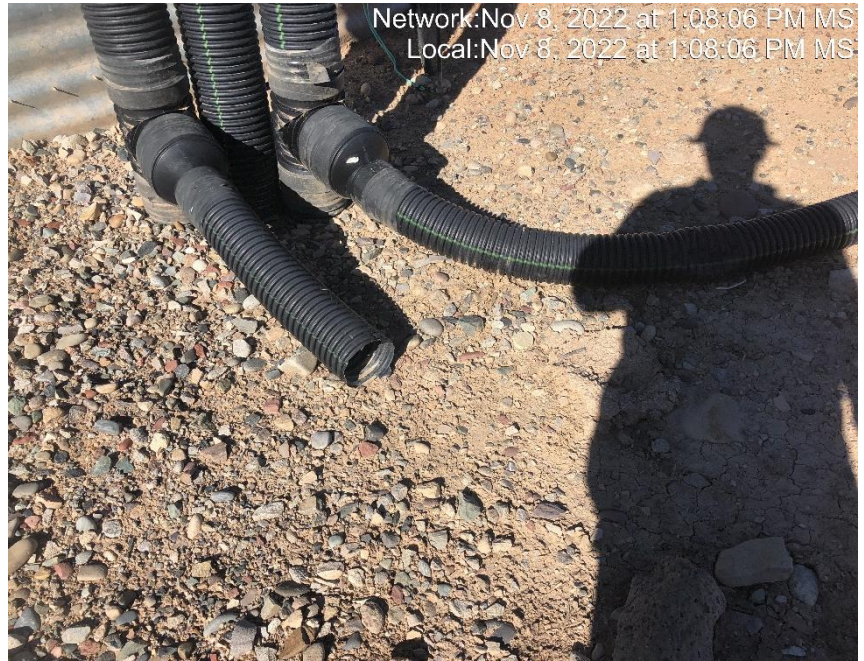
Photo #8348 Loadline open ended.

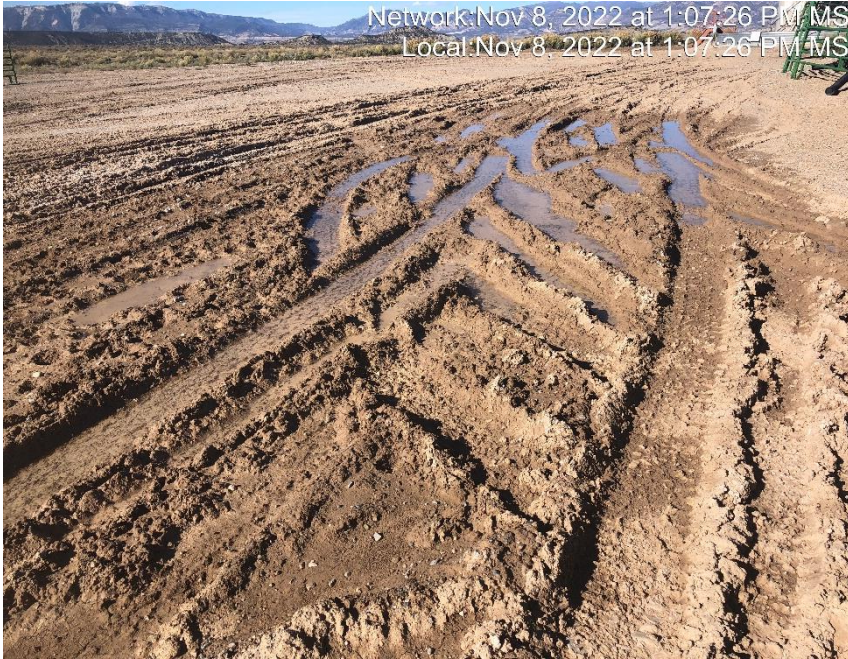
Photo #8345 Location lacks stabilization.

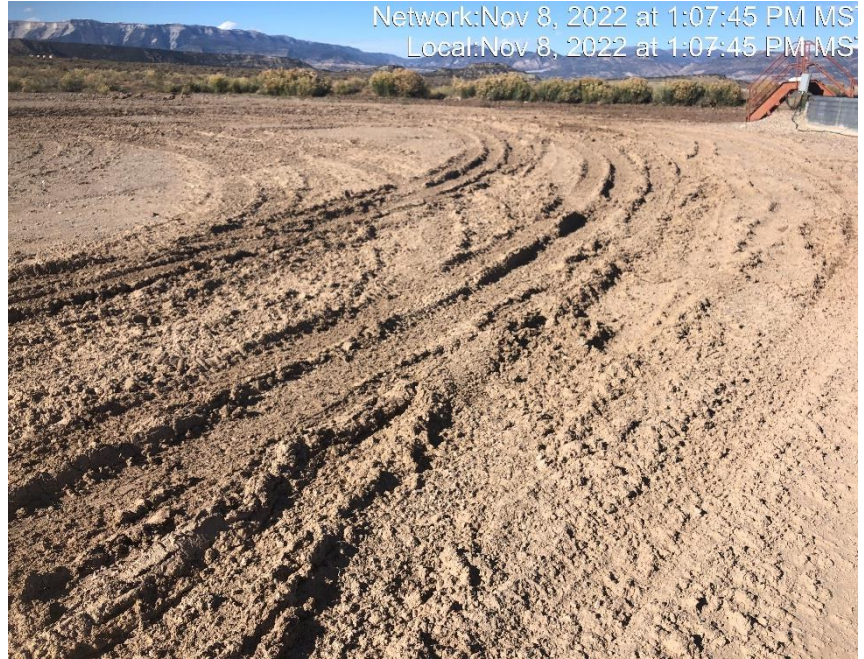
Photo #8346 Location lacks stabilization.

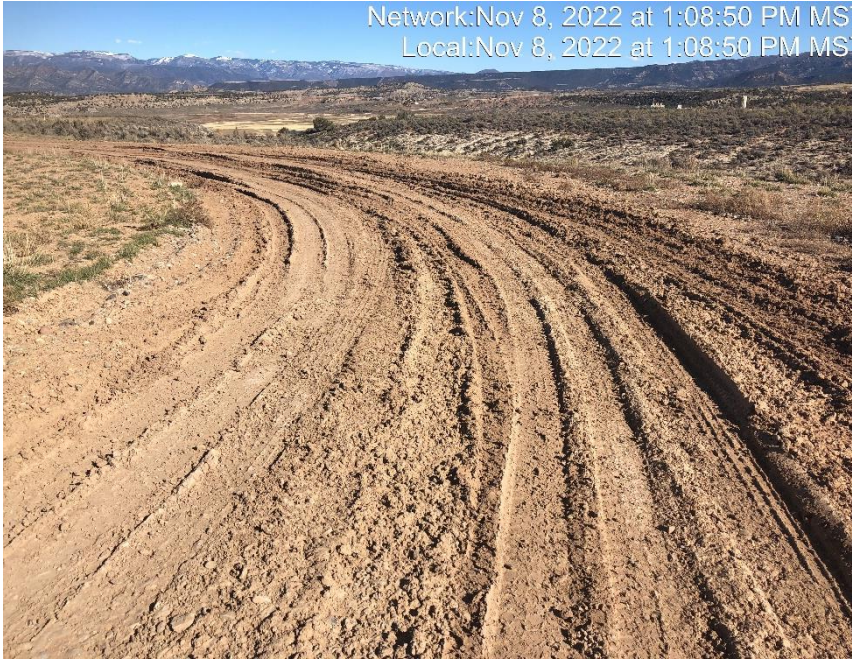
Photo #8349 Insufficnet tracking BMPs at entrance to location.
