Inspection Photogs
Location Name: McCarville B 1
Location ID: 333541

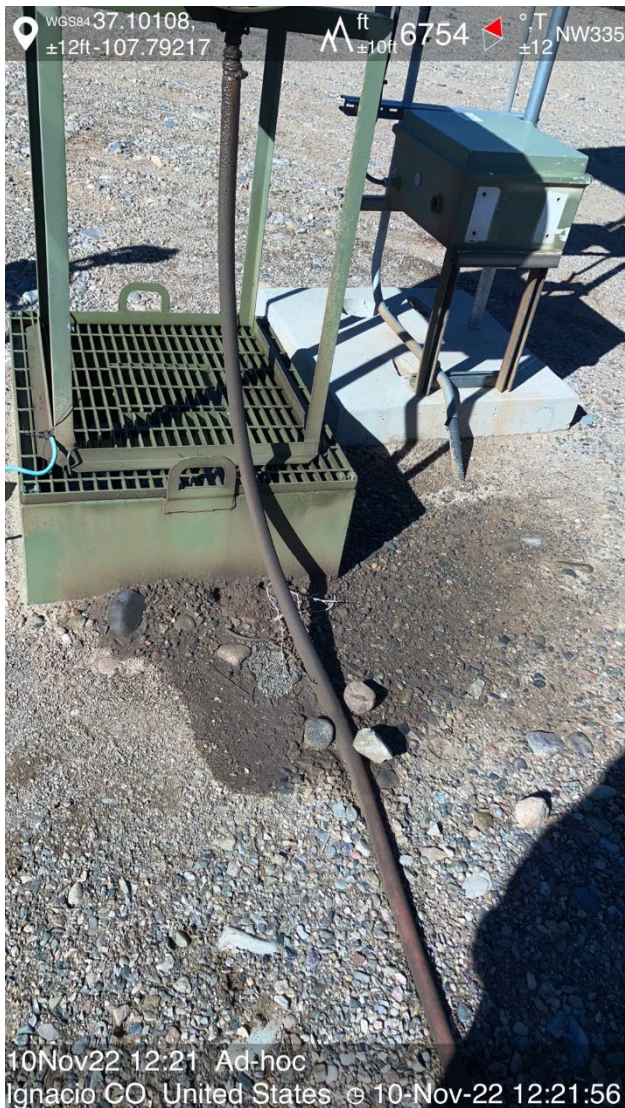
IMG 03

Lube oil has impacted surface material
