# Final Reclamation Inspection

Operator: PDC ENERGY INC - 69175

Location ID: 318461

Inspection Photos  
Location Name: Succo Gas Unit 3  
Location ID: 318461

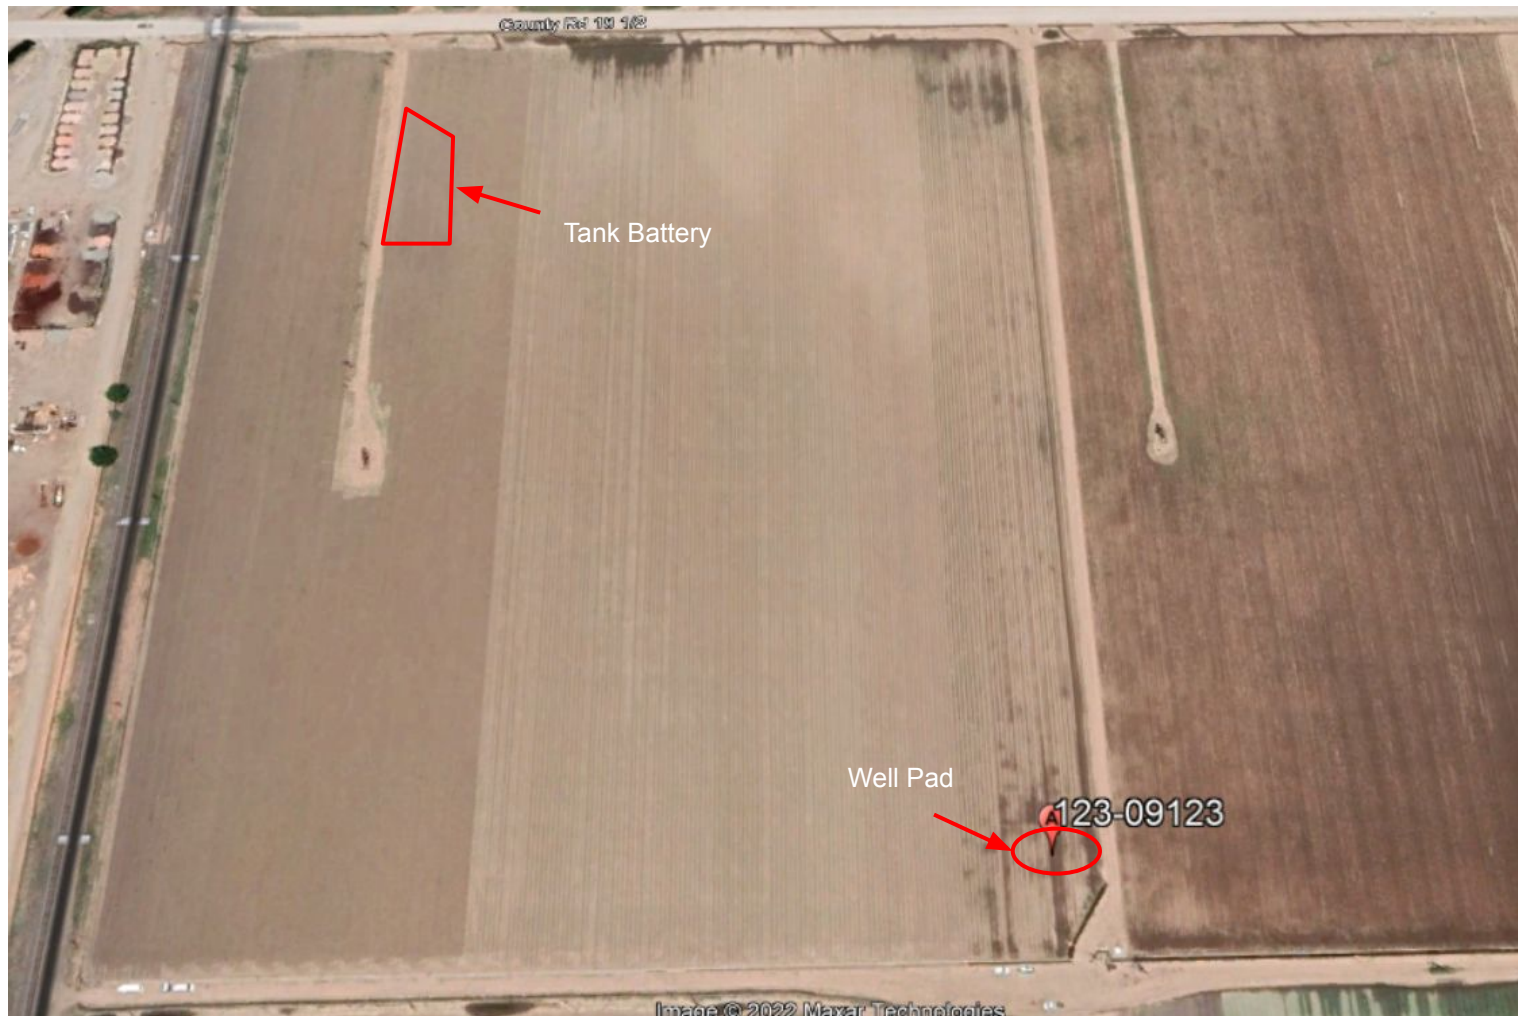
**Photo 1.** 2021 aerial imagery of the well pad and tank battery.

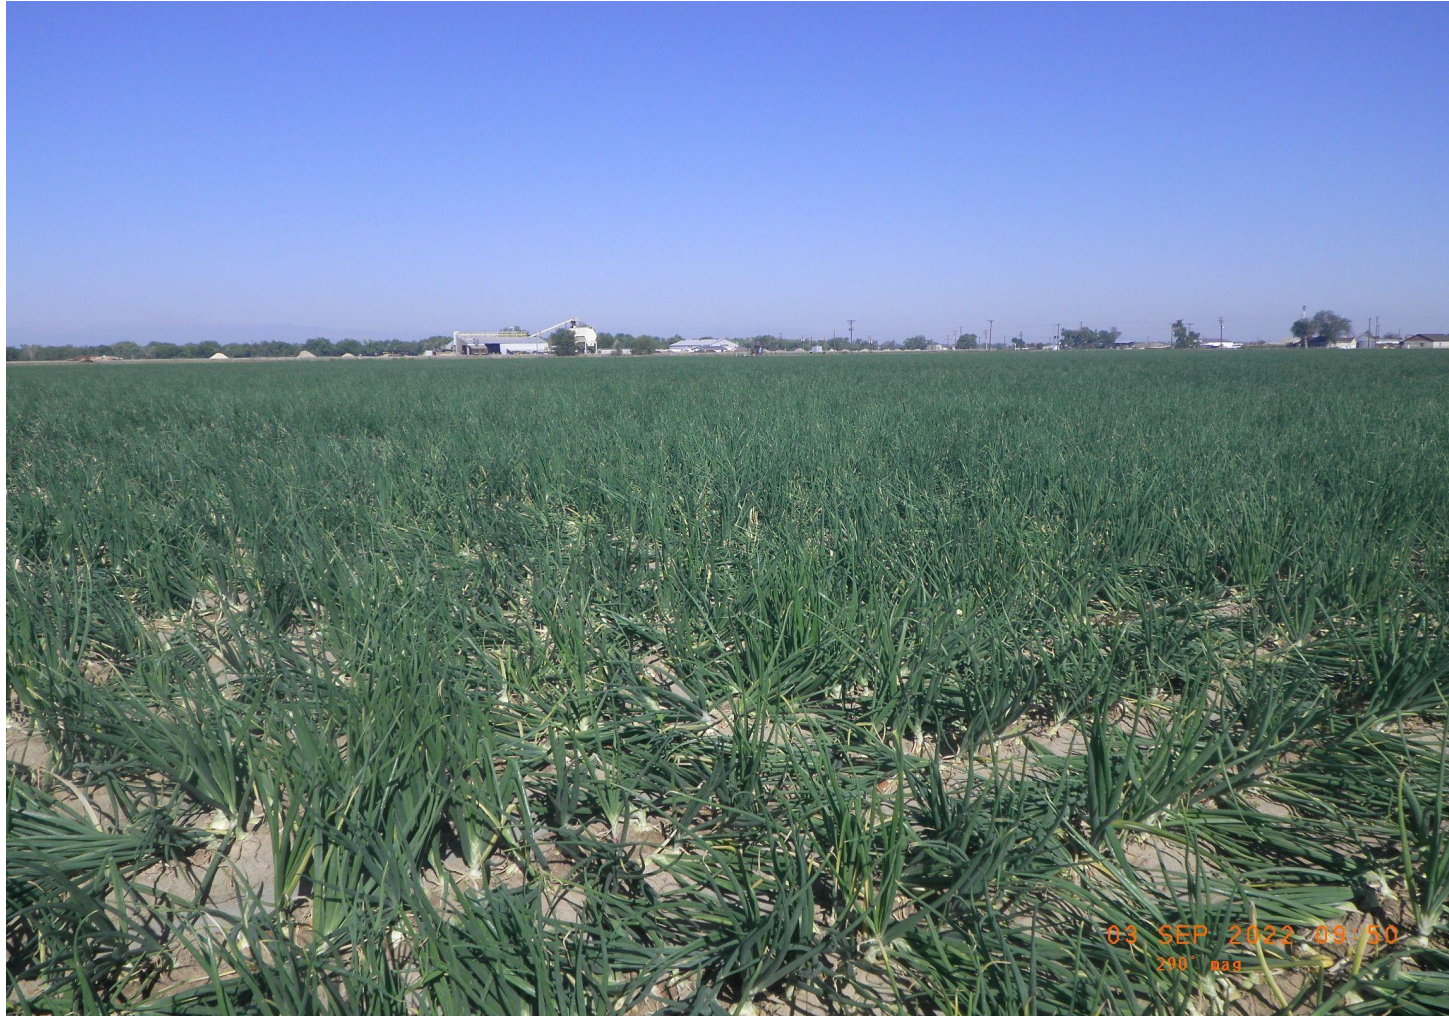
**Photo 2.** Overview photo of the well pad taken at ground level from the eastern edge facing west.

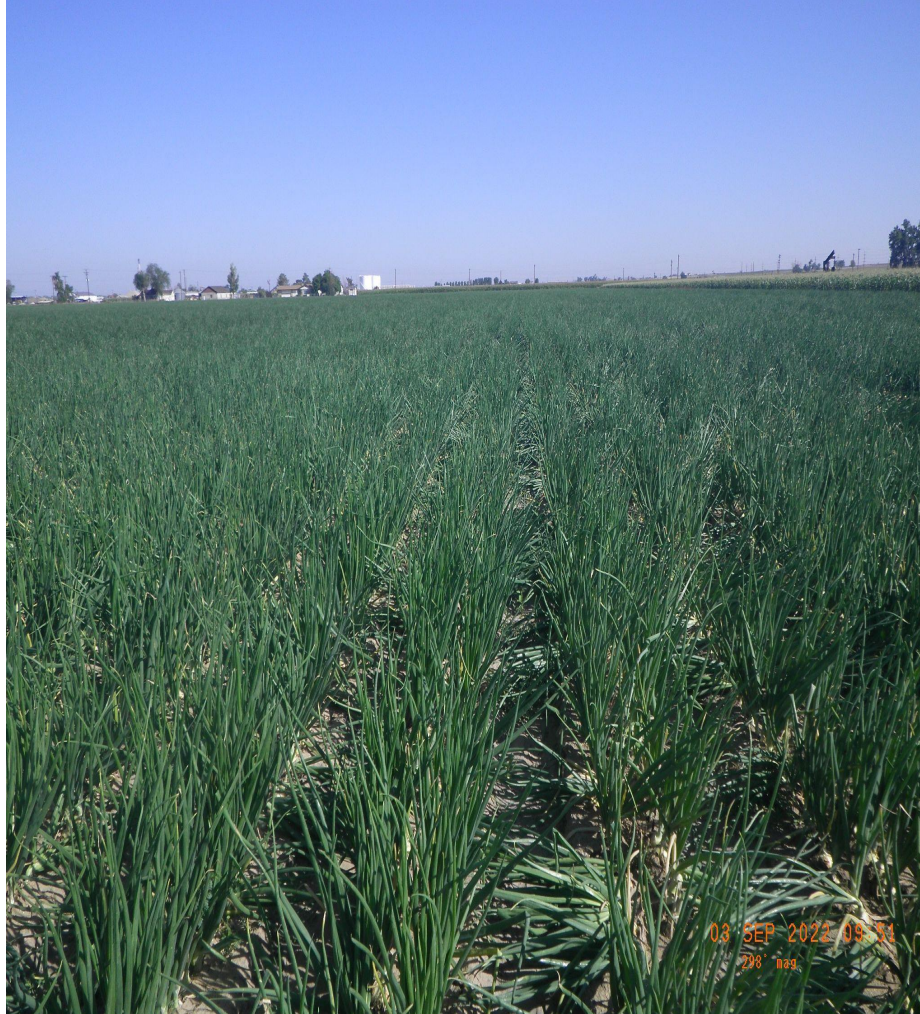
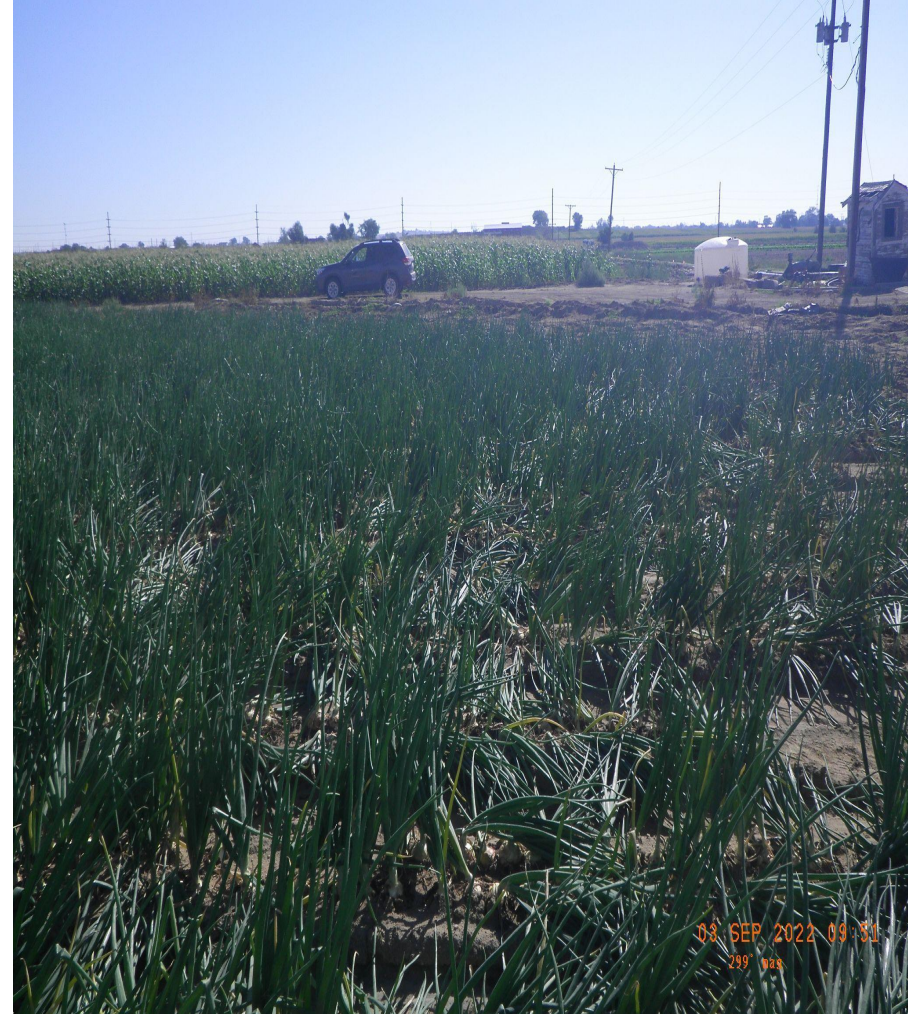
**Photo 3.** Cardinal photos taken from the middle of the well pad. Left photo facing north, right photo facing east.

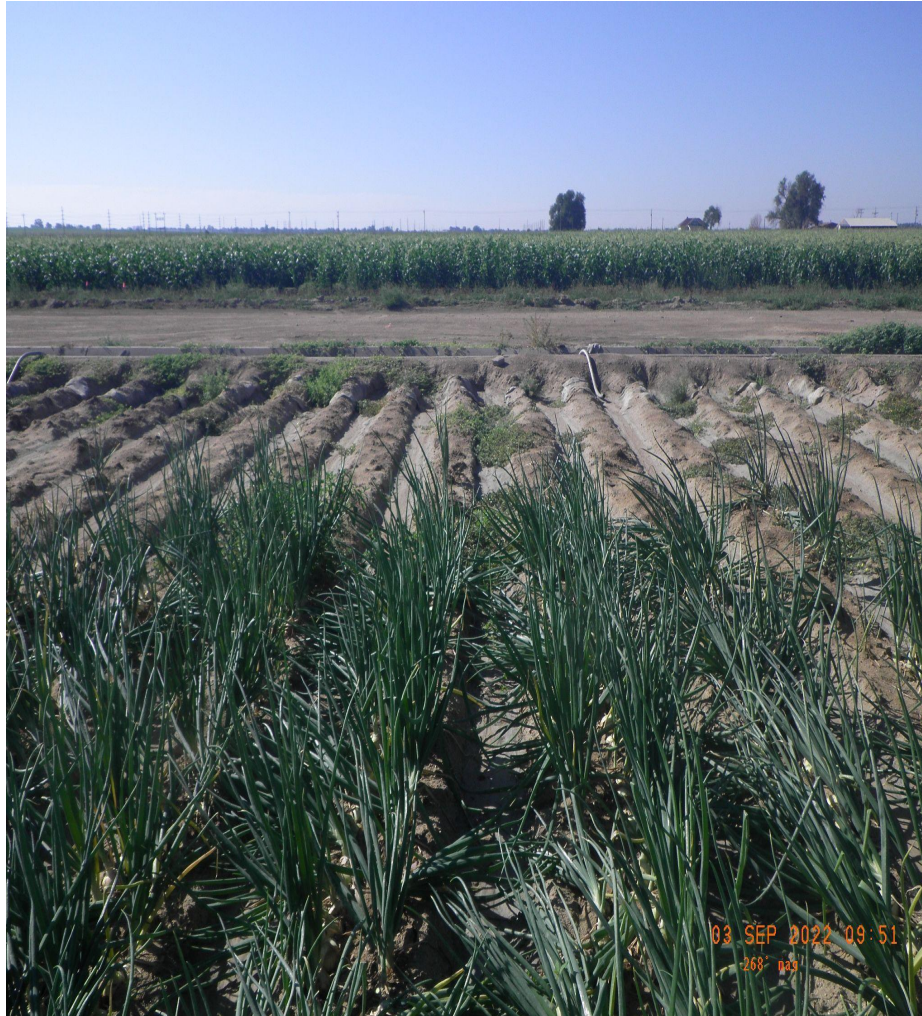
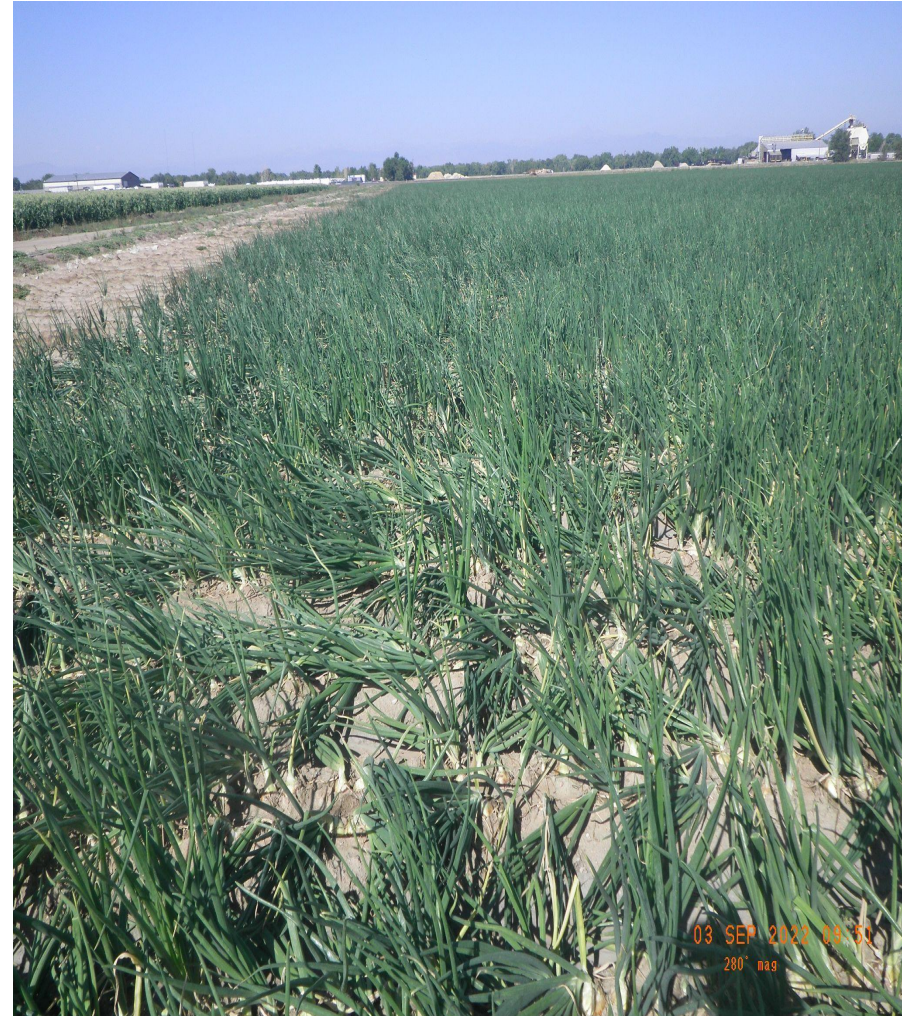
**Photo 4.** Cardinal photos taken from the middle of the well pad. Left photo facing south, right photo facing west. Note: well pad appears consistent with the reference area (see photo 5).

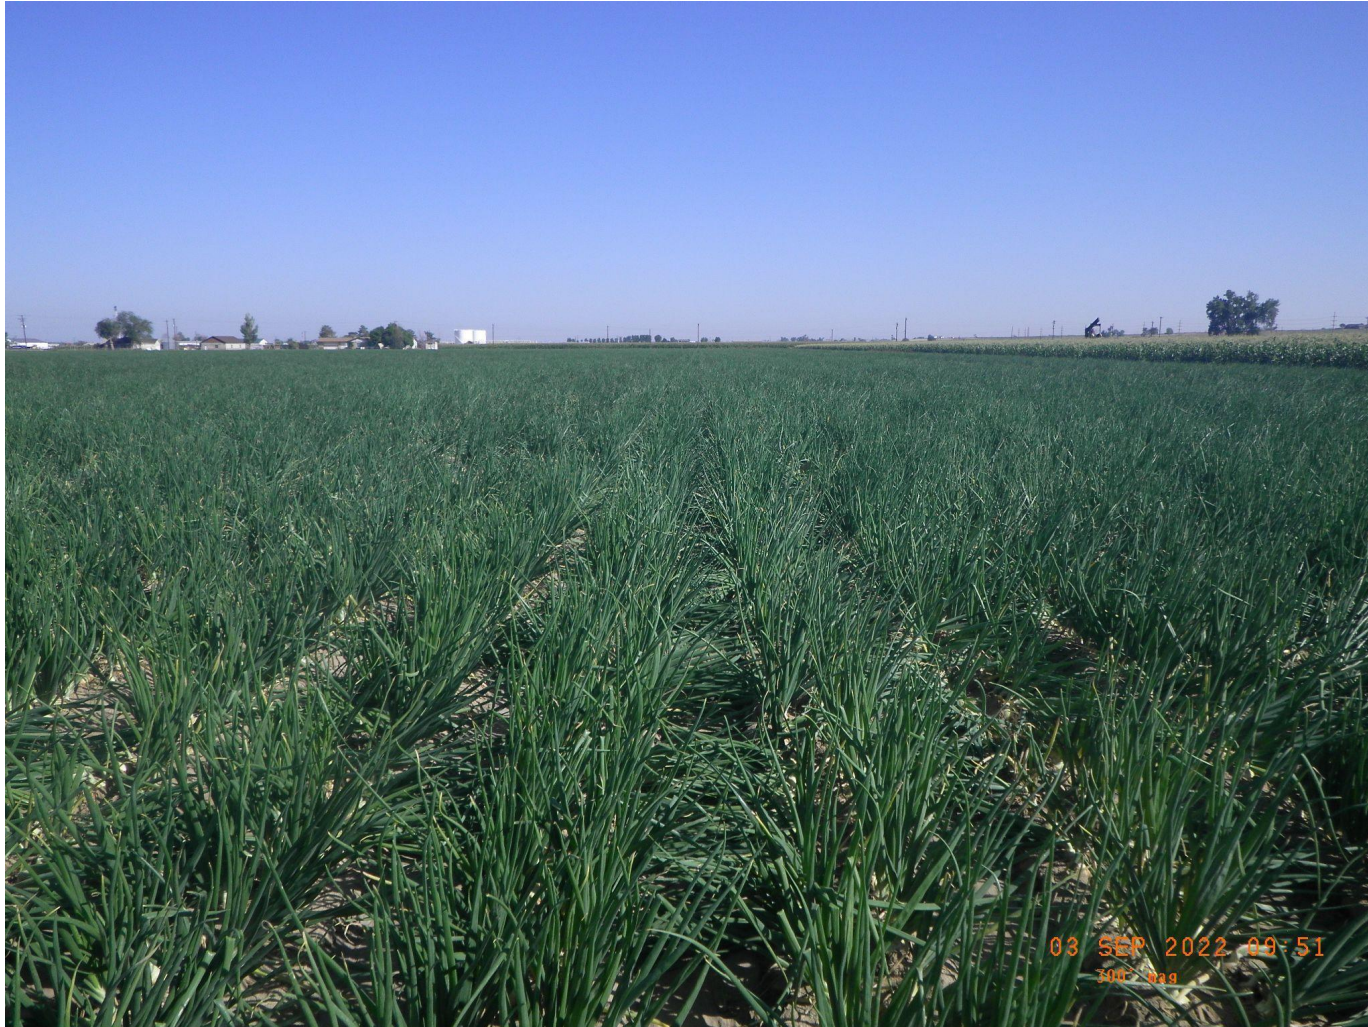
**Photo 5.** Well pad and tank battery reference area.

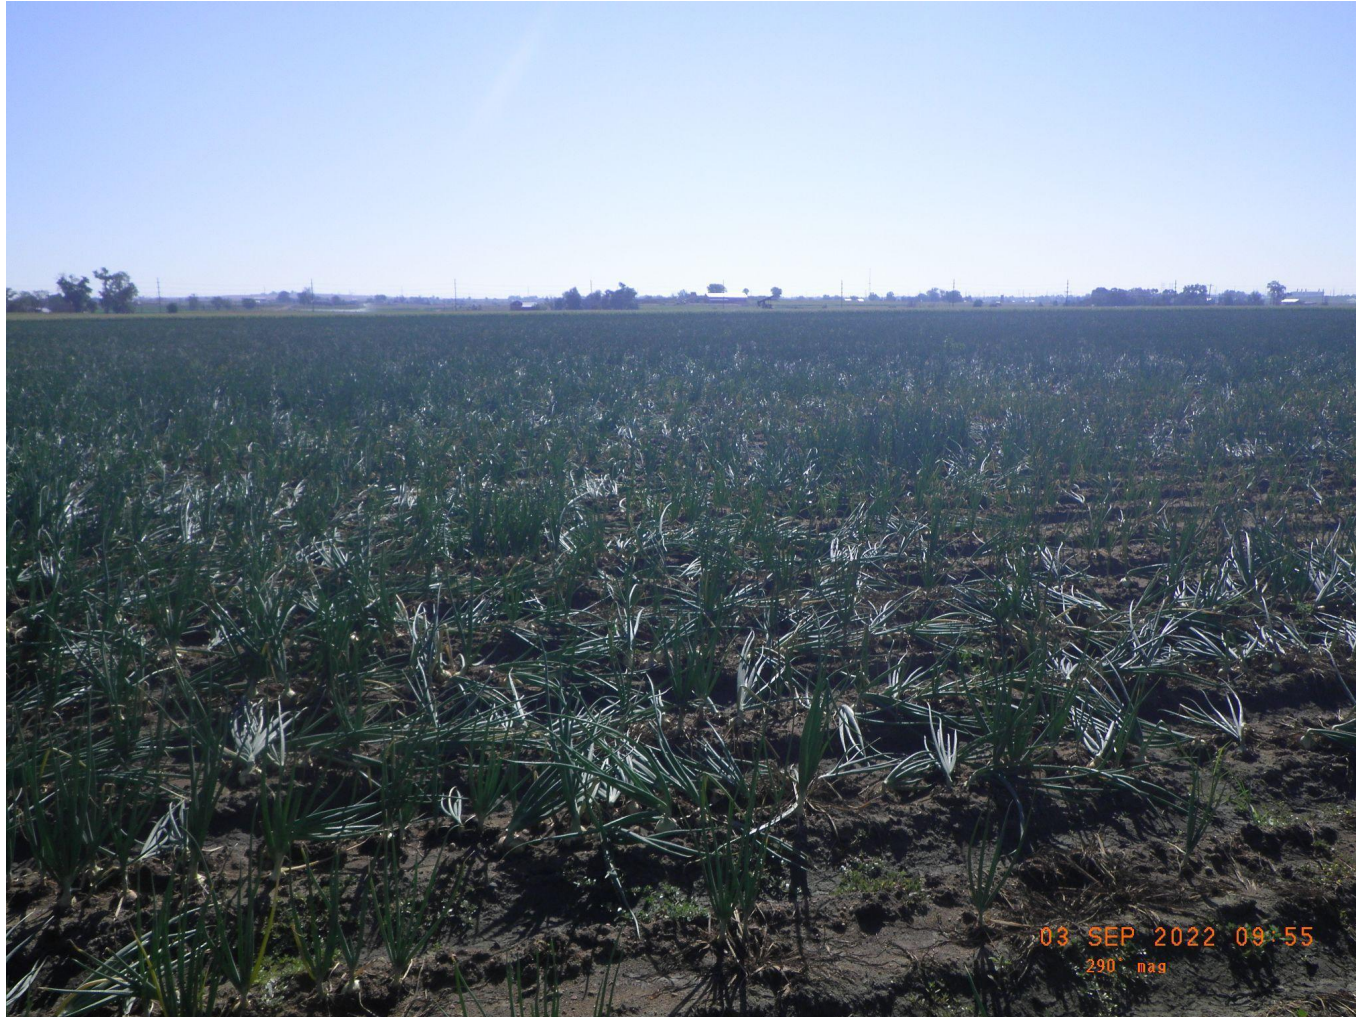
**Photo 6.** Overview photo of the tank battery taken at ground level from the western edge facing east.

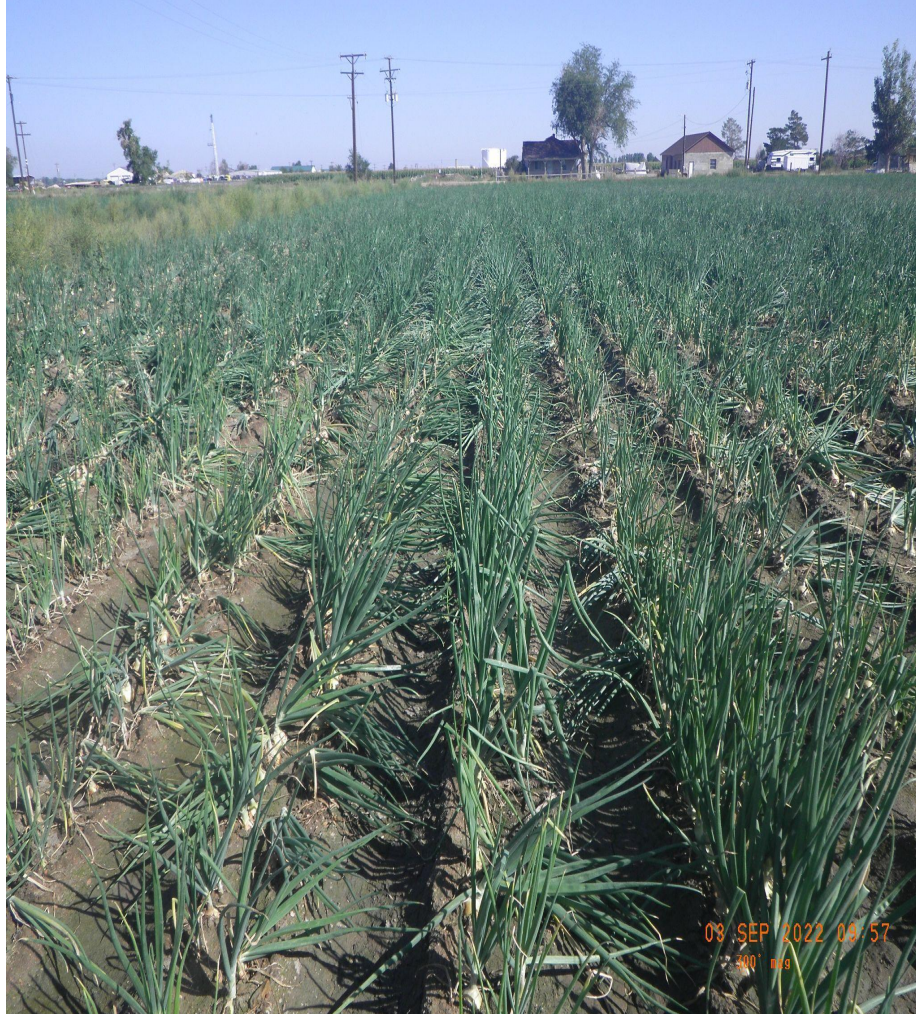
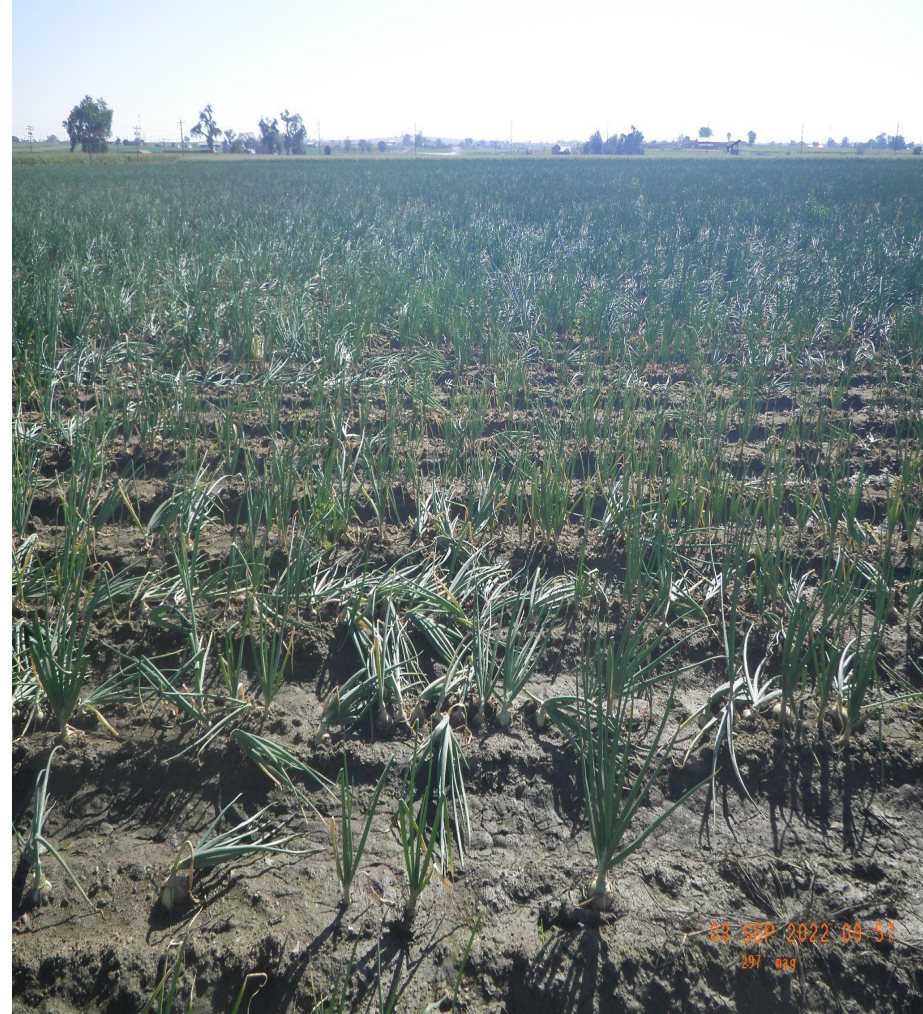
**Photo 7.** Cardinal photos taken from the middle of the tank battery. left photo facing north, right photo facing east.

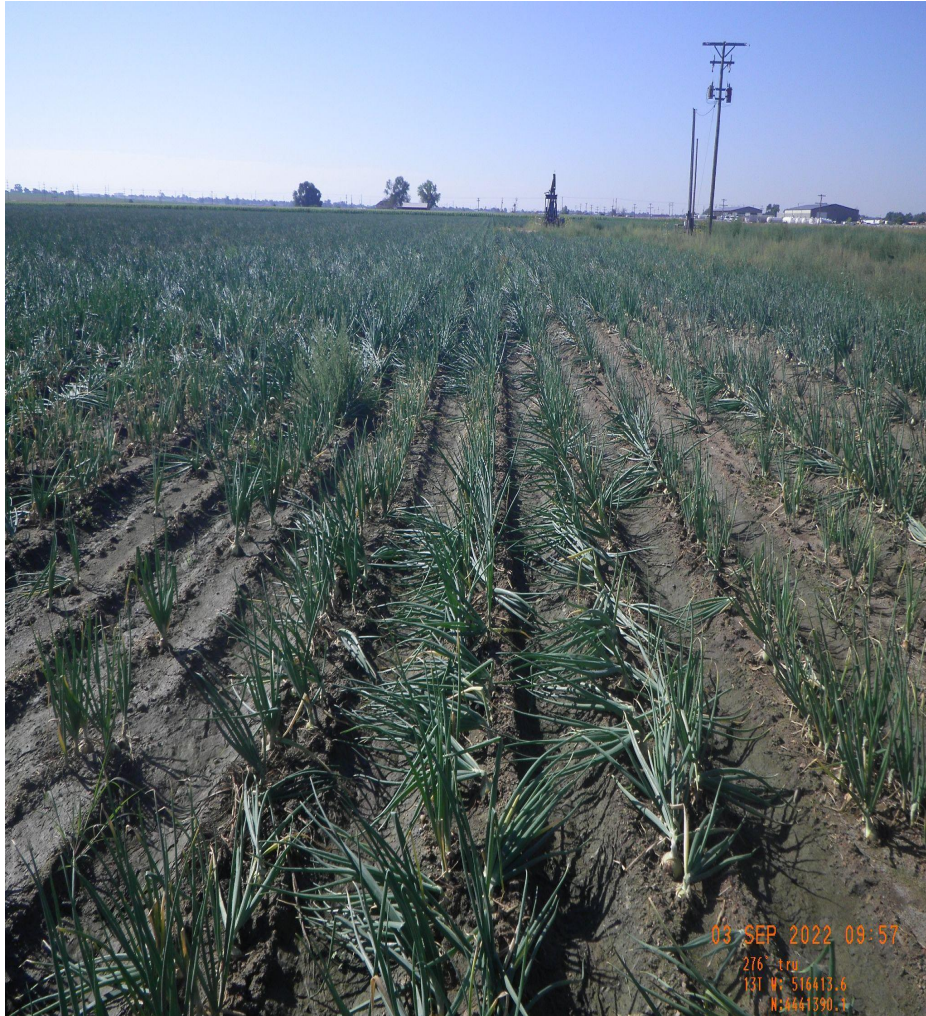
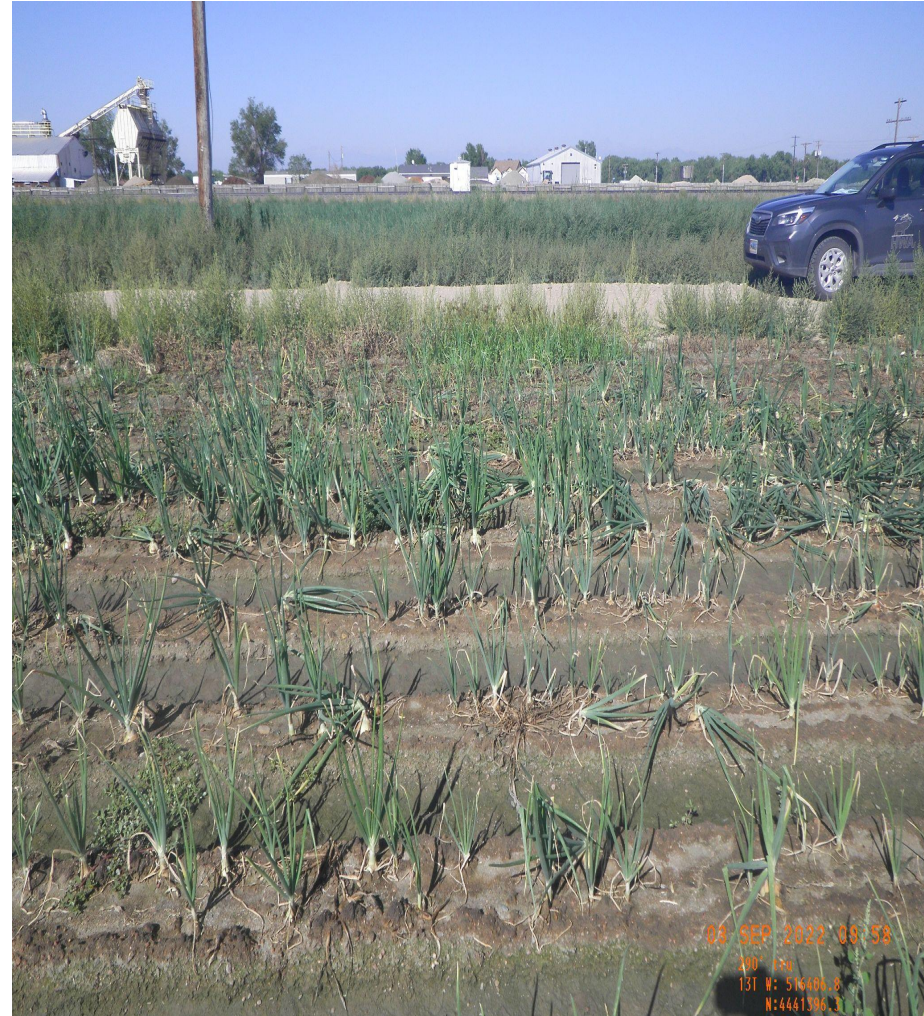
**Photo 8.** Cardinal photos taken from the middle of the tank battery. Left photo facing south, right photo facing west. Note: tank battery shows bare ground and does not appear consistent with the adjacent crop reference area (see photo 5).
