# Inspection Photos

Location ID: 478568

Location Name: FEDERAL/RWF 43-9

Inspection Document #: 702800919

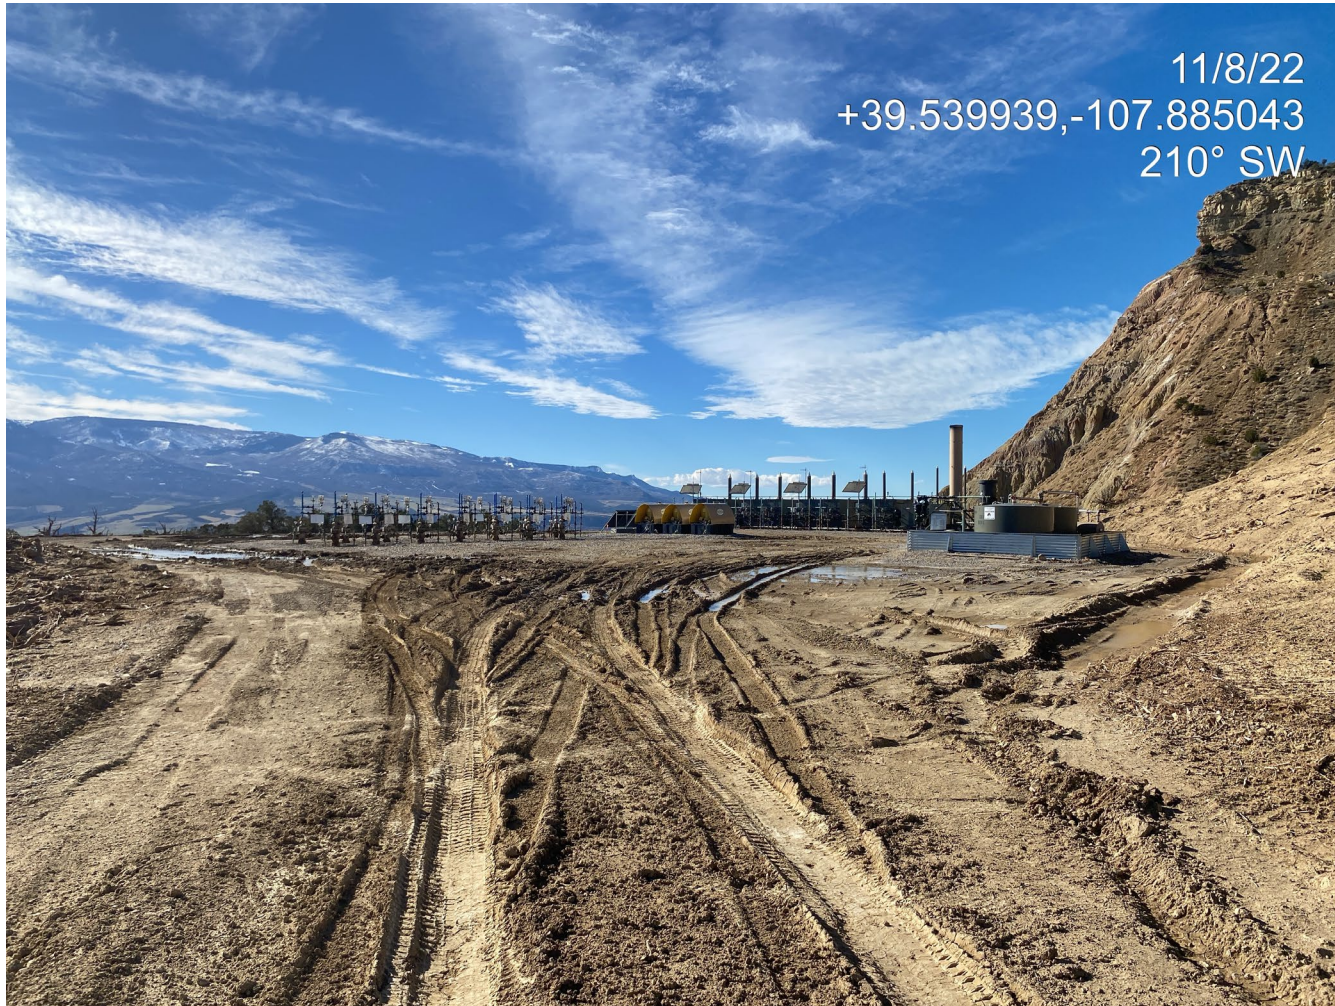
**Photo 1.** Photo taken from the location entrance shows an overview of the Location. Note pad surface compaction degradation.

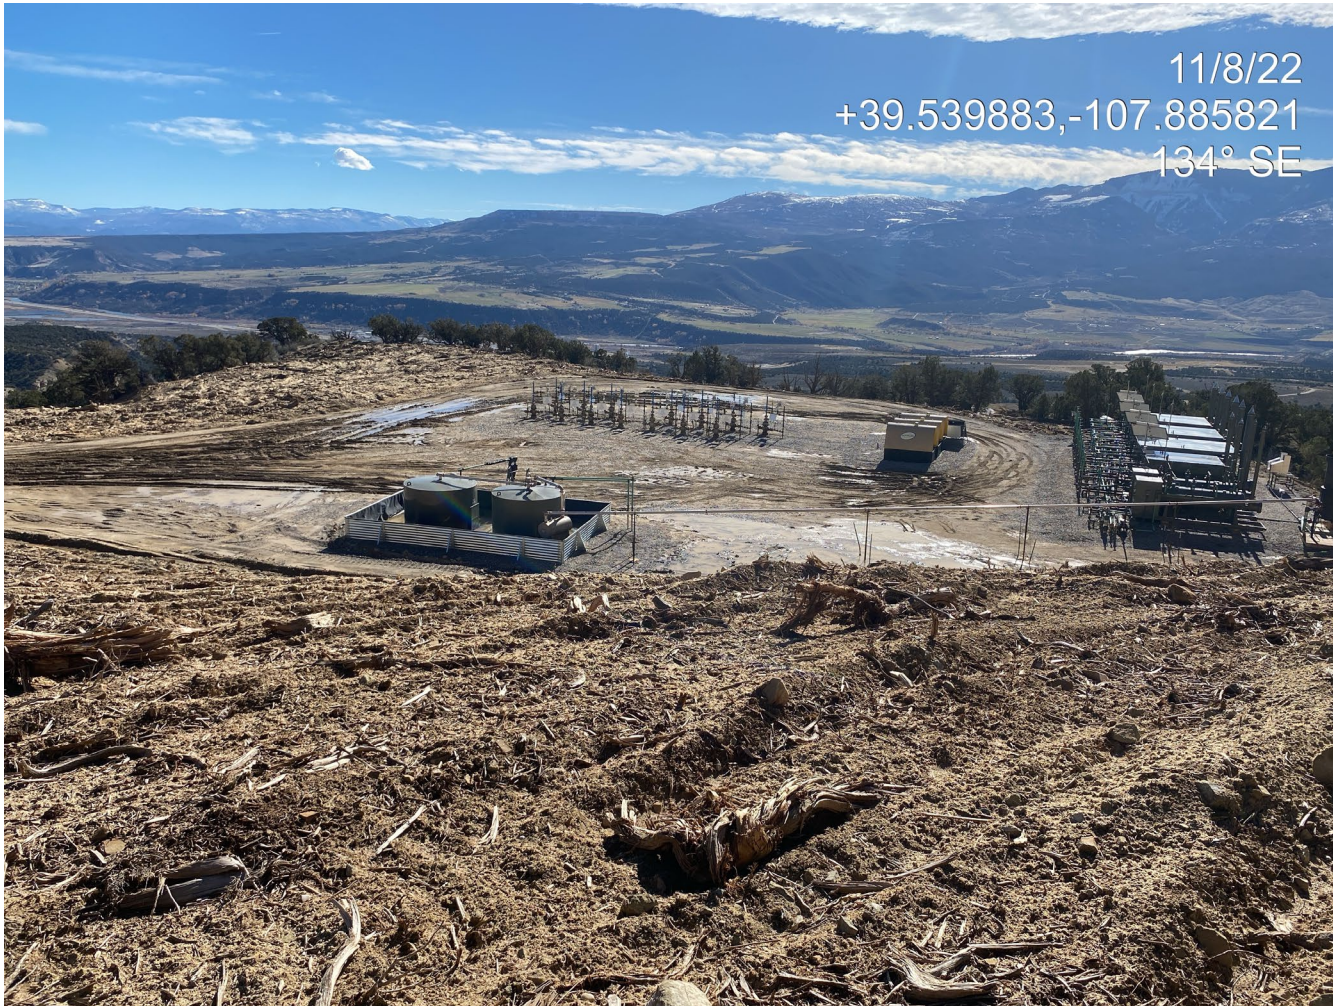
**Photo 2.** Photo taken from the north shows an overview of the location, including interim areas.

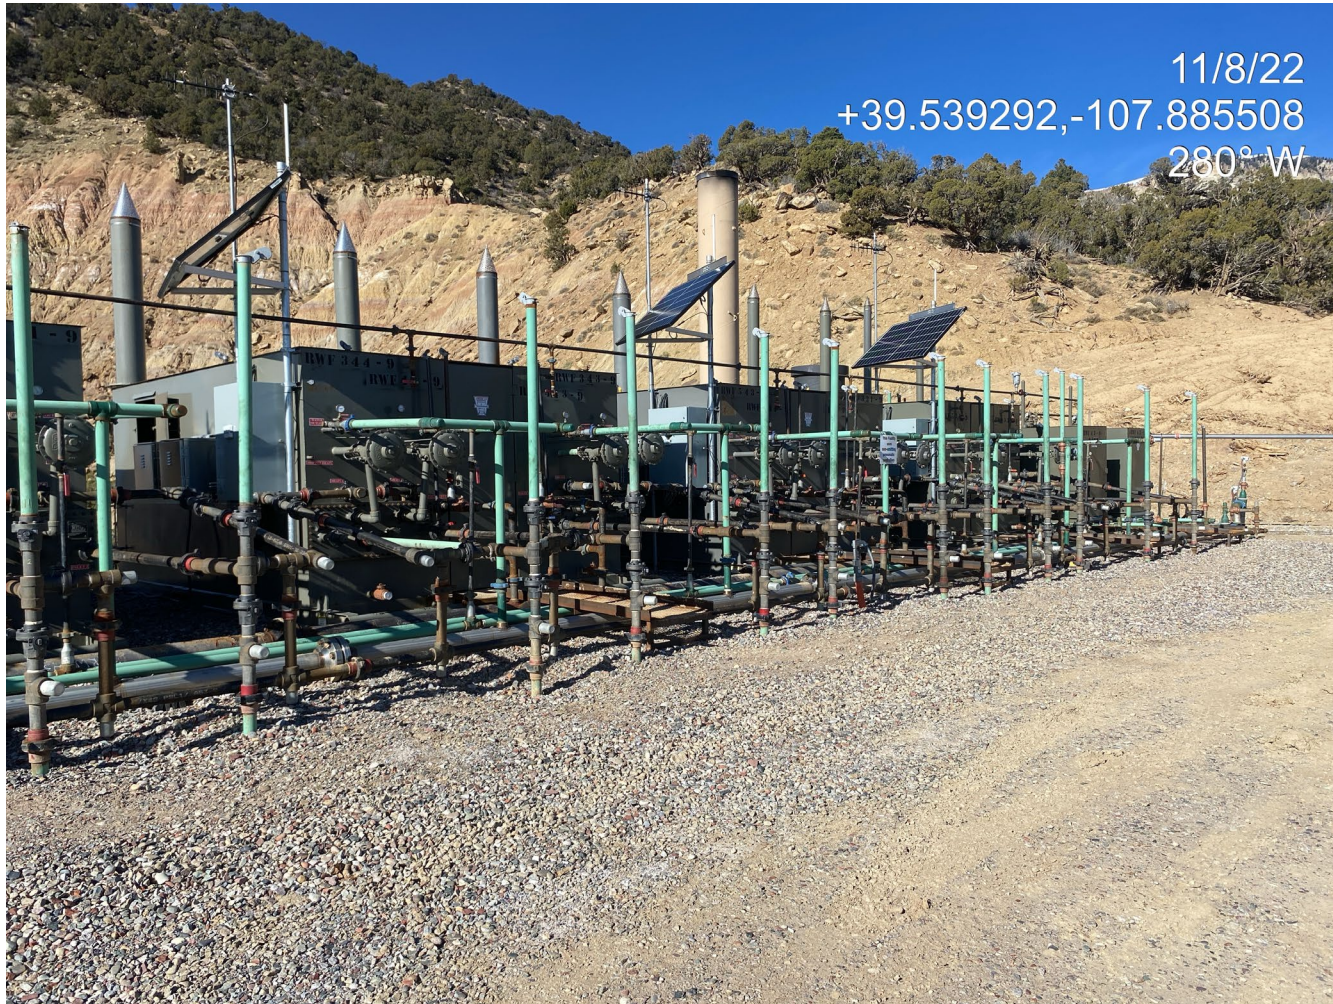
**Photo 3.** Photo shows production equipment.

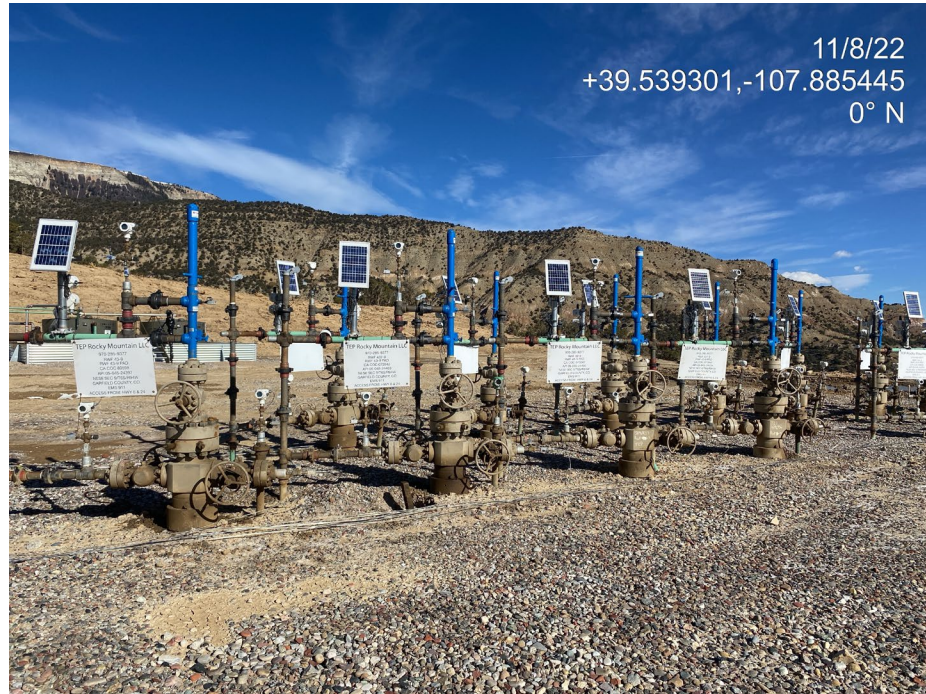
**Photo 4.** Photo shows production equipment.

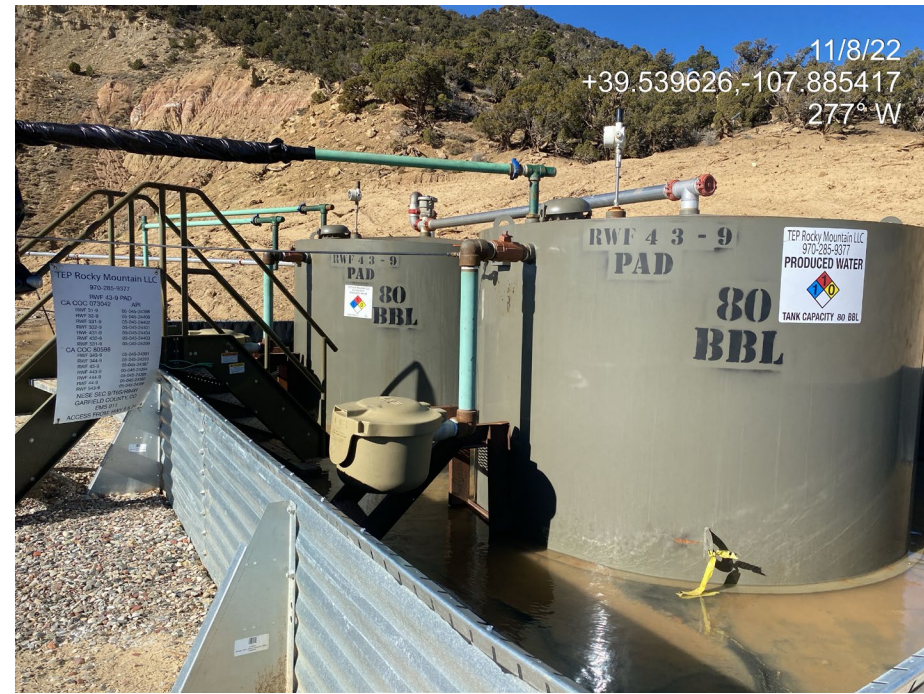
**Photo 5.** Photo shows production equipment.

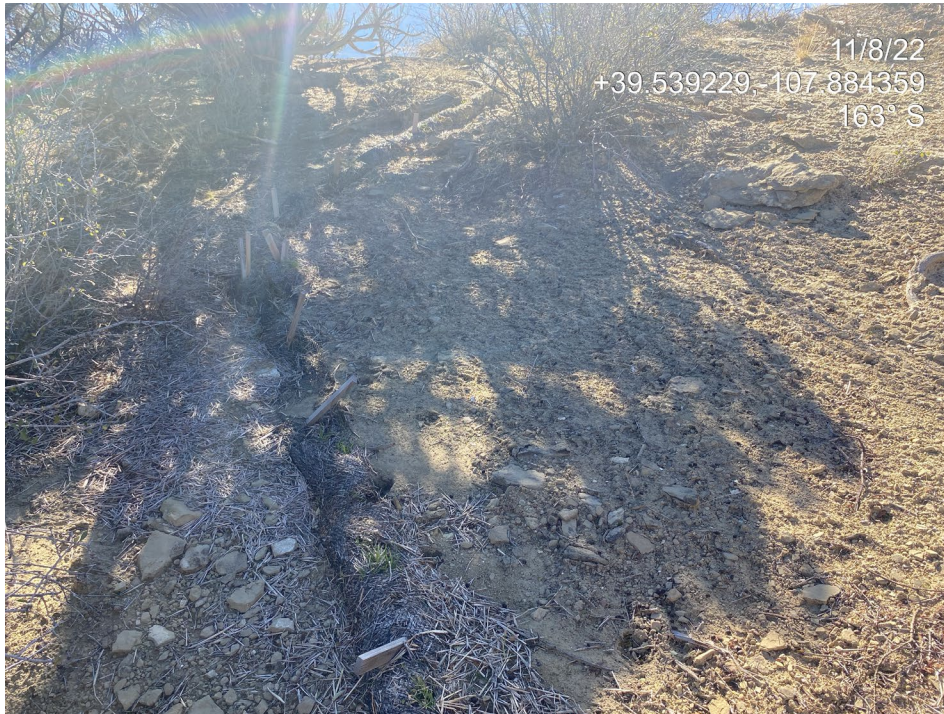
**Photo 6.** Photo shows an example of a perimeter wattle which is not in proper functioning condition; wattle is in disrepair (unstaked, losing straw) and sediment is overtopping the wattle.

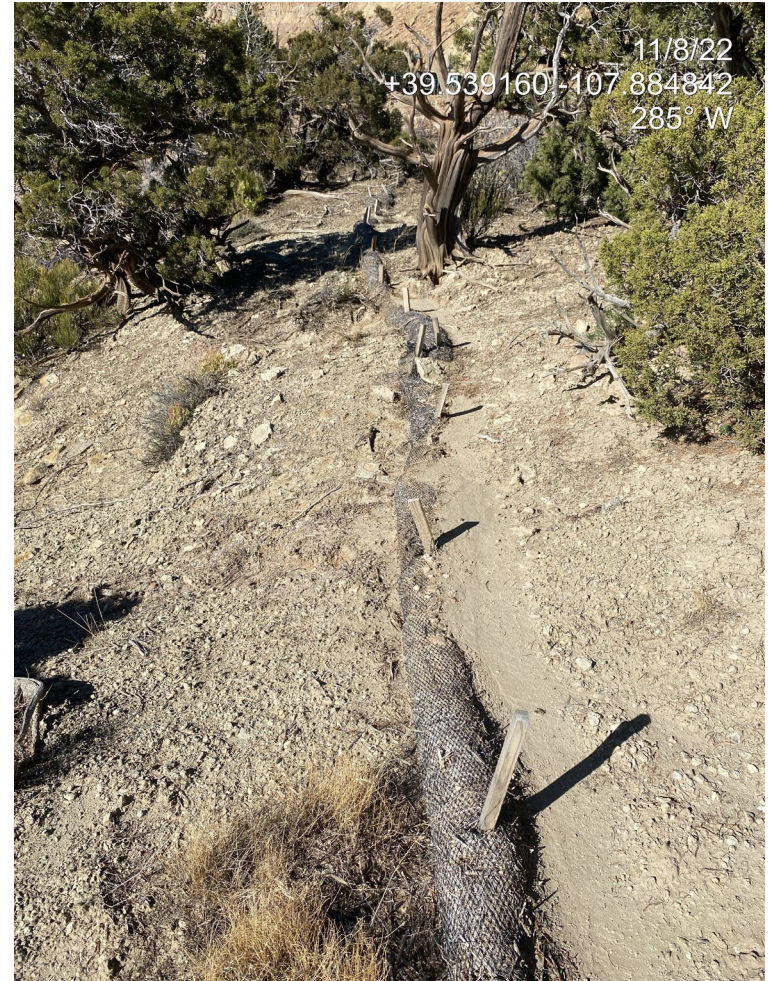
**Photo 7.** Photo shows an example of a wattle which is overwhelmed by sediment which is beginning to overtop the wattle.

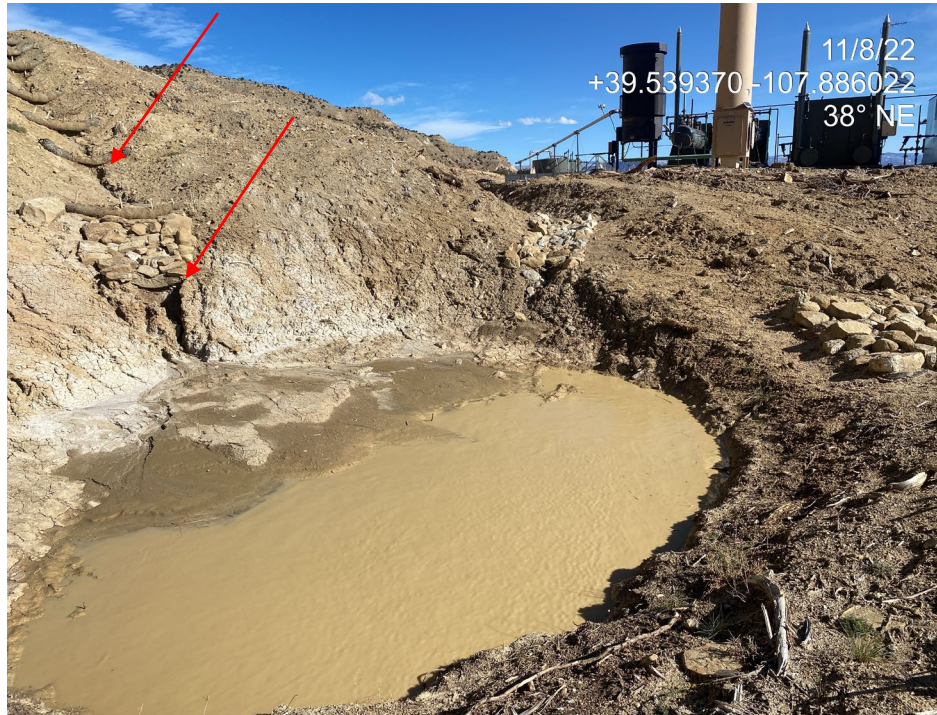
**Photo 8.** Photo shows where a diversion ditch enters a sediment trap at the west of the location. Degradation is occurring at the ditch outlet/trap inlet. Note also stormwater flows cutting beneath wattles in the diversion ditch. See Photos 10 and 11.

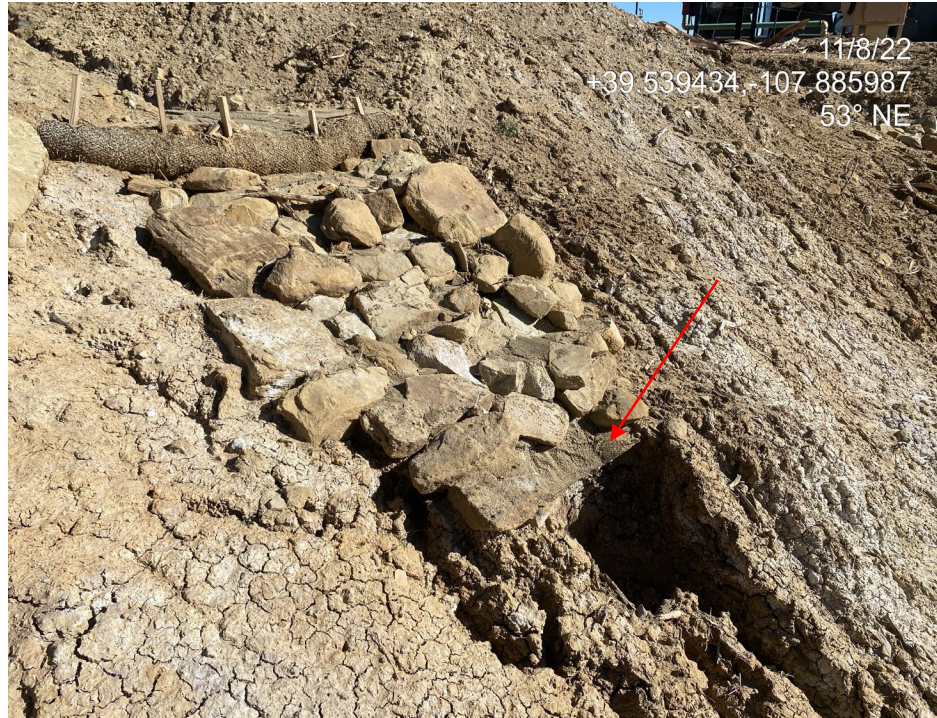
**Photo 9.** Photo shows a close-up of the ditch outlet/trap inlet in Photo 8. Degradation begins where a geotextile liner ends.

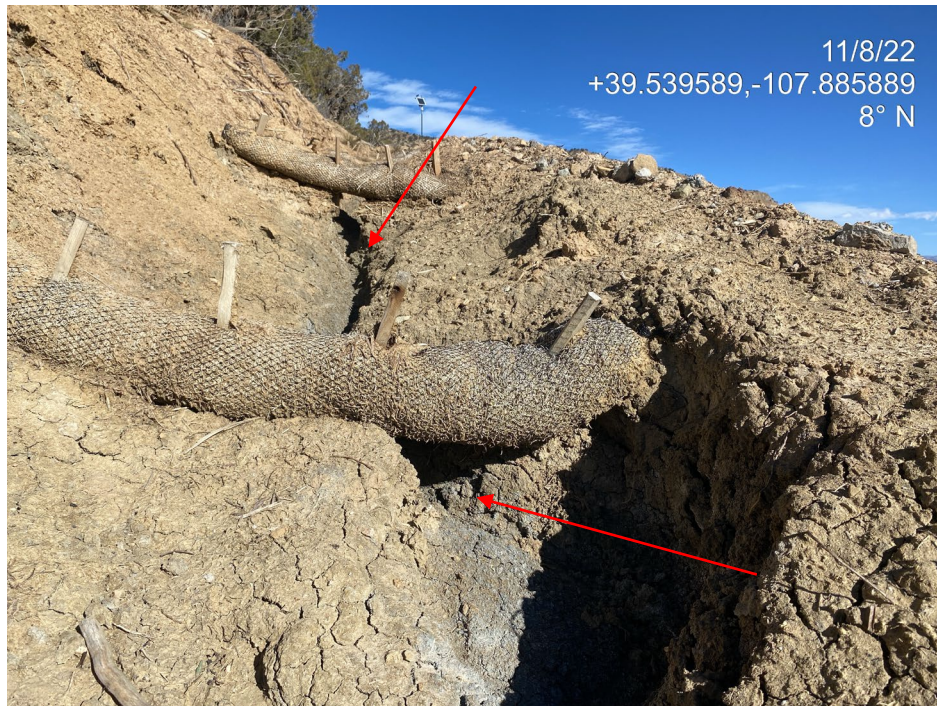
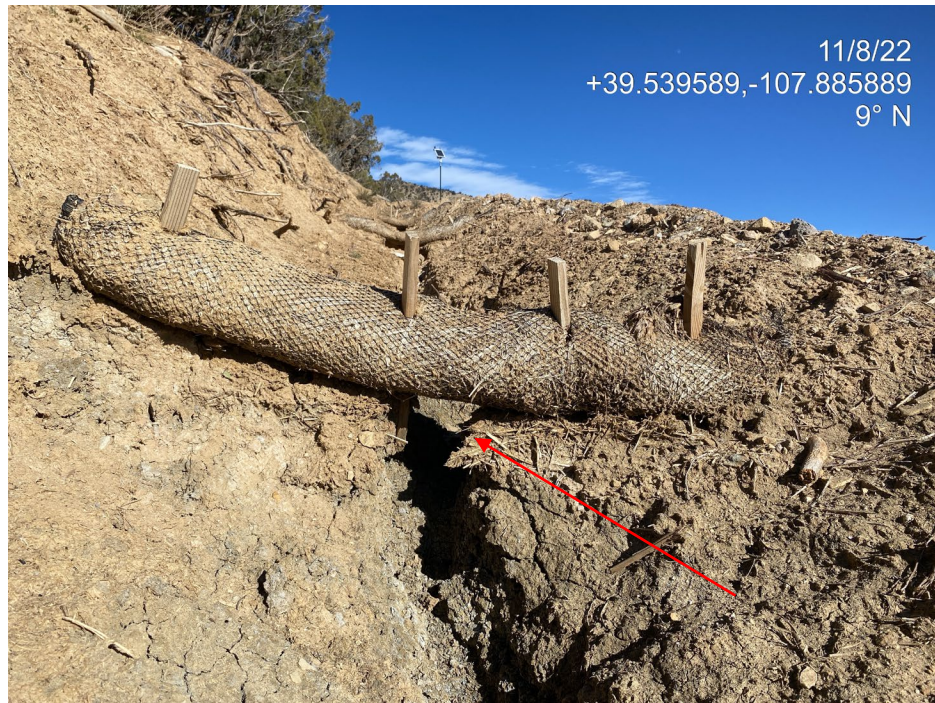
**Photo 10.** Photo shows degradation occurring in the diversion ditch at the northwest of the location. Concentrated flows are cutting beneath wattles in the ditch.

**Photo 11.** Refer to Photo 10 comment.

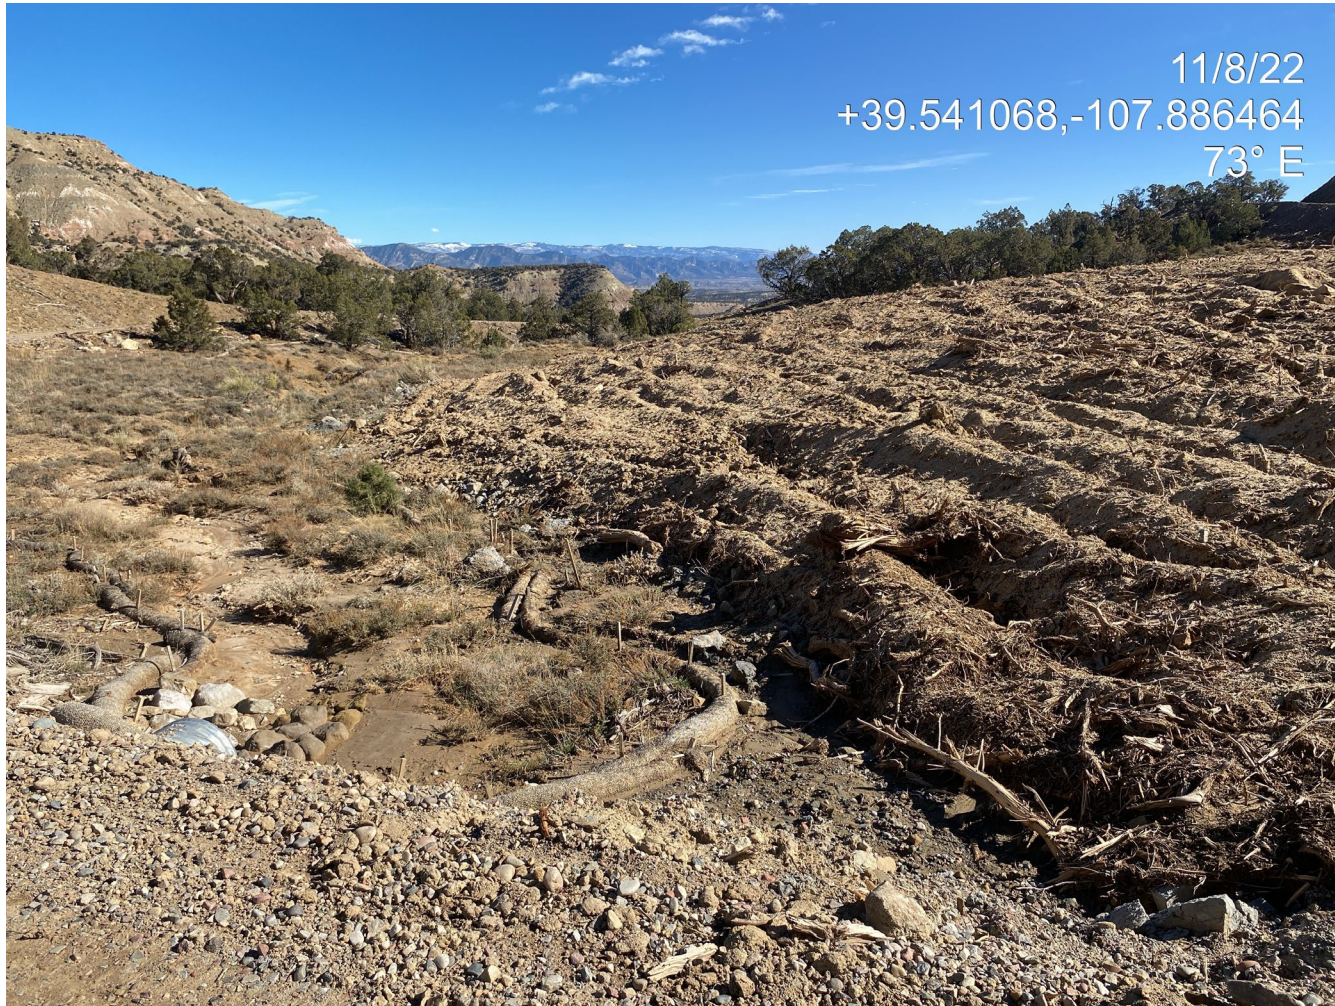
**Photo 12.** Photo taken to the north of the location shows a reclaimed area adjacent to the access road, as well as stormwater controls where the road intersects a natural drainage.
