Inspection Photos

Location Name: TEP ROCKY MOUNTAIN LLC UNION-66S96W /33NWSE.

Location ID: 335237

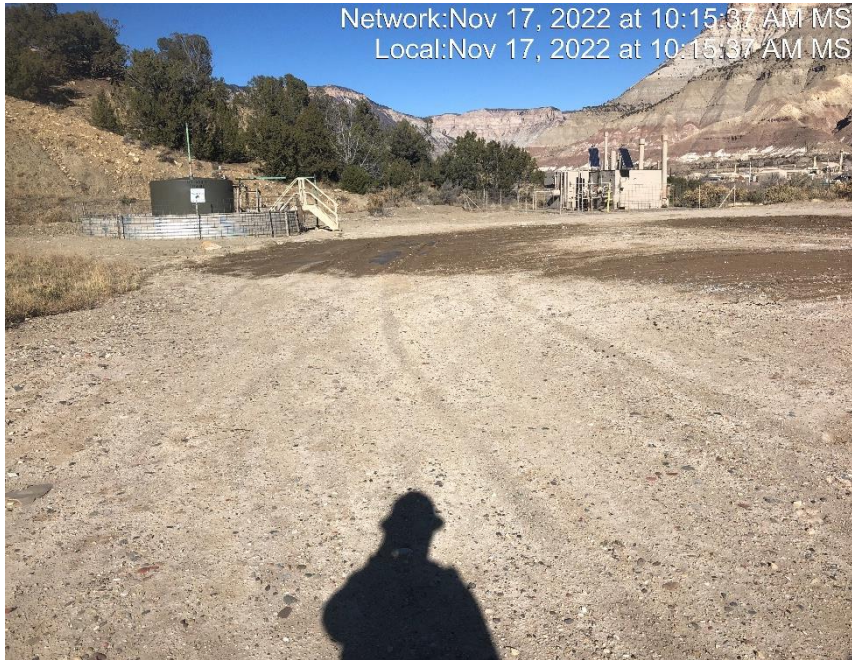
Photo #8401 From entrance to location.

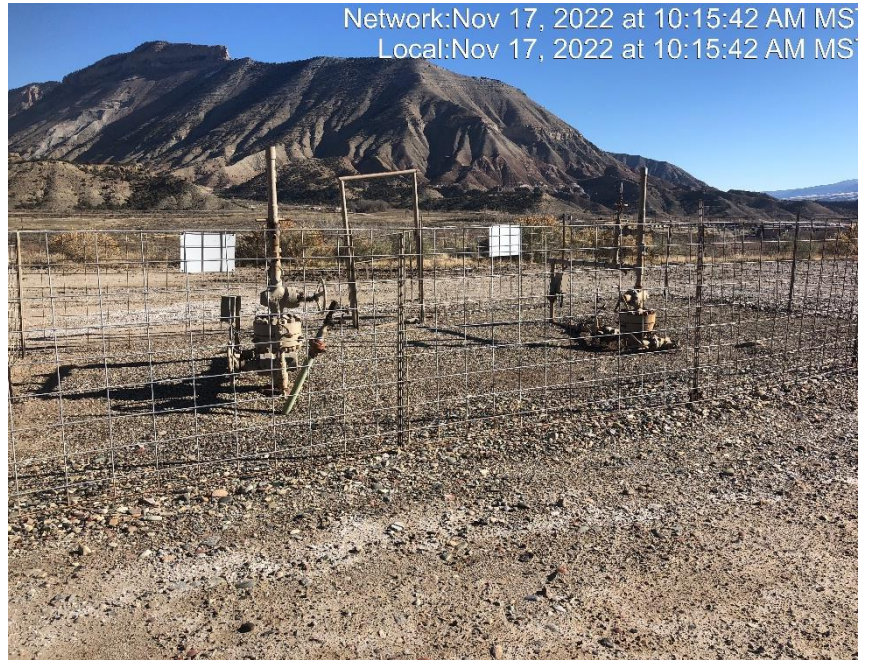
Photo #8402 From entrance to location

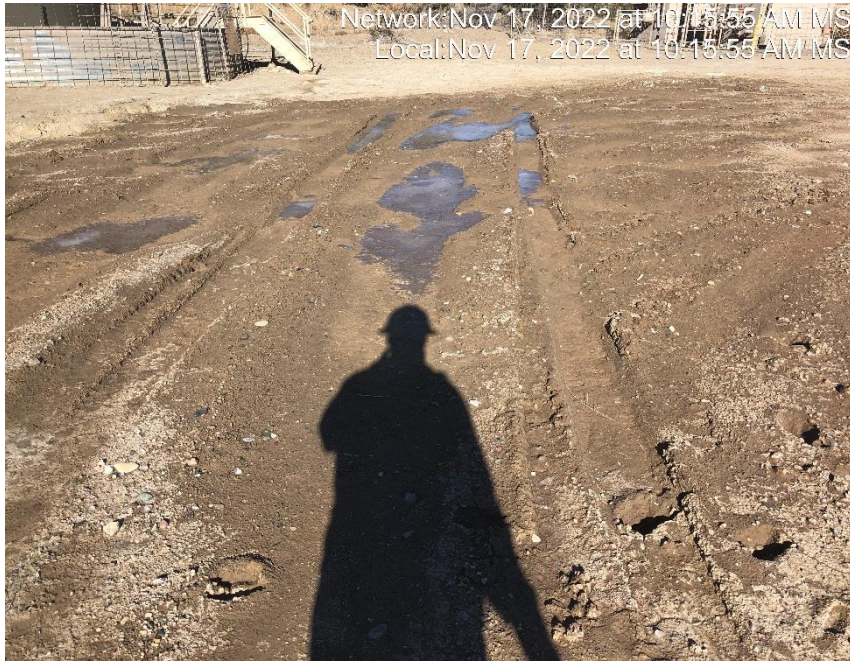
Photo #8403 Location lacks stabilization.

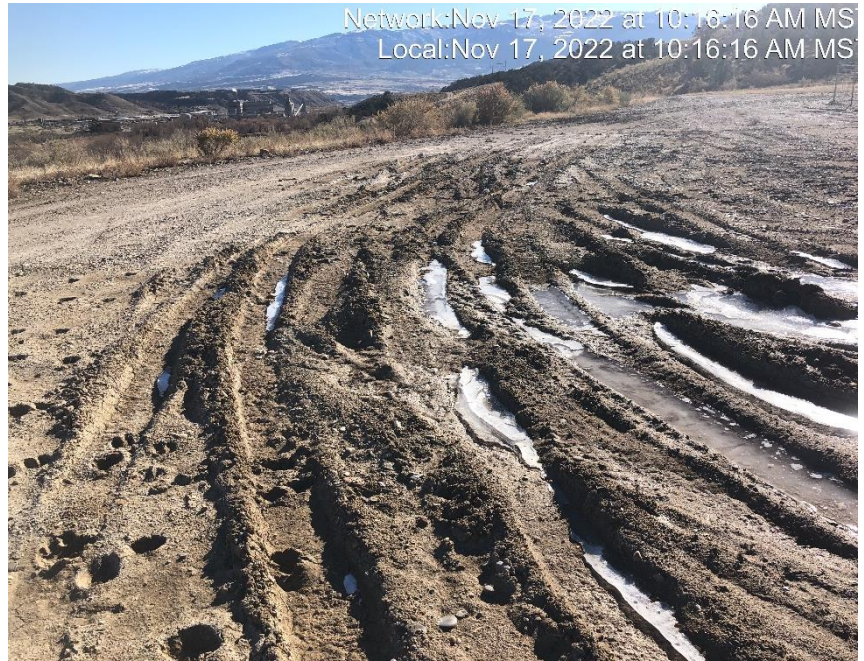
Photo #8404 Location lacks stabilization.

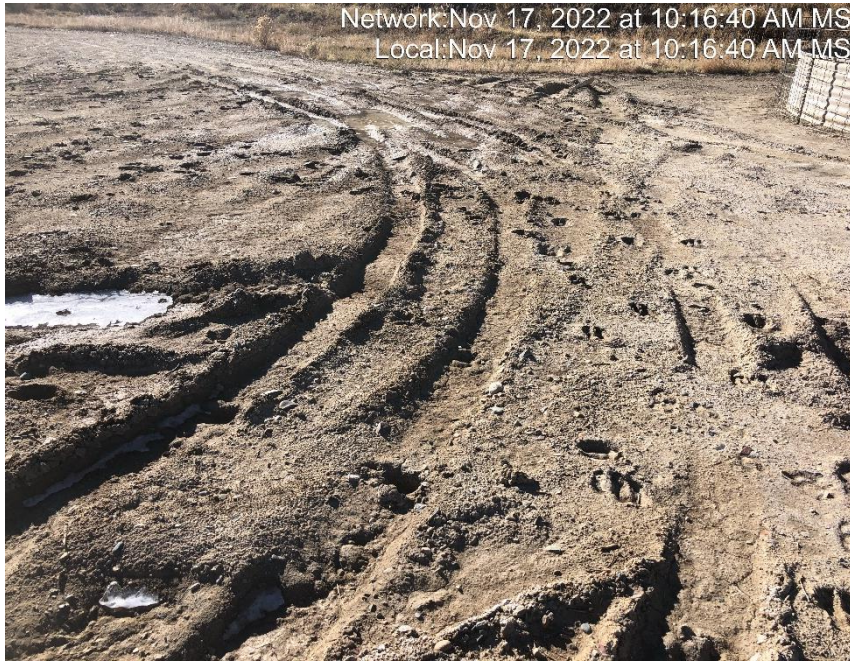
Photo #8405 Location lacks stabilization.

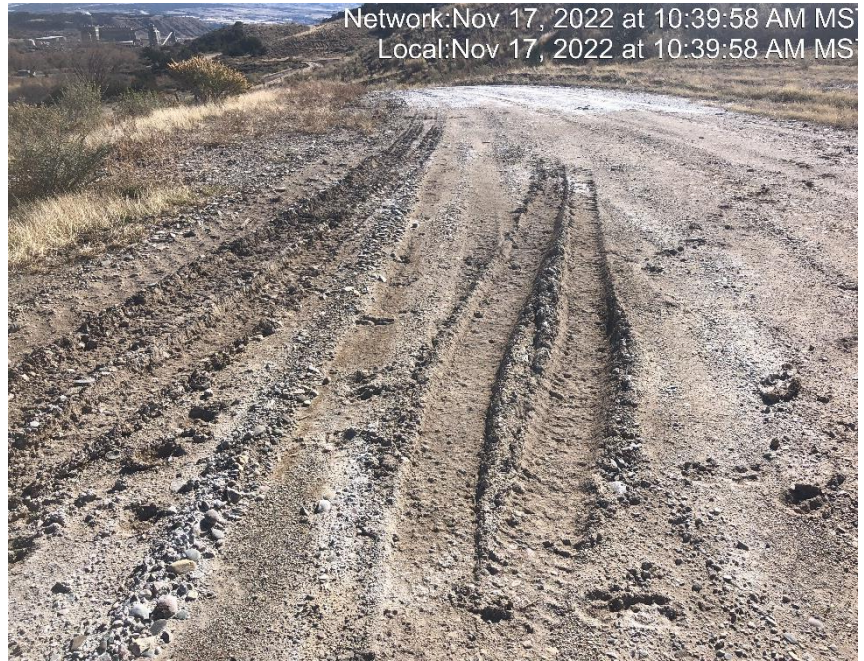
Photo #8407 Insufficient tracking BMP at entrance to location.

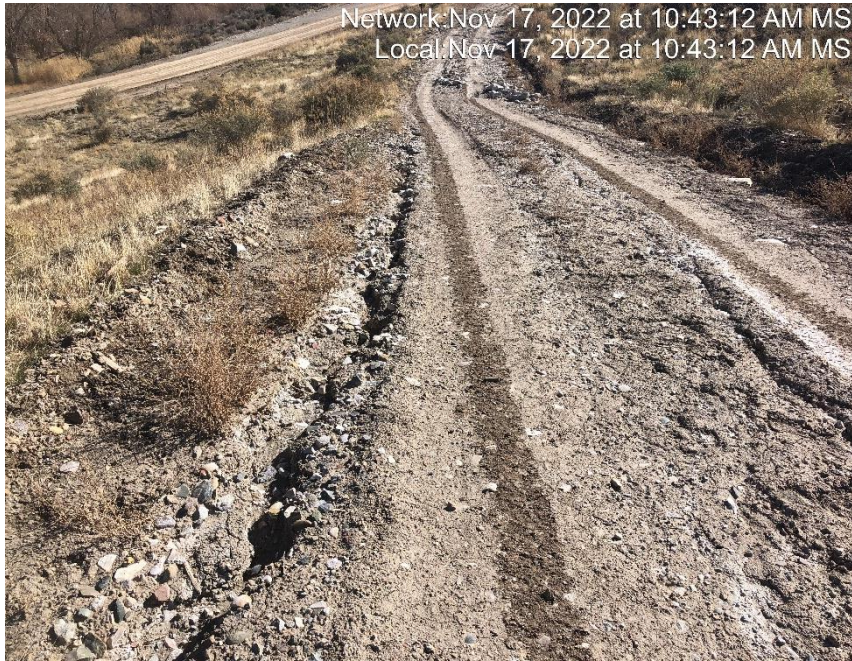
Photo #8409 Rill erosion occurring in access road.

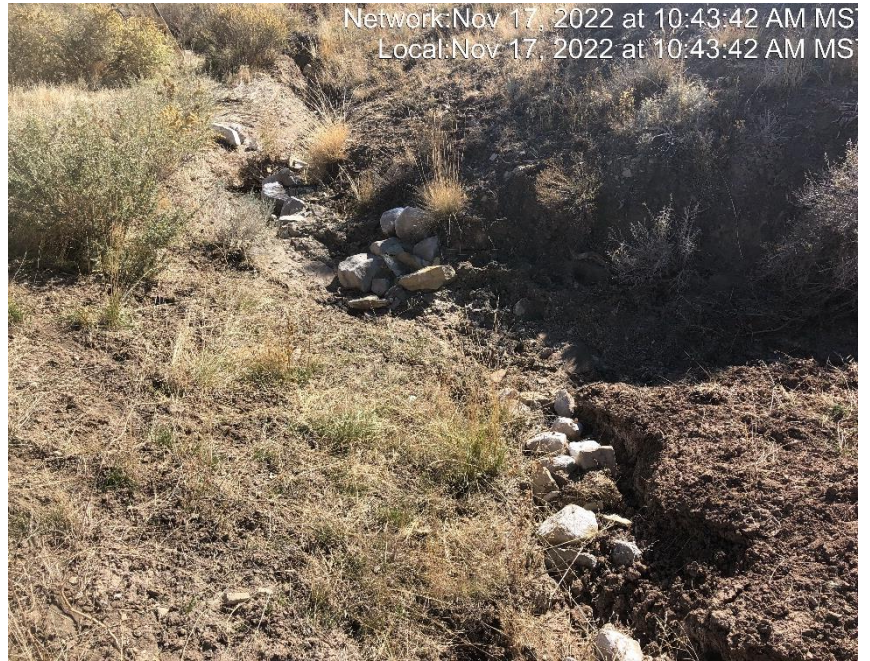
Photo #8410 Gully erosion occurring in access road ditch.

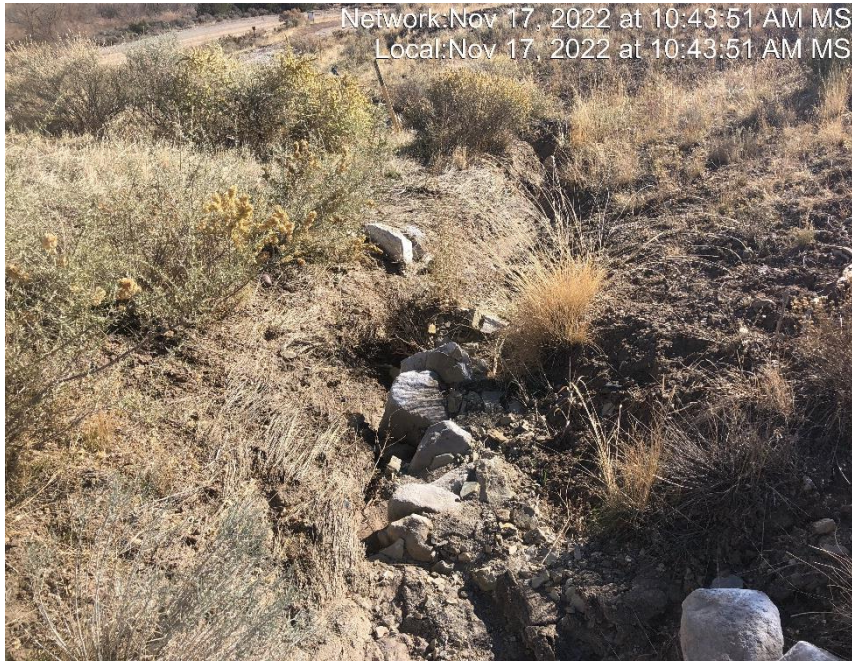
Photo #8411 Gully erosion occurring in access road ditch

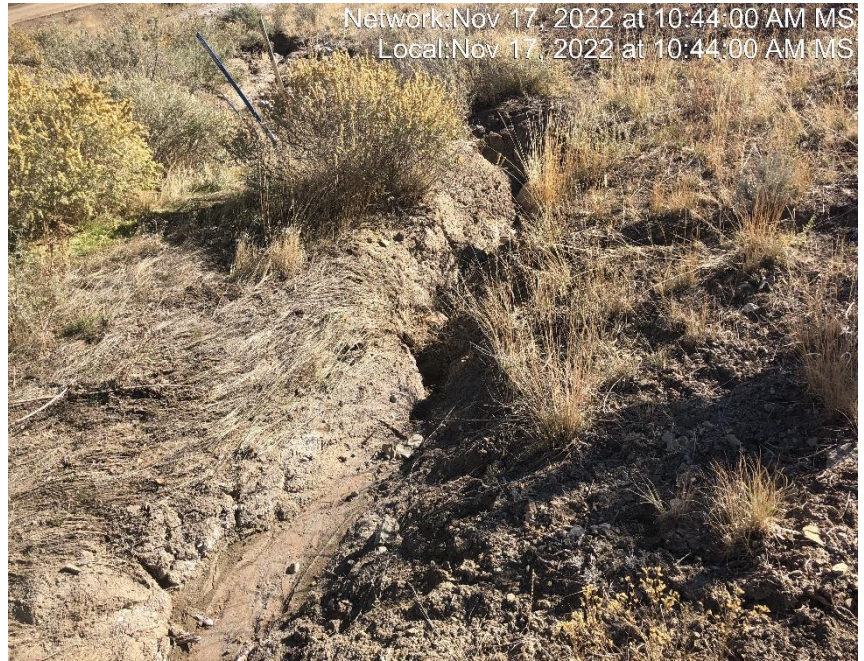
Phot #8412 Gully erosion occurring in access road ditch

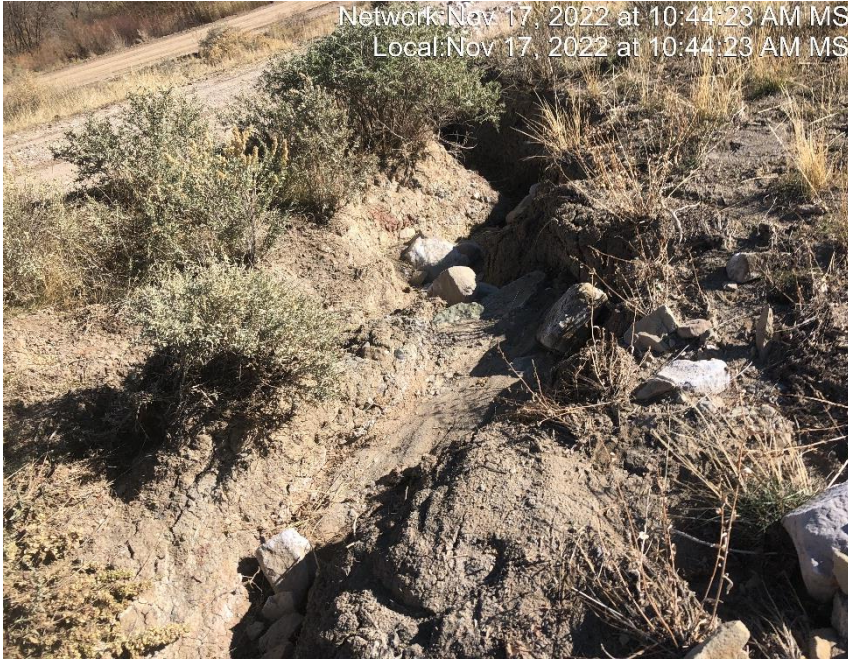
Photo #8414 Gully erosion occurring in access road ditch

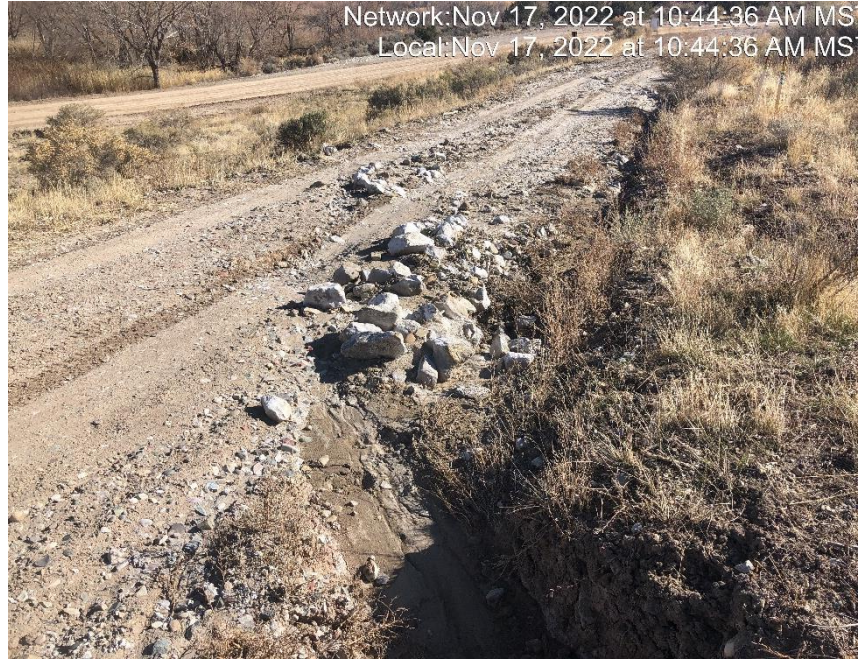
Photo #8415 Insufficient velocity checks.
