Colorado Oil and Gas Conservation Commission

TEP, Pitchers Mount WRF, #439690 Annotation Report

TEP, Pitchers Mount WRF, #439690 Issue Report

Inspection Photos and Issue Report

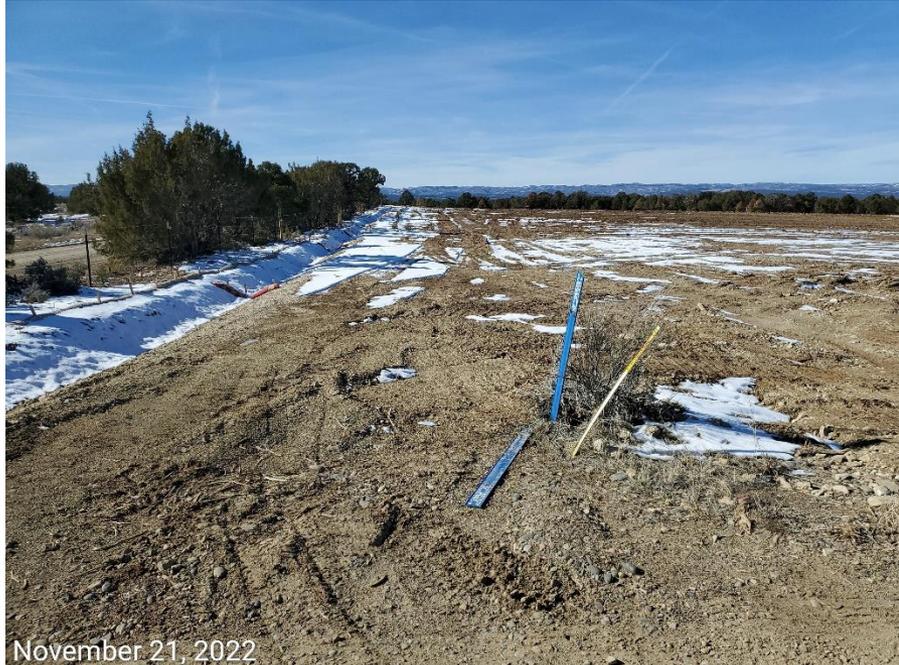
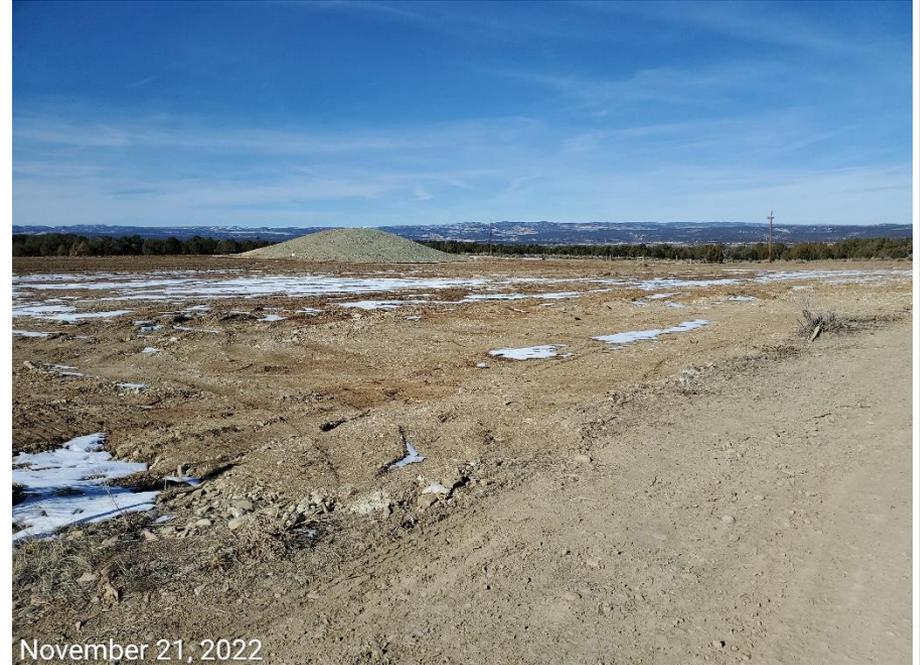
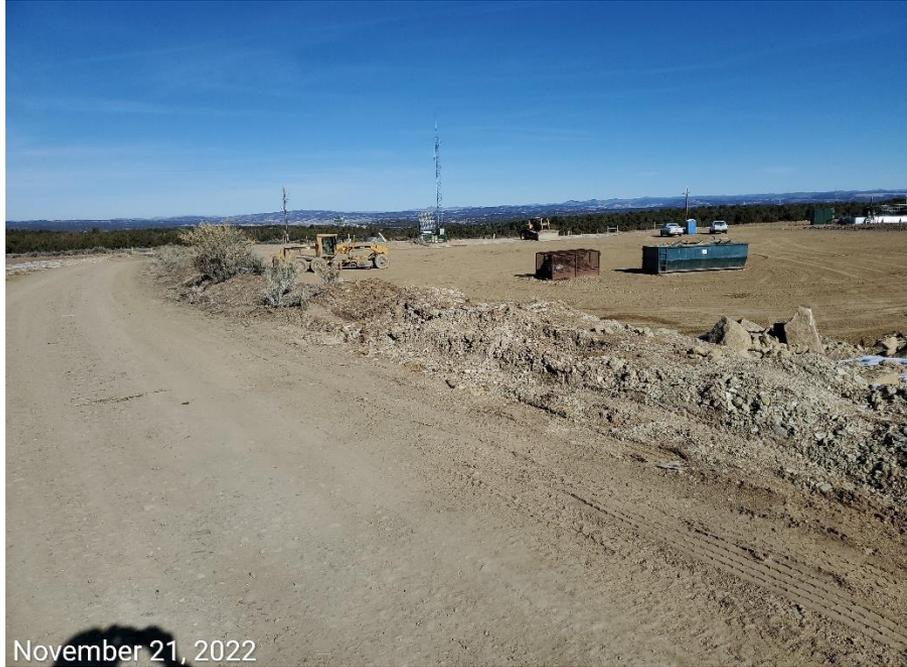
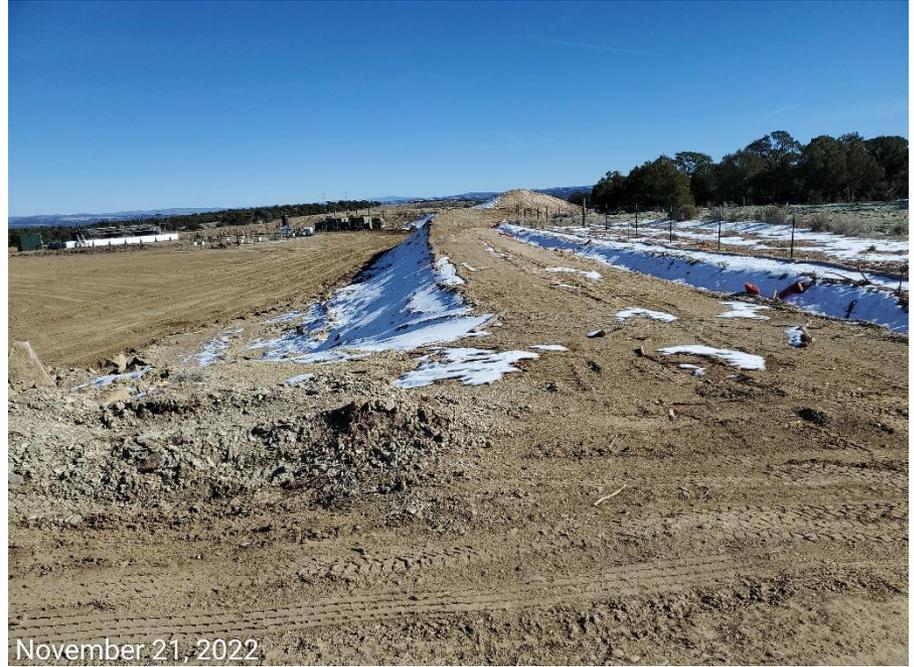
Photo 1: Photos taken from the entrance on the south end of the Location. Photos 1-2 provide an overview of the Location from west, northwest, northeast to east.

Photo 2: See comments under photo 1.

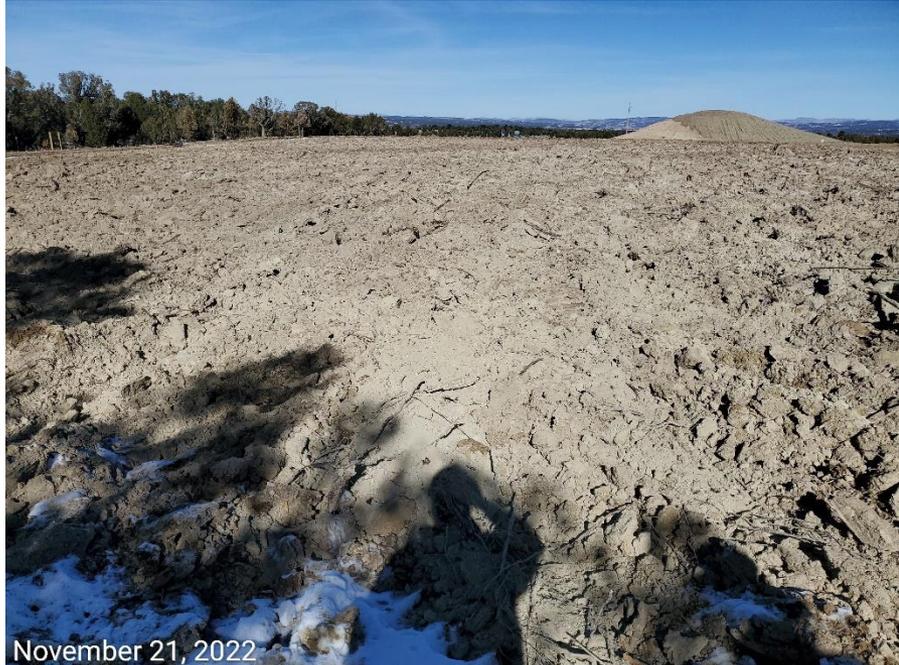
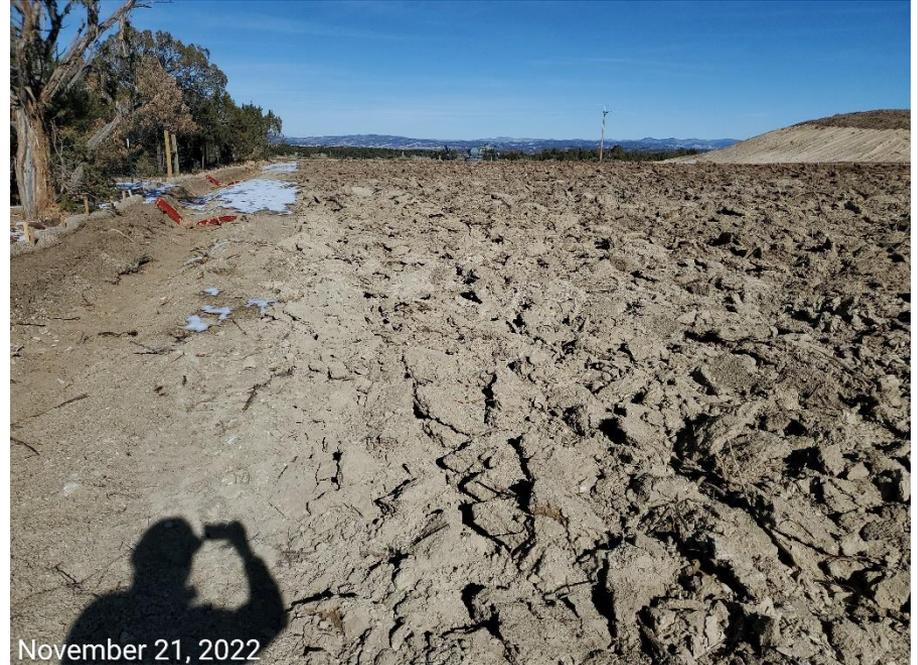
Photo 3: Photos shows areas on the west end of the Location that appear to have been ripped/roughened.

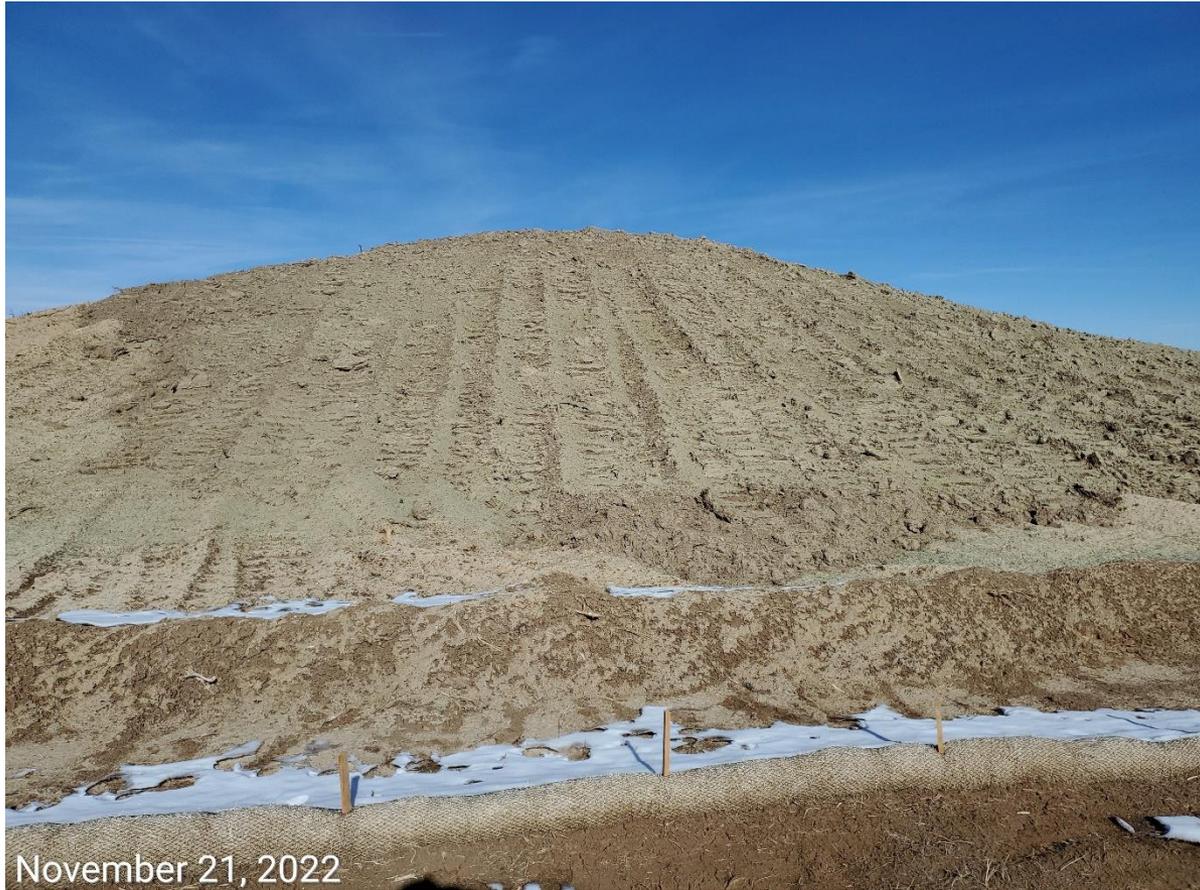
Photo 4: Photo shows topsoil stockpile on the west end of the Location.

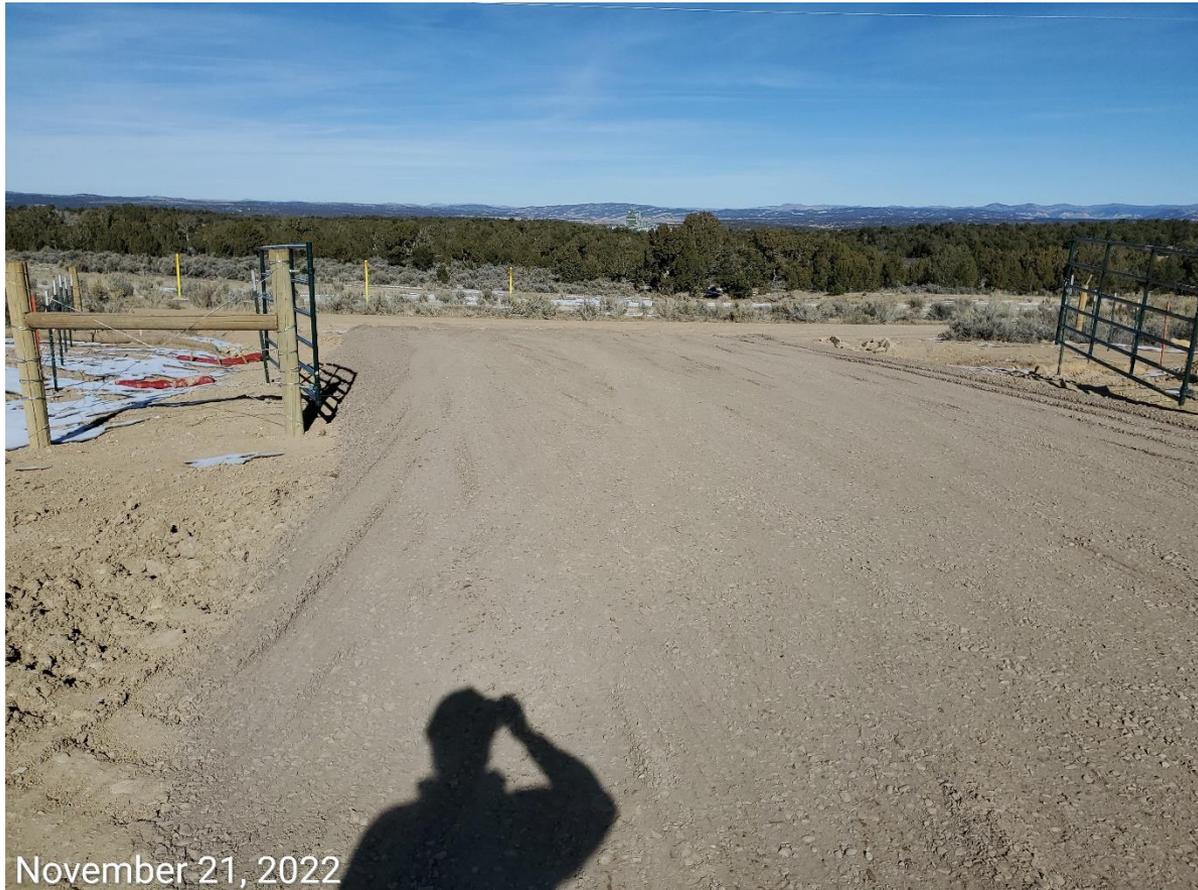
Photo 5: Photo shows the northeastern Location entrance; road base appears to have been installed at entrance.

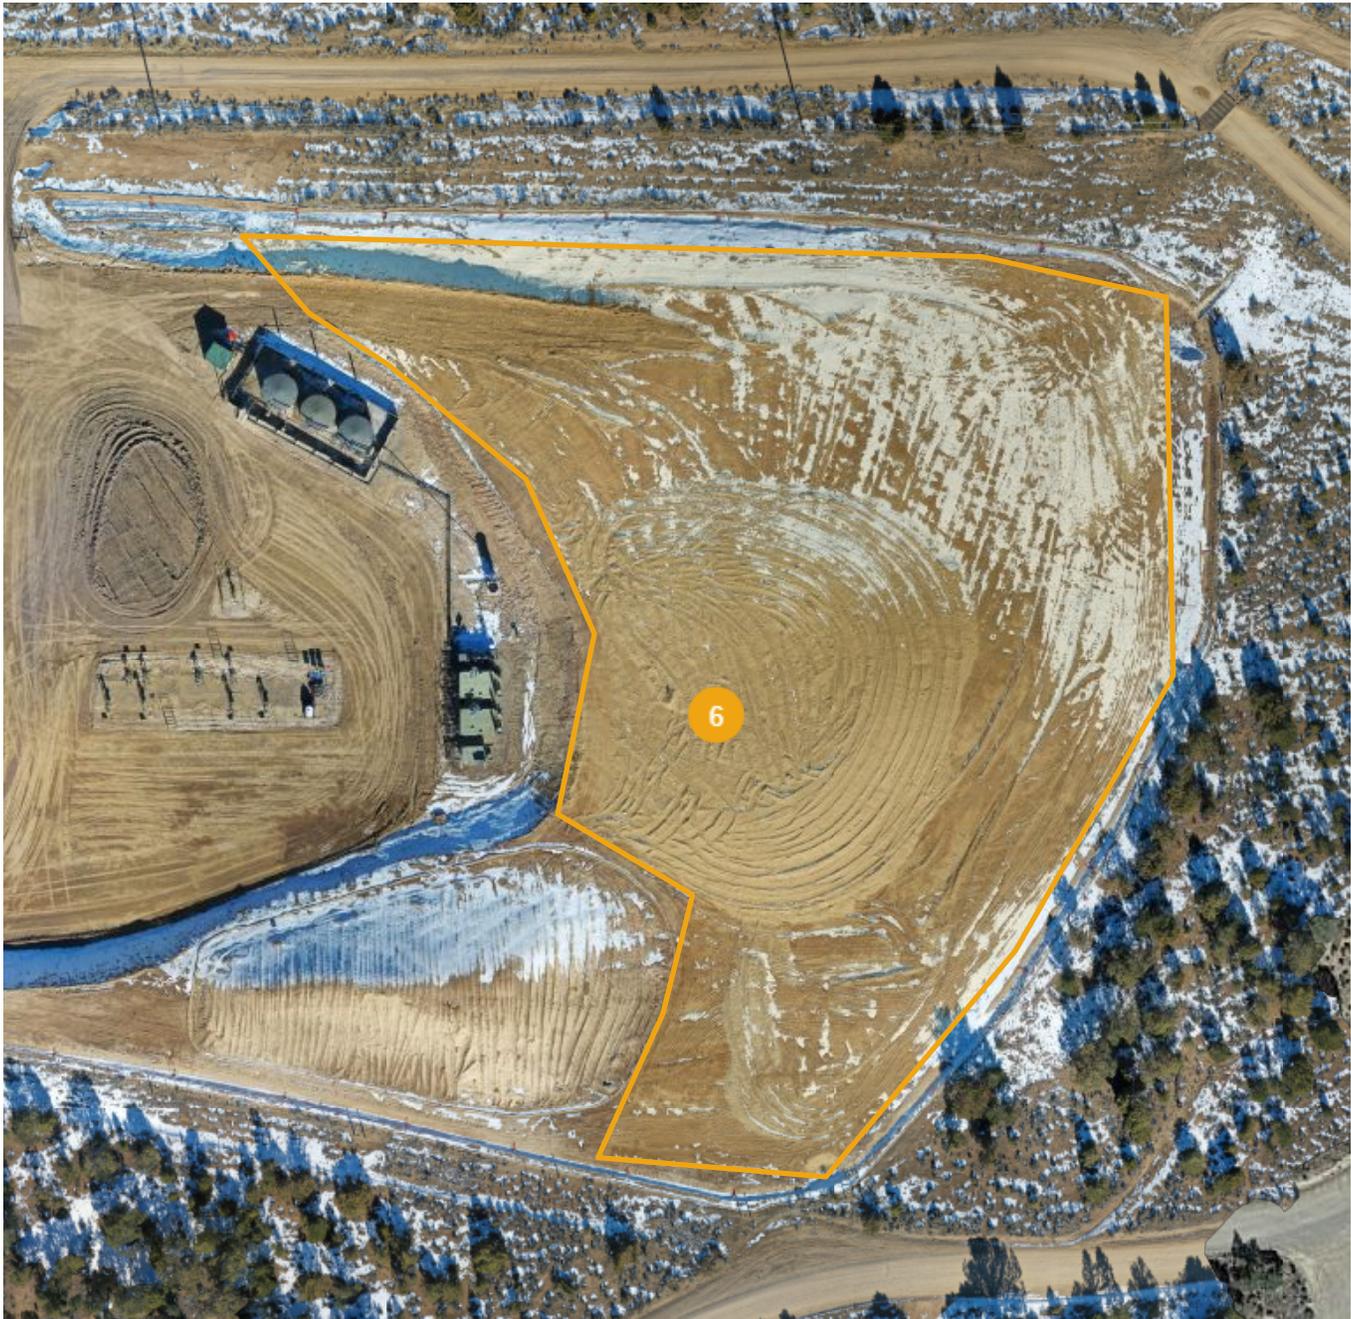
6 - Observation

Summary: **Soils within interim areas left loose; temporary controls to stabilize soils required until reclamation is performed and long-term stabilization achieved.**

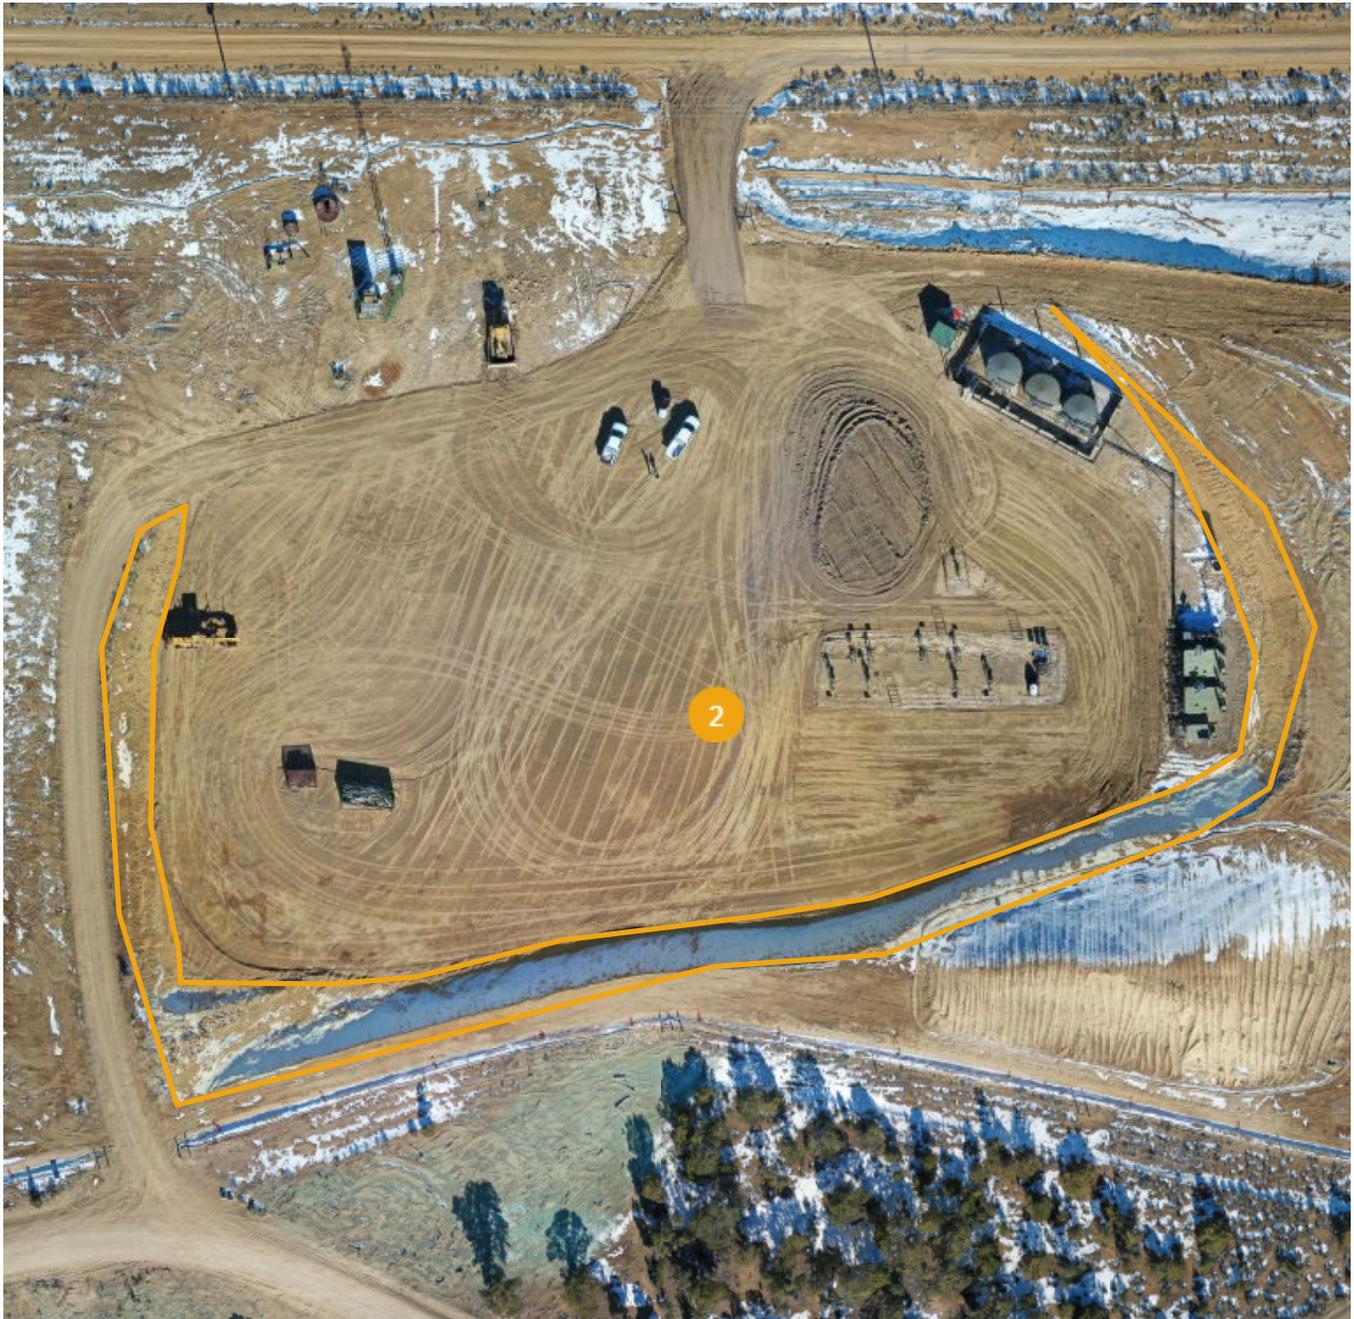
2 - Observation

Summary:	BMPs to minimize erosion, degradation missing or insufficient at cutslopes.
Created:	Nov 22, 2022, 8:11am by Aaron Trujillo
Cost of Repair:	—
Coordinates:	39.91897, -108.36298
Area:	0.48 acres
Surface Area:	0.54 acres

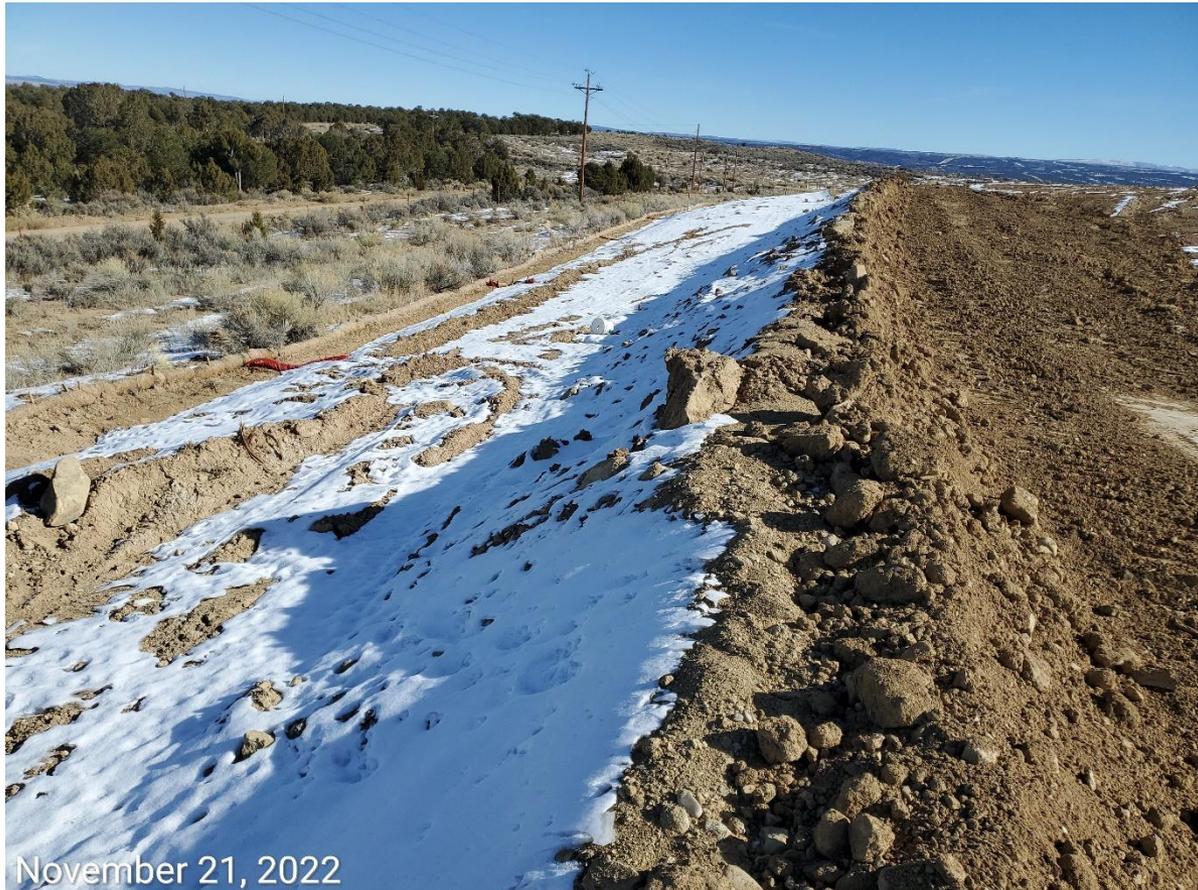
Photo 6: Photo taken from the northeastern areas of the Location. Photo shows BMPs to stabilize the soils and slopes remain missing or insufficient.

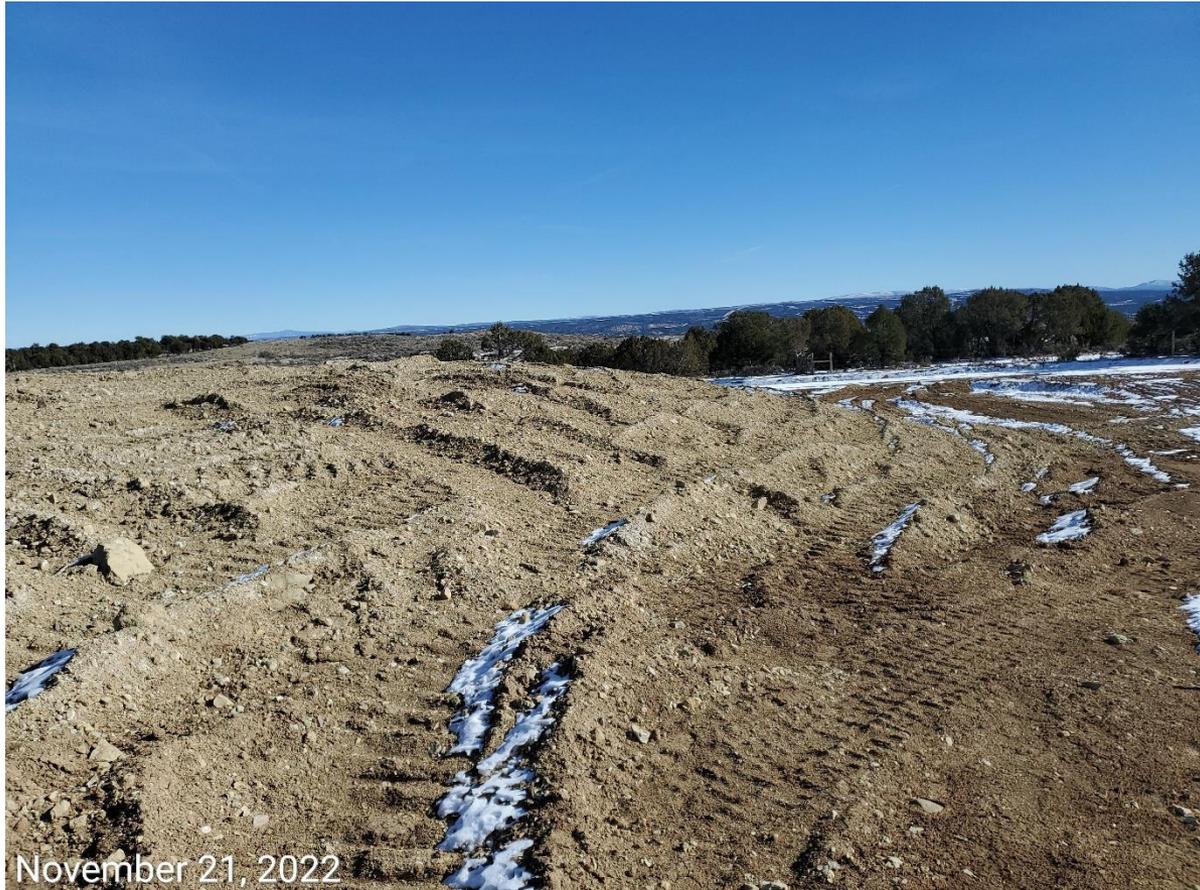
Photo 7: Photo example showing BMPs to stabilize the soils/slopes on the east end of the Location are missing or insufficient. Temporary BMPs (such as tracking, hydromulch, etc...) are required along the interim areas until reclamation work is performed, and long term stabilization has been achieved.

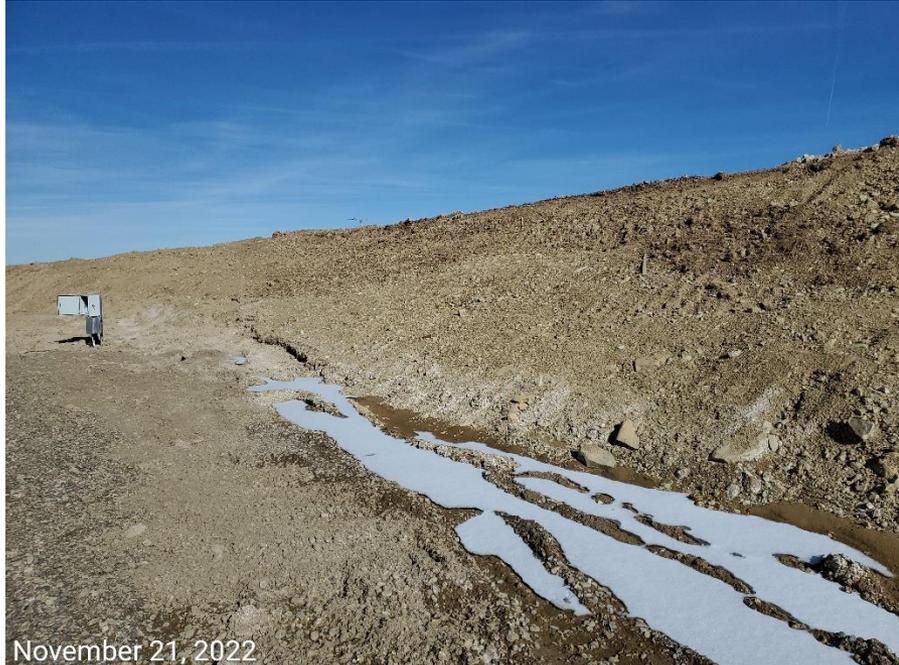
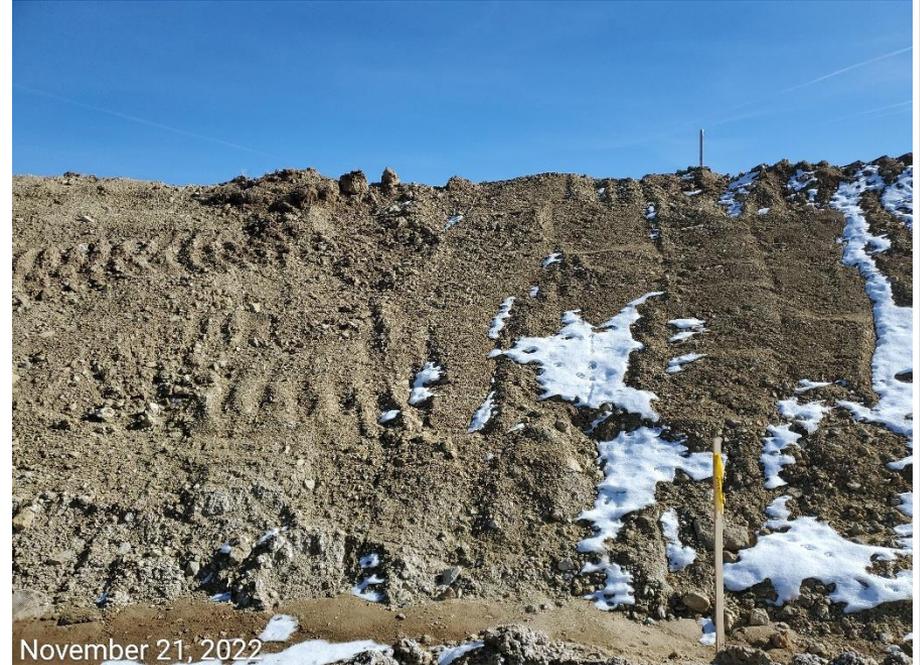
Photo 8: Photo shows BMPs to minimize erosion and degradation at the cut slopes on the east end of the location are missing or insufficient.

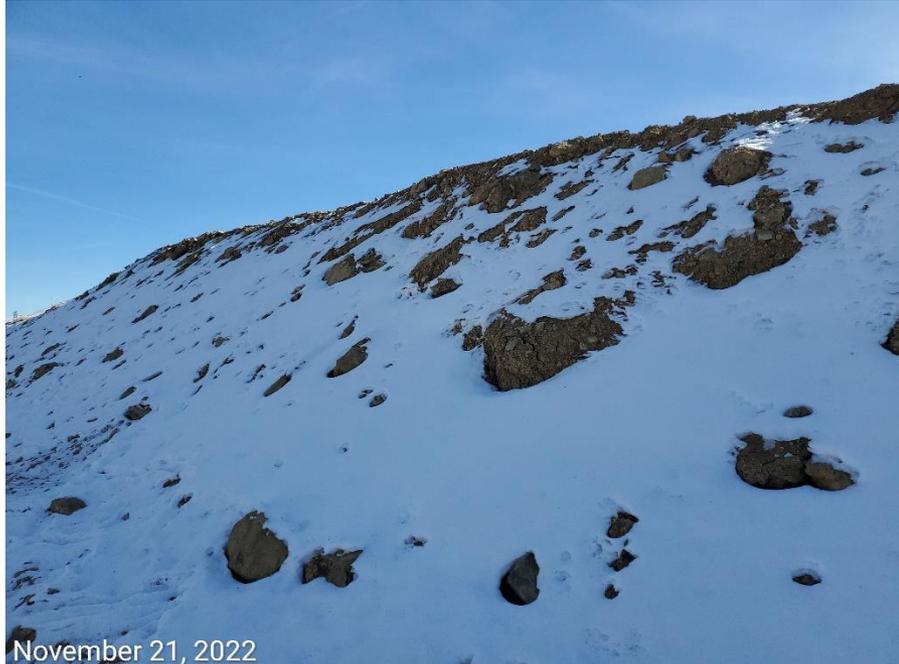
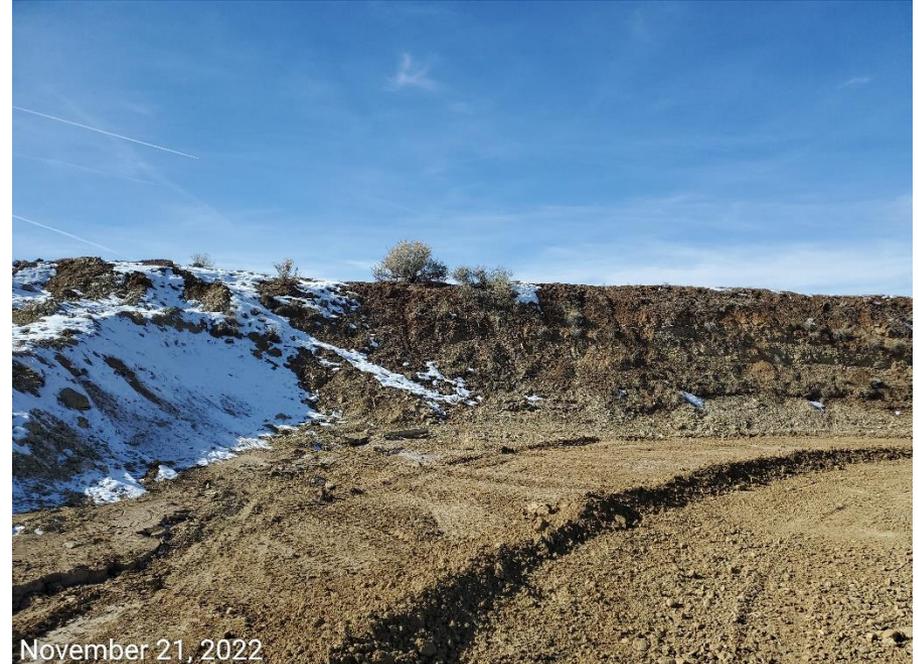
Photo 9: Photo shows BMPs to minimize erosion and degradation at the cut slopes on the east end of the location are missing or insufficient.

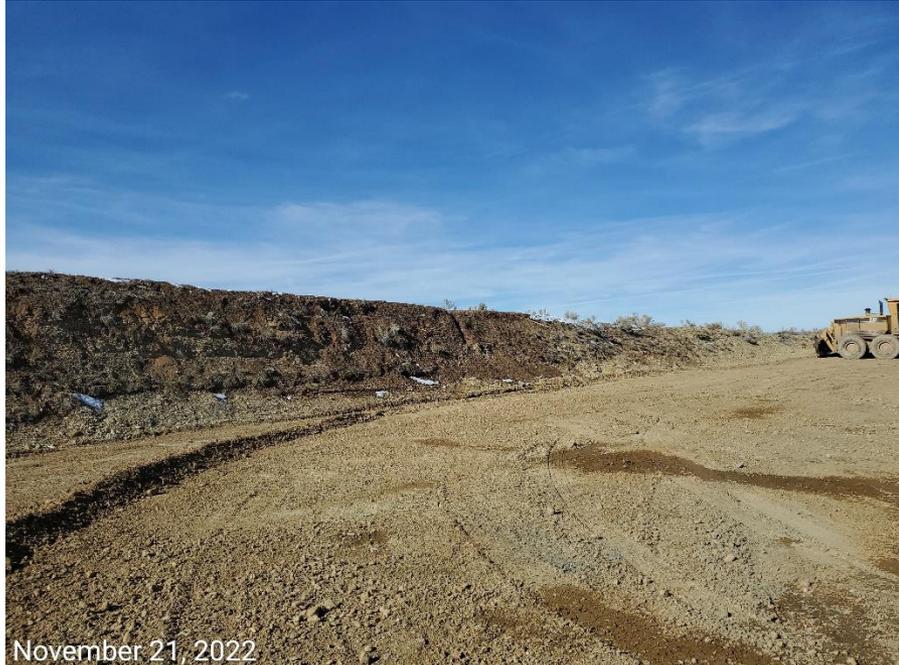
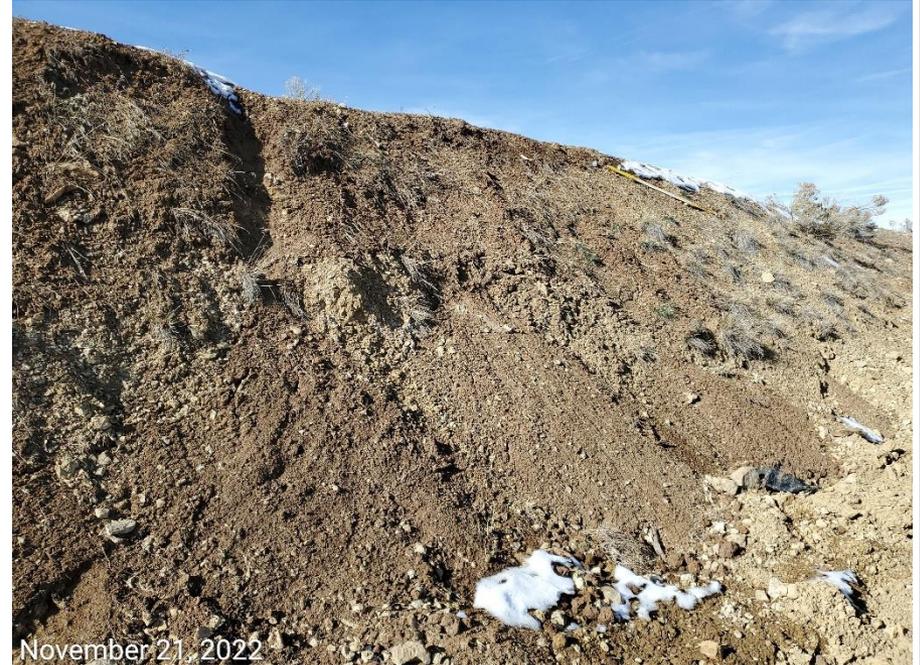
Photo 10: Photo shows BMPs to minimize erosion and degradation at the cut slopes on the east end of the location are missing or insufficient.

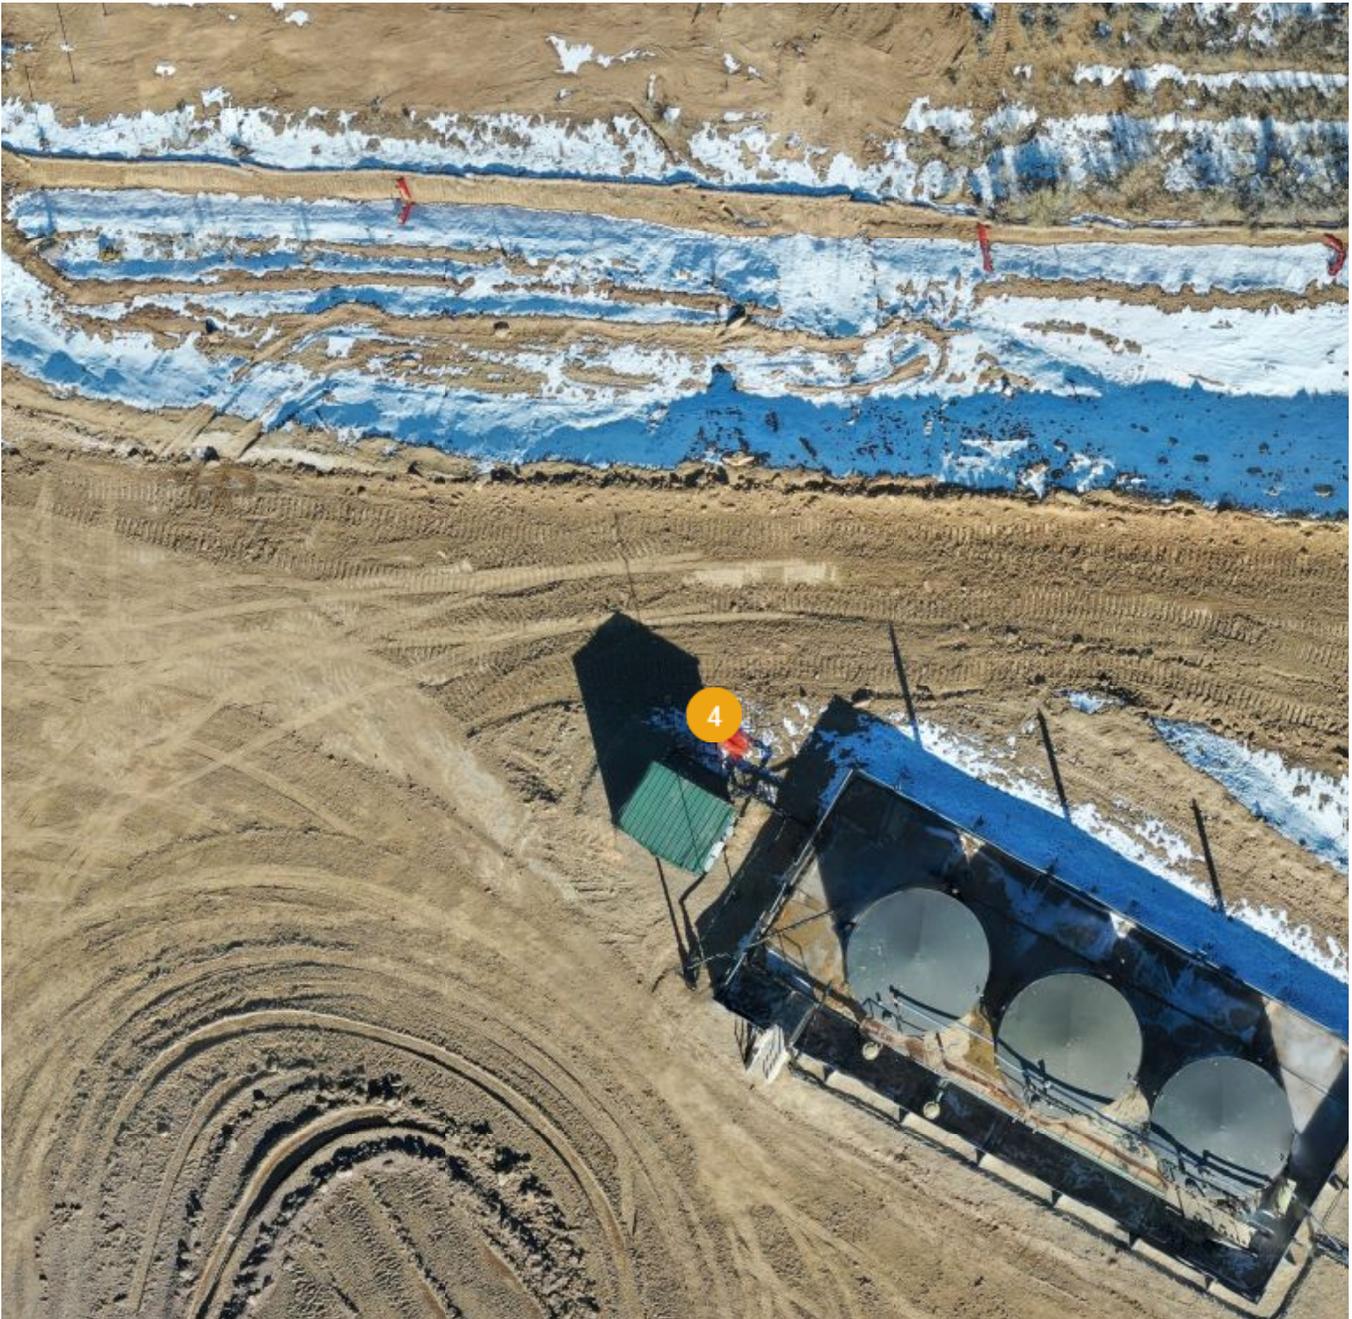
4 - Observation

Summary:	Unused fence, t-posts
Created:	Nov 22, 2022, 8:13am by Aaron Trujillo
Cost of Repair:	—
Coordinates:	39.91961, -108.36252
Elevation:	-17.14 ft

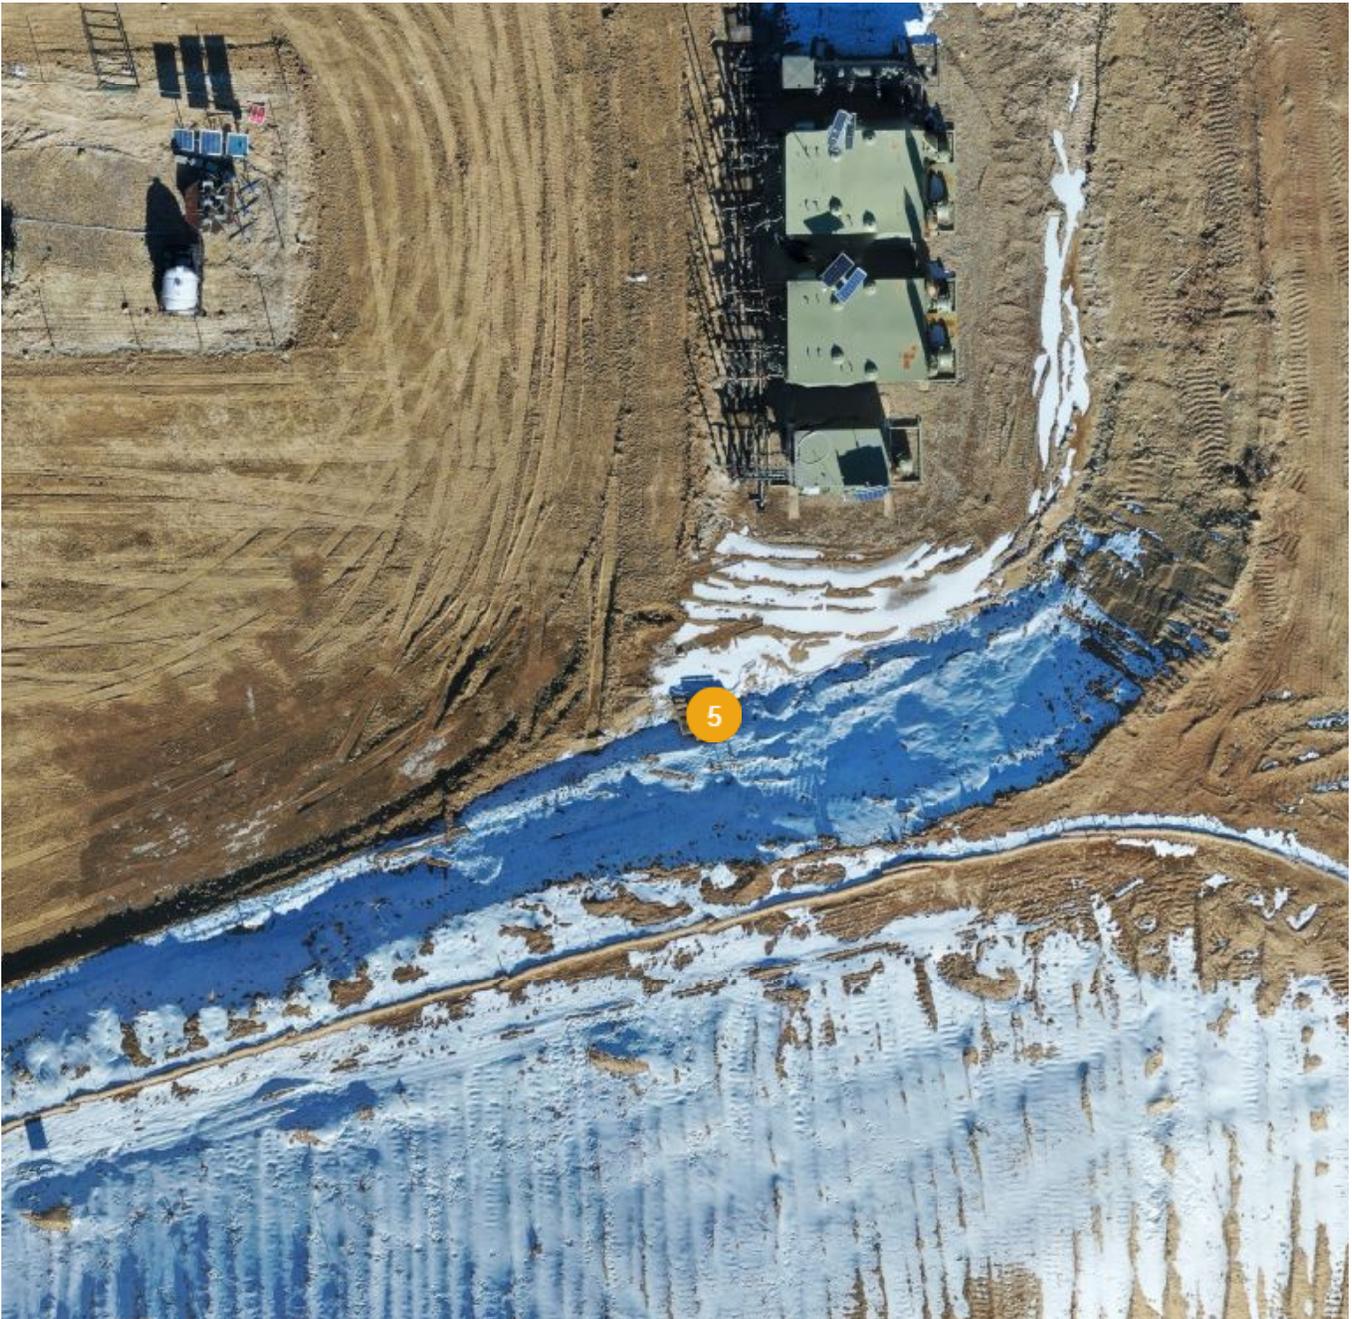
5 - Observation

Summary:	Pallets
Created:	Nov 22, 2022, 8:14am by Aaron Trujillo
Cost of Repair:	—
Coordinates:	39.91903, -108.36219
Elevation:	-14.92 ft

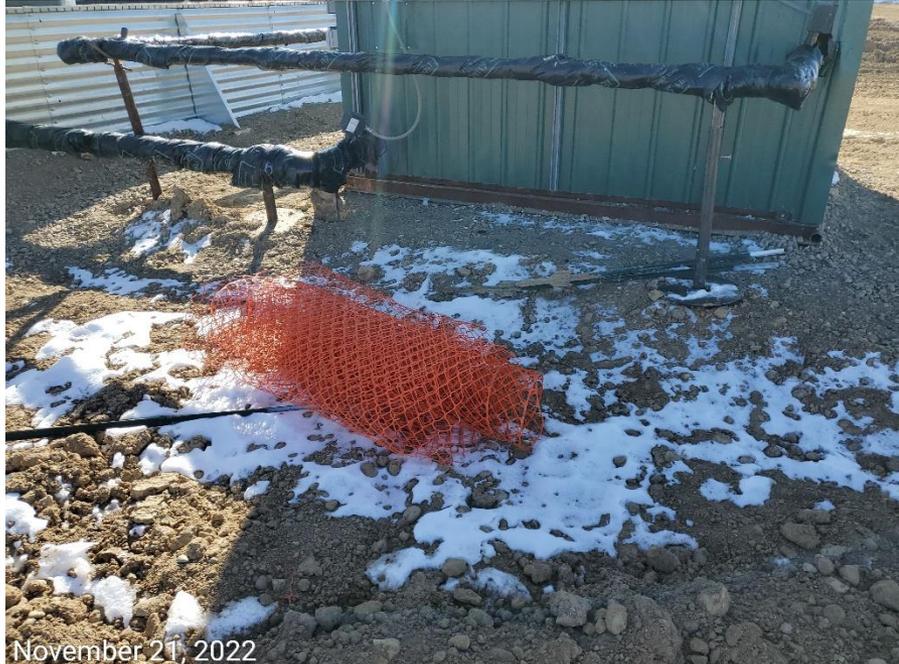
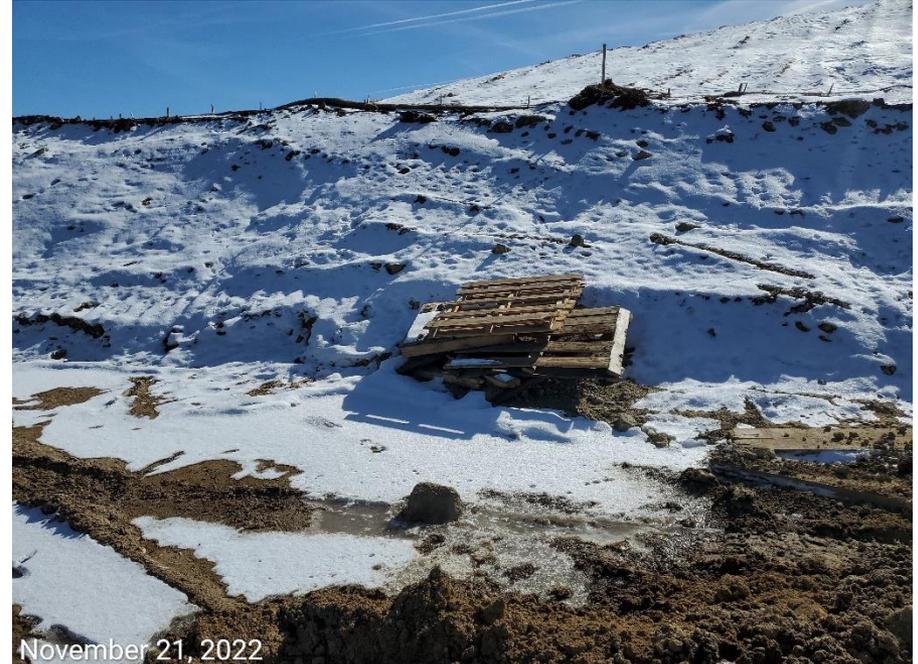
Photo 11: Photos show unused fence, t-post and pallet materials stored on Location.

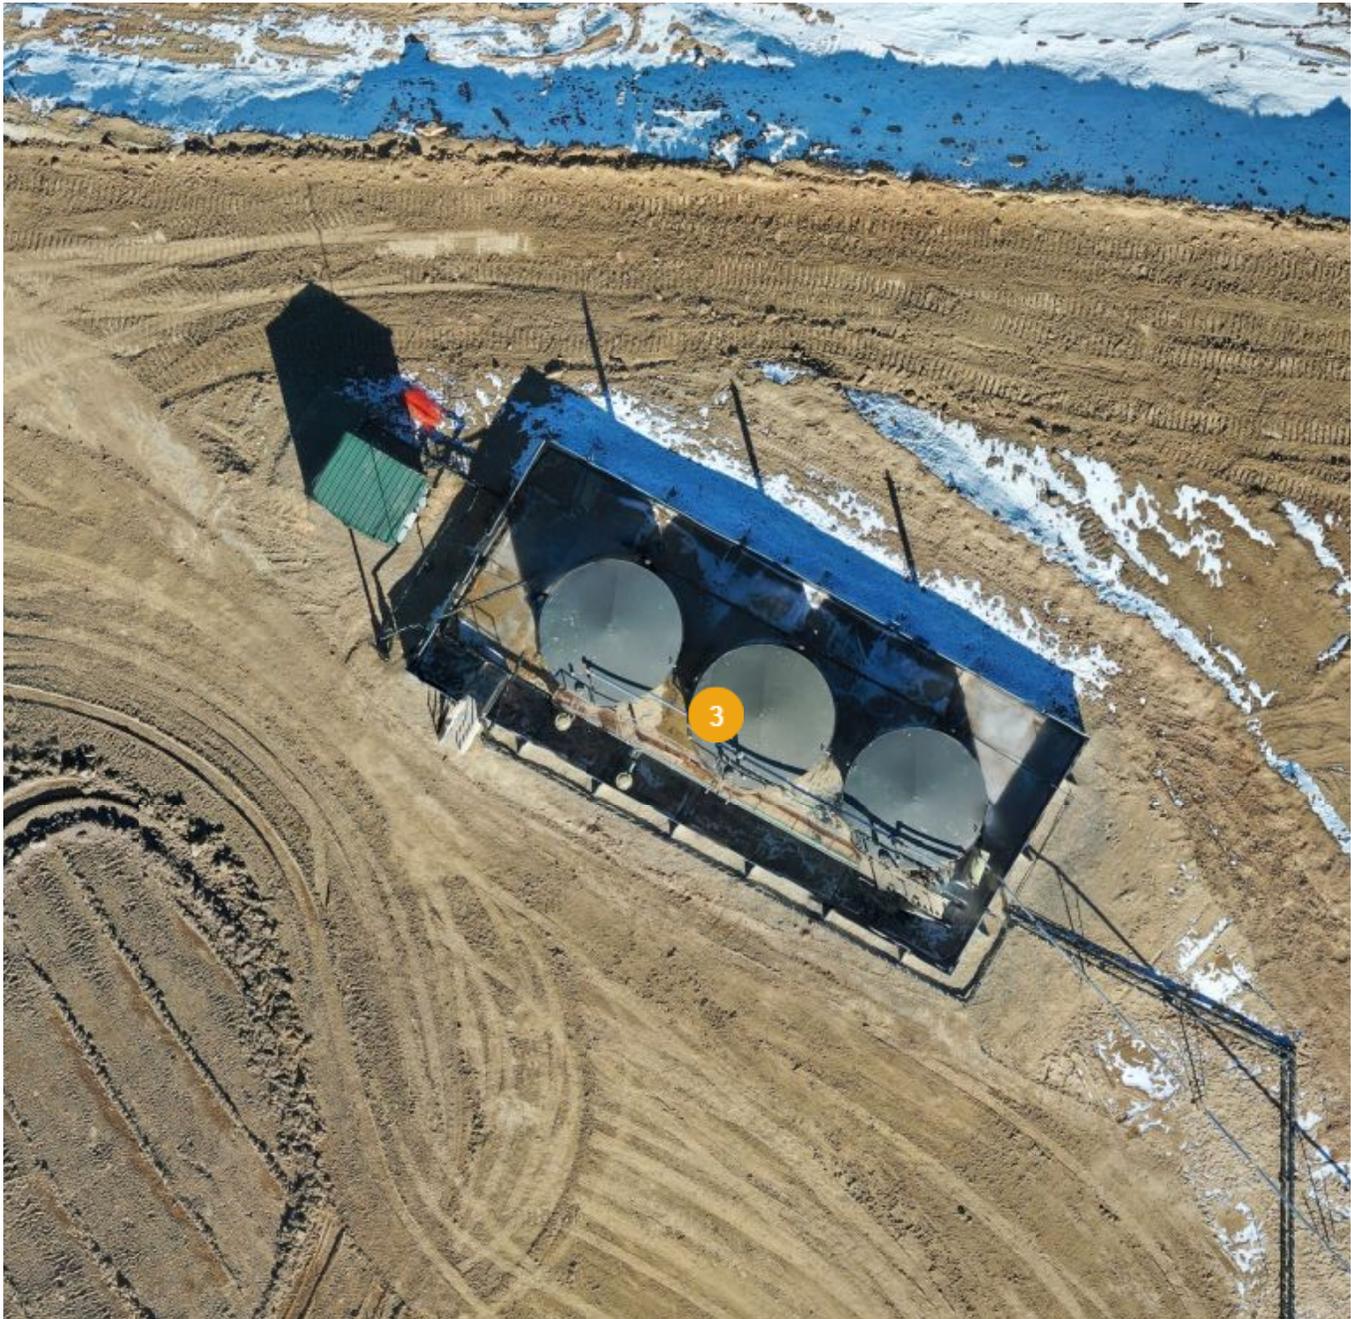
3 - Observation

Signage missing at tank battery. Tanks missing required labelling.
