Colorado Oil and Gas Conservation Commission

TEP, Pitchers Mount WRF, #439690 Annotation Report

TEP, Pitchers Mount WRF, #439690 Issue Report

Inspection Photos and Issue Report

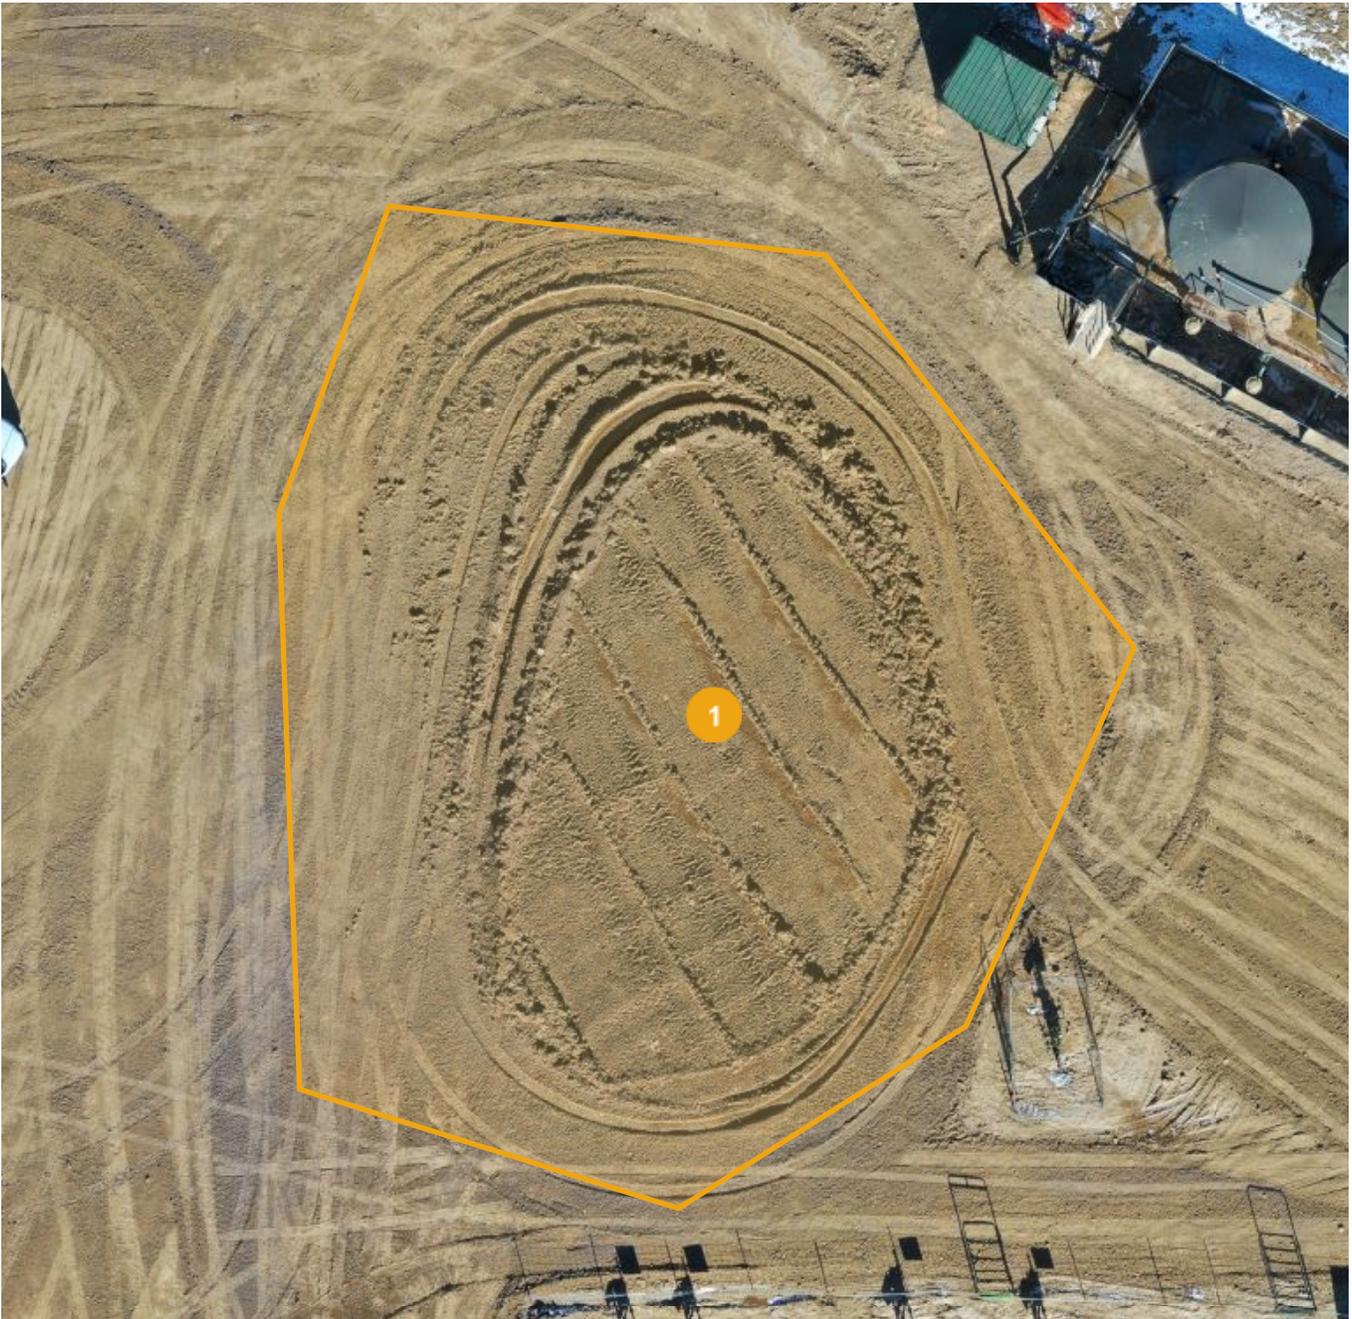
1 - Observation

Summary:	Inadequate stabilization on working pad surface. Tracking evident.
Created:	Nov 22, 2022, 8:09am by Aaron Trujillo
Cost of Repair:	—
Coordinates:	39.91939, -108.36266
Area:	7284.63 ft ²
Surface Area:	7494.25 ft ²

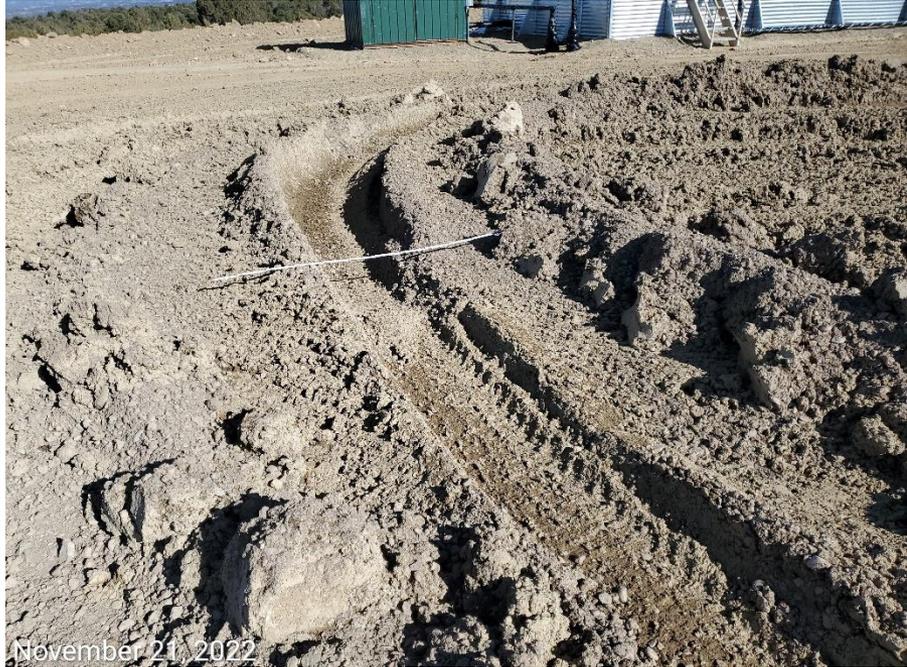
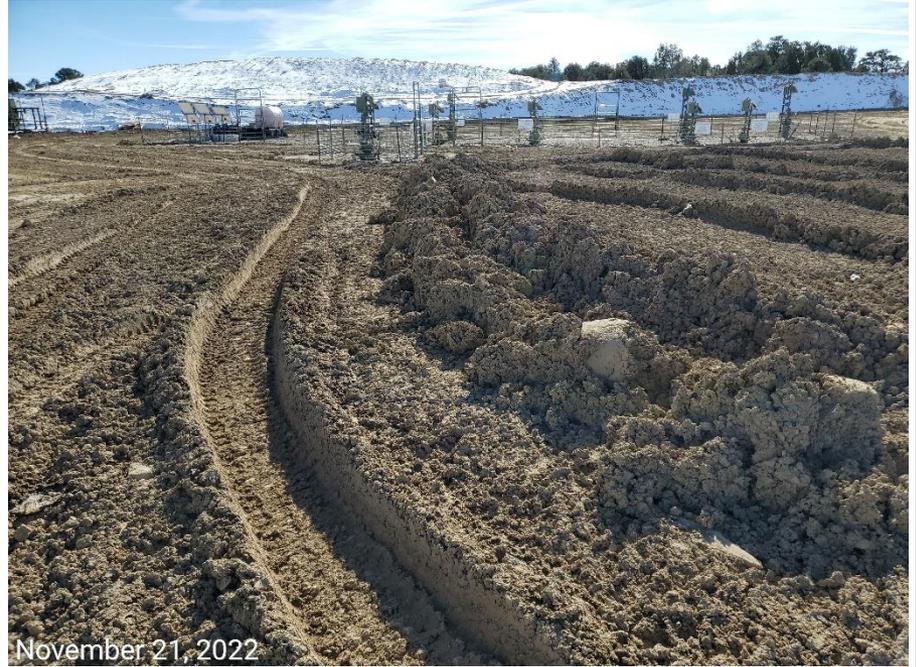
Photo 12: Photo taken from the production areas north of the wells. Photo shows large areas of unconsolidated soils on the working pad; pad not adequately stabilized

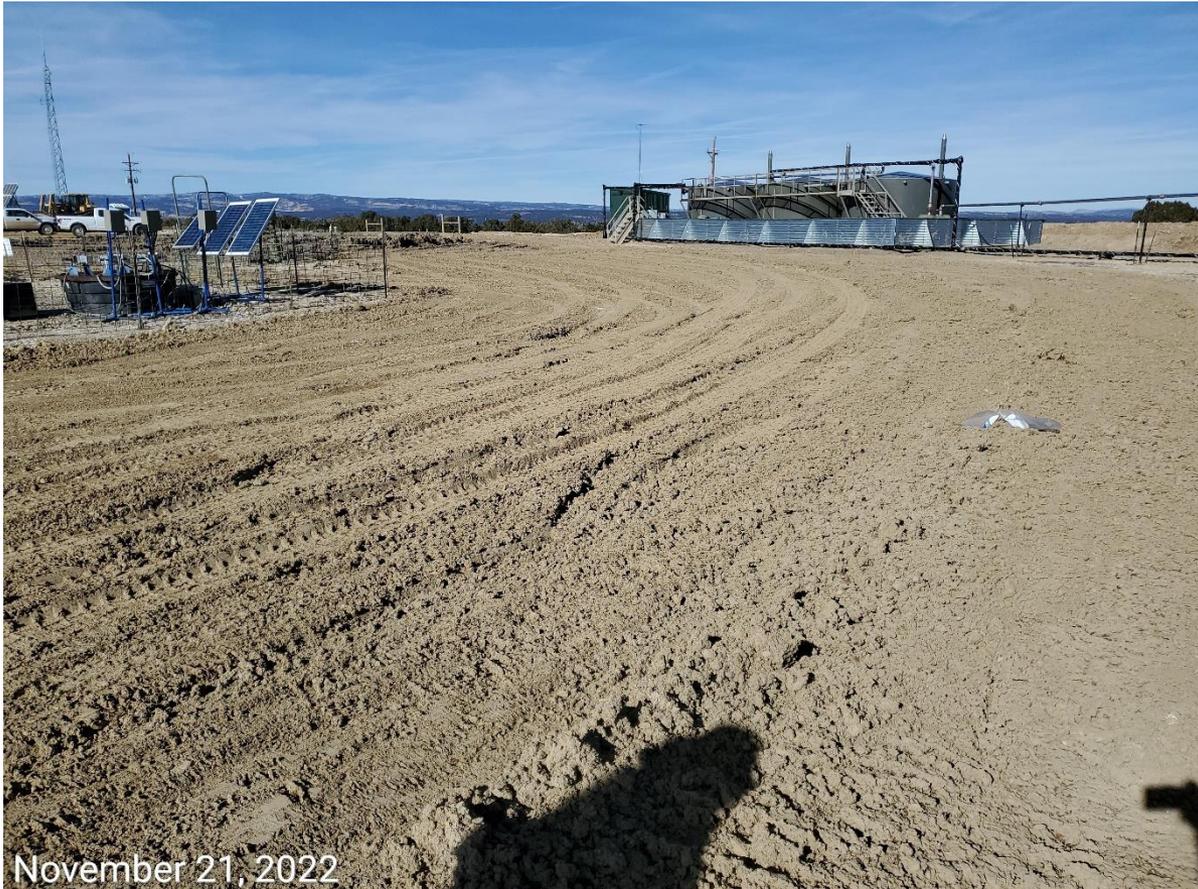
Photo 13: Photo example showing BMPs to stabilize working pad area, and to minimize erosion, degradation and sediment transport are missing or insufficient.

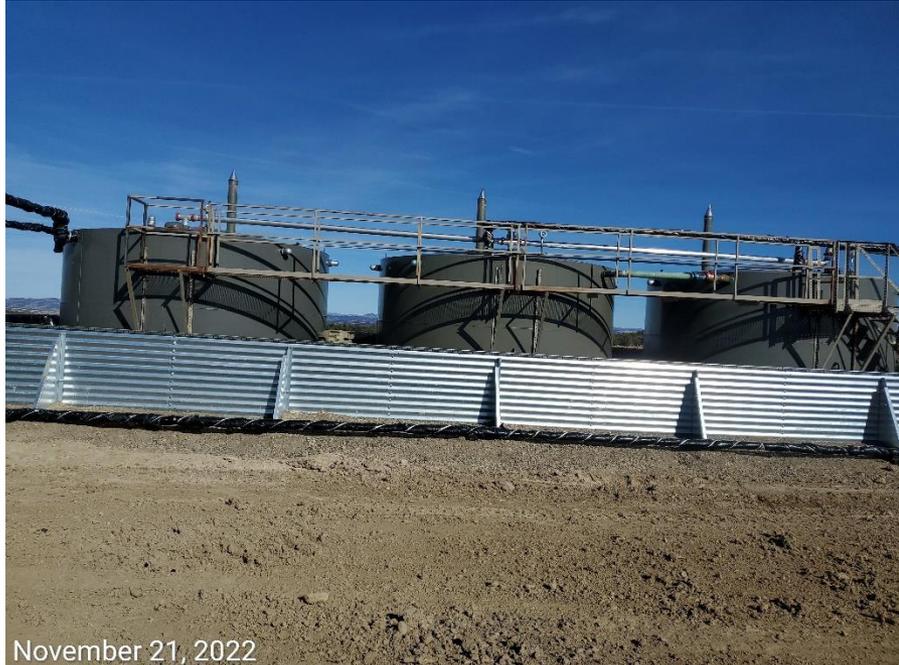
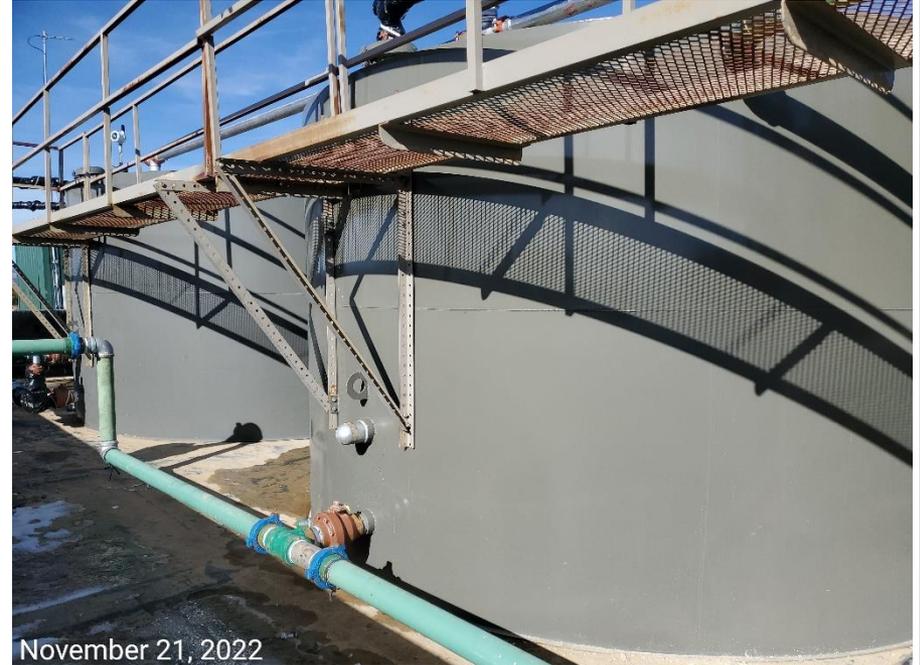
Photo 14: Photo taken from the tank battery on the northeast end of the Location. Photo shows battery signage, and tank labels are missing.

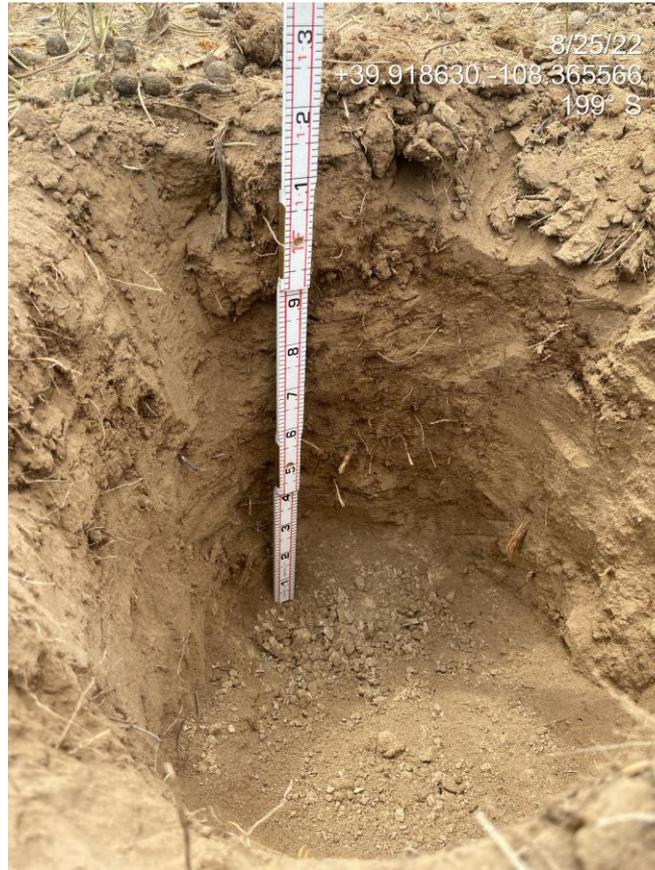
Photo 15: 8/25/2022 photo shows example topsoil sample pit conducted within the western areas of the Location. Reclamation staff observed a topsoil depth of 10" within these areas.
