Inspection Photos

Operator: Caerus Piceance LLC - #10456

Location Name: SAVAGE-67S94W/5NWSW

Inspection Document #: 702800965

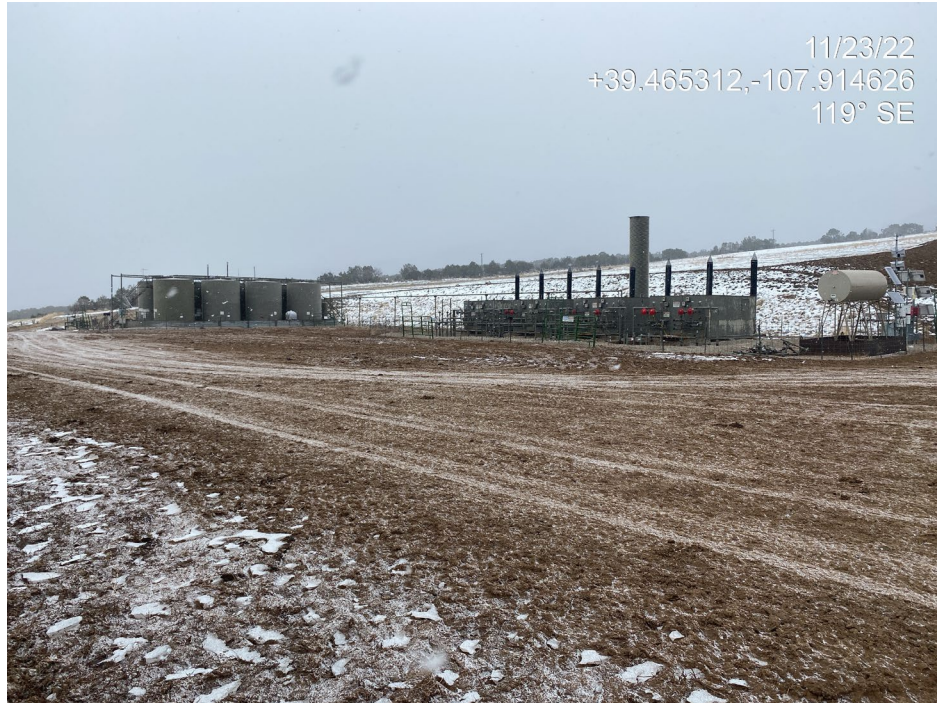
Photo 1. Photo shows an overview of eastern production areas.

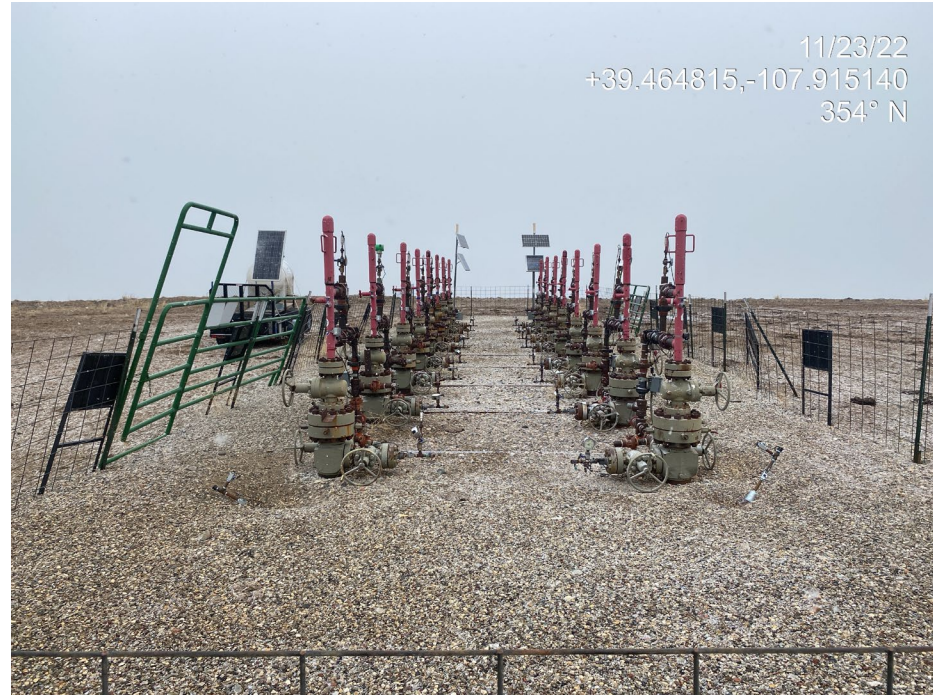
Photo 2. Photo shows western production areas.

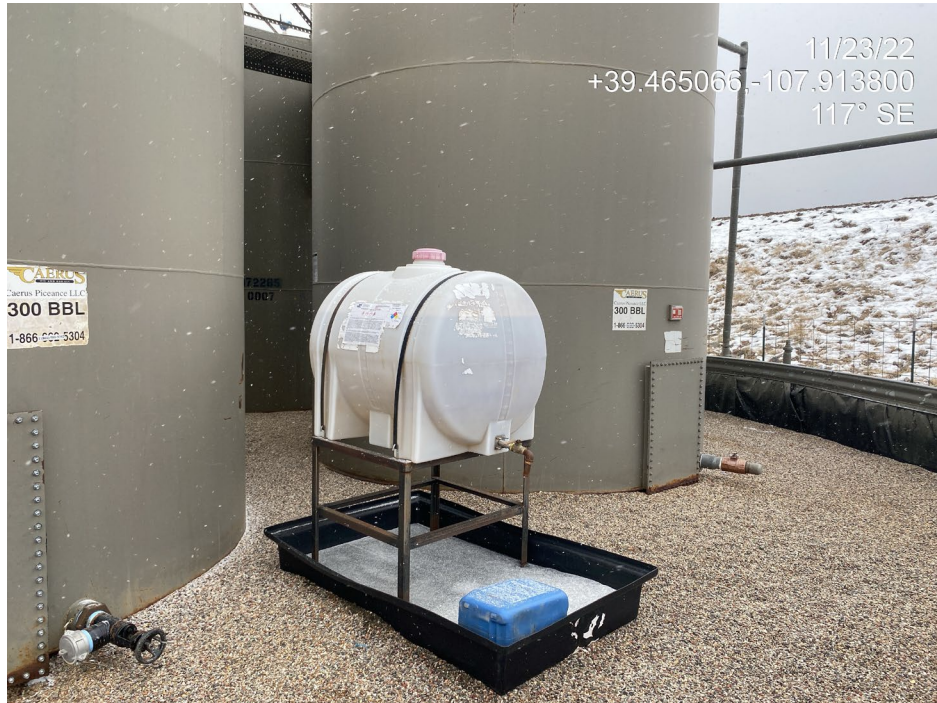
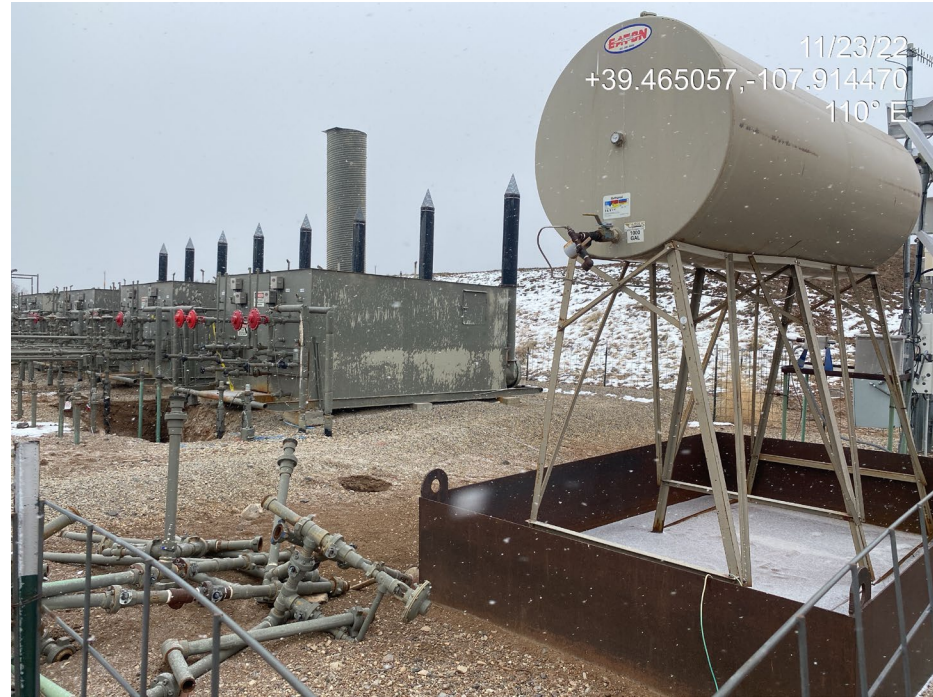
Photo 3. Photos show two secondary containment tanks lacking wildlife protection BMPs.

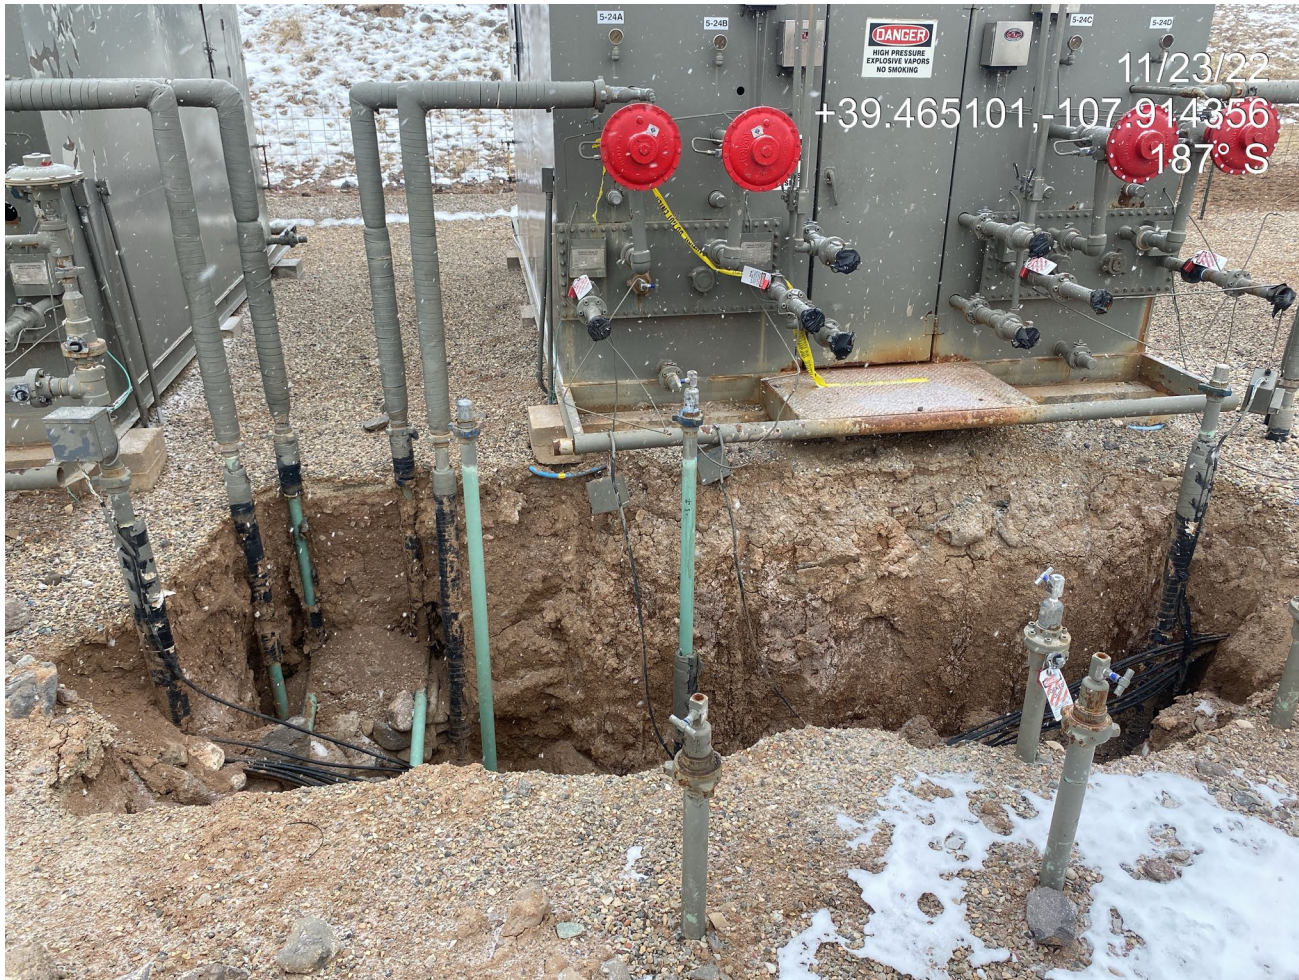
Photo 4. Photo taken from the south shows an excavation at the separators lacks protections to prevent personnel from entering or falling into the trench.

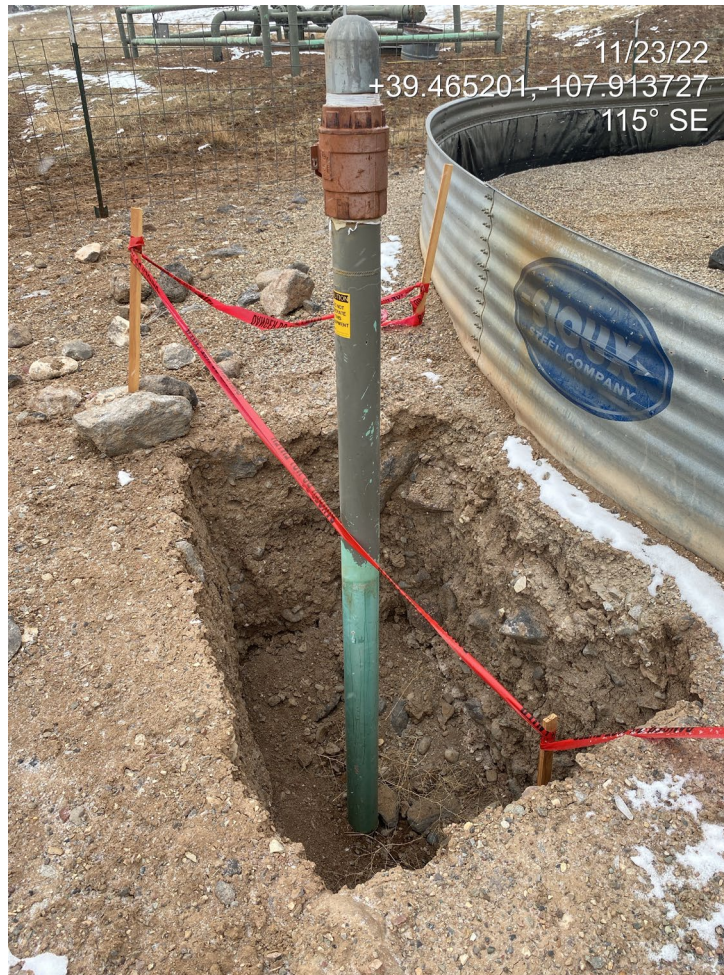
Photo 5. Photo taken from the east shows protections to prevent wildlife, livestock or personnel from entering or falling into an excavation are missing or insufficient.

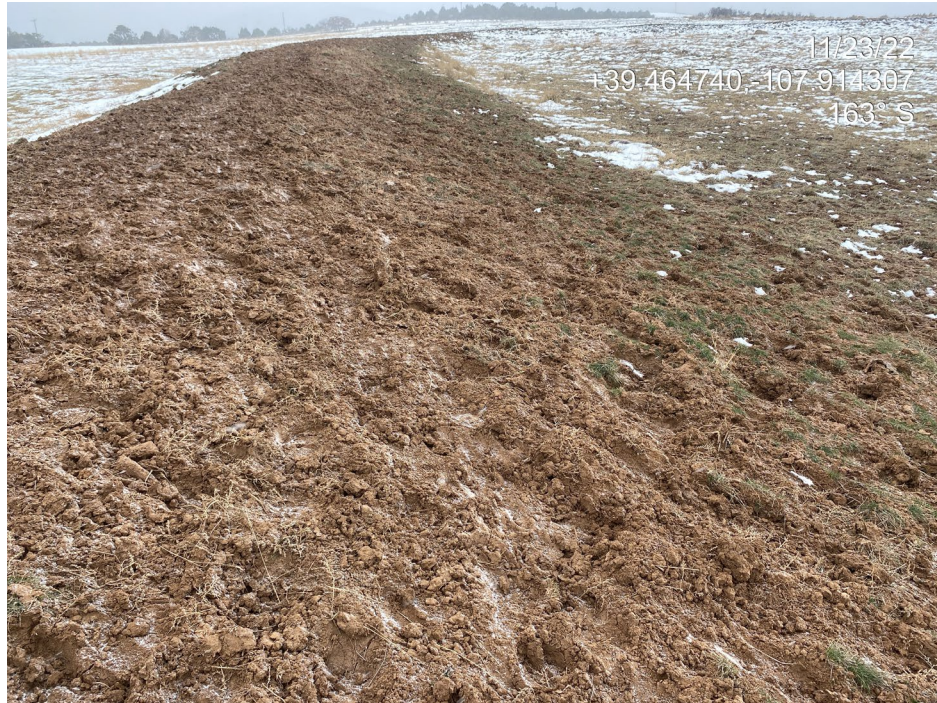
Photo 6. Photo shows an overview of interim areas to the southwest. Perennial grasses appear to be established, but are impacted by livestock grazing and hoof action. A follow up inspection will be conducted during the growing season to assess revegetation.

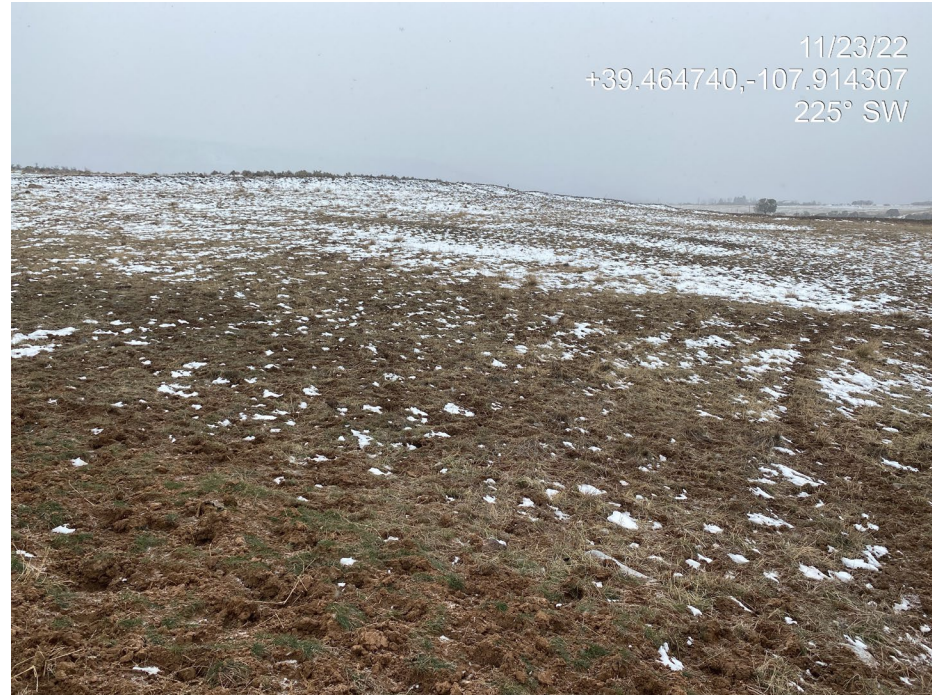
Photo 7. Refer to Photo 6 comment.

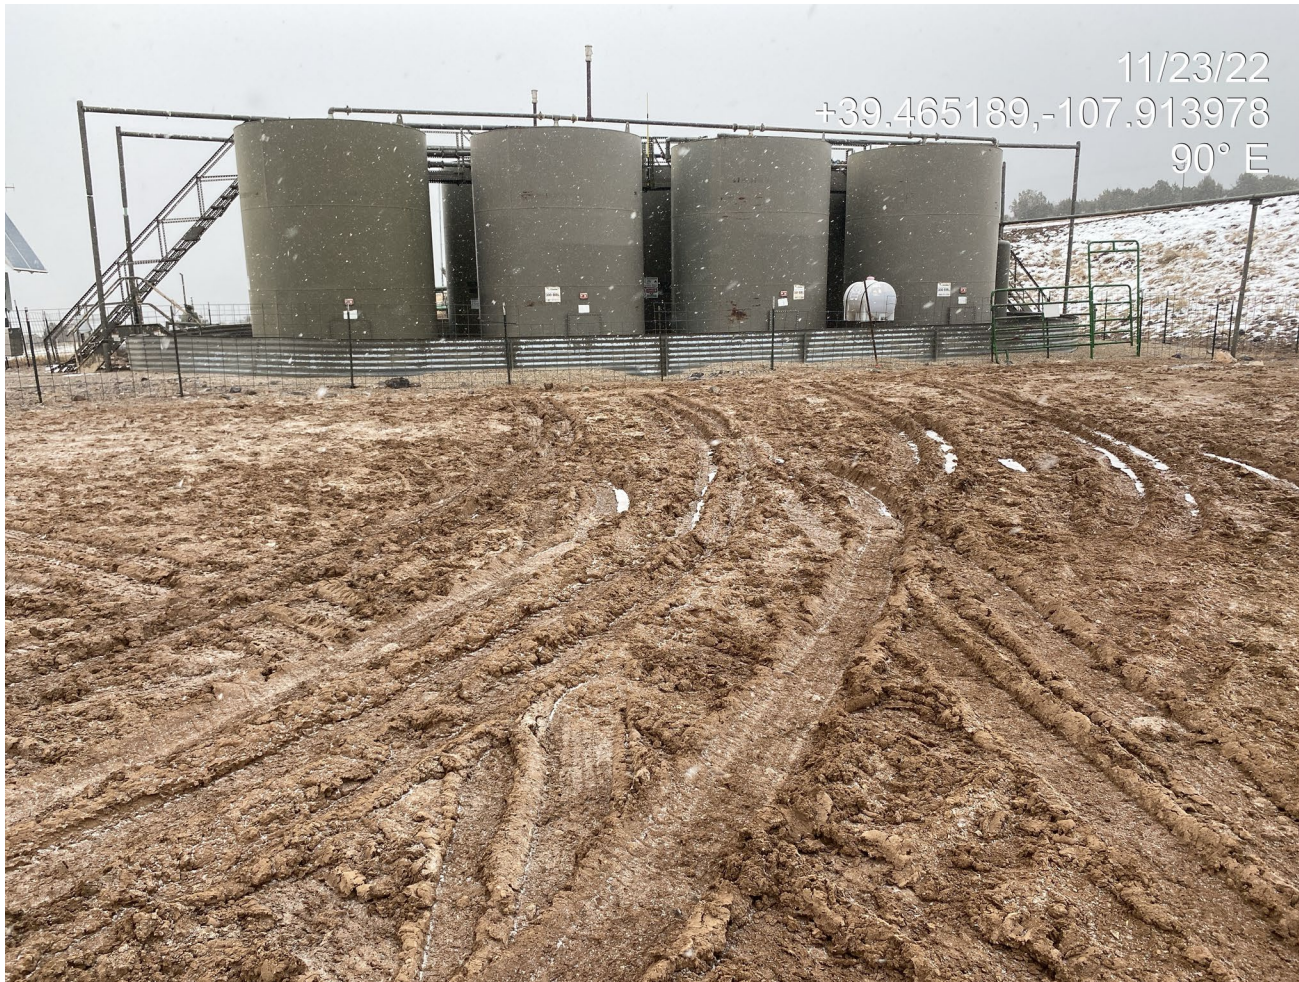
Photo 8. Photo shows degradation to the pad surface.
