Final Reclamation Inspection

Operator: PDC ENERGY INC - 69175

Location ID: 336387

Inspection Document #: 701900768

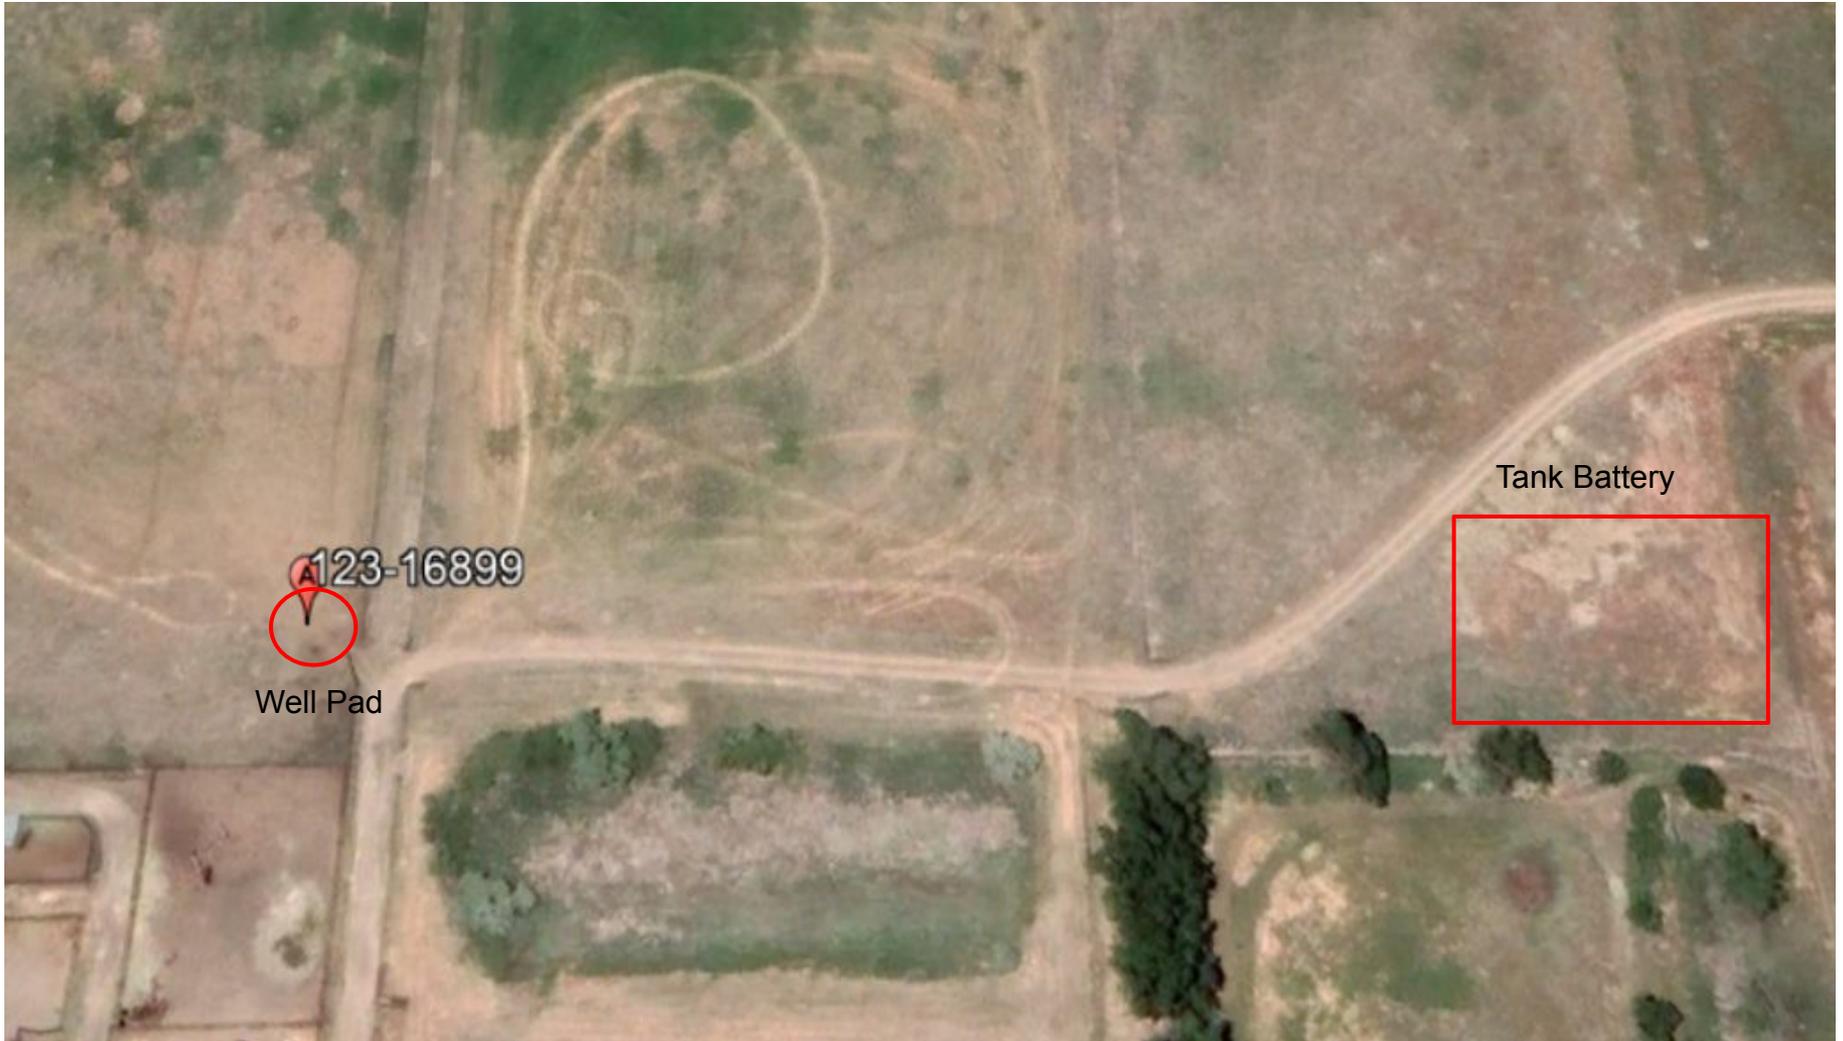
Photo 1. 2021 aerial imagery of the well pad and tank battery. Well pad access road remains for the equestrian facility.

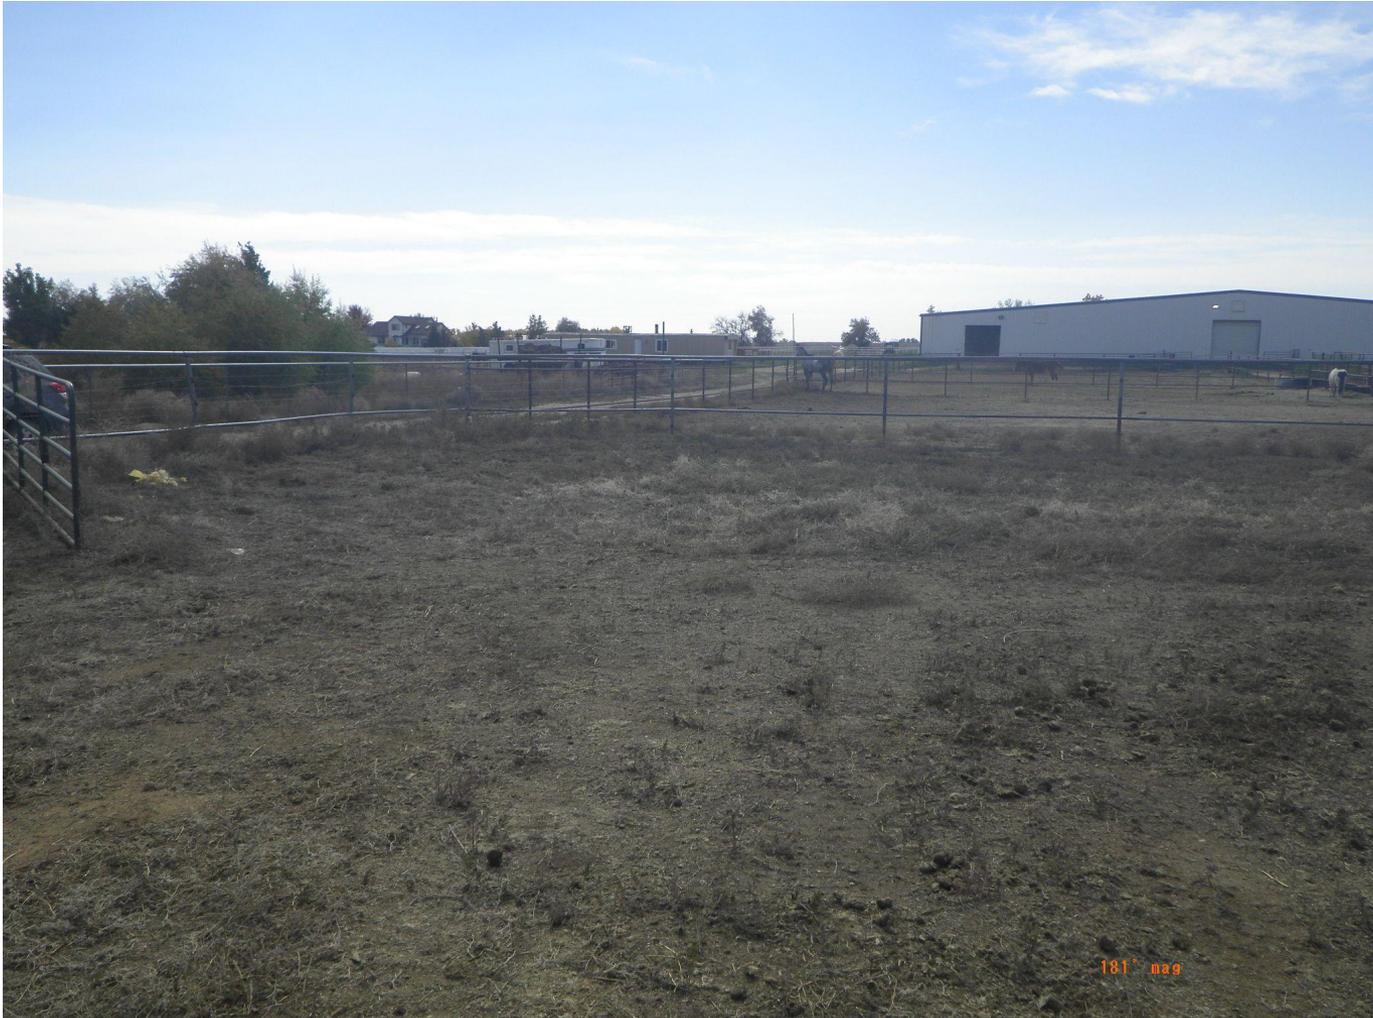
Photo 2. Overview photo of the well pad taken at ground level from the northern edge facing south.

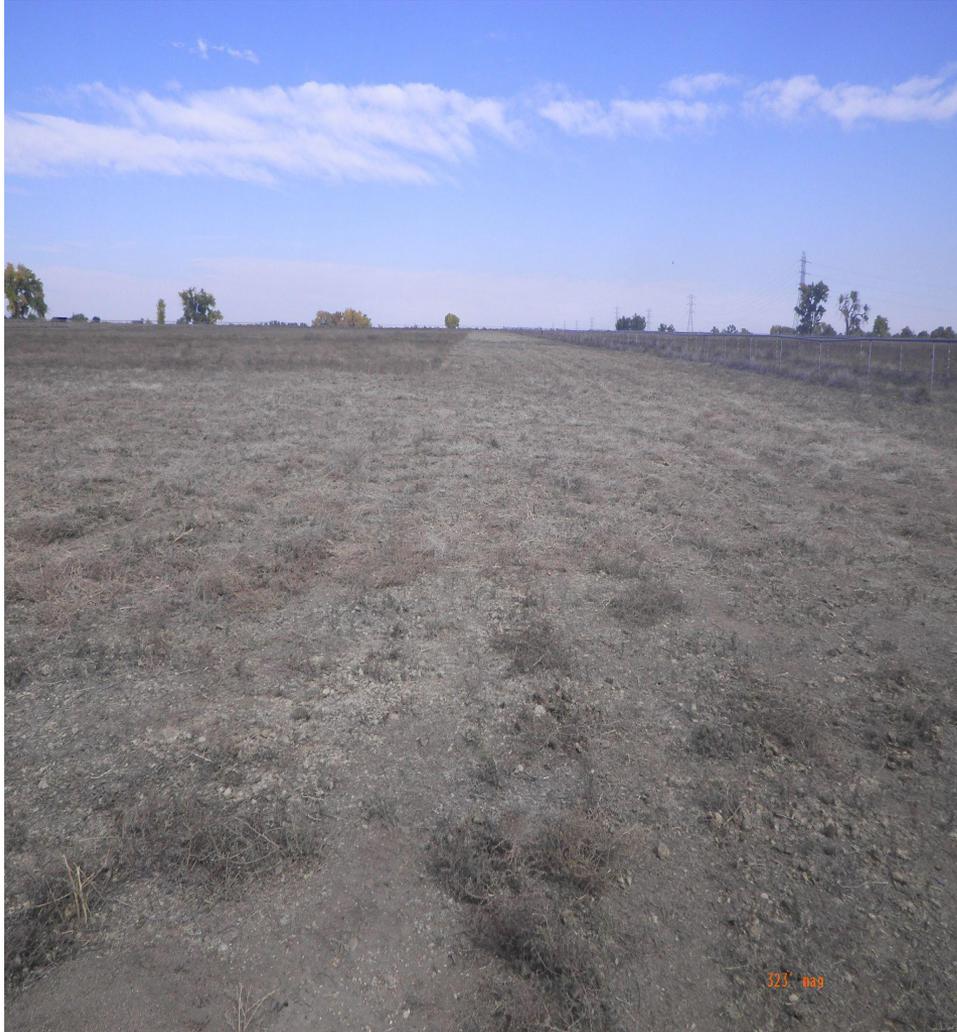
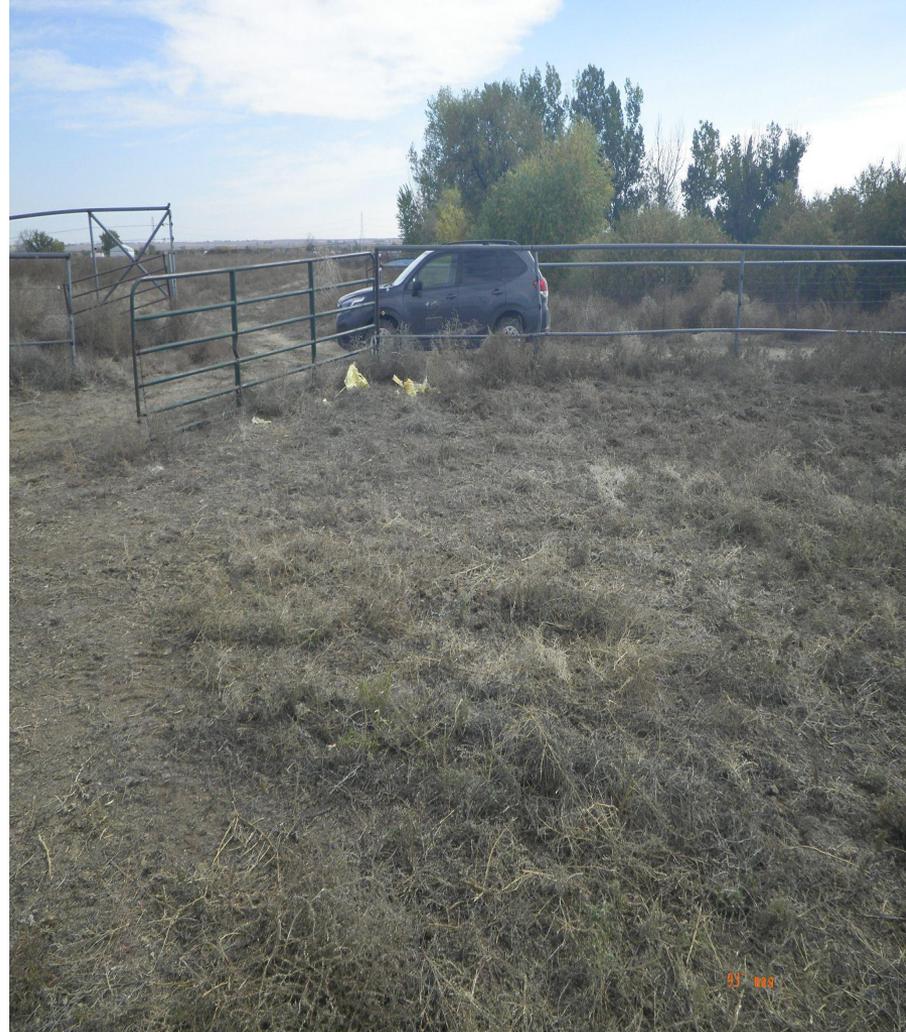
Photo 3. Cardinal photos taken at ground level from the middle of the well pad. Left photo facing north, right photo facing east.

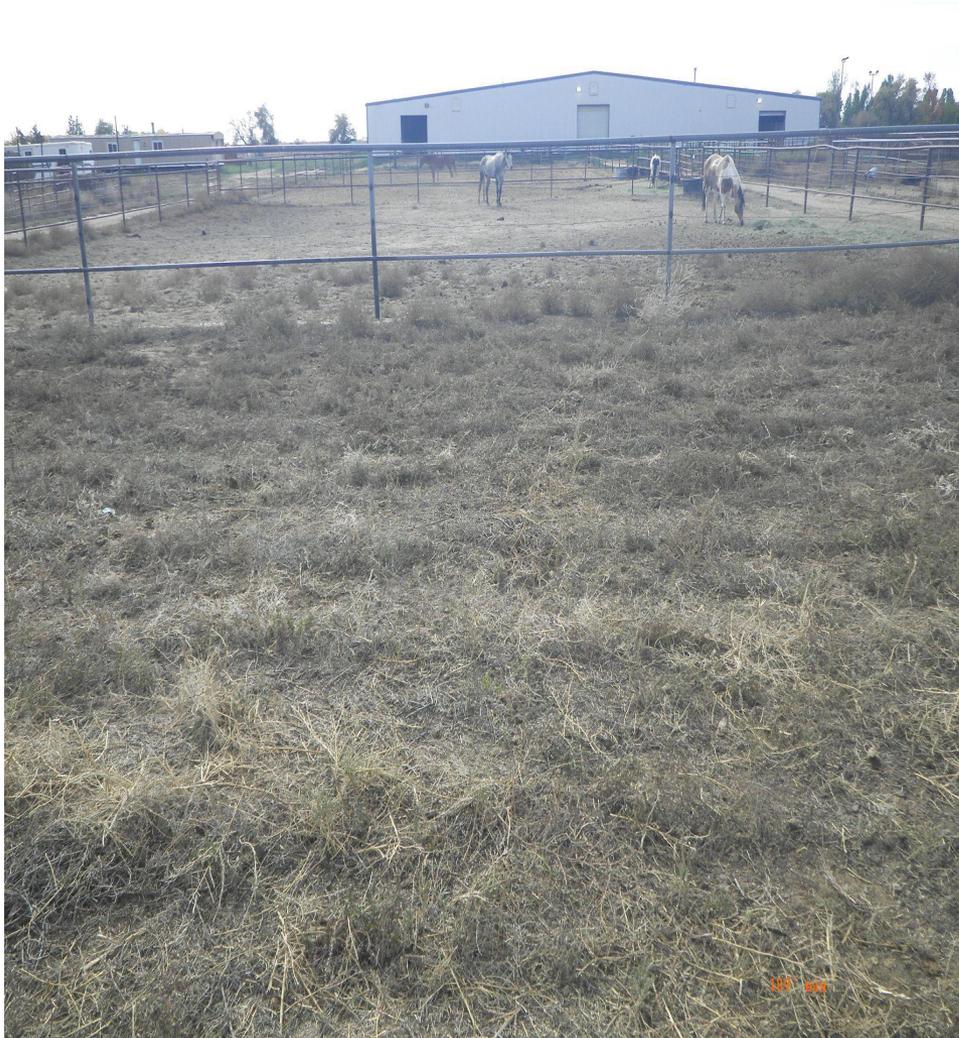
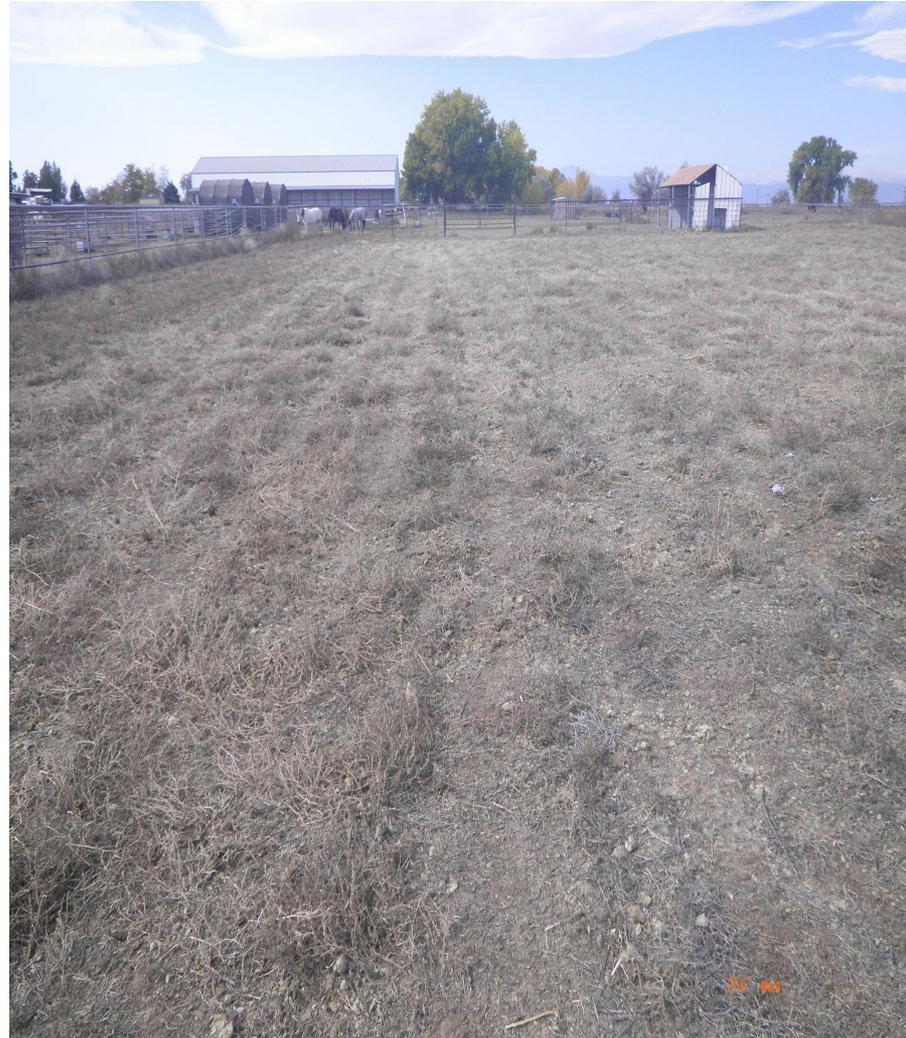
Photo 4. Cardinal photos taken at ground level from the middle of the well pad. Left photo facing south, right photo facing west. Note: well pad appears consistent with reference area (see photo 6).

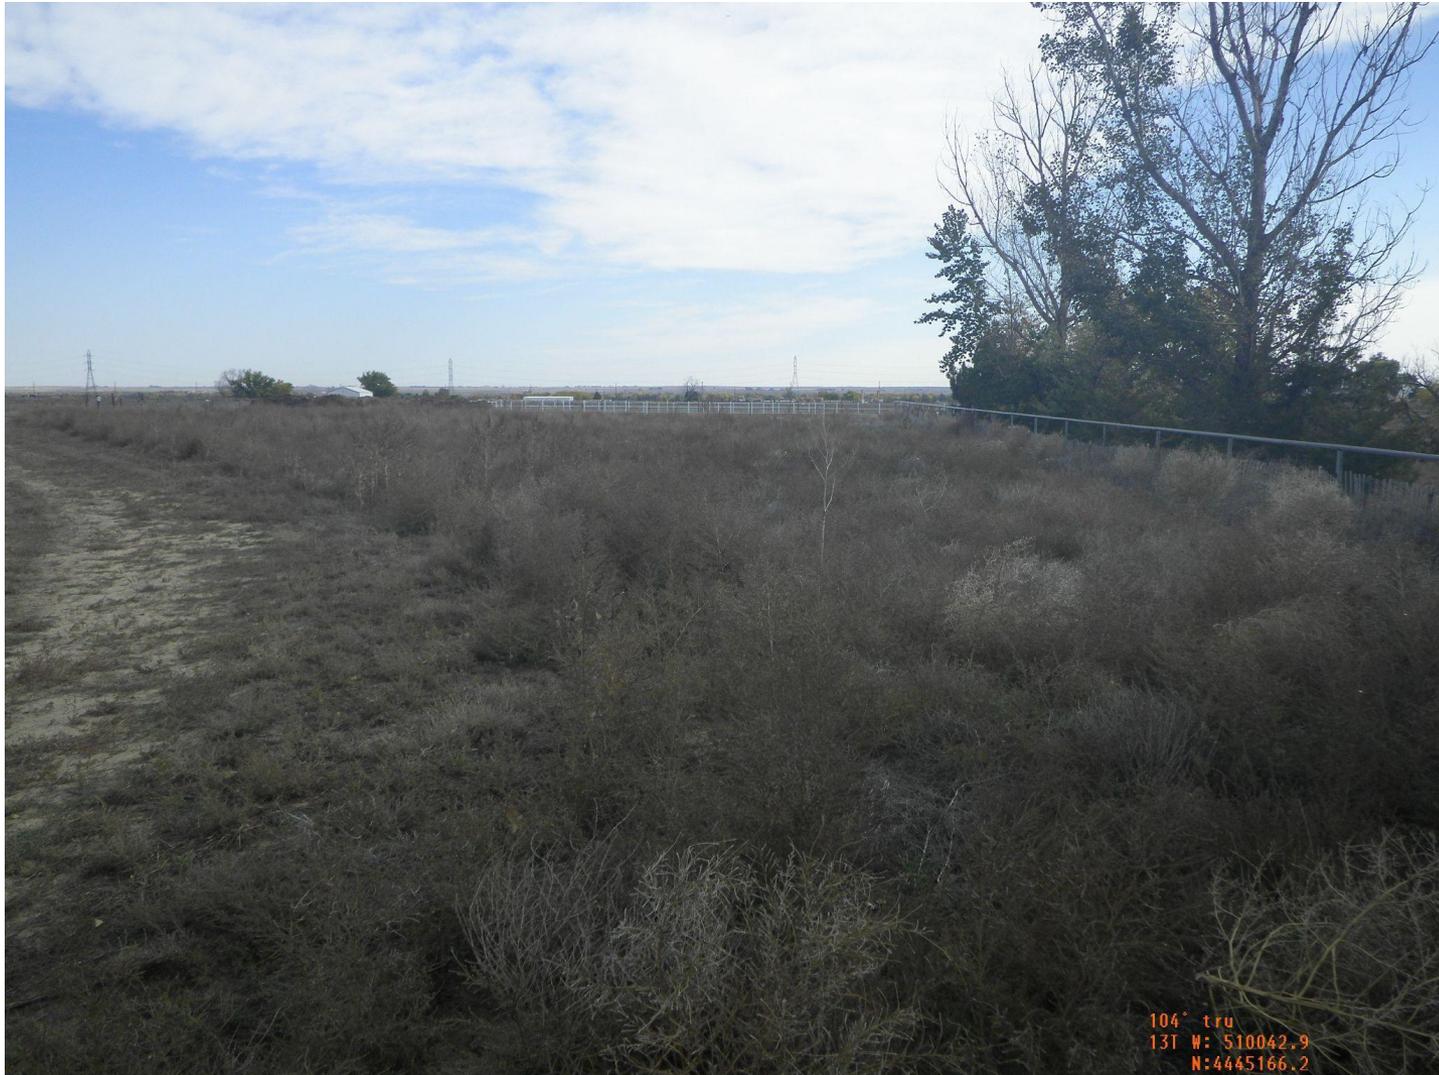
Photo 5. Overview photo of the tank battery taken at ground level from the western edge facing east. Note: tank battery appears consistent with reference area (see photo 6).

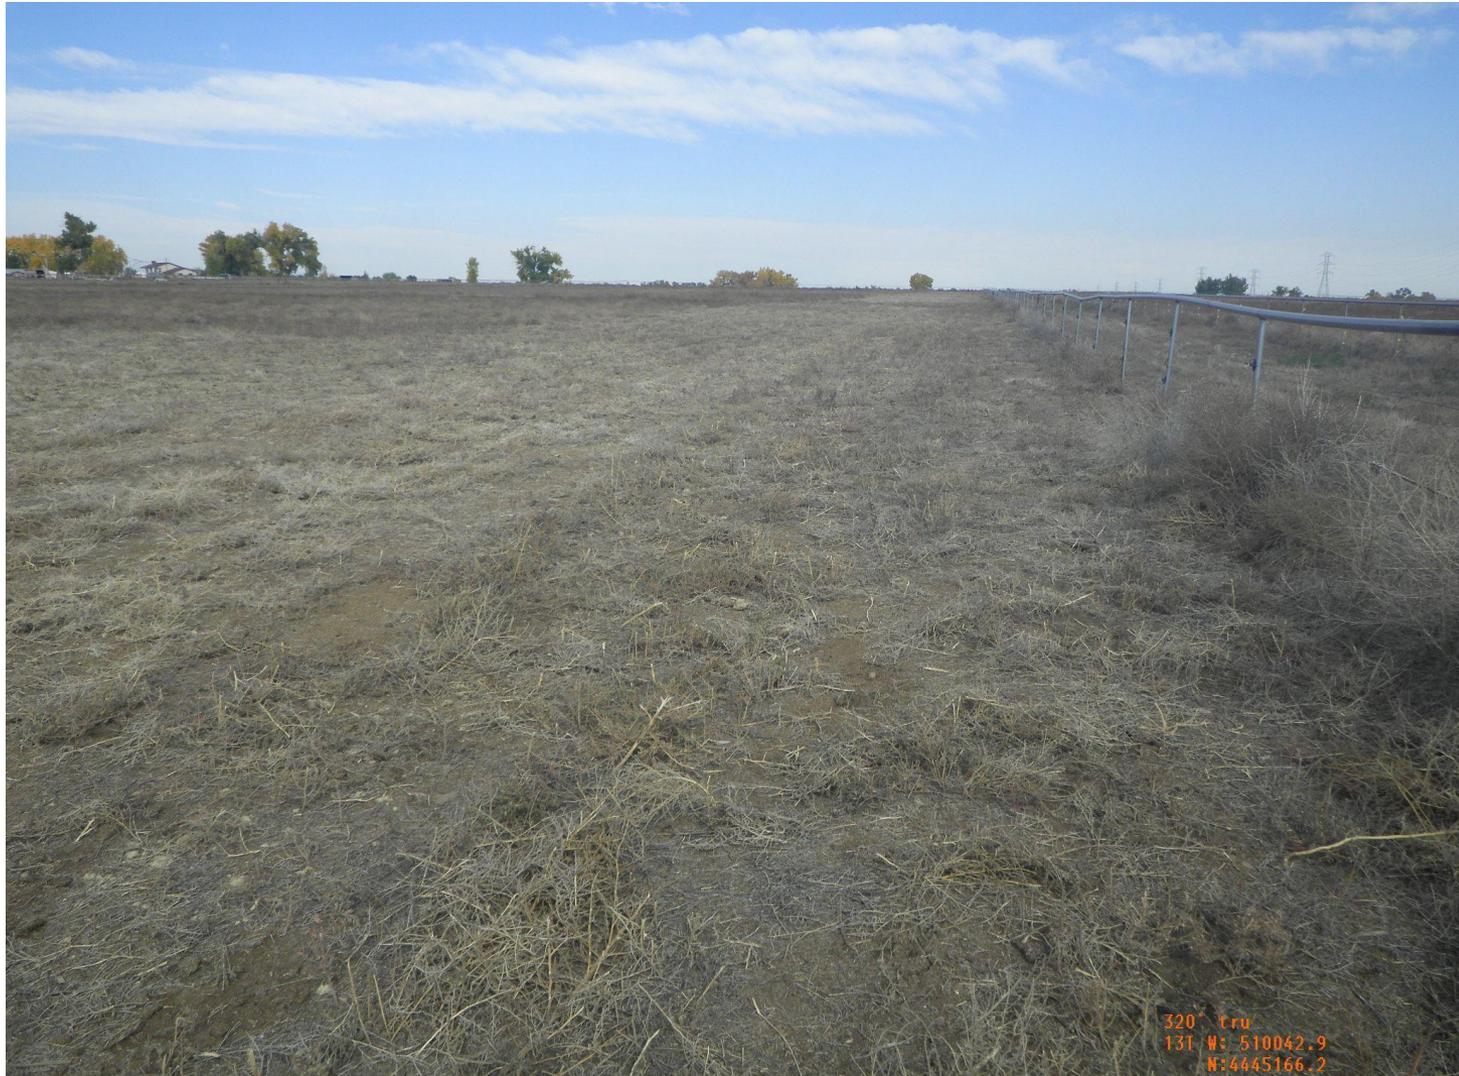
Photo 6. Well pad/tank battery reference area.
