Inspection Photos
Location Name: Bernhardt 7-16
API #123-22698

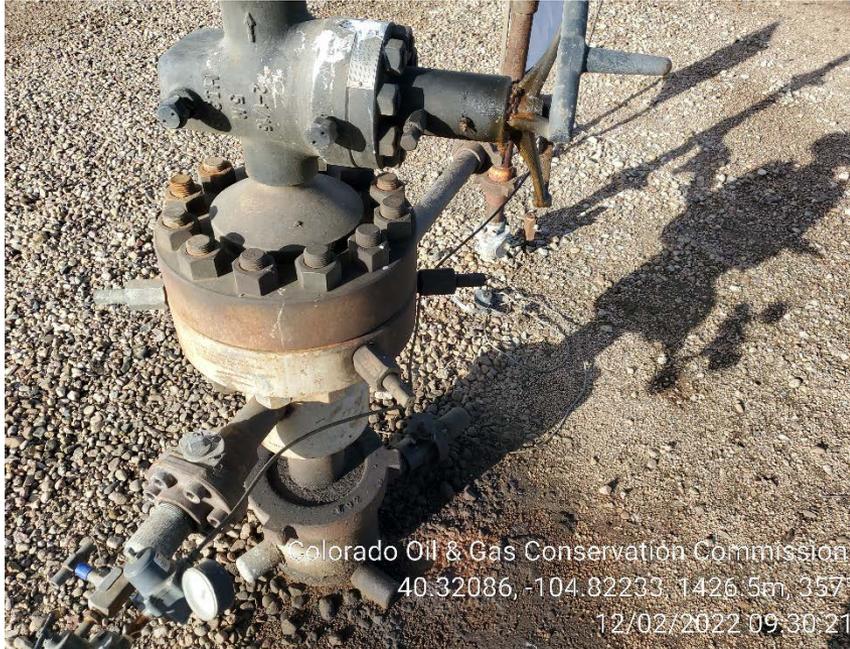
Master valve leak and stained soil

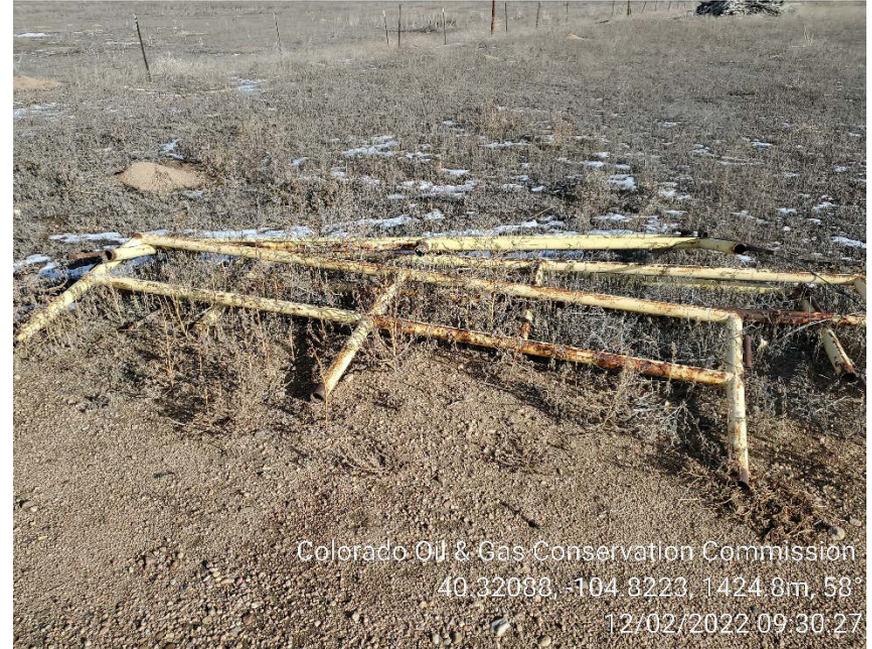
Unused equipment
