Final Reclamation and Stormwater Inspection

Operator: WESTERN OPERATING COMPANY - 95620

Location ID: 312291

Inspection Photos
Location Name: Propst 1
Location ID: 312291

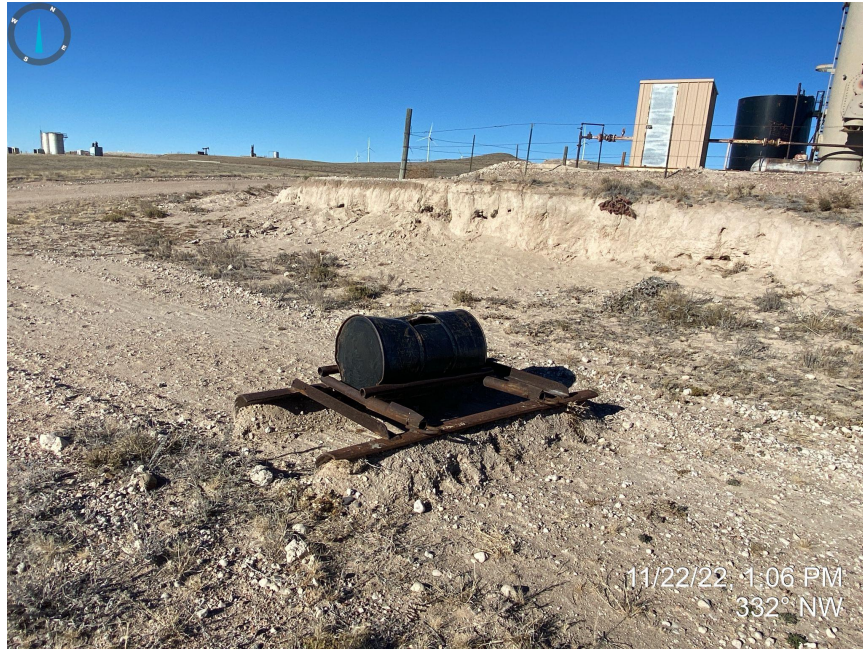
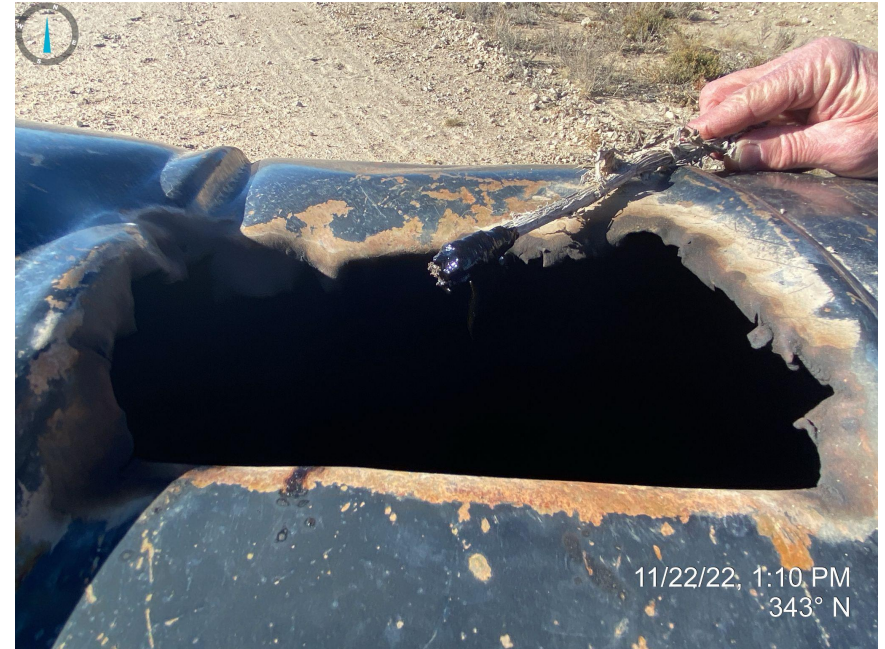
Photo 1. Taken from the northern portion of the location, facing north. Photo illustrates a road maintenance piece of equipment with an open barrel of crude/condensate. This road maintainer and crude/barrel need to be properly removed and disposed of. See Environmental Inspection (Doc #690900222) for additional information.

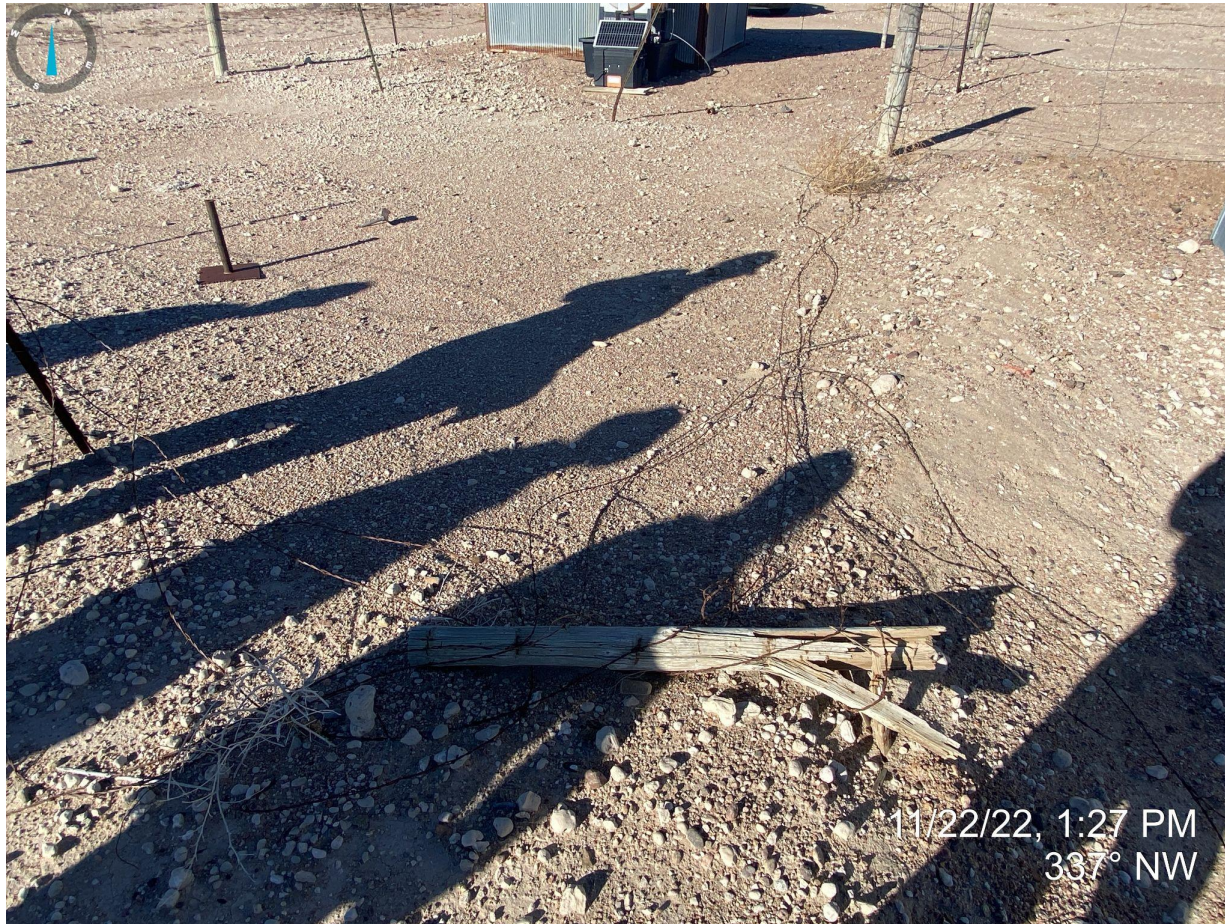
Photo 2. Taken on the northwest corner of pit, facing northwest. Photo illustrates a broken fence post; this is now considered debris and needs to be removed or repaired.

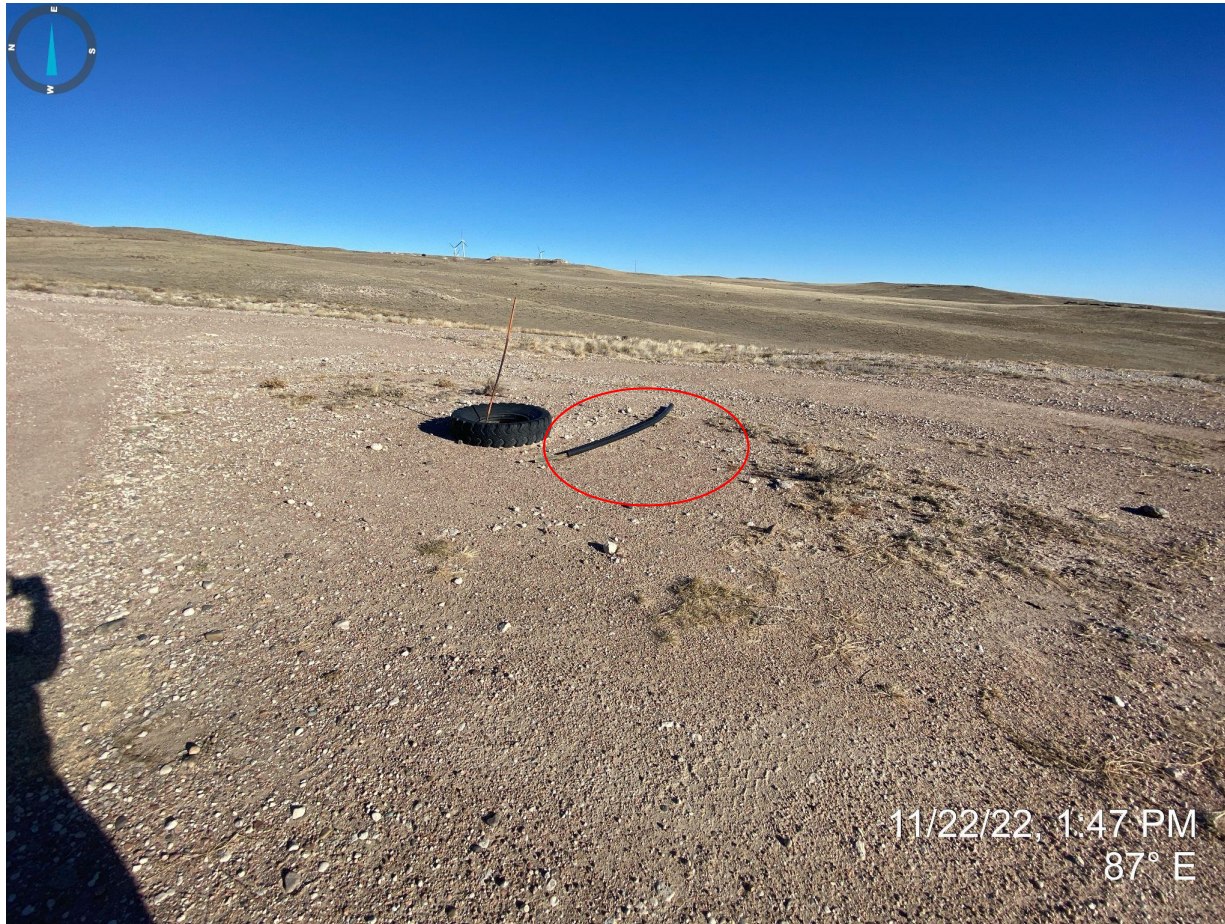
Photo 3. Taken from the eastern portion of the location, facing east. Photo illustrates debris (t-post) that needs to be disposed of.

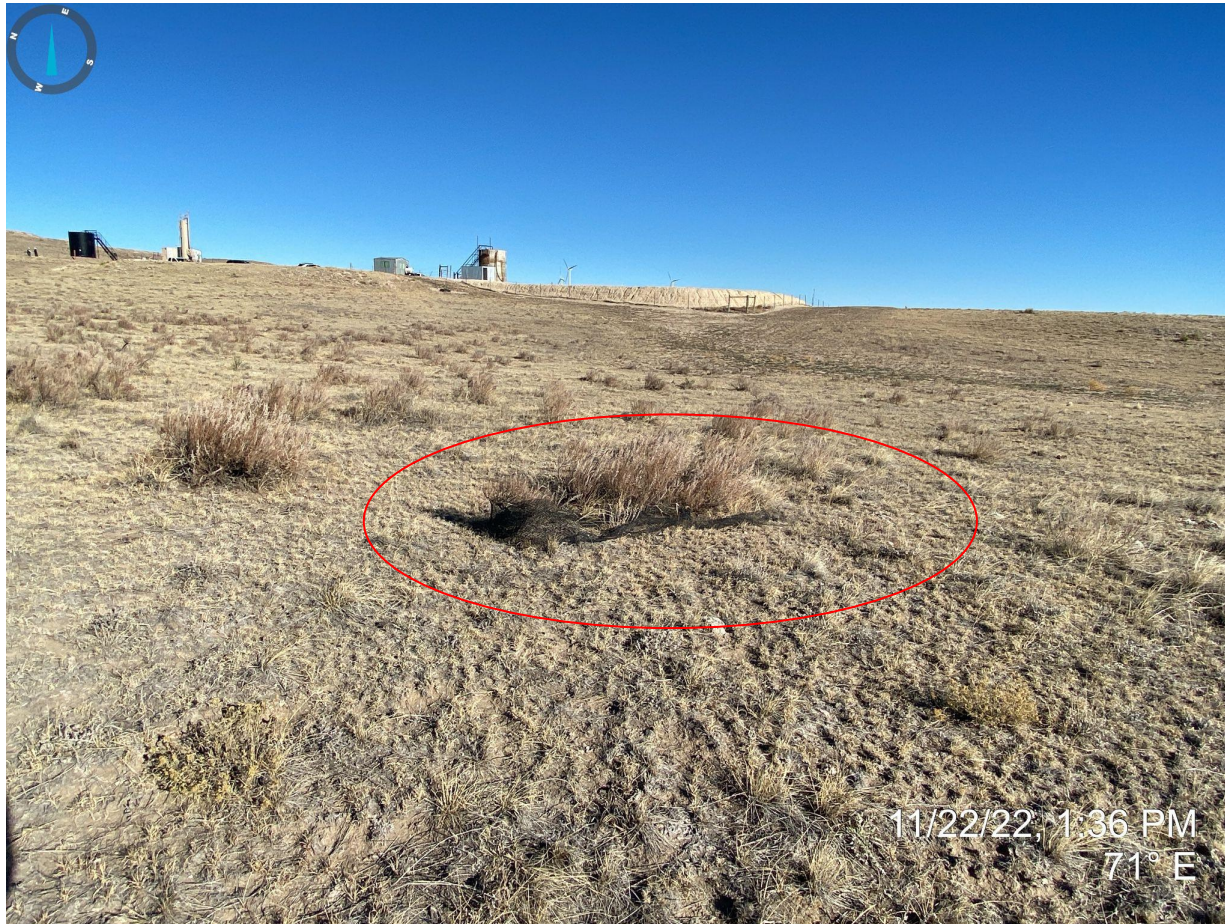
Photo 4. Taken southwest of the pit, facing east. Photo illustrates straw wattle netting that was identified in a previous inspection report, was given a corrective action to dispose of, and remains on the location as of 11/22/2022.

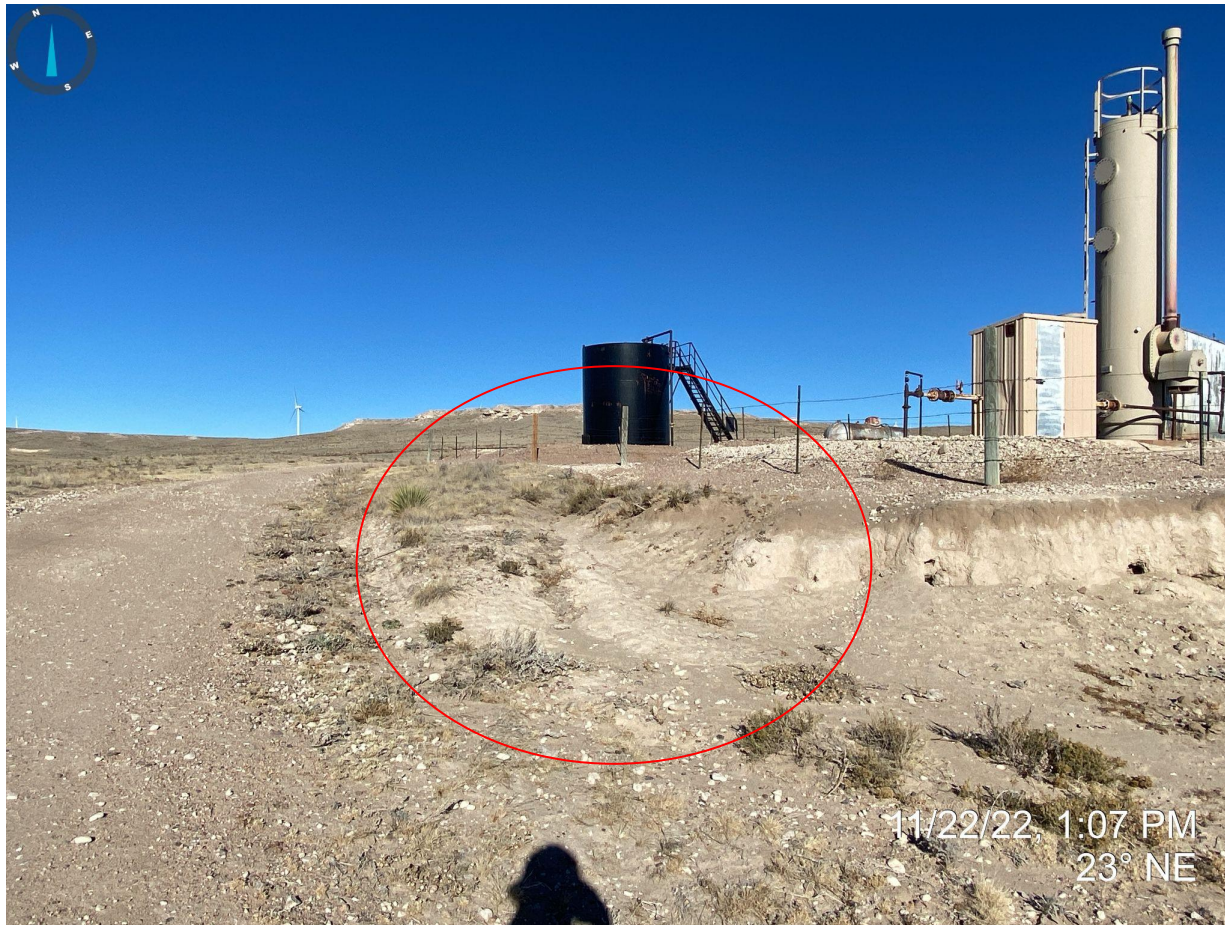
Photo 5. Taken from the northern portion of the location, facing northeast. Photo illustrates gully erosion that has not been stabilized and/or had stormwater BMPs implemented; this has been addressed in prior inspections.

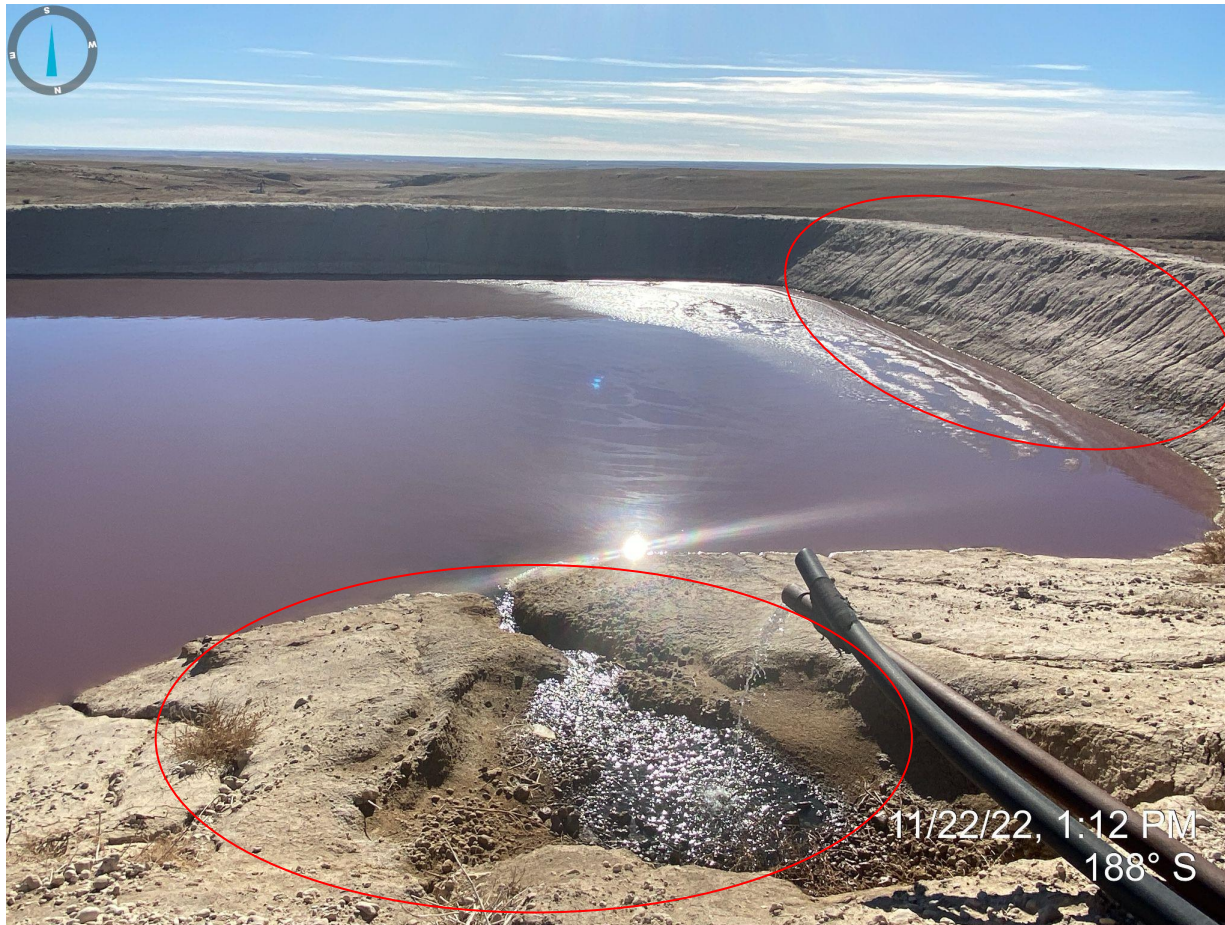
Photo 6. Taken from the northern wall of the pit, facing south. Photo illustrates rill and gully erosion on the pit walls, outlined in red.

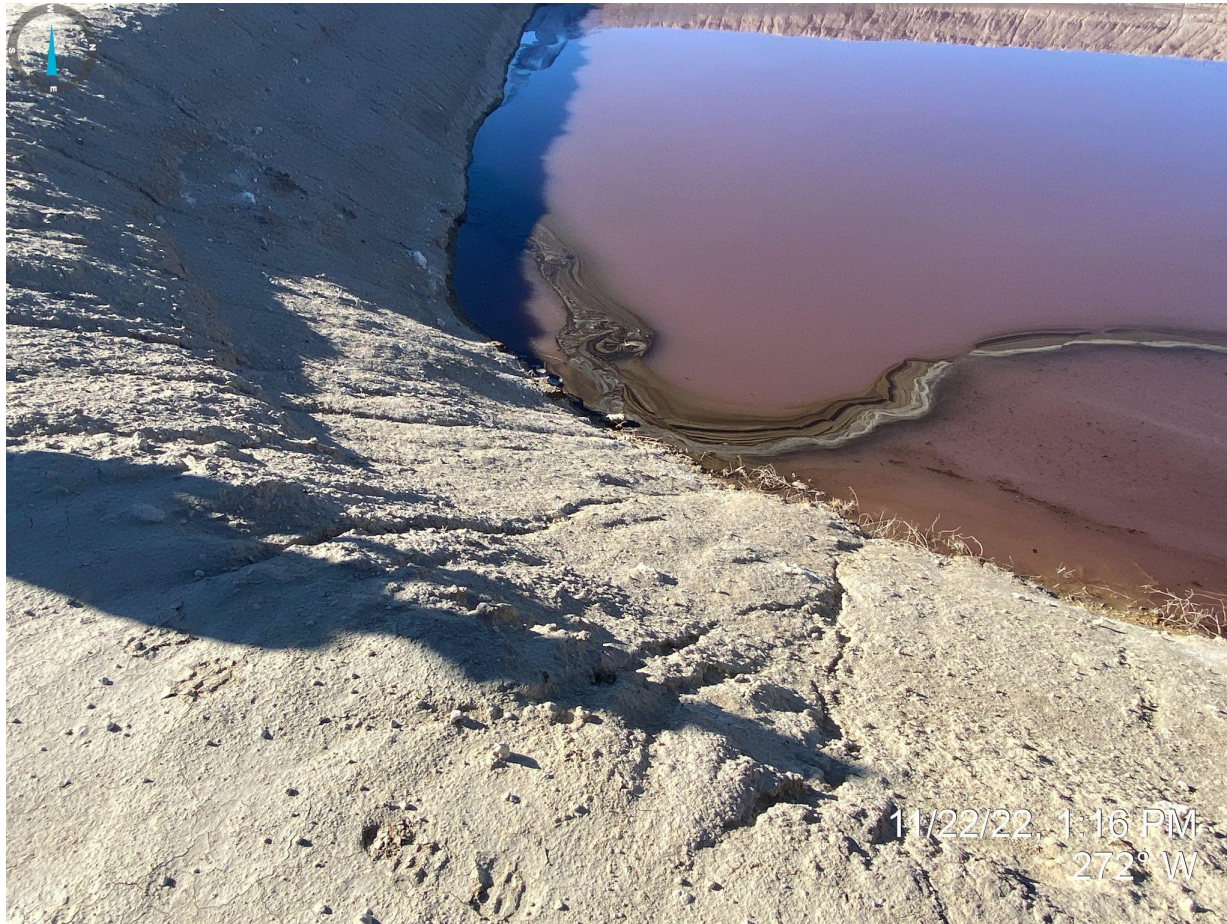
Photo 7. Taken from the southeastern corner of the pit, facing west. Photo illustrates an oil skim on the surface of the water.

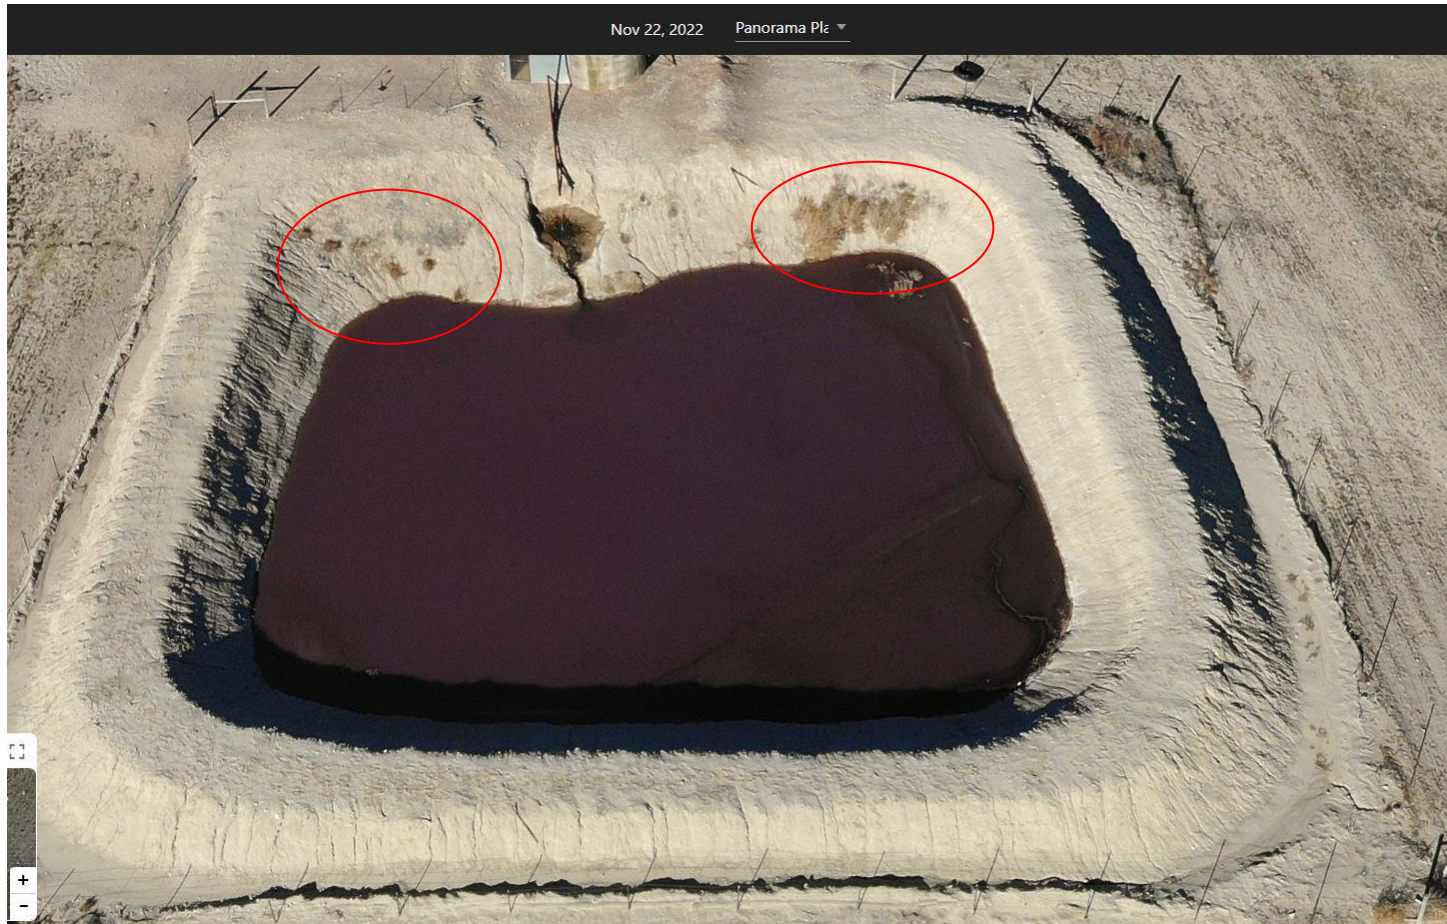
Photo 8. Drone aerial imagery taken from the southern part of the location, facing north. Photo illustrates the presence of rill and gully erosion that is occurring on all pit walls from stormwater run-on and run-off. Also observed is undesirable vegetation (e.g. kochia) in red and the oil skim on the surface of the water.

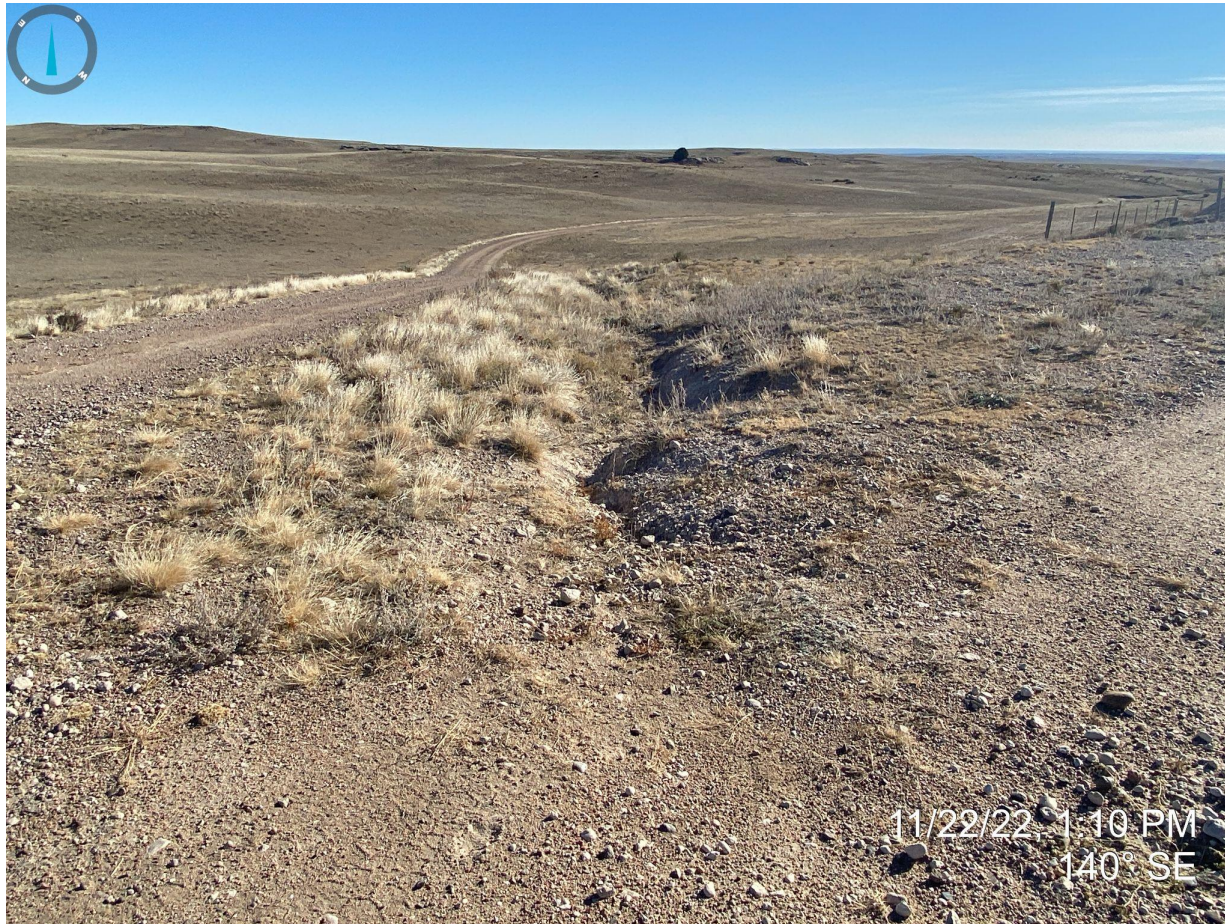
Photo 9. Taken from the eastern portion of the location, facing southeast. Photo illustrates gully erosion that has not been repaired and stabilized, and does not have any evidence of stormwater BMPs to prevent further off-site sediment transport and degradation to adjacent areas.

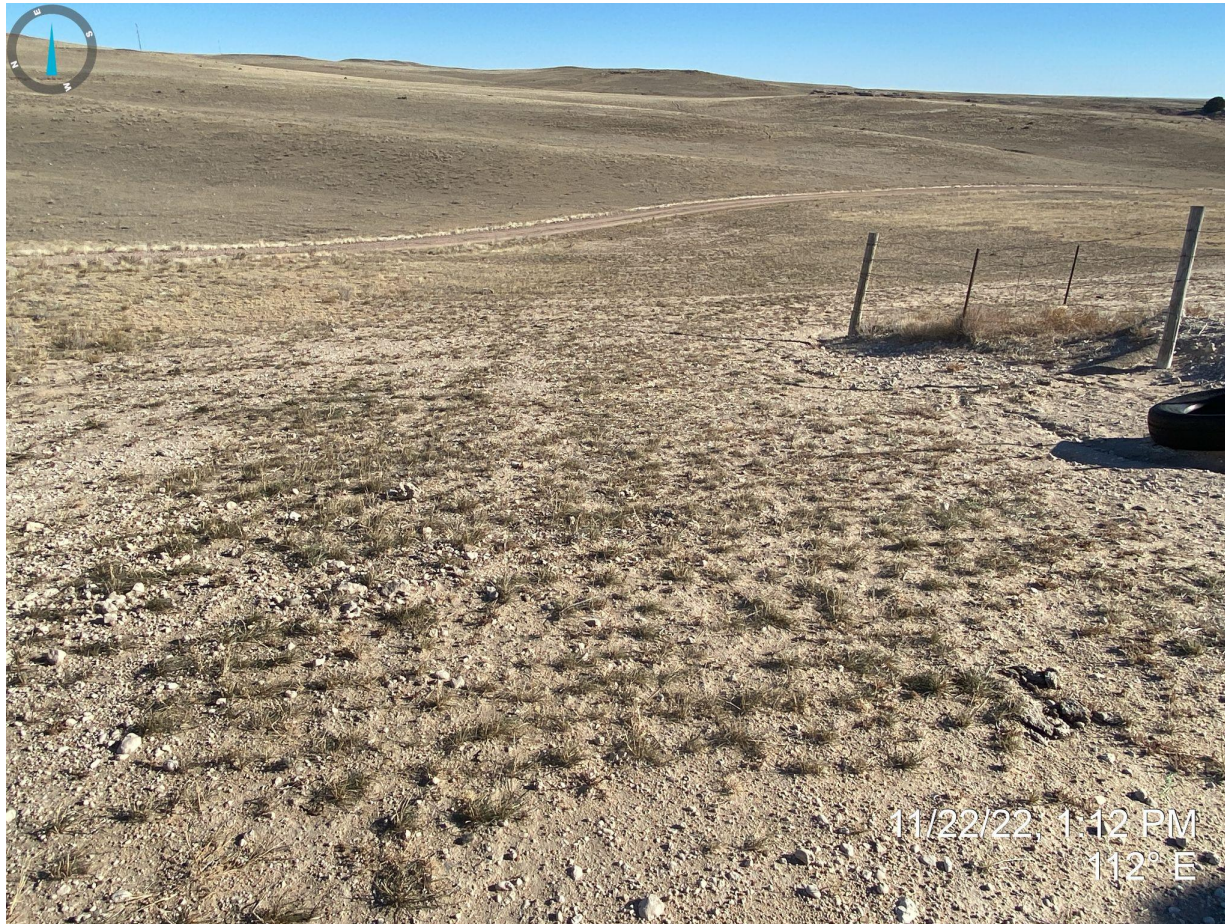
Photo 10. Taken from the northeast corner of the pit, facing east. Photo illustrates that reclamation efforts don't appear to be achieving reclamation standards as vegetation is sparse and bare soil is evident. Additionally, it does not appear that are any stormwater BMPs to prevent erosion from occurring.

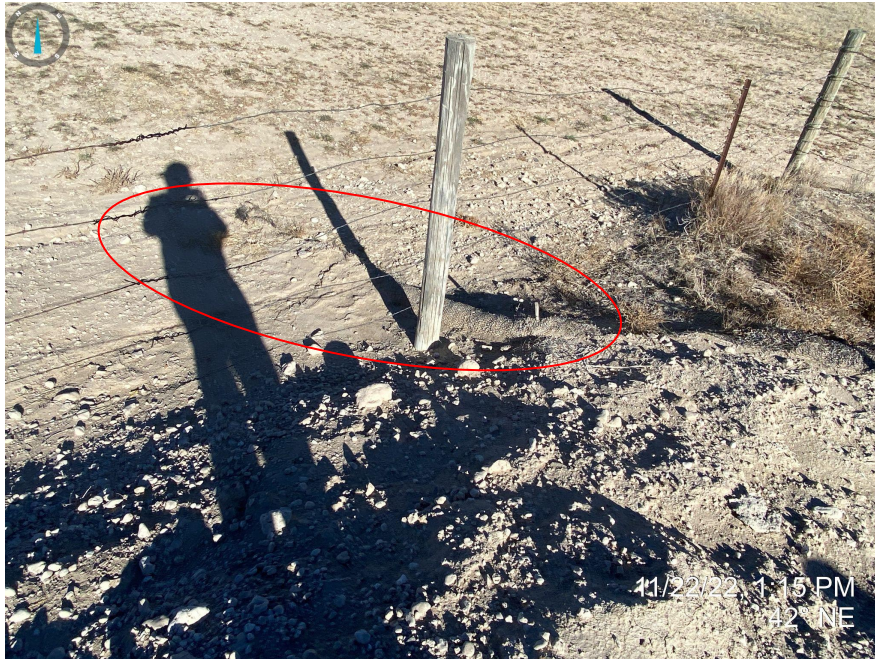
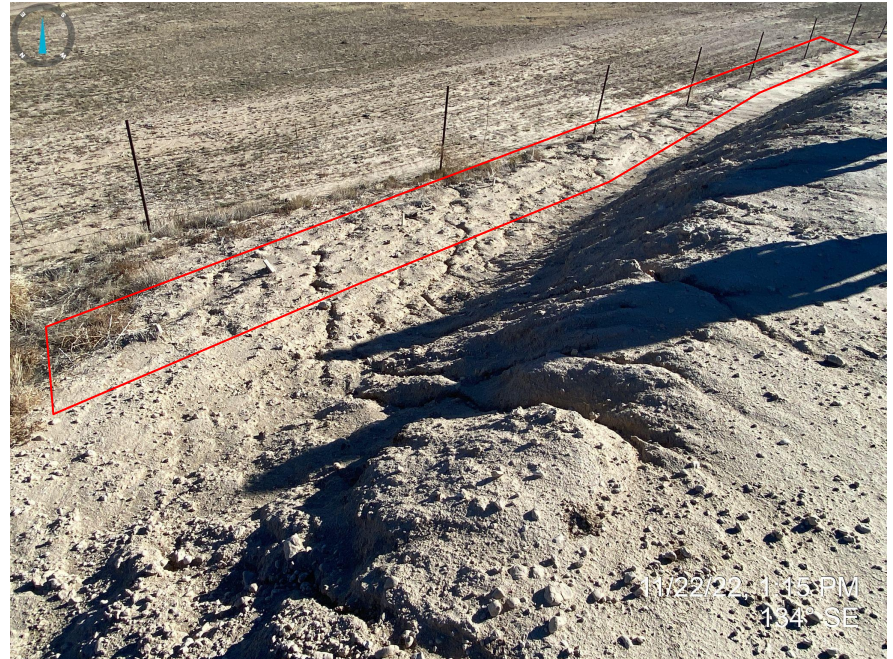
Photo 12. Taken from the northeast pit wall, facing northeast. Photo illustrates a buried straw wattle (left photo); and the right photo shows rill erosion occurring on the pit walls. It does not appear there are any stormwater BMPs to prevent sediment laden stormwater from exiting off location, outlined in red.

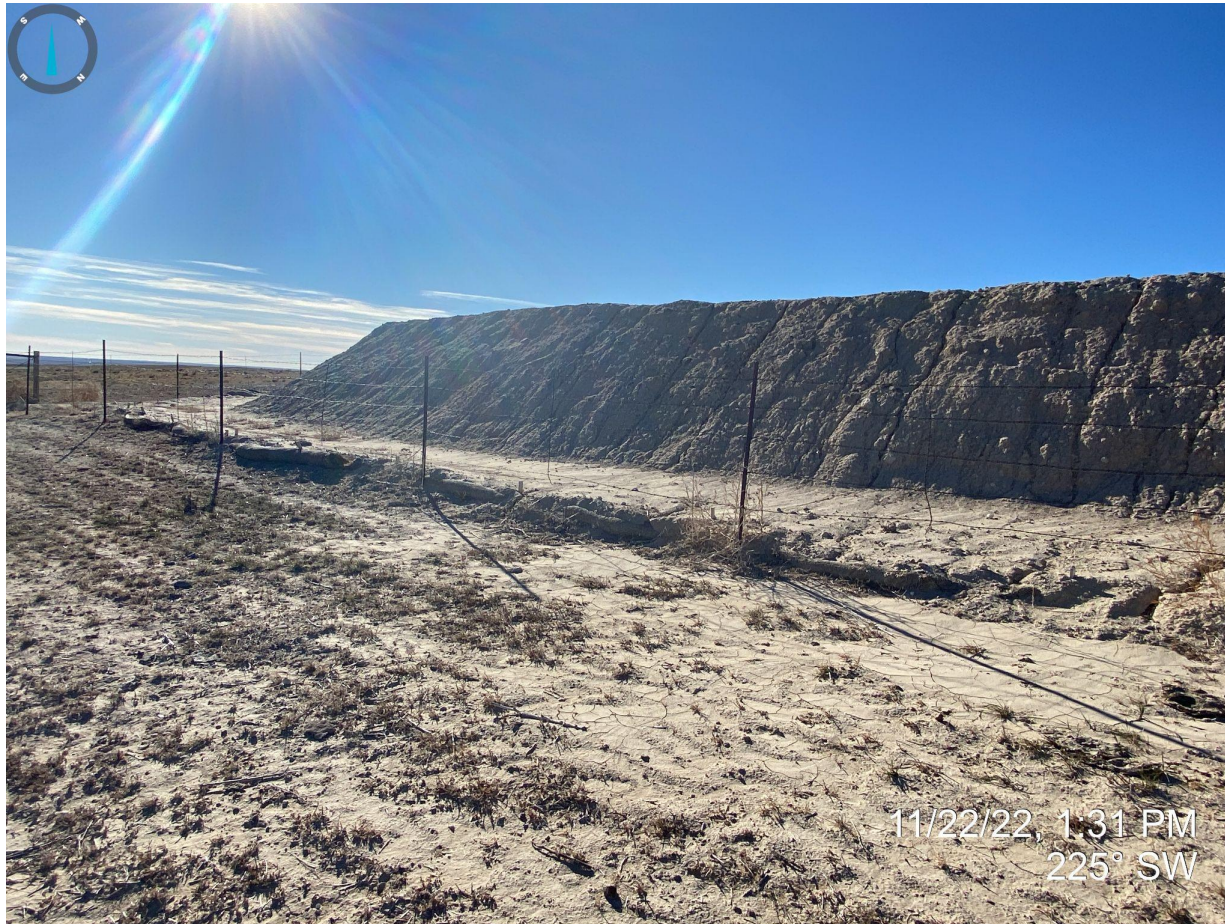
Photo 14. Taken east of the pit, facing southwest. Photo illustrates that the pit walls are unstabilized as evidenced by rill erosion and there are no apparent stormwater BMPs to prevent sediment laden stormwater from exiting off location. Areas of bare soil in foreground are a result of stormwater exiting off location and impacts of salt kill.

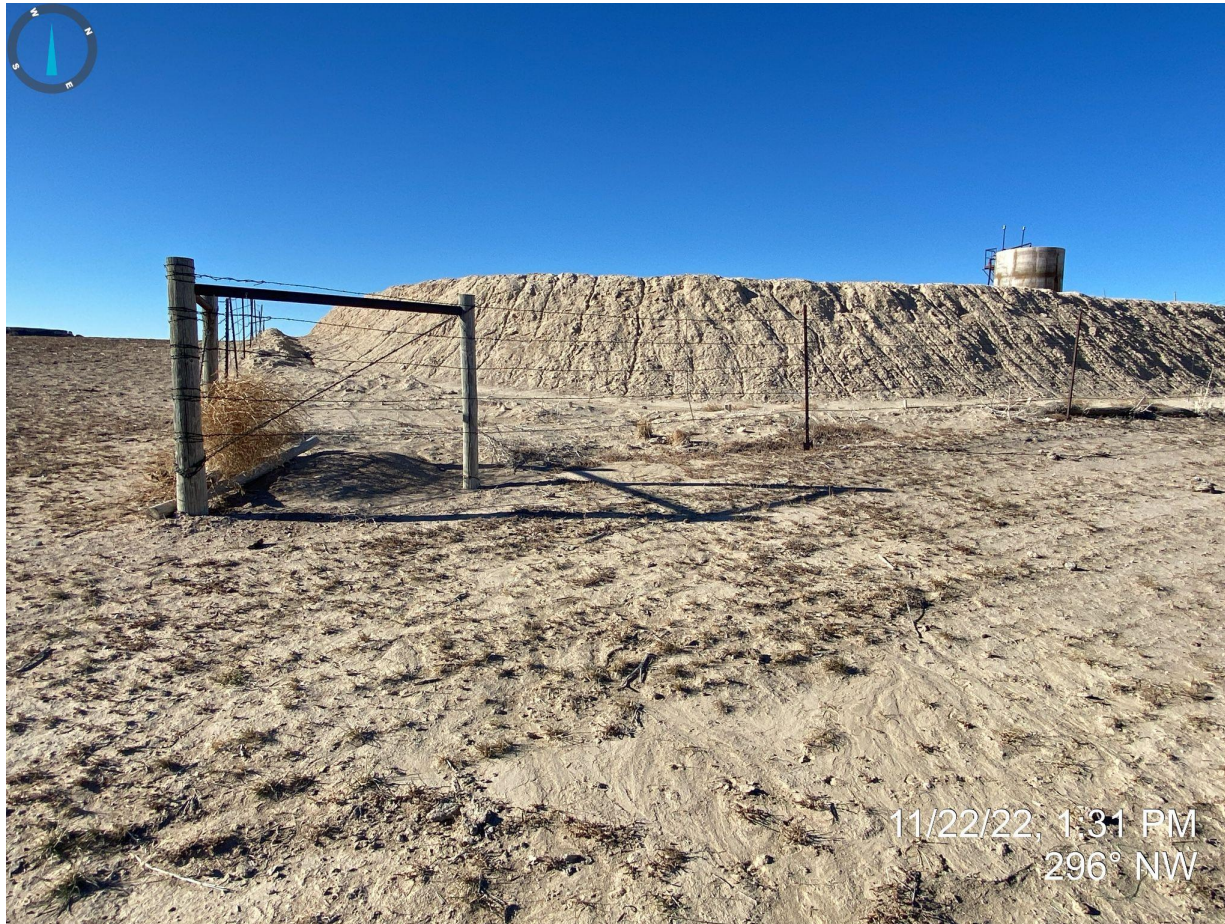
Photo 15. Taken from the southeast corner of the pit, facing northwest. Photo illustrates that the salt kill area has failed to revegetate as evidenced by bare soil and presence of undesirable vegetation (e.g. kochia). Further, it does not appear stormwater BMPs has been implemented to prevent further erosion and off-site degradation to adjacent land.

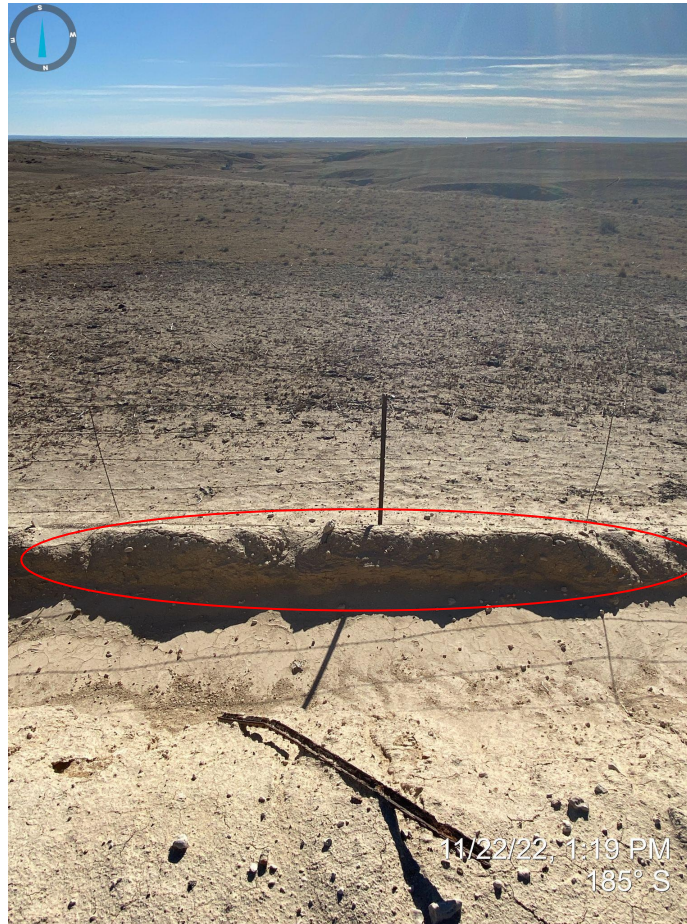
Photo 16. Taken from the southern, middle portion of the pit wall, facing south. T-post in foreground is considered debris and needs to be removed. Red outline illustrates buried straw wattles that have been covered with impacted material from the pit walls.

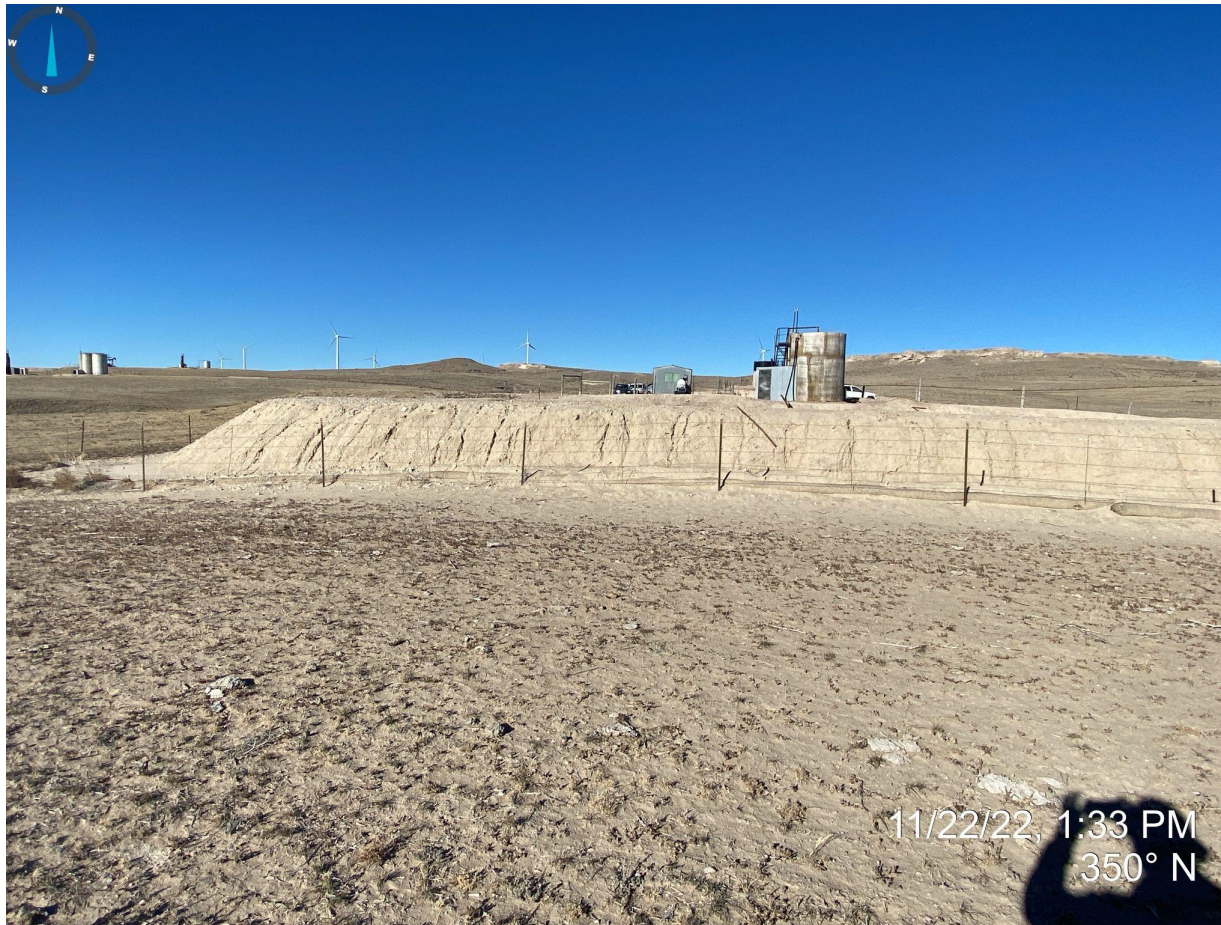
Photo 17. Taken south of the pit, facing north. Photo illustrates that the salt kill areas have failed to revegetate resulting in bare soil and undesirable vegetation (e.g. kochia).

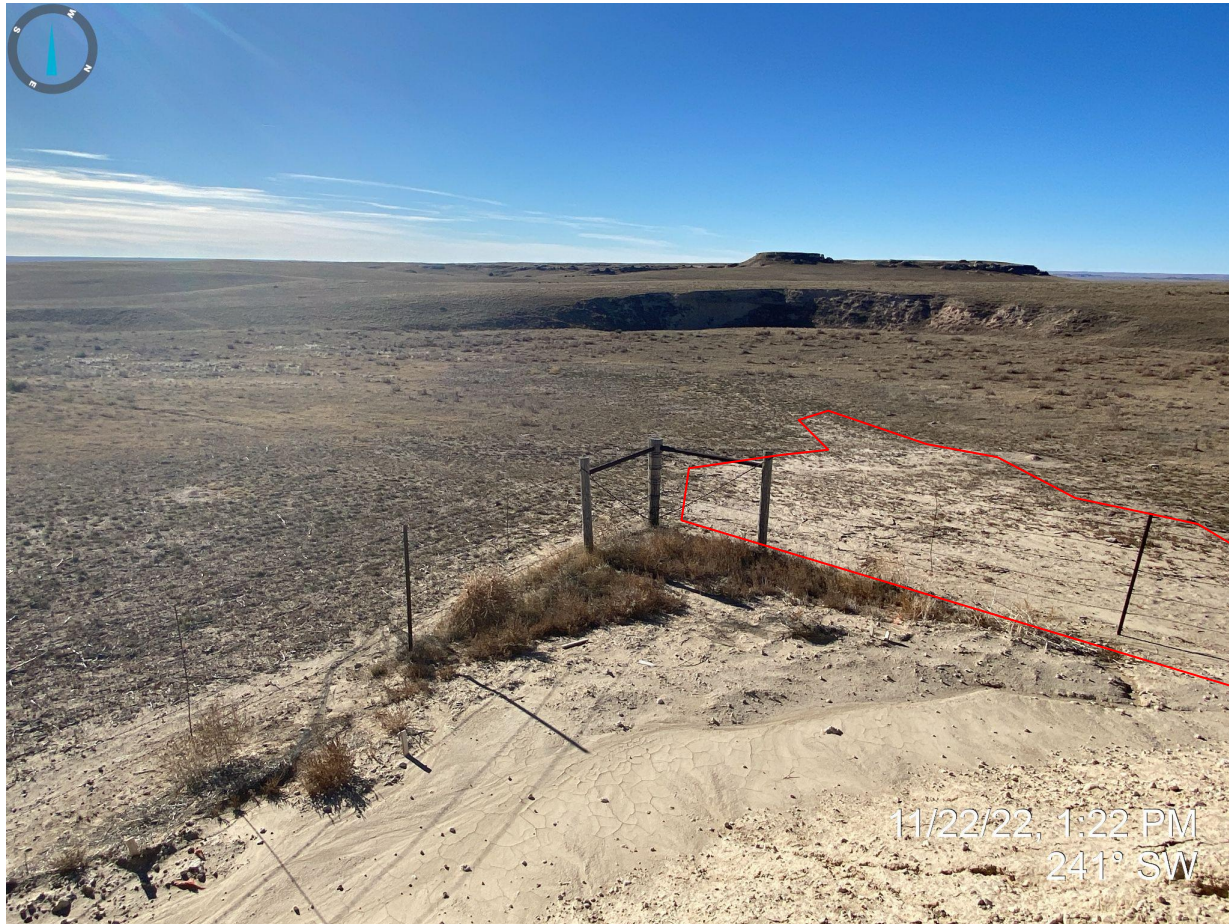
Photo 19. Taken from the southwest pit wall, facing southwest. Photo illustrates that no stormwater BMPs appear to be implemented and that sediment laden stormwater has exited off location, outlined in red.

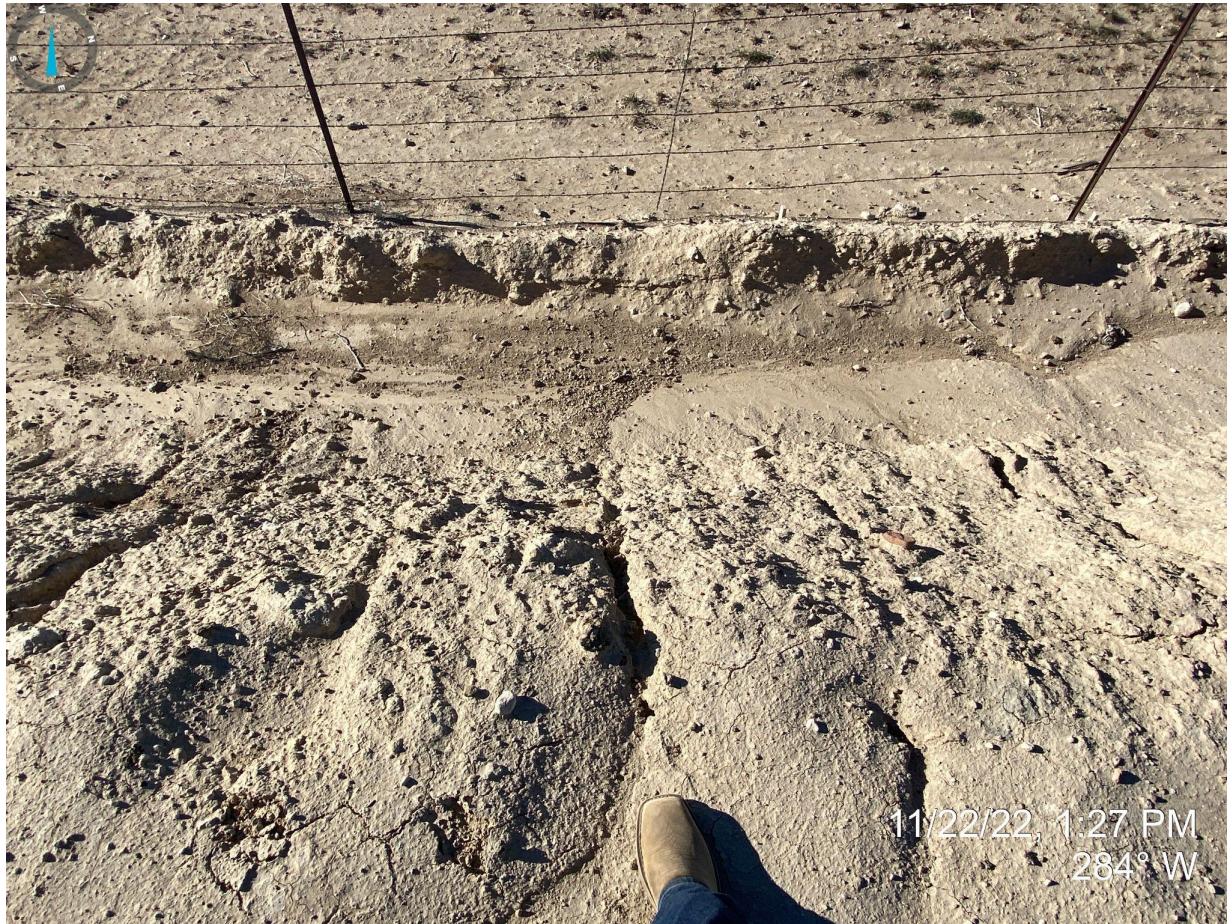
Photo 21. Taken from the western pit wall, facing west. Photo illustrates the unstabilized pit walls and evidence of rill erosion.

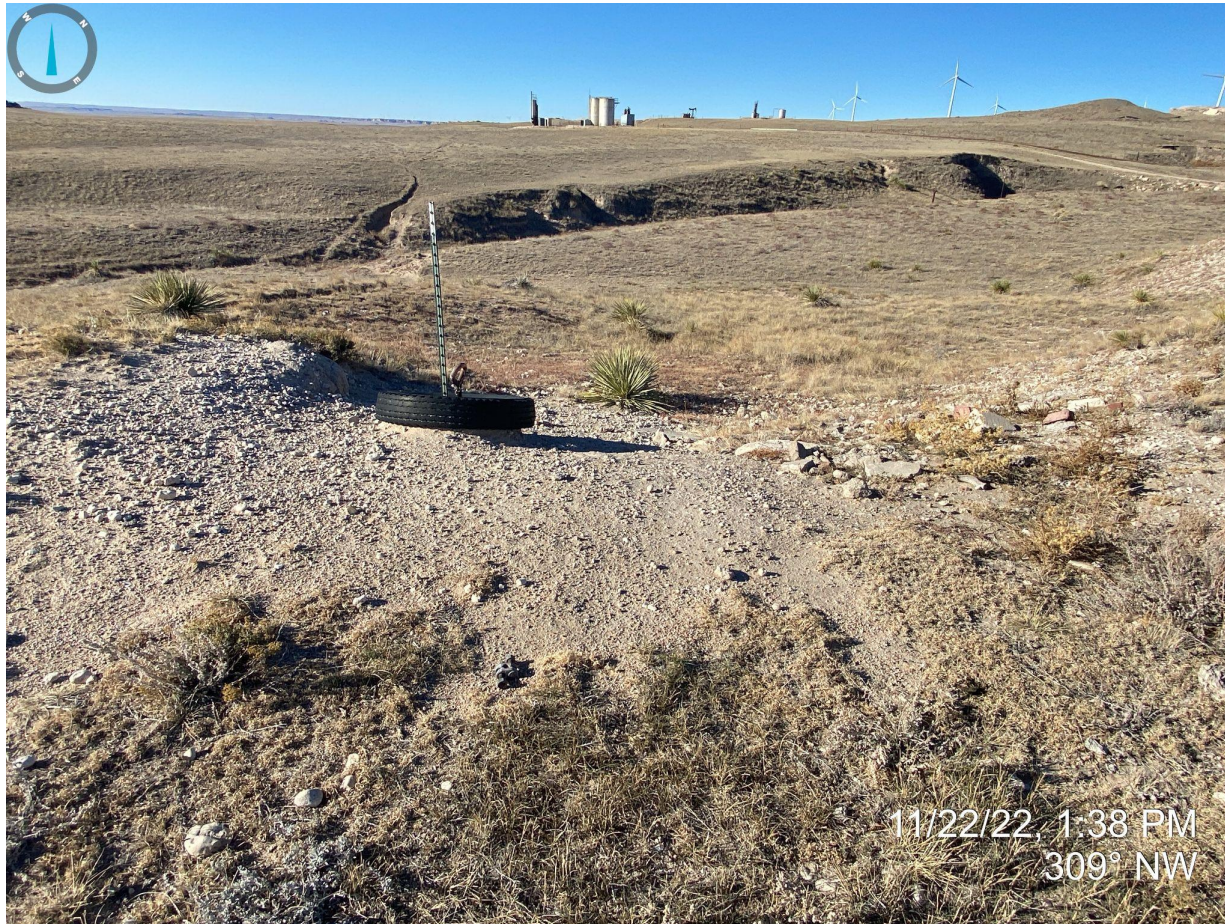
Photo 23. Taken from the northwestern portion of the location, facing northwest. Photo illustrates erosion occurring around one of the buried guy line anchors. This area needs to be stabilized with BMPs from wind and water erosion to prevent off-site degradation and sediment migration.

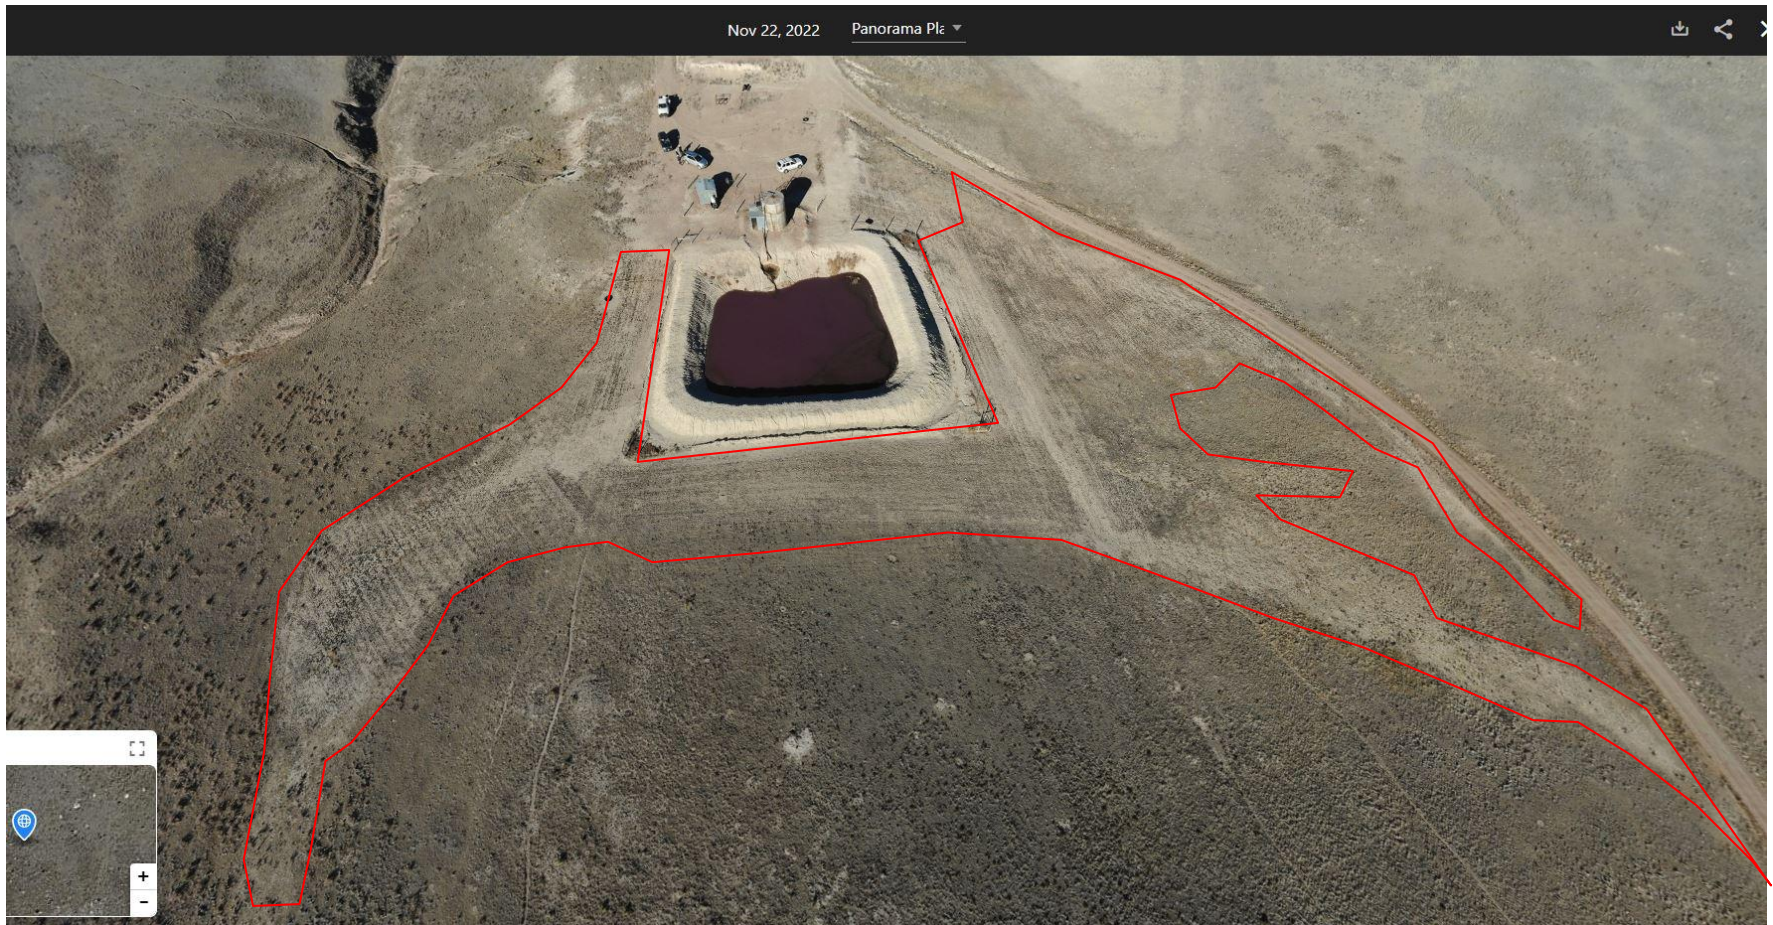
Photo 24. Drone aerial imagery taken south of the location. Photo illustrates the salt kill area with evidence of bare soil and no apparent stormwater BMPs within the salt kill area.
