# Site Inspection Report

**Site: MILTON NELSON**  
12/02/2022

SITE/LOCATION	DATE	TIME	INSPECTOR
MILTON NELSON	12/02/2022	09:16 AM	COGCC Representative
Comments			
Work Activity Notes			
Changes since previous inspection?	No	Drive by inspection	No
Actively being worked?	No		
Fieldwork Oversight Performed?	No	Oversight Type	
Were Oversight Samples Collected?	No	Sample Details

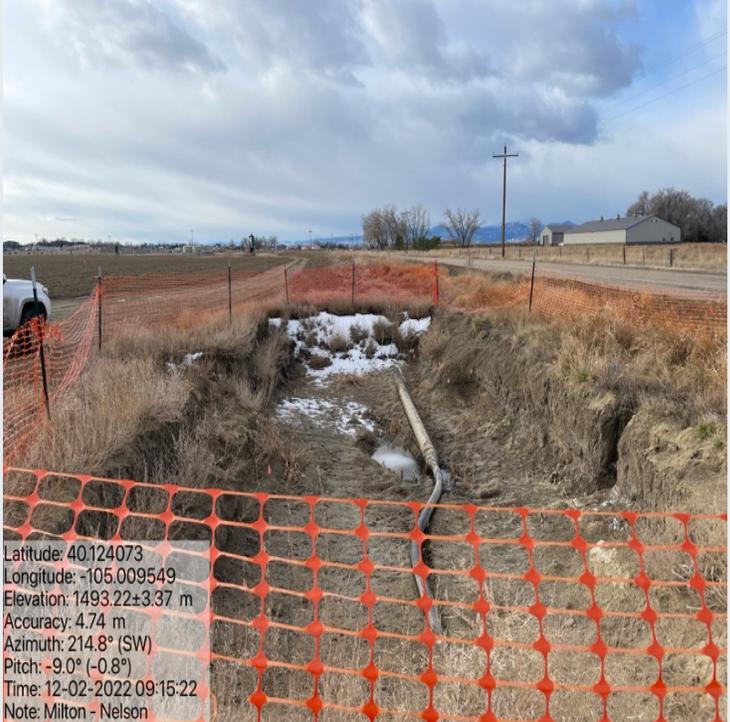
Photo
<p><b>Question:</b> Open excavation(s)? Note: Approximate size(s) (Length x Width x Depth, ft)</p> <p><b>Response:</b> Yes</p> <p><b>Notes:</b> 61' X 19' X 4'</p>

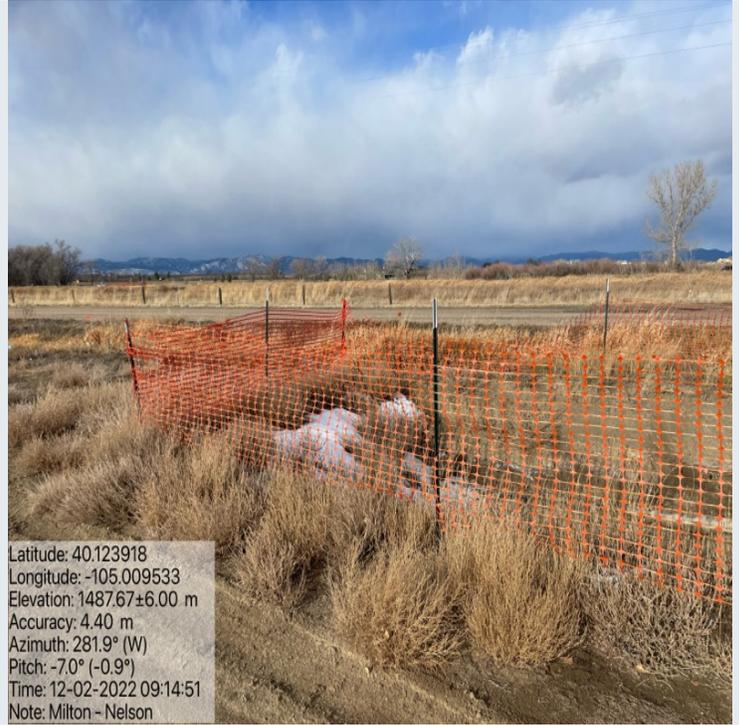
**Question:** Open excavation(s)? Note: Approximate size(s) (Length x Width x Depth, ft)

**Response:** Yes

**Notes:** 61' X 19' X 4'

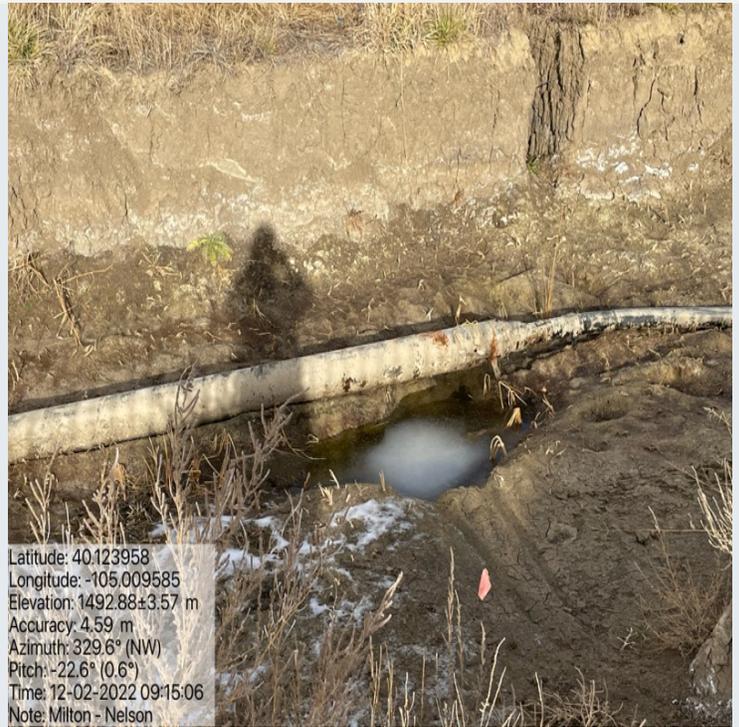
**Question:** Groundwater present within excavation? Note: Depth to water below grade surface (ft), free product/sheen

**Response:** Yes

**Notes:** Approximately 4.5' from ground surface. No free product or sheen visible. Water frozen.

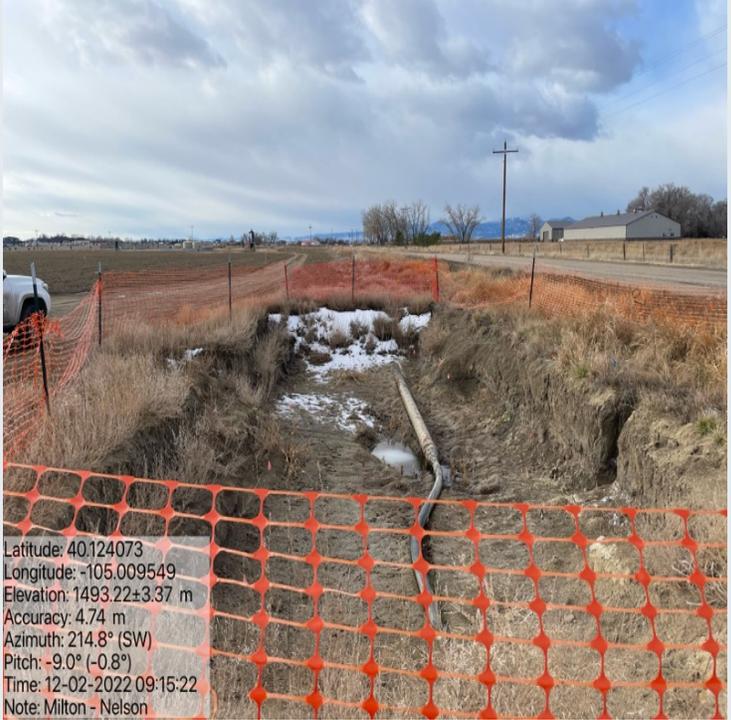
Photo
<p><b>Question:</b> Monitoring well(s) present? Note: Number, approximate location(s), condition <b>Response:</b> No <b>Notes:</b></p>	<p>No Photo</p>
<p><b>Question:</b> Soil impacts remain in situ? <b>Response:</b> Yes <b>Notes:</b></p>

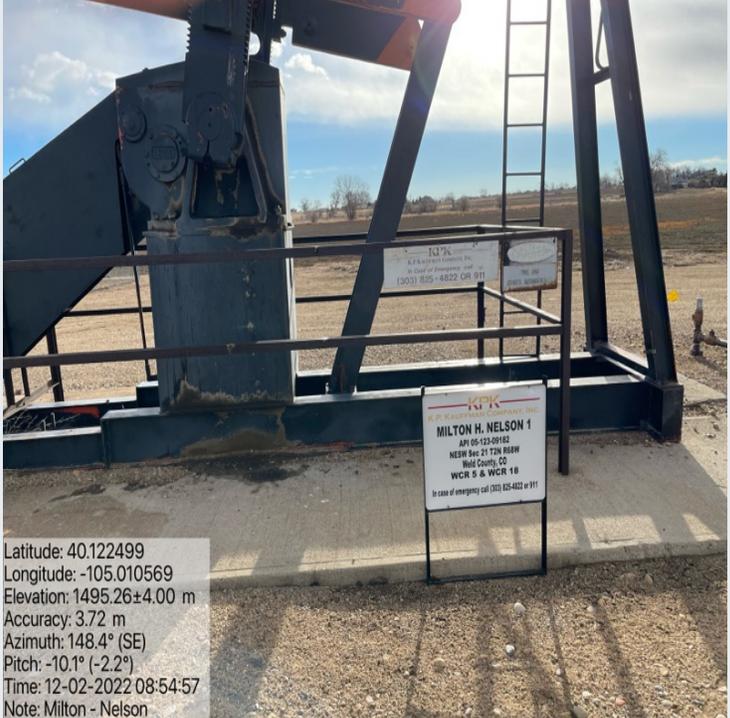
Photo
<p><b>Question:</b> E&amp;P waste signage present, legible, accurate and up to date (labelled per KPK CWMP)?</p> <p><b>Response:</b> N/A</p> <p><b>Notes:</b> No waste present</p>	<p>No Photo</p>
<p><b>Question:</b> Emergency signage in compliance with 605.g.?</p> <p>Note: Location of signage - Location entrance, Tank Battery, Wellhead(s).</p> <p><b>Response:</b> Yes</p> <p><b>Notes:</b> At nearby pump jack</p>

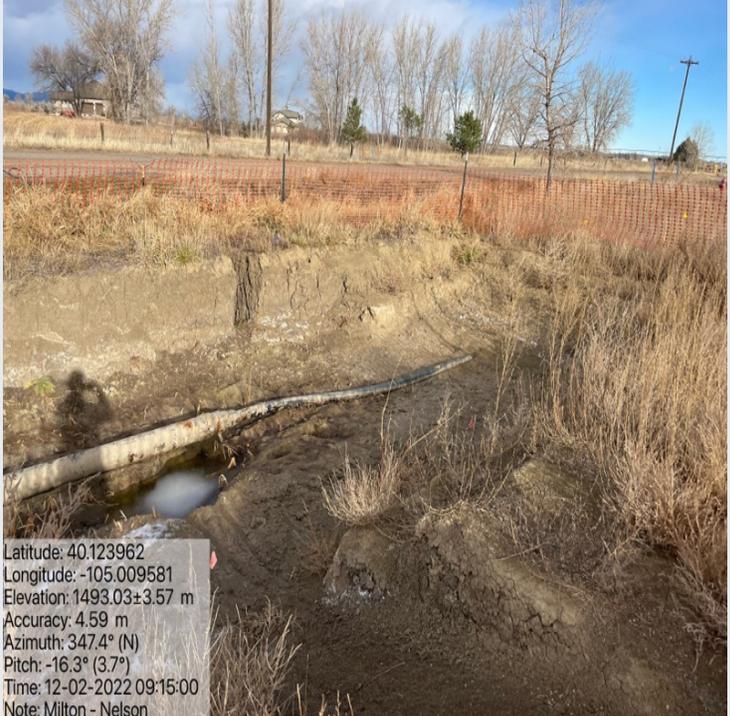
<p>Latitude: 40.122499          Longitude: -105.010569          Elevation: 1495.26±4.00 m          Accuracy: 3.72 m          Azimuth: 148.4° (SE)          Pitch: -10.1° (-2.2°)          Time: 12-02-2022 08:54:57          Note: Milton - Nelson</p>
<p><b>Question:</b> Ground surface appears clean (no evidence of new equipment leaks, oil leaks, spills, or releases)?</p> <p><b>Response:</b> Yes</p> <p><b>Notes:</b></p>

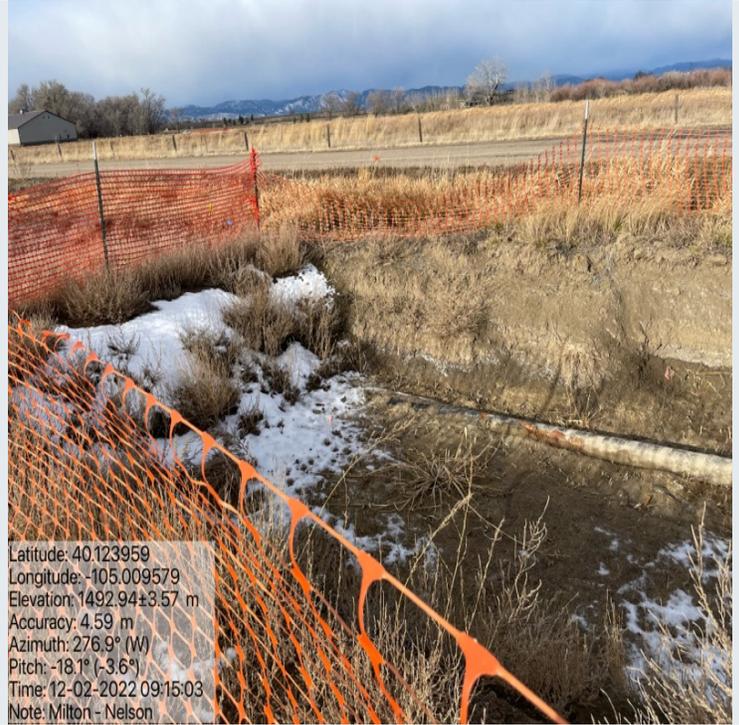
**Question:** Ground surface appears clean (no evidence of new equipment leaks, oil leaks, spills, or releases)?

**Response:** Yes

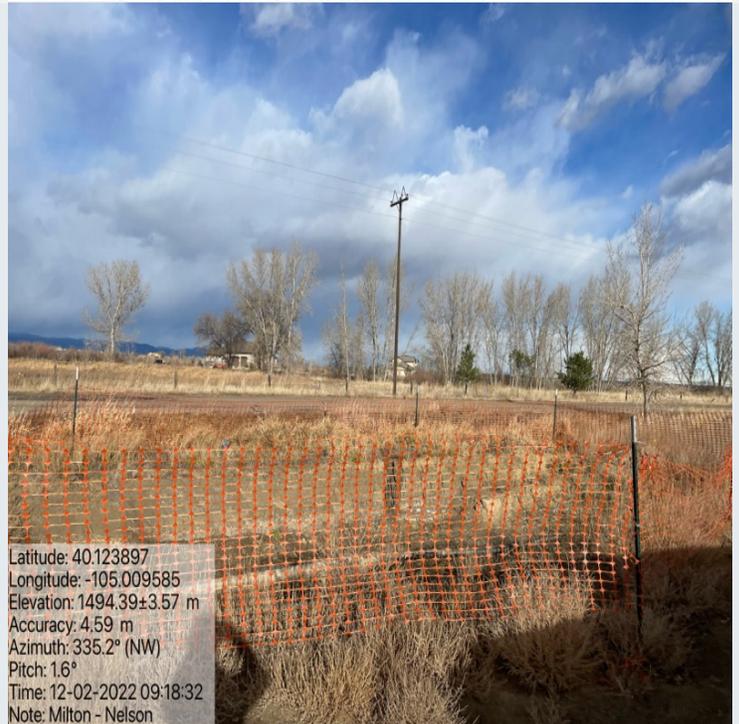
**Question:** Open excavation properly fenced/covered (in accordance with Rule 913.b.(5)B.i.)?

**Response:** Yes

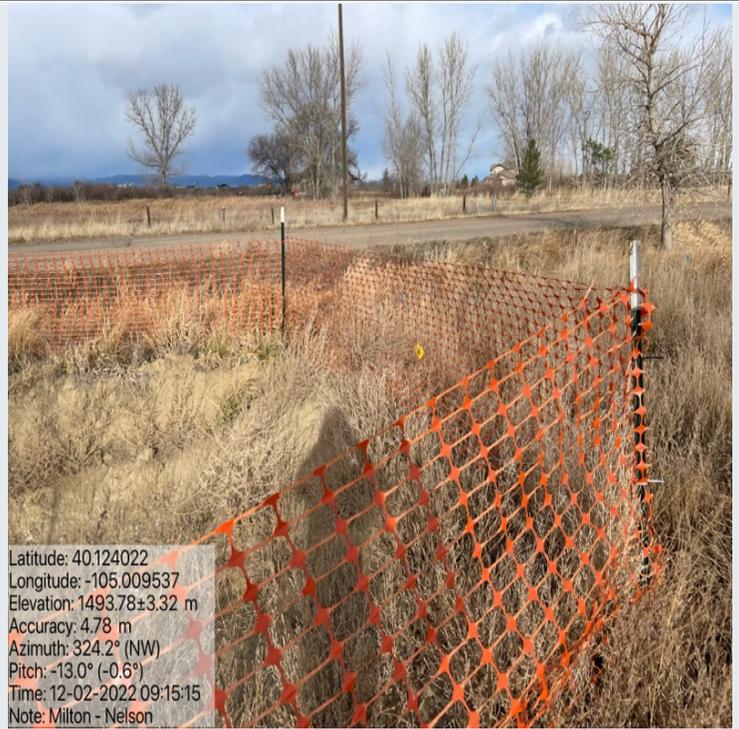
**Question:** Open excavation properly fenced/covered (in accordance with Rule 913.b.(5)B.i.)?

**Response:** Yes

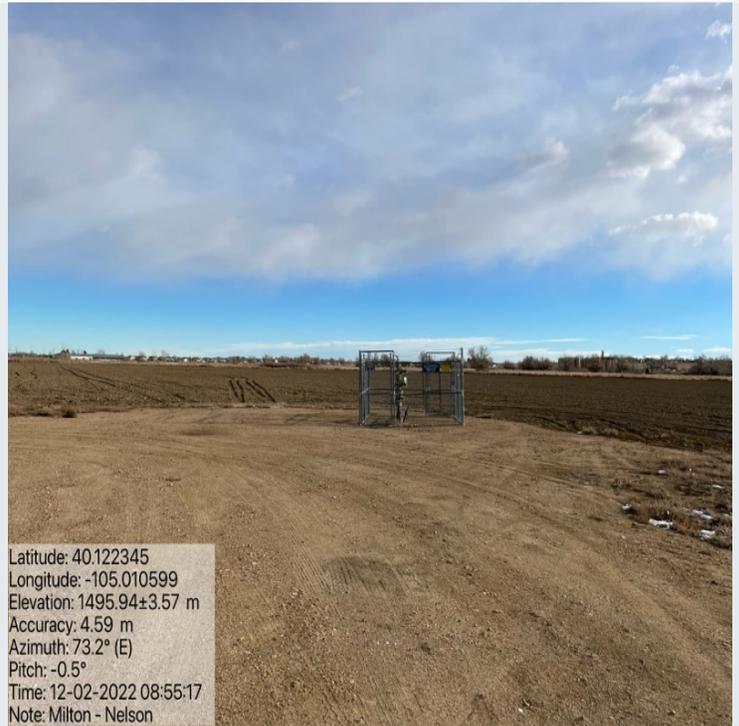
**Question:** Is fencing adequate/appropriate for site and well(s) and maintained?

**Response:** Yes

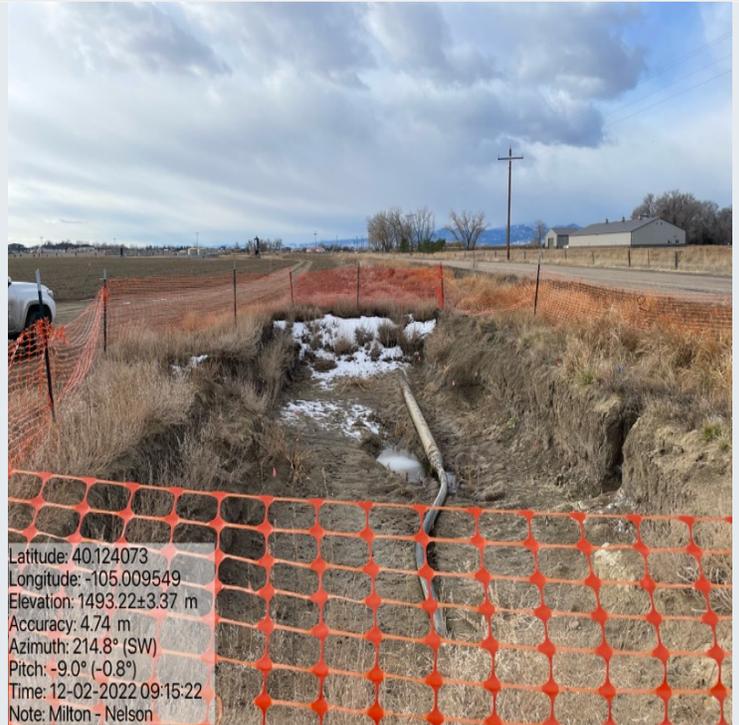
**Question:** Is fencing adequate/appropriate for site and well(s) and maintained?

**Response:** Yes

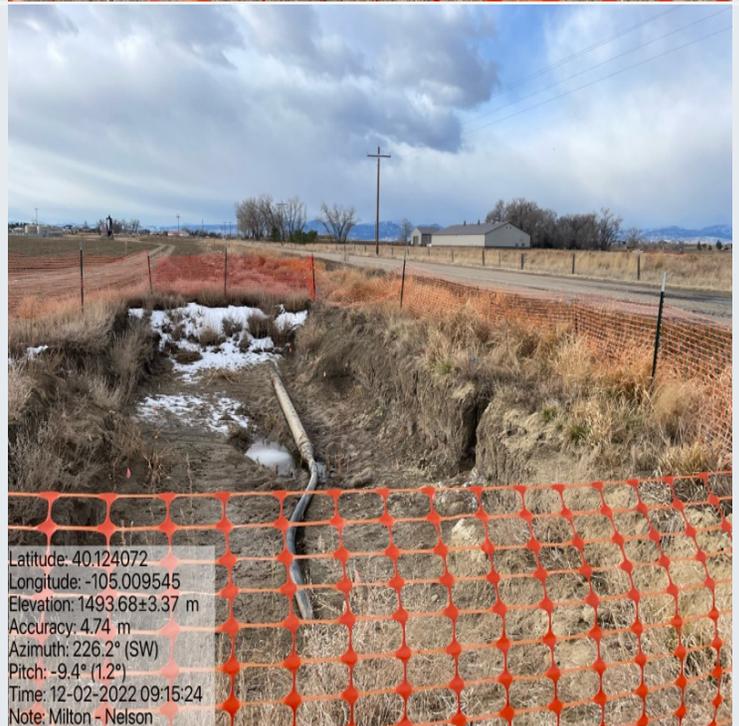
**Question:** Exposed buried/underground flowlines within excavation?

**Response:** Yes

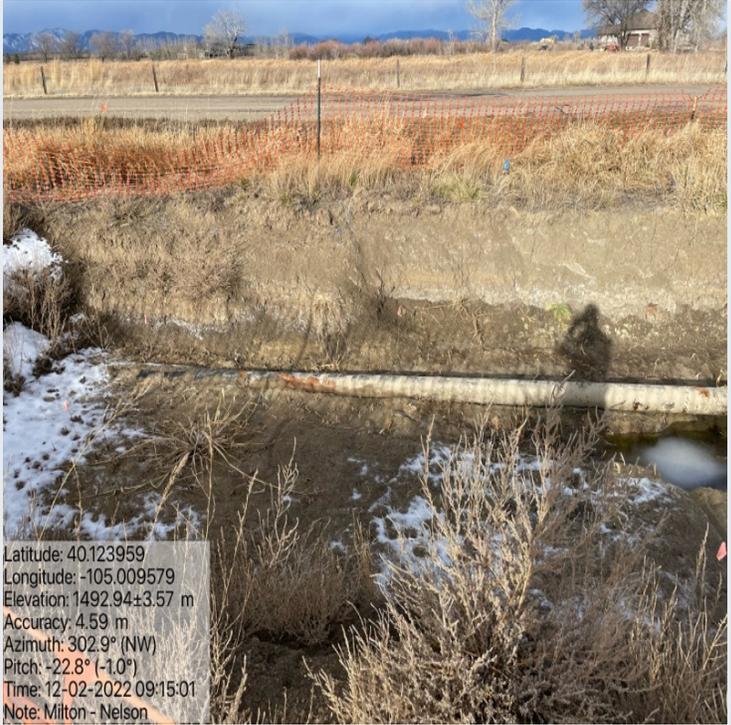
Photo
<p><b>Question:</b> Exposed buried/underground flowlines within excavation?  <b>Response:</b> Yes  <b>Notes:</b></p>

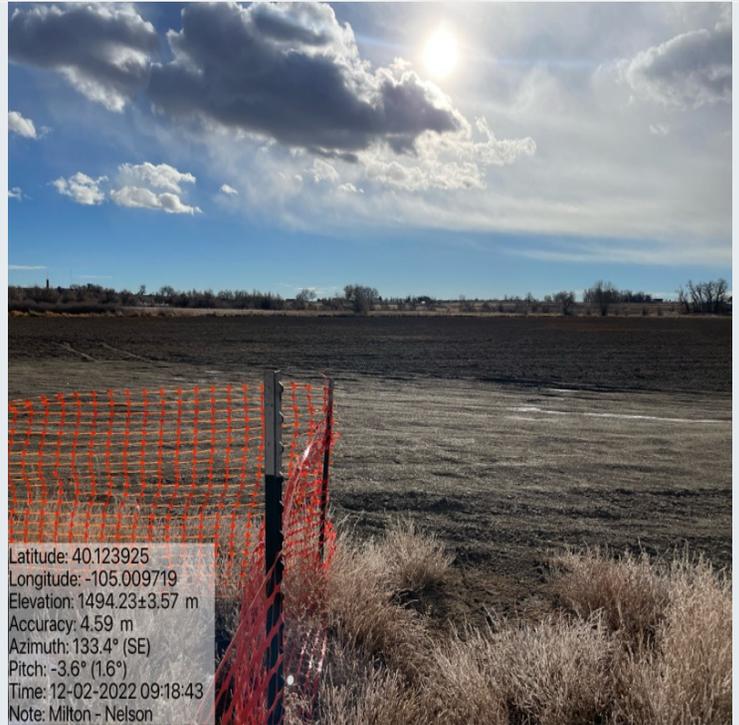
**Question:** Is work being conducted in a minimal footprint?

**Note:** Any property/crop damage

**Response:** Yes

**Notes:** Possible cropland damage for access road.

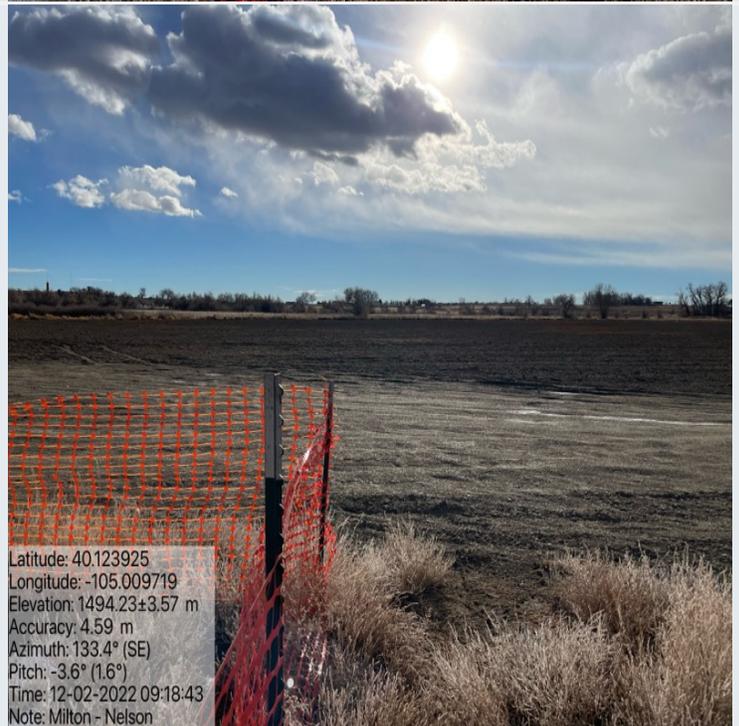
**Question:** Is location adjacent to any Potential Receptors?

**Response:** Yes

**Notes:** Possible cropland to the south east. Occupied structures to the west and north.

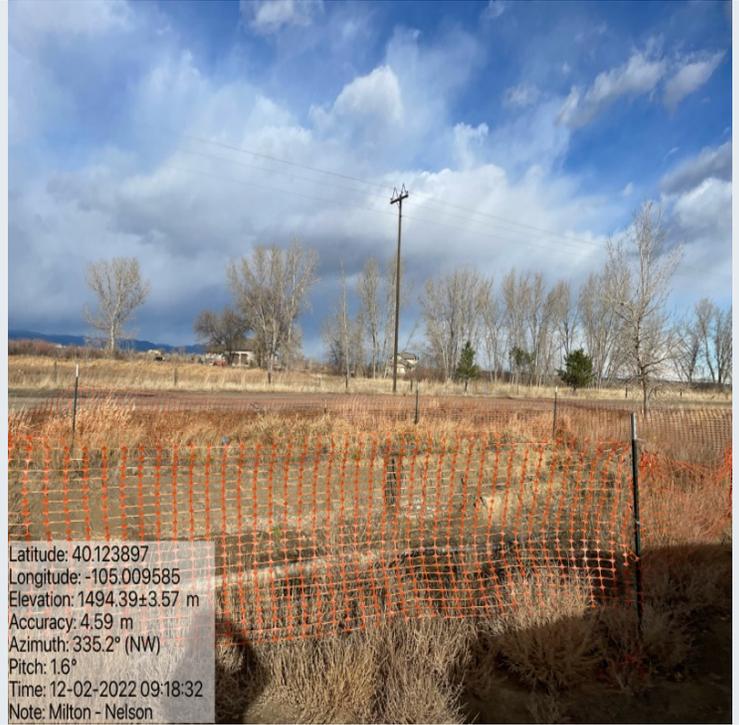
**Question:** Is location adjacent to any Potential Receptors?  
**Note:** Livestock, surface water, occupied structure, adjacent land use, etc.  
**Response:** Yes  
**Notes:** Possible cropland to the south east. Occupied structures to the west and north.

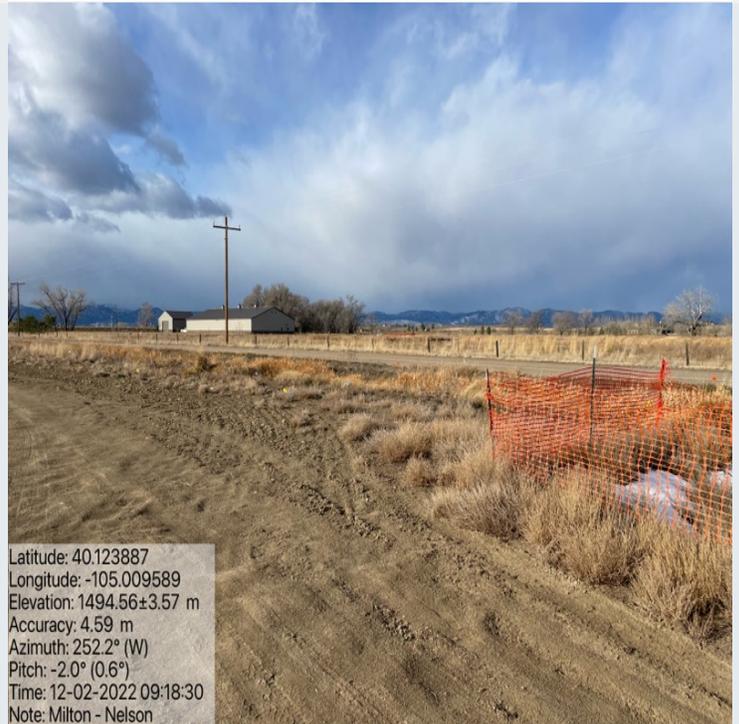
**Question:** Is location adjacent to any Potential Receptors?  
**Note:** Livestock, surface water, occupied structure, adjacent land use, etc.  
**Response:** Yes  
**Notes:** Possible cropland to the south east. Occupied structures to the west and north.

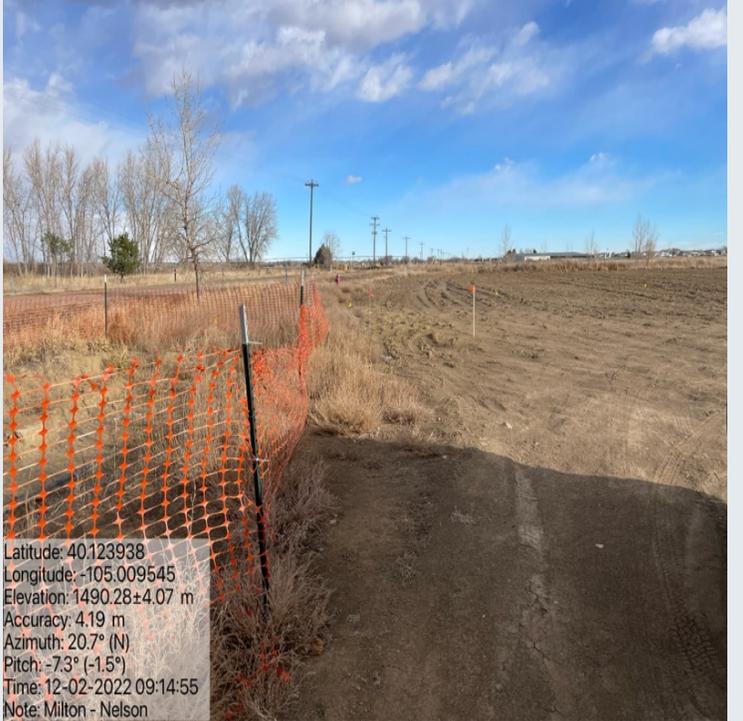
Photo
<p><b>Question:</b> Evidence of pollutants being discharged off-site?  <b>Response:</b> No  <b>Notes:</b></p>	<p>No Photo</p>
<p><b>Question:</b> All stormwater erosion control measures and BMPs are present and in good/working condition?  <b>Response:</b> N/A  <b>Notes:</b> None visible.</p>	<p>No Photo</p>
<p><b>Question:</b> Site free of unused equipment, weeds, debris/trash?  <b>Response:</b> Yes  <b>Notes:</b></p>
