# Inspection Photos

API: 043-40000

Operator: JAVERNICK OIL

Inspection Date: 12/1/2022

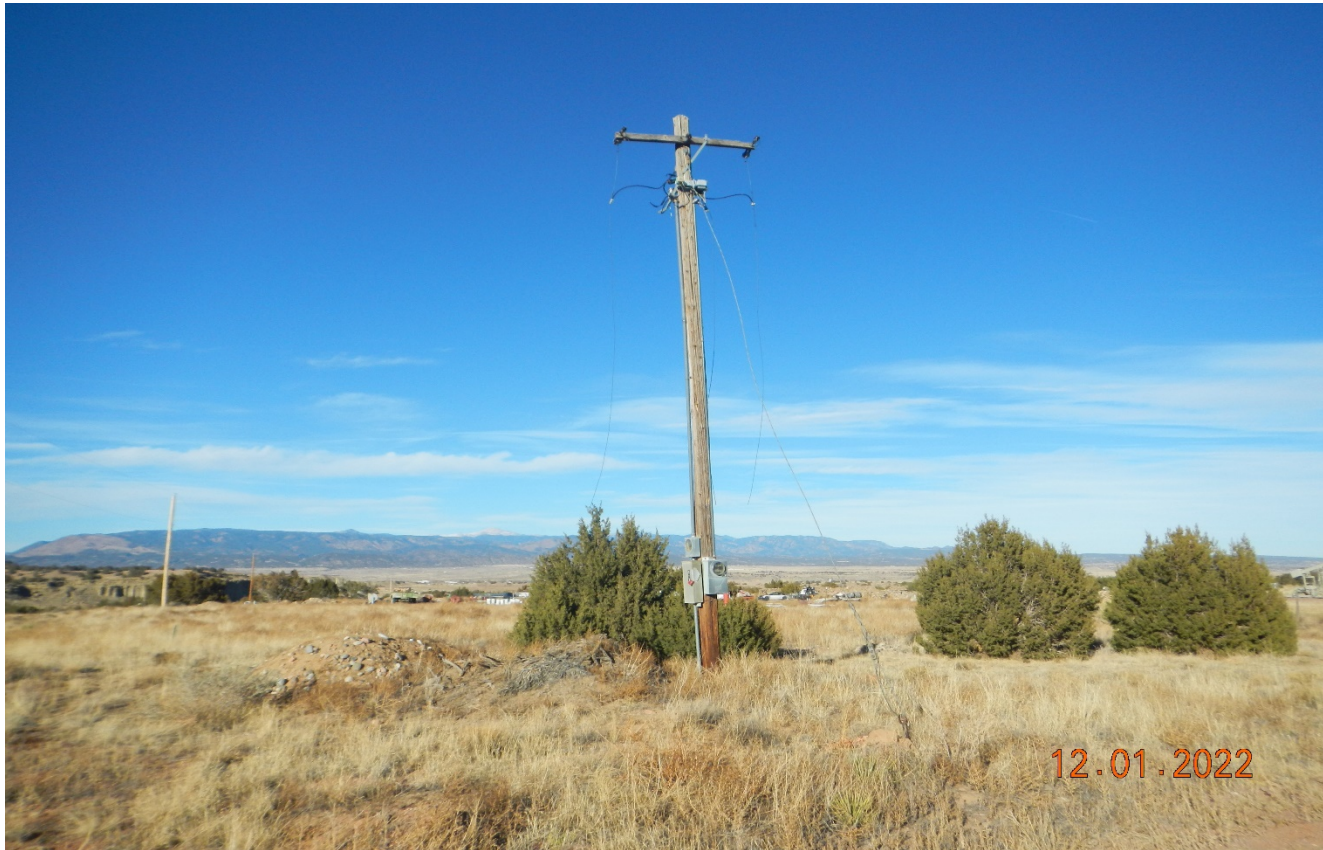
**Photo 1.** Facing northeast at the abandoned well site. There is an abandoned power pole that remains which needs to be removed.

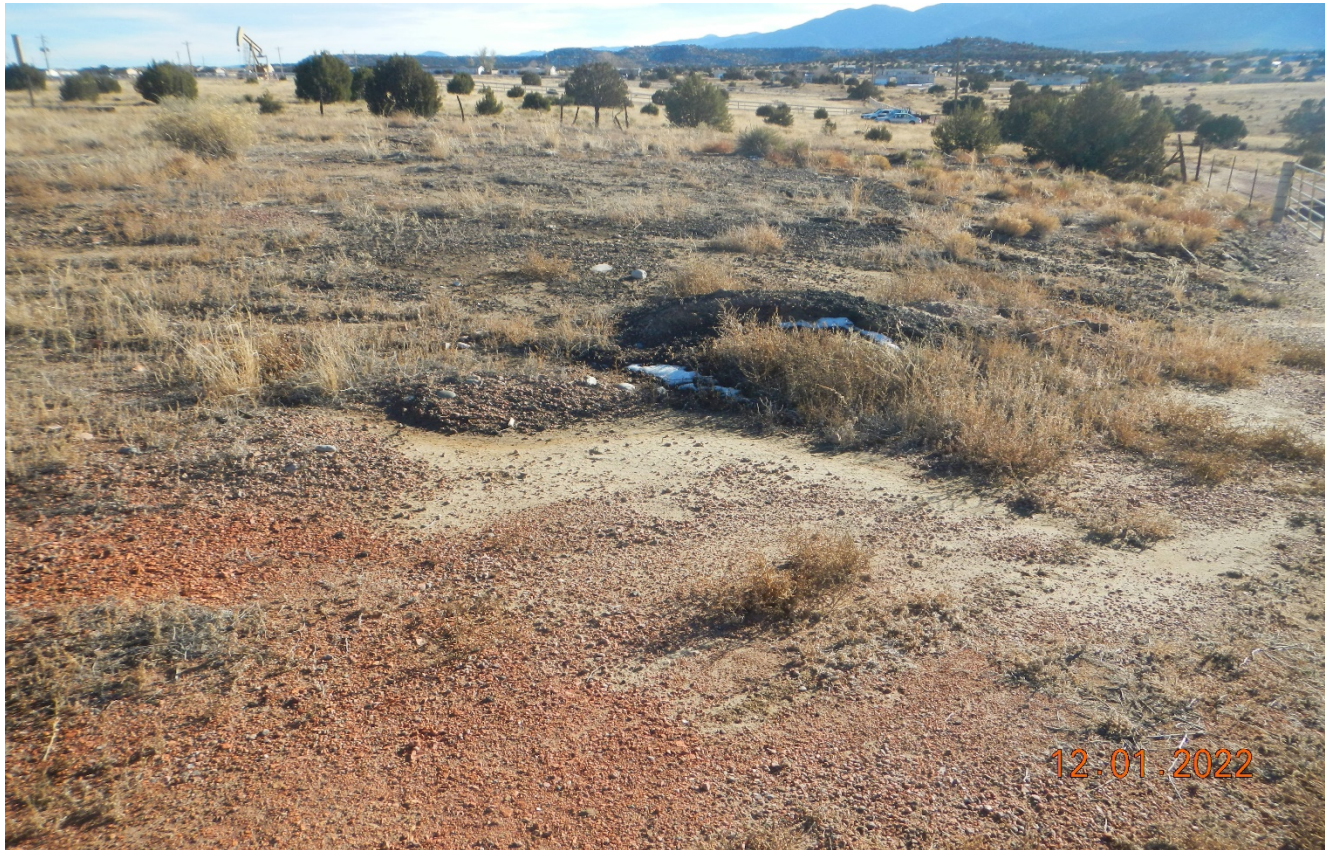
**Photo 2.** Facing south toward the location. There is gravelly soils that remain and the location is not reclaimed.

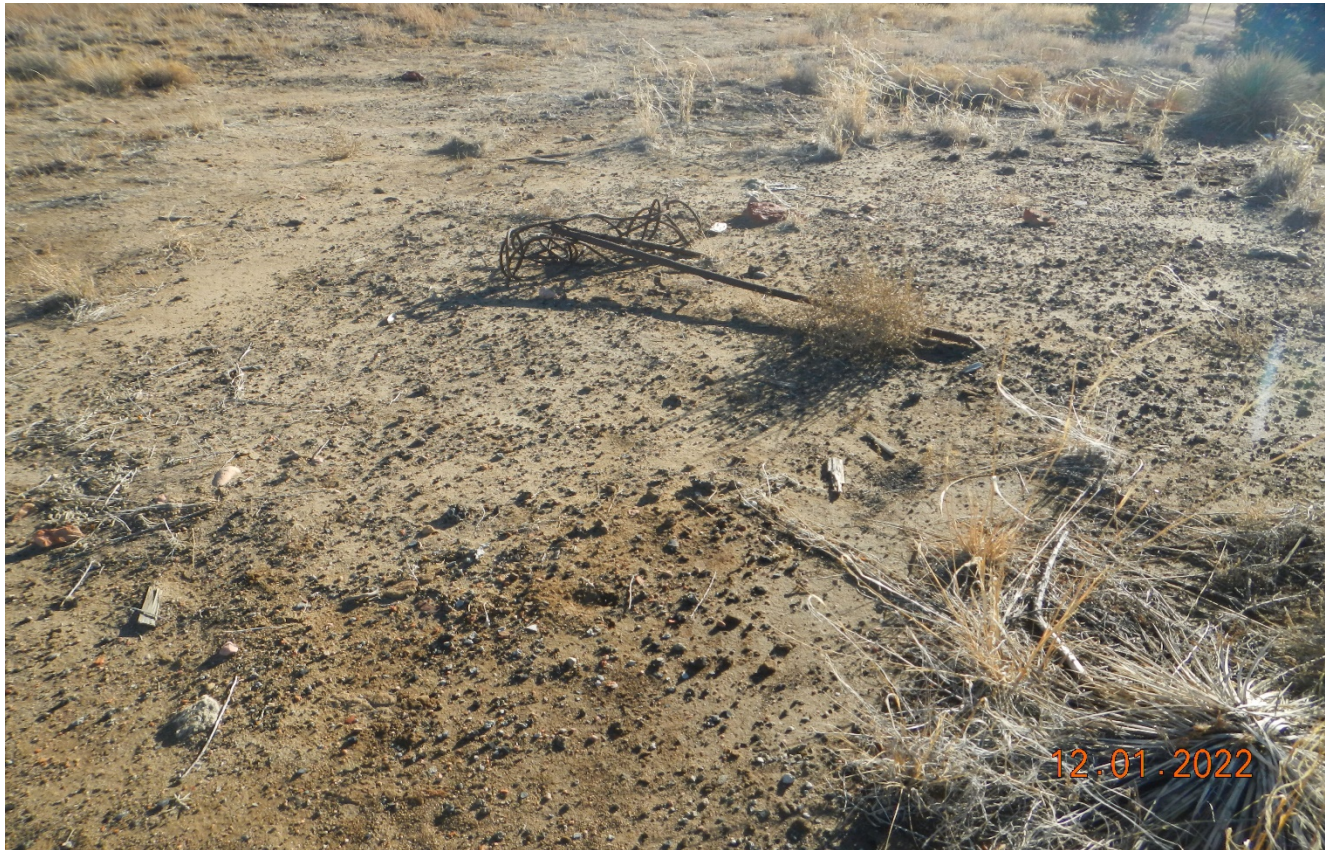
**Photo 3.** There is cable and various debris that remains.

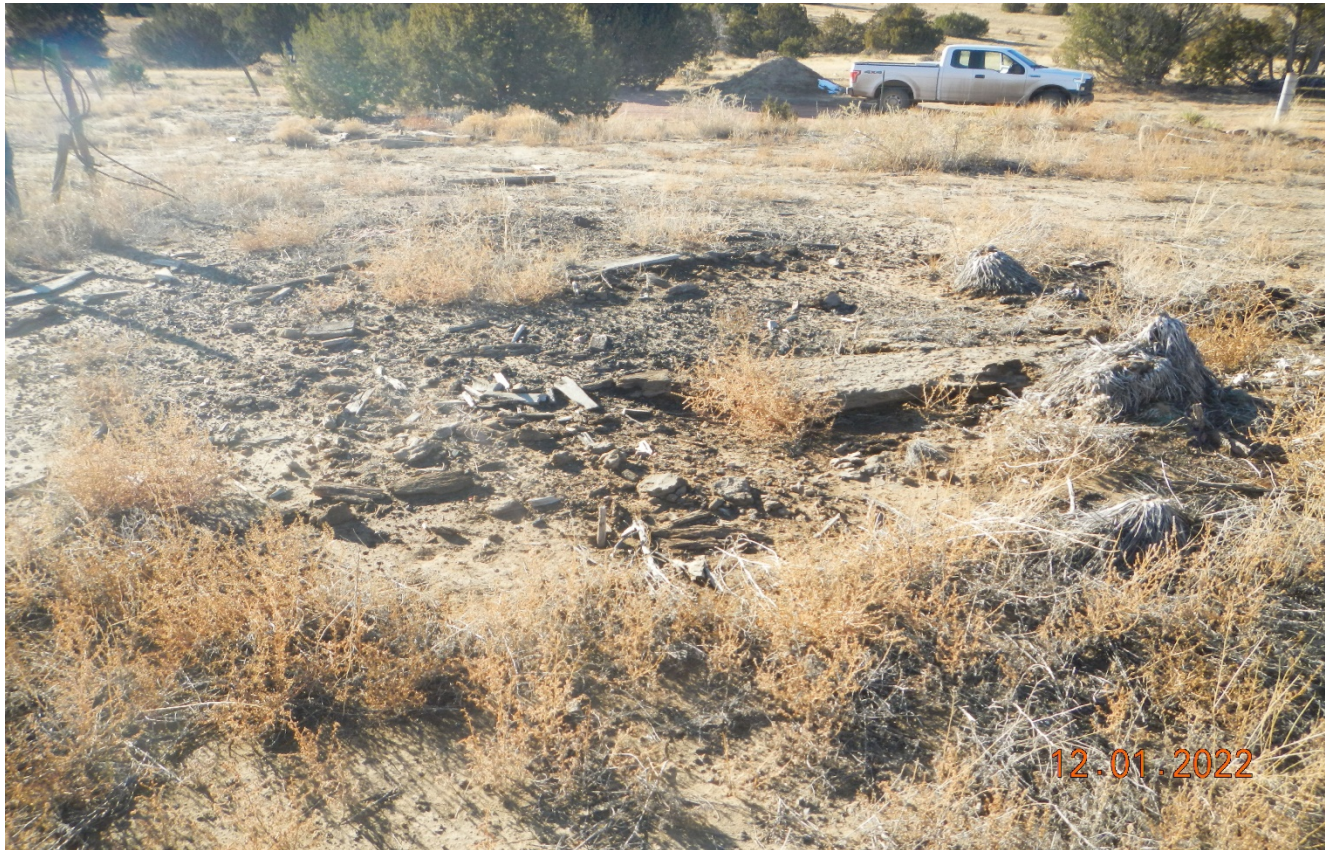
**Photo 4.** Facing west at the location. There is gravelly soils and debris that remains and the location is not reclaimed.

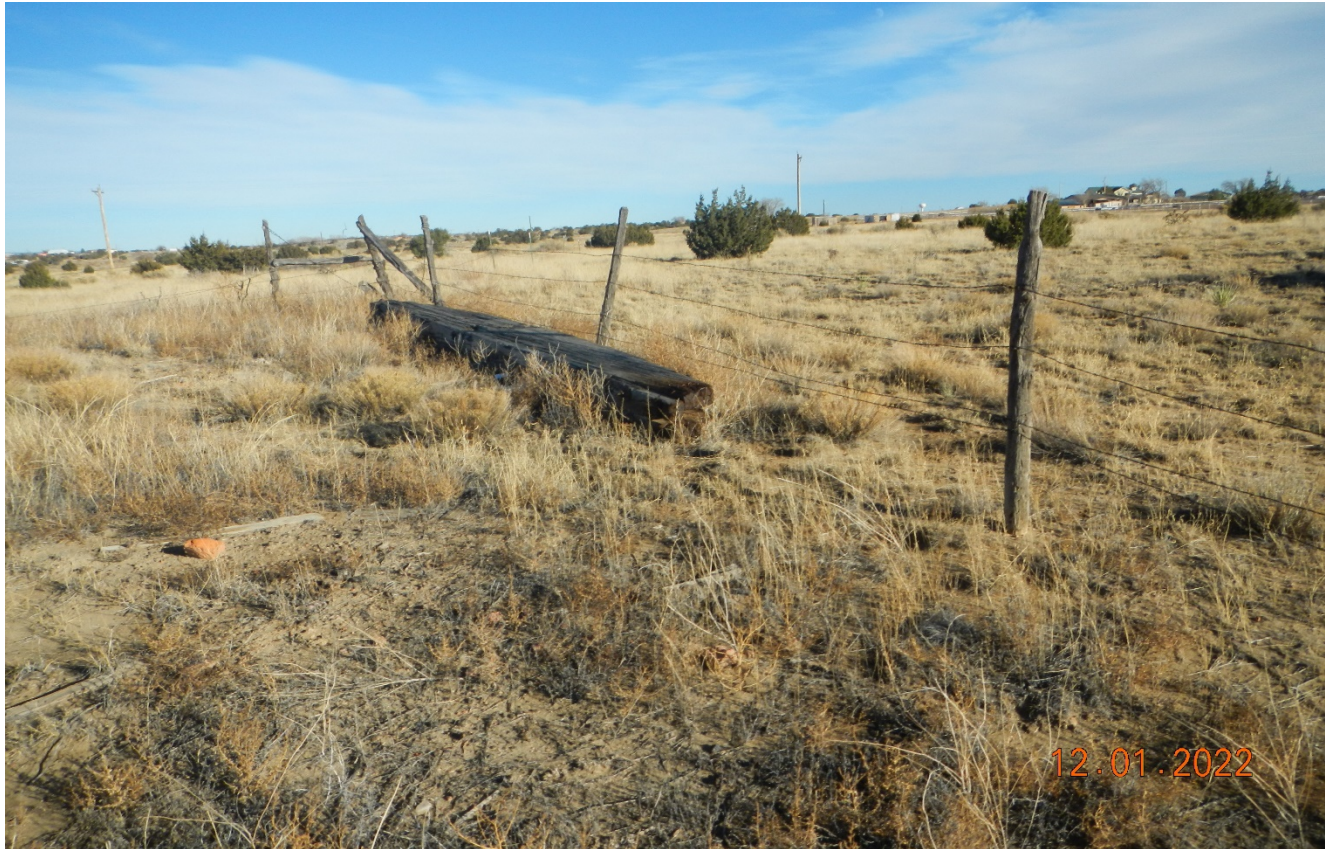
**Photo 5.** There is a bridge timber used for the pumpjack base that needs to be removed.

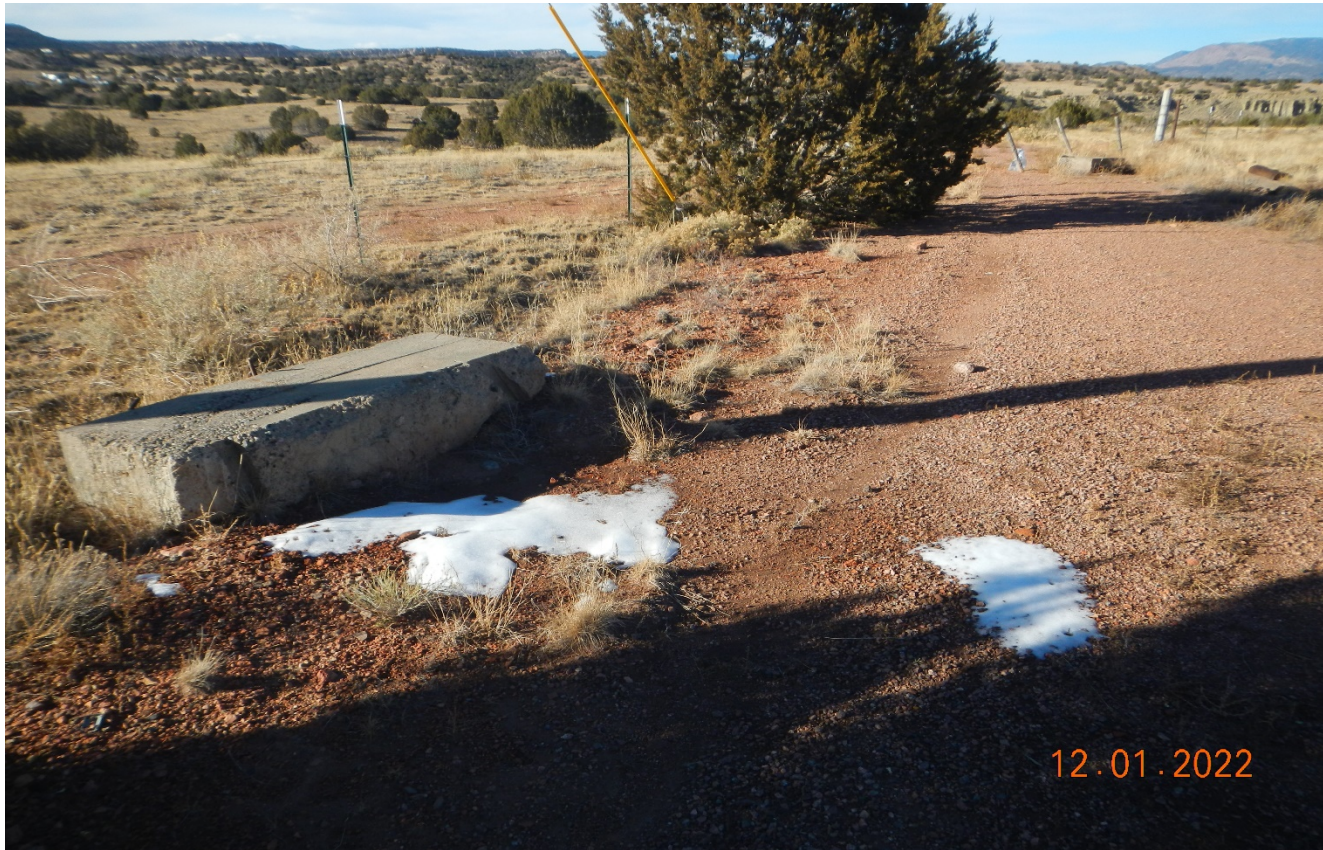
**Photo 6.** There are cement blocks that remain.
