Taproot – Big Mountain Viper Pad – Produced Water Release

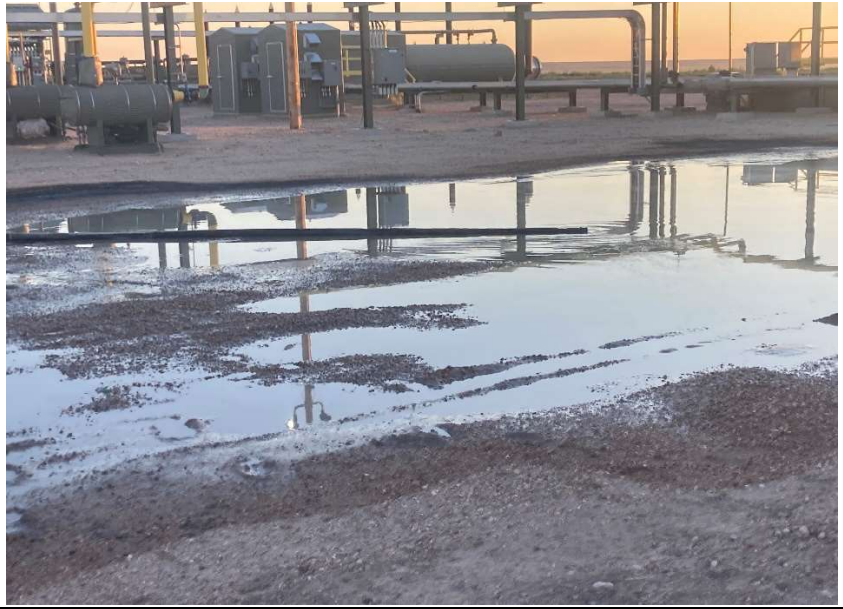
Photo: 1

Initial site conditions on 9/5 looking east.

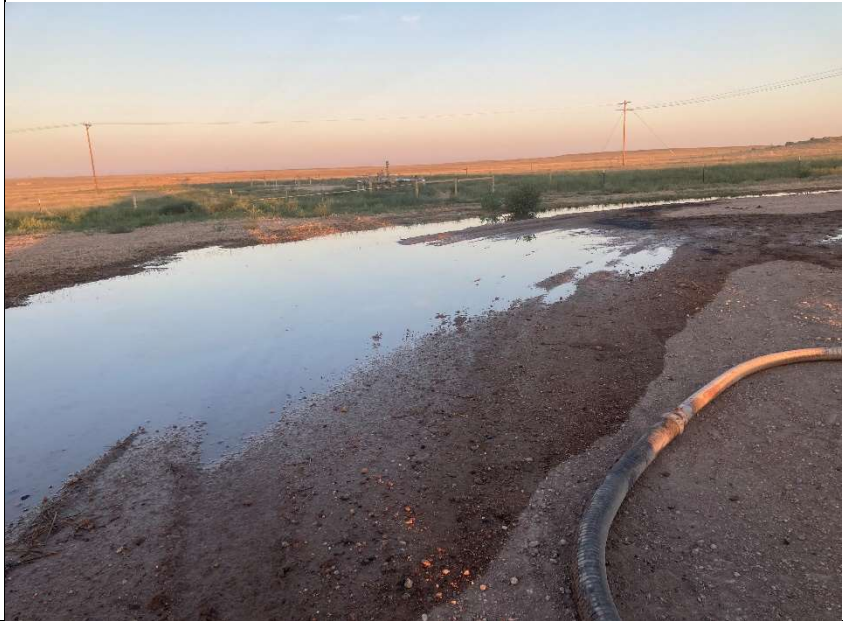
Photo: 2

Initial site conditions looking southwest.

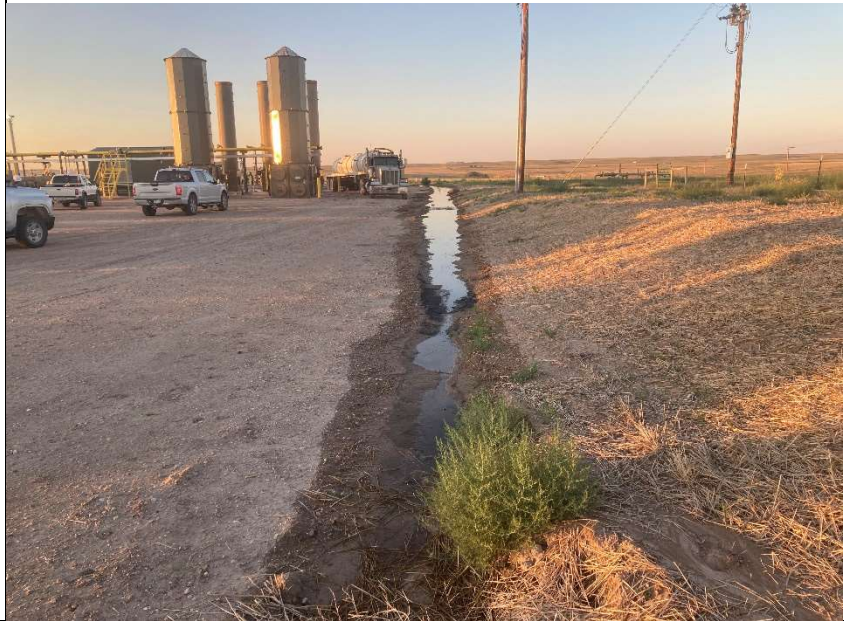
Photo: 3

Initial site conditions looking south.

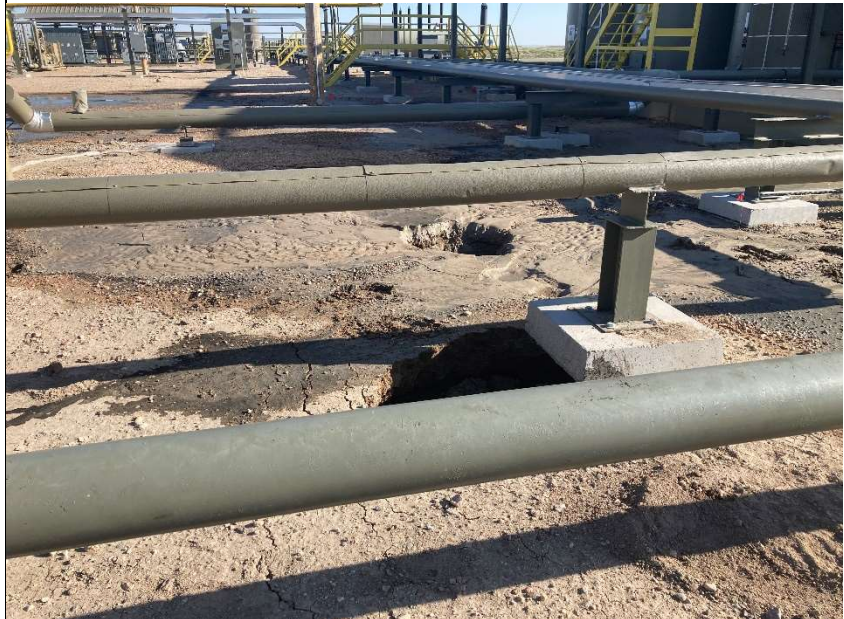
Photo: 4

Release location.

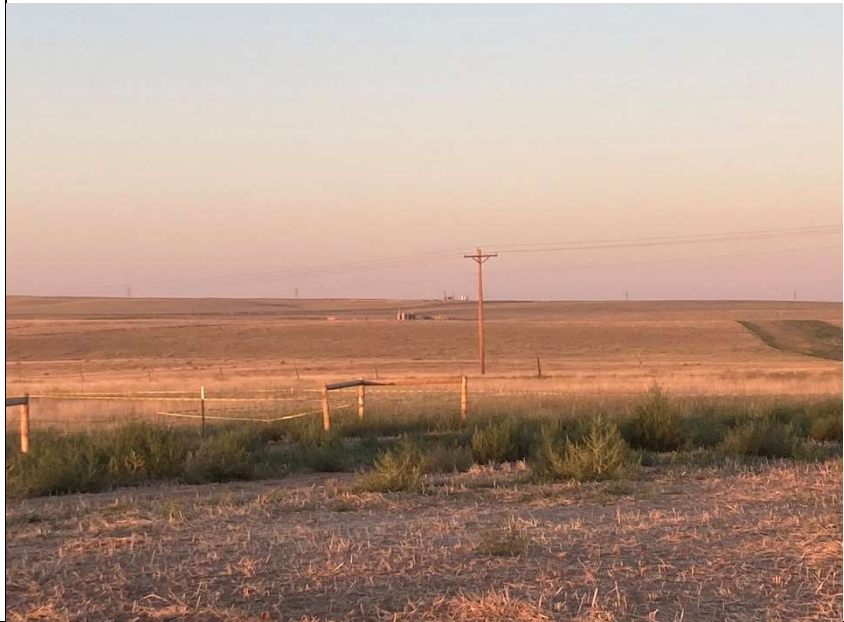
Photo: 5

The outlined impacted area of the adjacent property to the southwest.

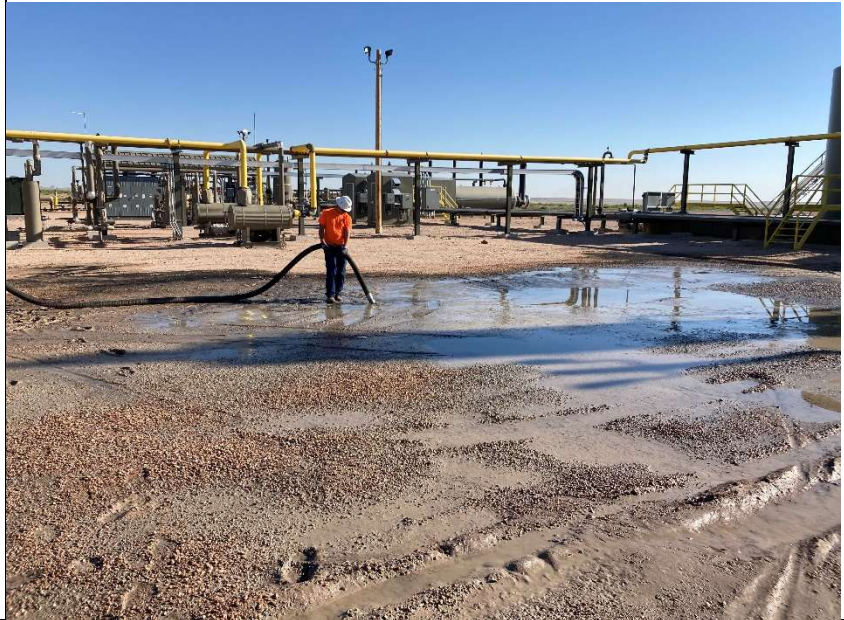
Photo: 6

Liquid Vac Truck Operator working to remove free liquids.

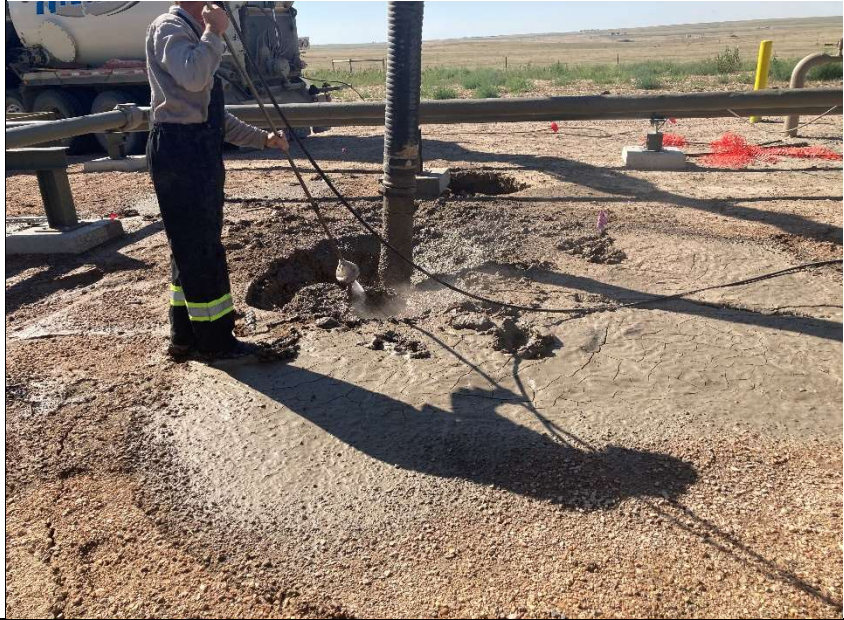
Photo: 7

Hydro excavator working in the primary excavation area to locate the pipeline failure.

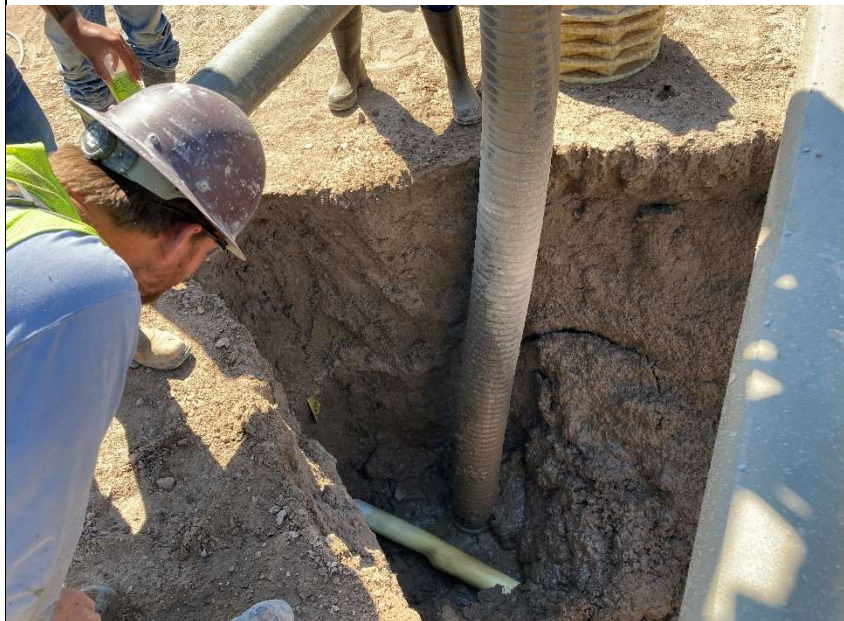
Photo: 8

Locating the failure in the pipeline.

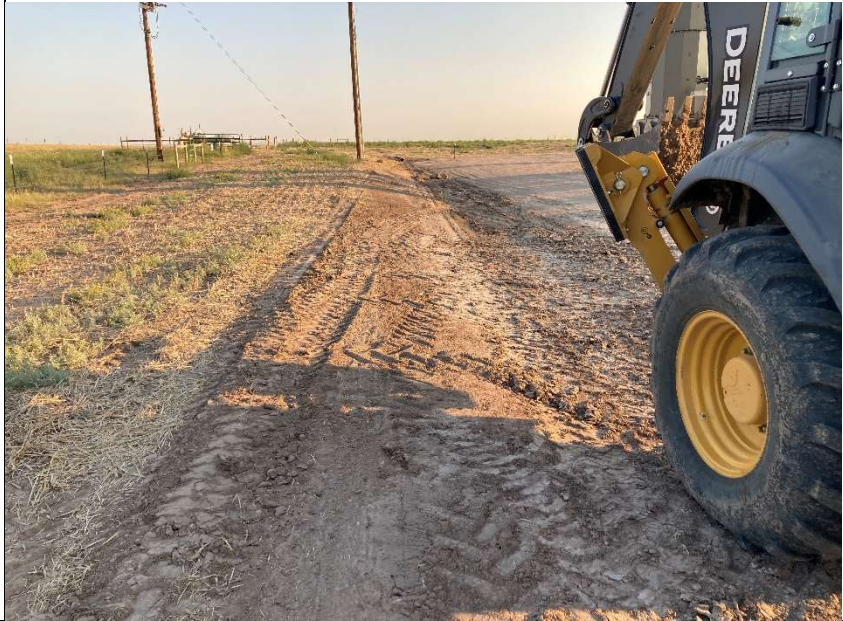
Photo: 11

Surface scrapping of impacted area to remove visible wet soil.

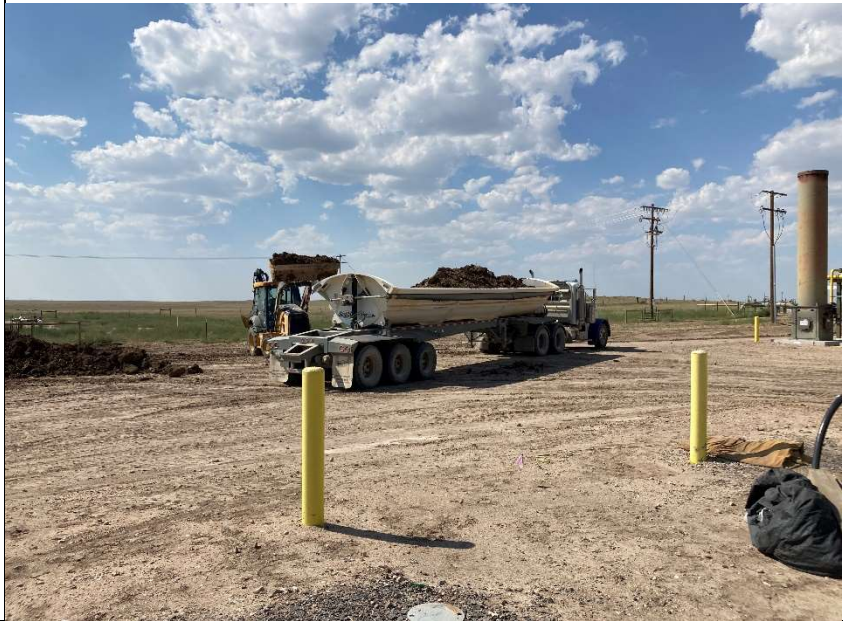
Photo: 12

Loading impacted soil for disposal.

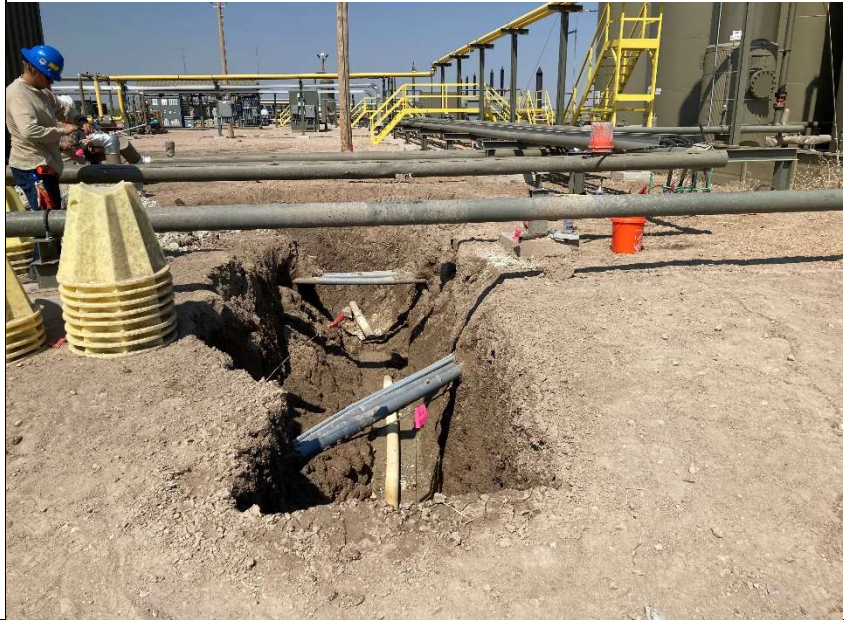
Photo: 13

Primary excavation area after exposing failed pipeline. View looking north.

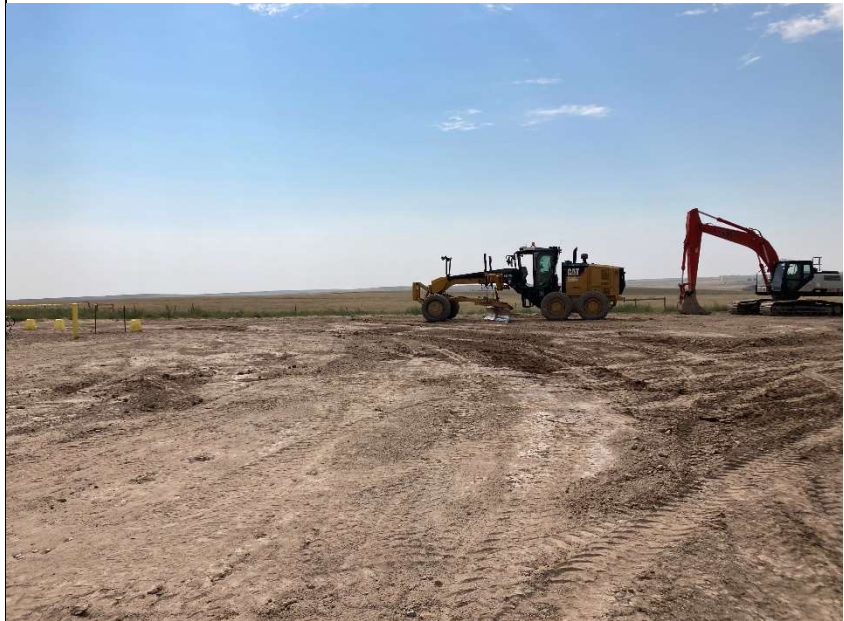
Photo: 14

Secondary excavation area after surface scrape looking west.

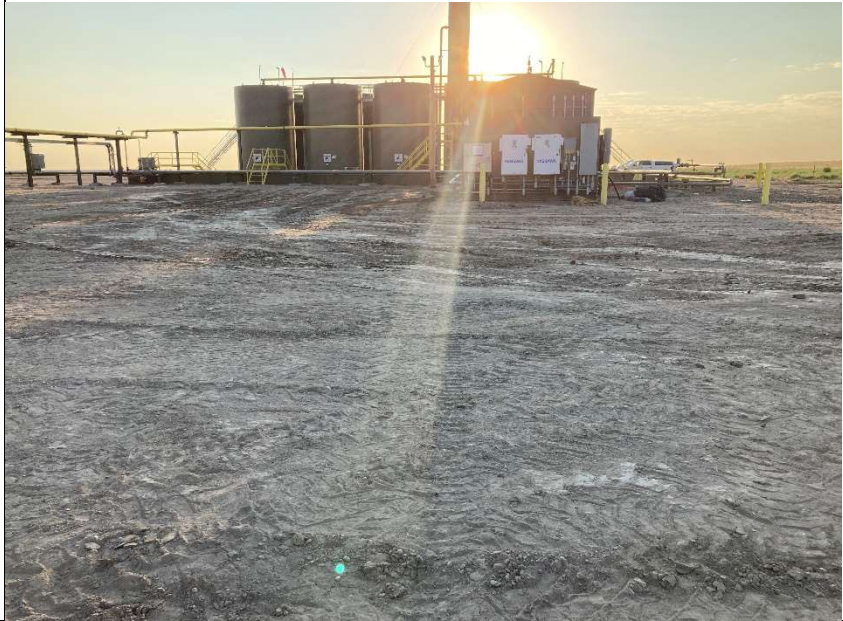
Photo: 15

Secondary excavation area
after surface scrape,
looking east.

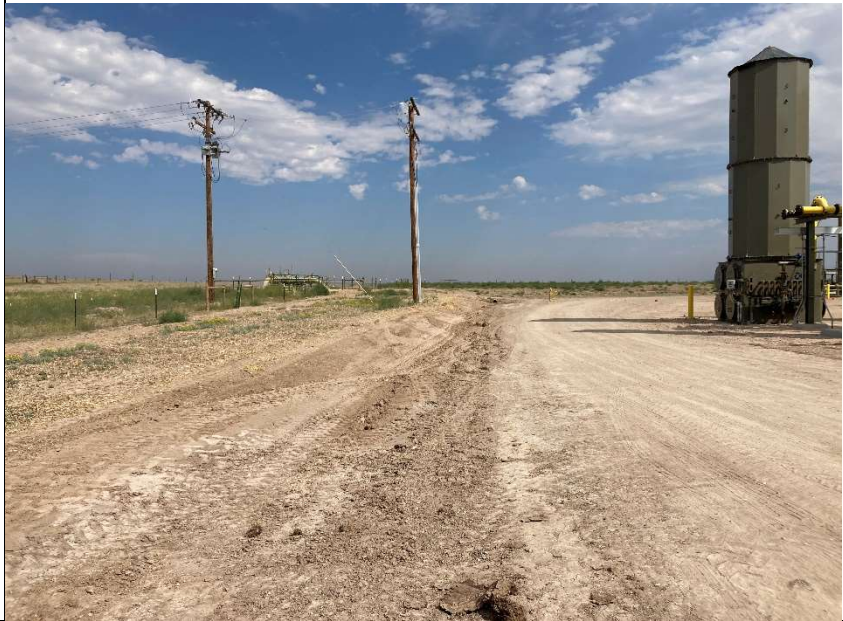
Photo: 16

Secondary excavation area
after surface scrape
looking north.

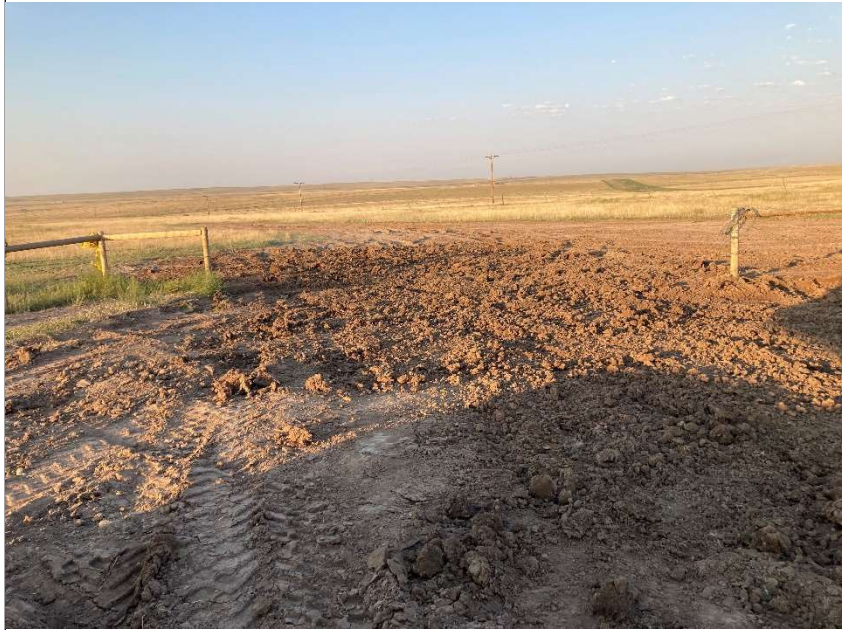
Photo: 17

Adjacent property after surface scrape.

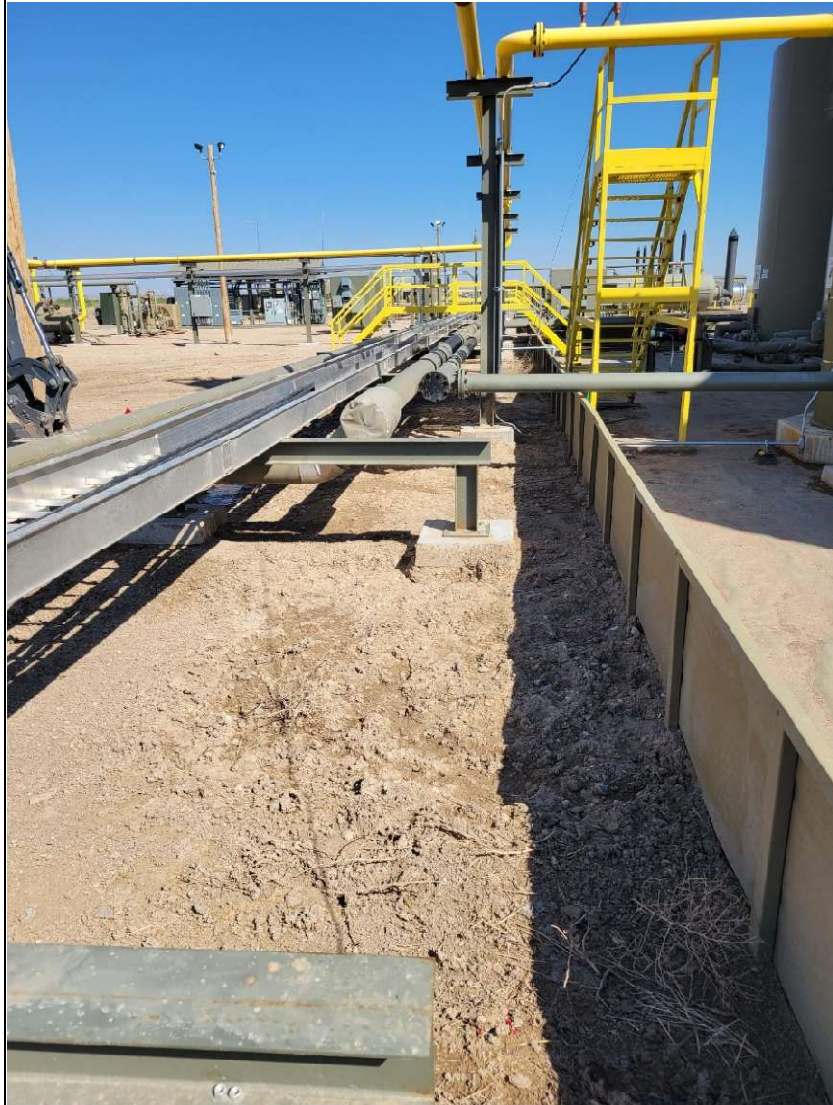
Photo: 19

Area of surface impacts to the east of the primary excavation. Hand digging and hydroexcavation performed until no observed impacts. View looking north.

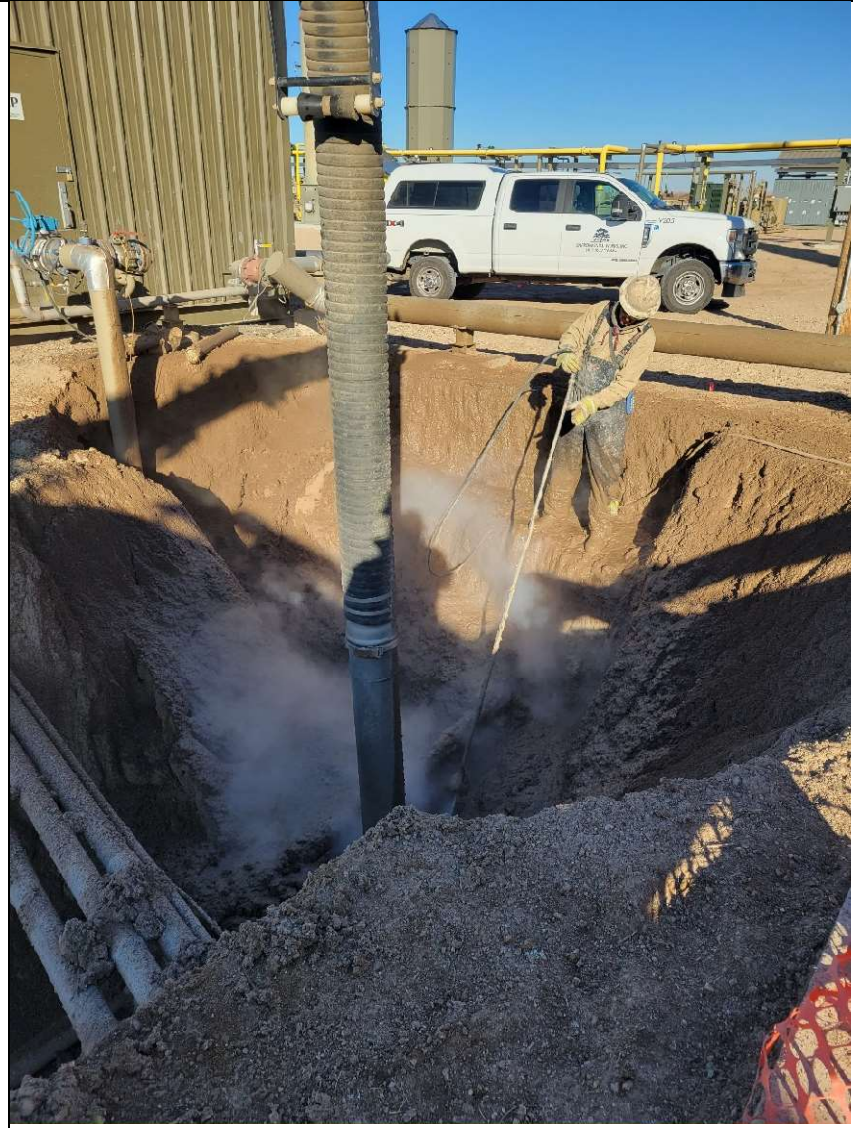
Photo: 20

Widening of primary excavation completed on 11/10 and 11/11. Secondary sidewall samples collected.

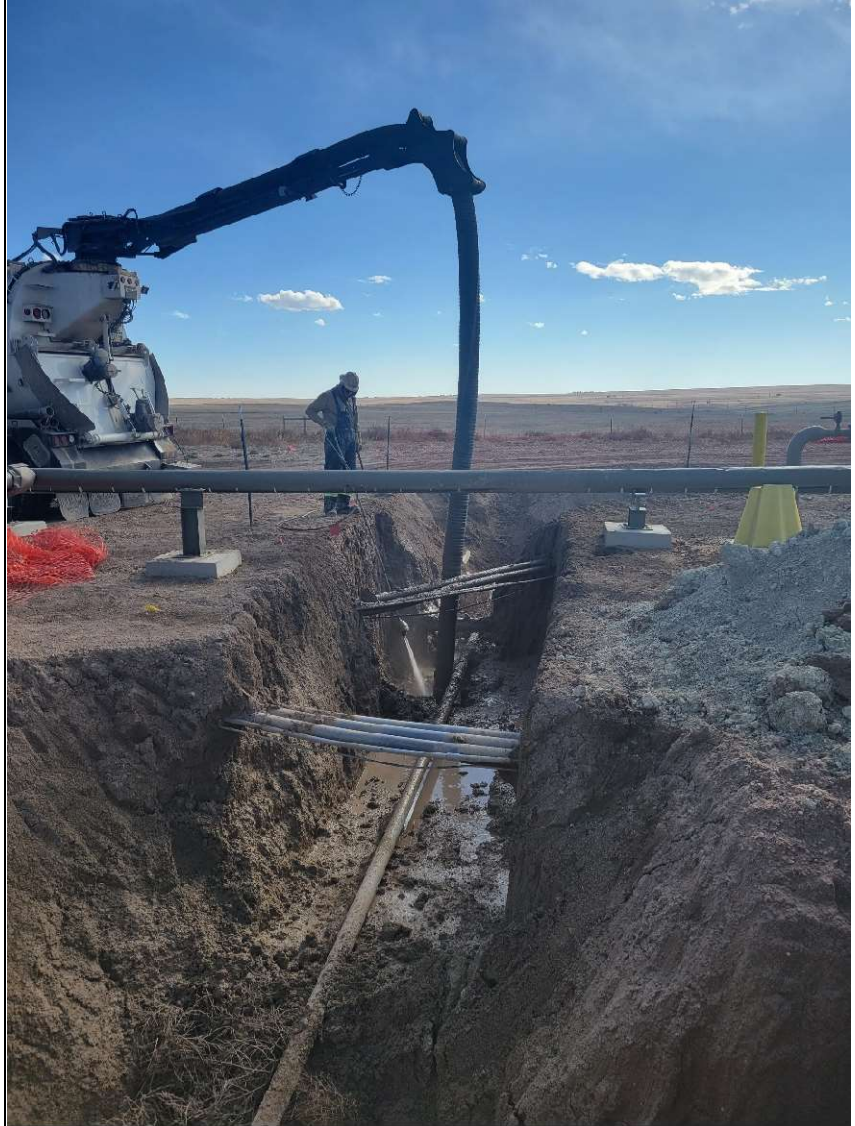
Photo: 21

Widening of primary excavation completed on 11/10 and 11/11. Existing infrastructure hindering further excavation.
