# Interim Reclamation and Stormwater Inspection

Operator: FUNDARE RESOURCES OPERATING COMPANY - 10773

Location ID: 420243

Inspection Document #: 696105630

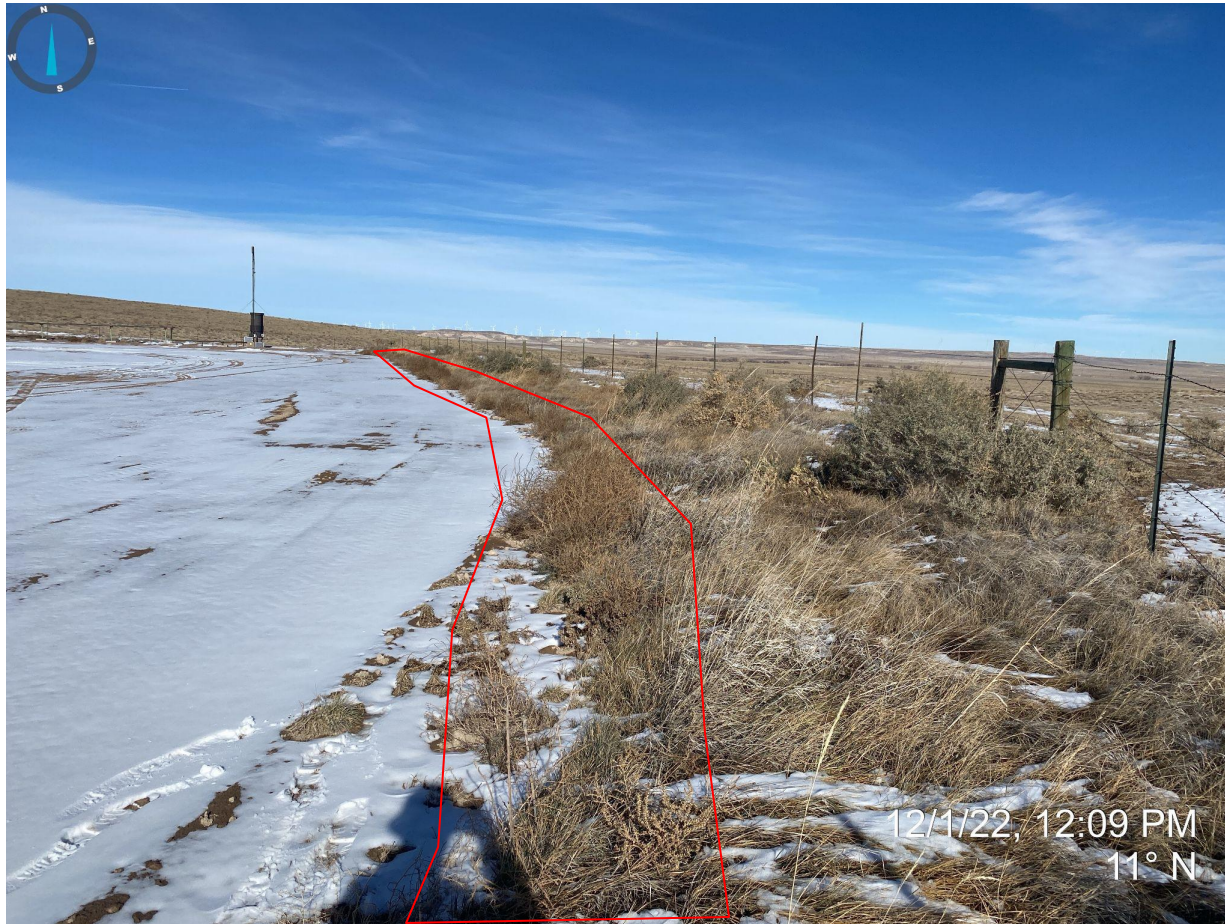
**Photo 1.** Taken near the location entrance, facing north. Photo illustrates presence of undesirable vegetation (e.g. kochia and russian thistle) outlined in red.

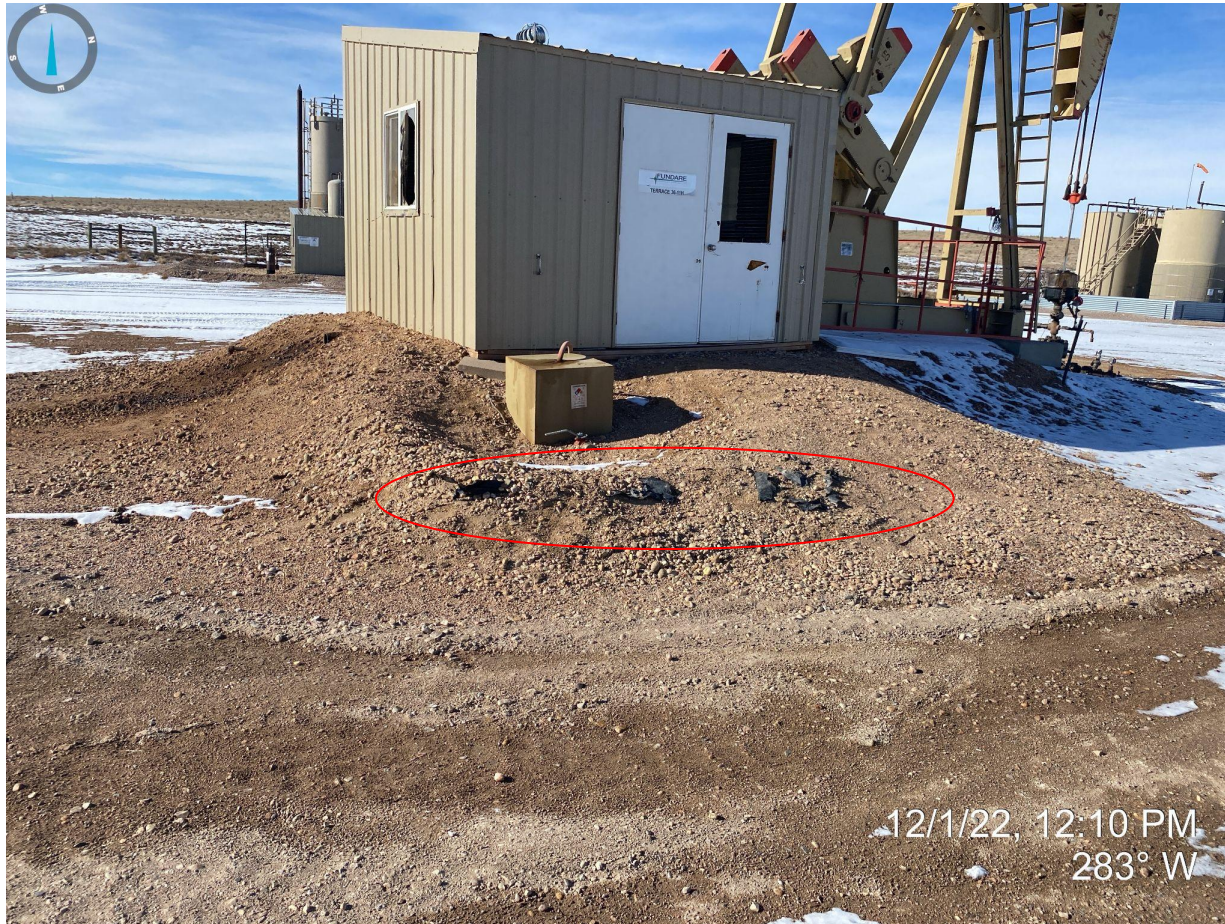
**Photo 2.** Facing west at pump jack. Photo illustrates the berm around the condensate tank is inadequate as the eastern berm wall is degrading/eroded away.

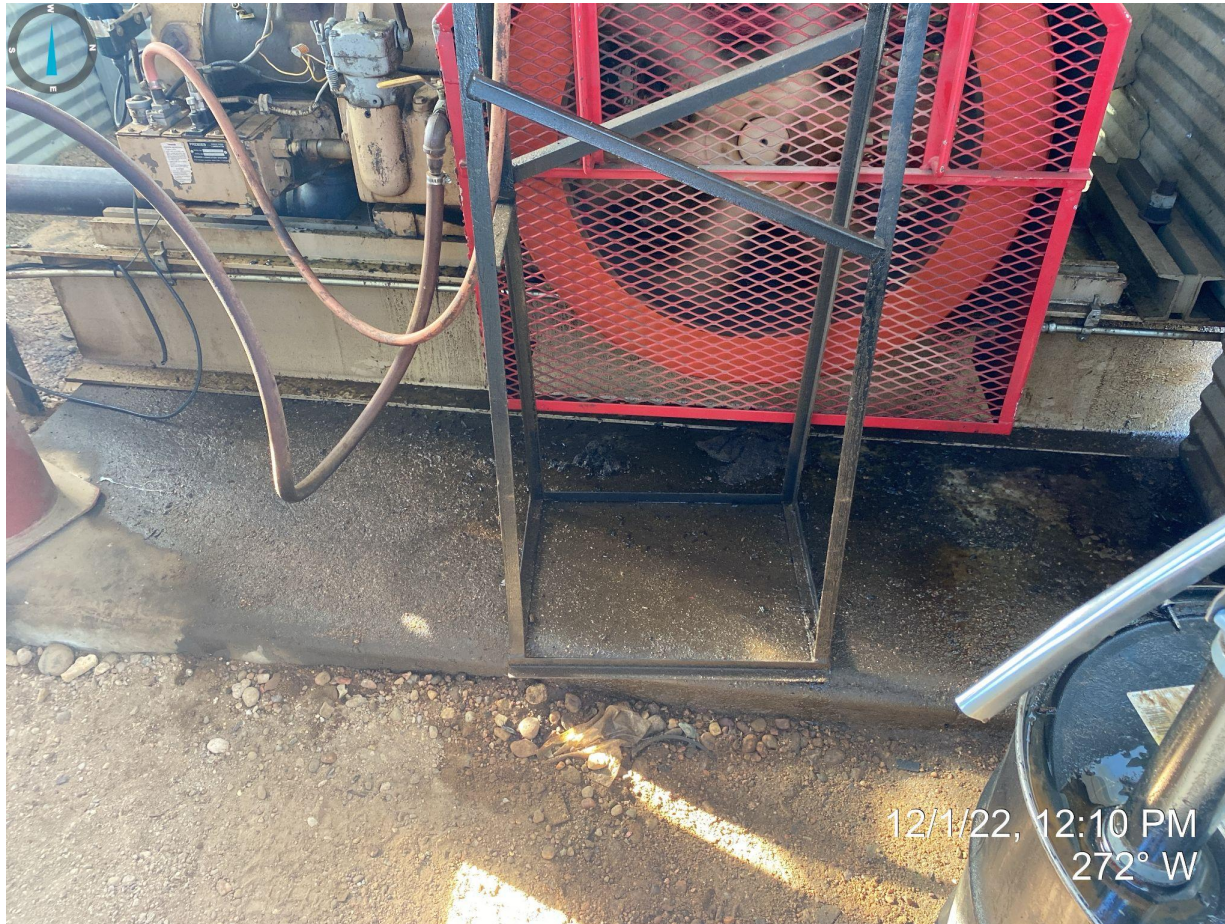
**Photo 3.** Close-up photo of pump jack motor, illustrating the oily stained/saturated foundation.

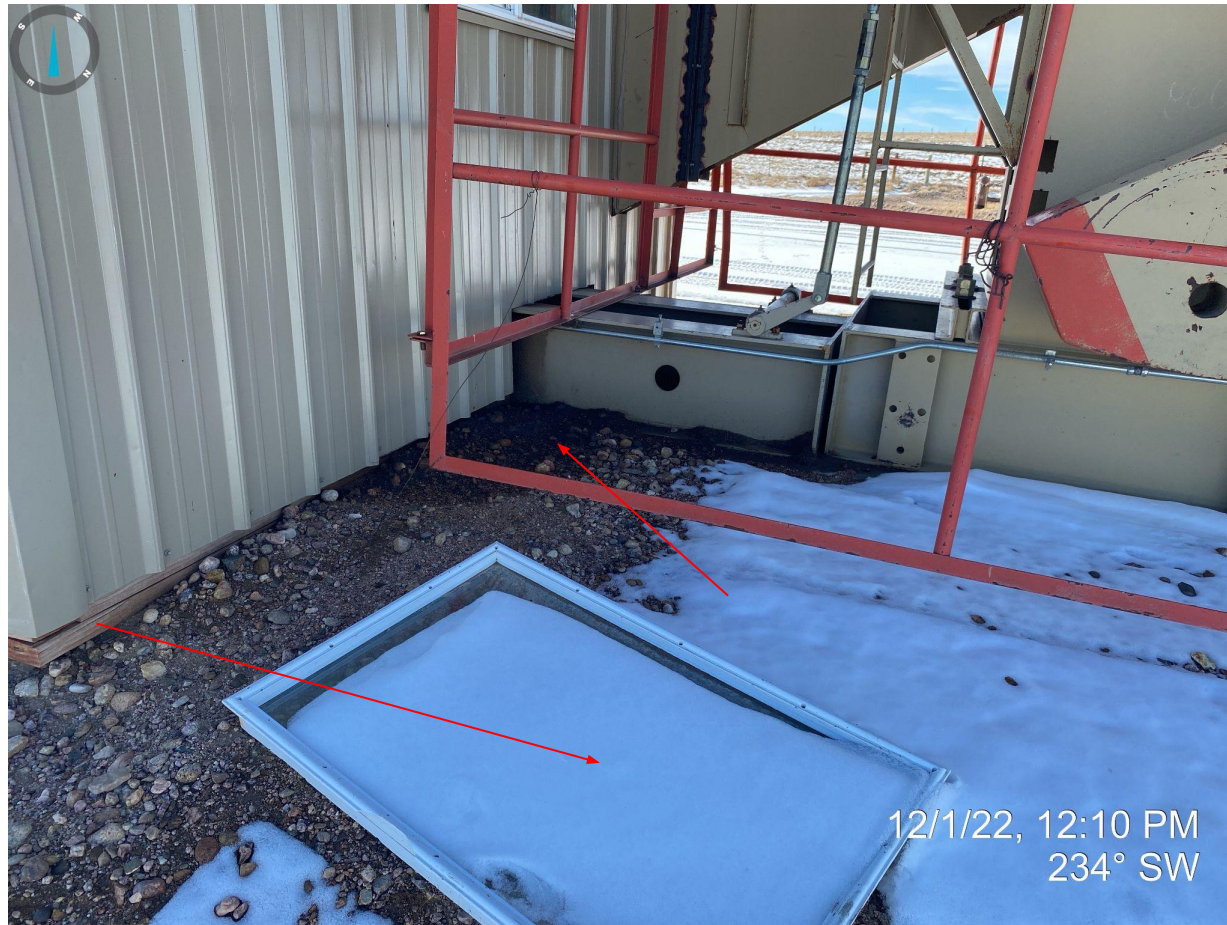
**Photo 4.** Taken from the north side of the pump jack, facing southwest. Photo illustrates debris (window) that needs to be removed and oily stained soil near building.

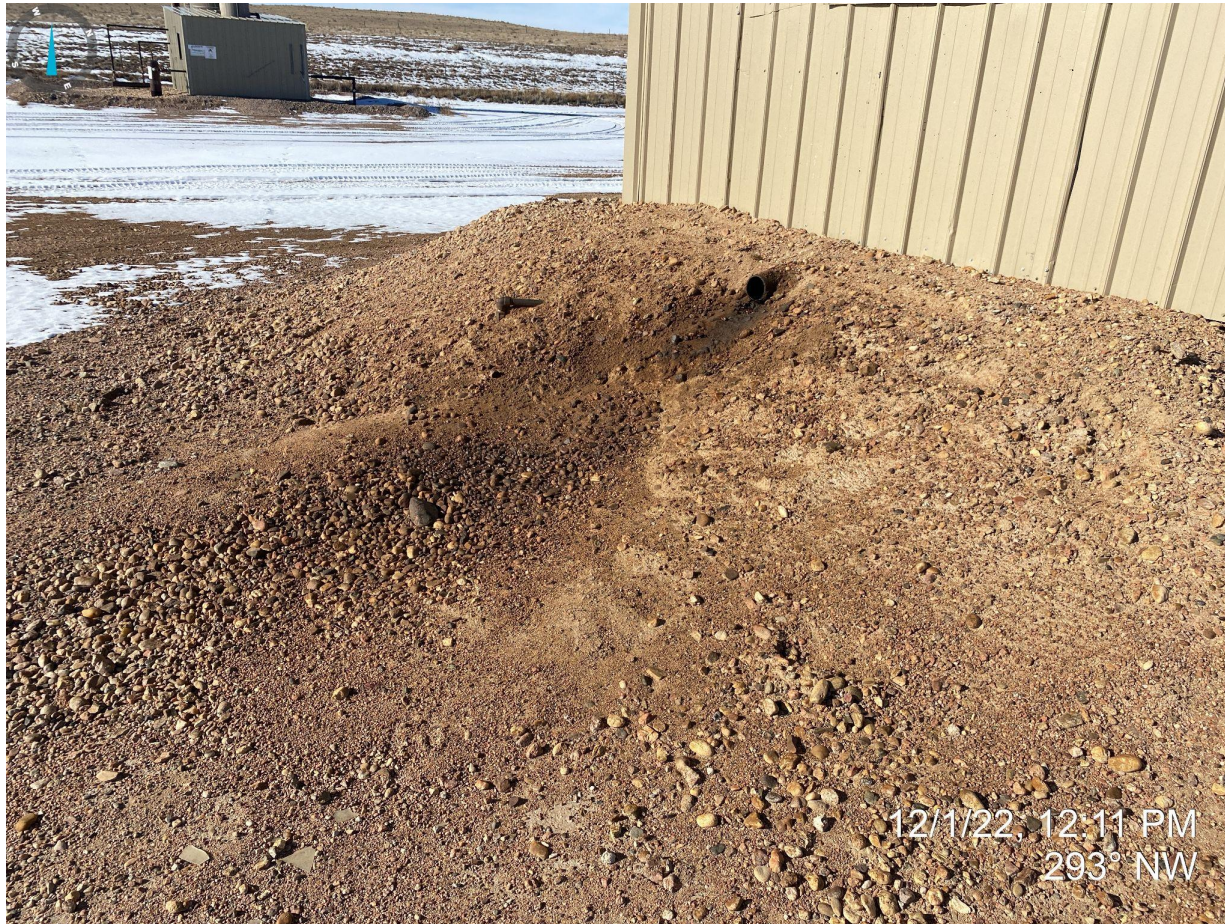
**Photo 5.** Taken from the southern end of pump jack, facing northwest. Photo illustrates oily stained soil near exhaust.

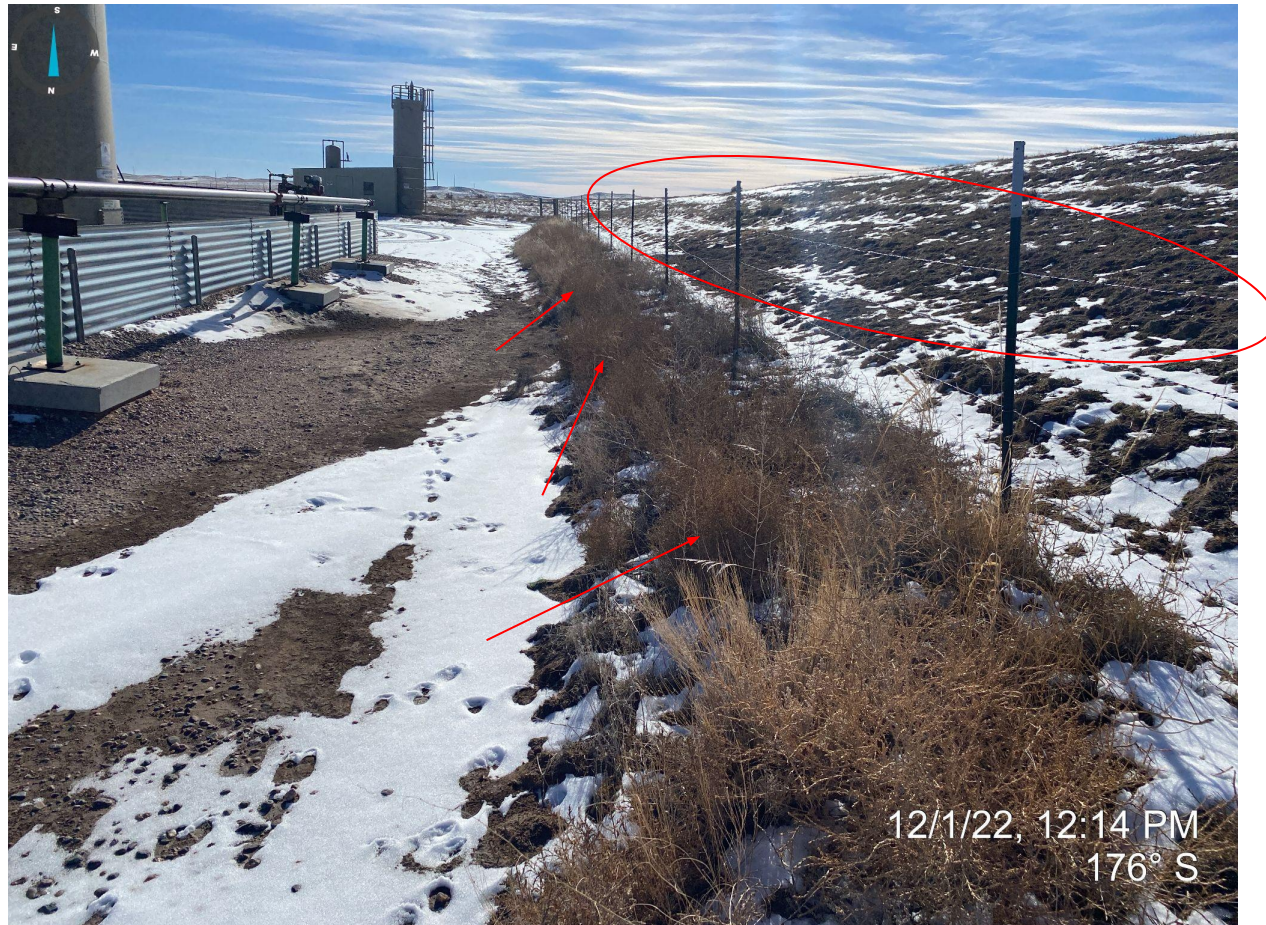
**Photo 6.** Taken from the western portion of the location, facing south. Photo illustrates evidence of undesirable vegetation (e.g. russian thistle and kochia) and also shows areas of bare soil within the cut slope for the location.
