# Inspection Photos

API: 071-09838

Operator: WAPITI OPERATING LLC

Inspection Date: 12/7/2022

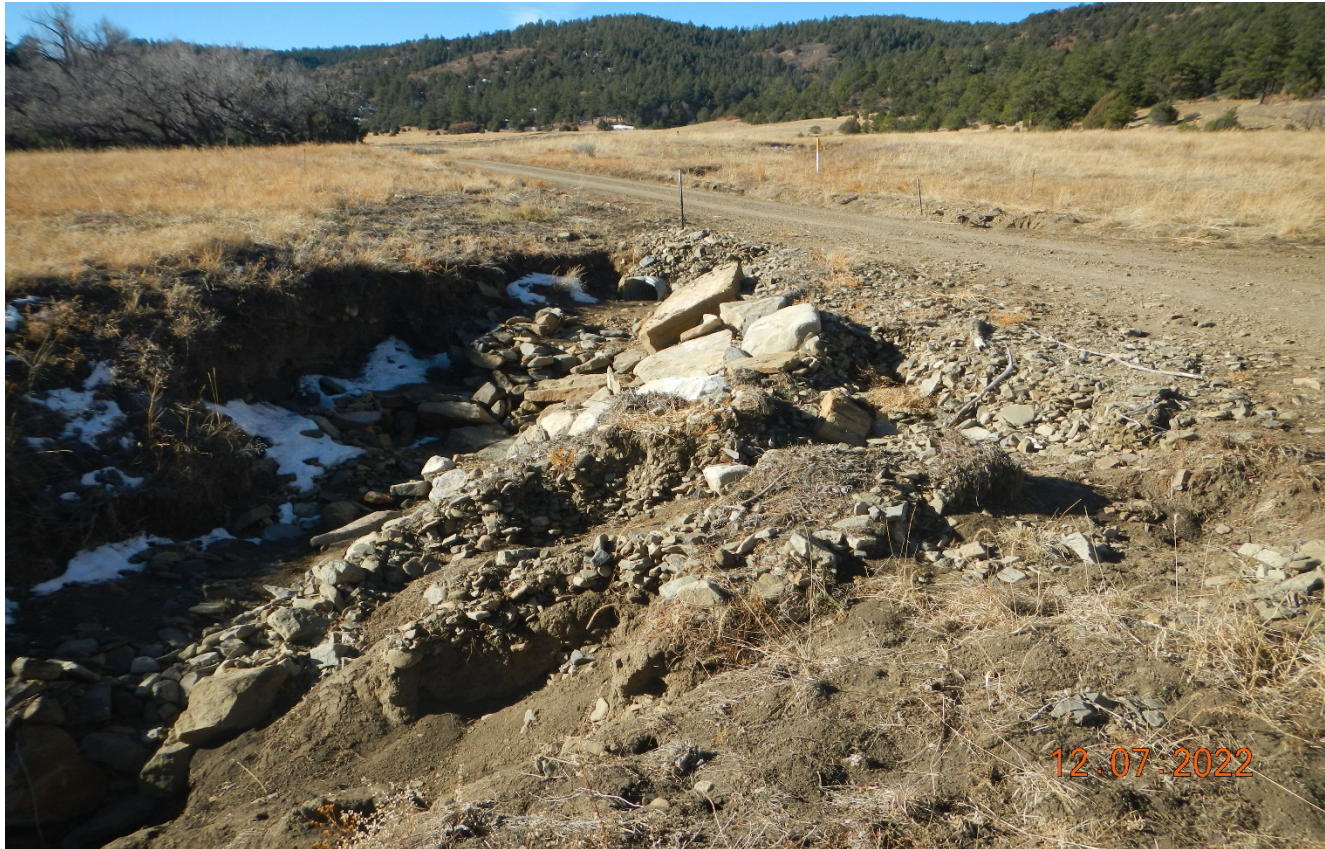
**Photo 1.** The culvert outlet has eroded and needs to be repaired. Previous corrective action was not completed.

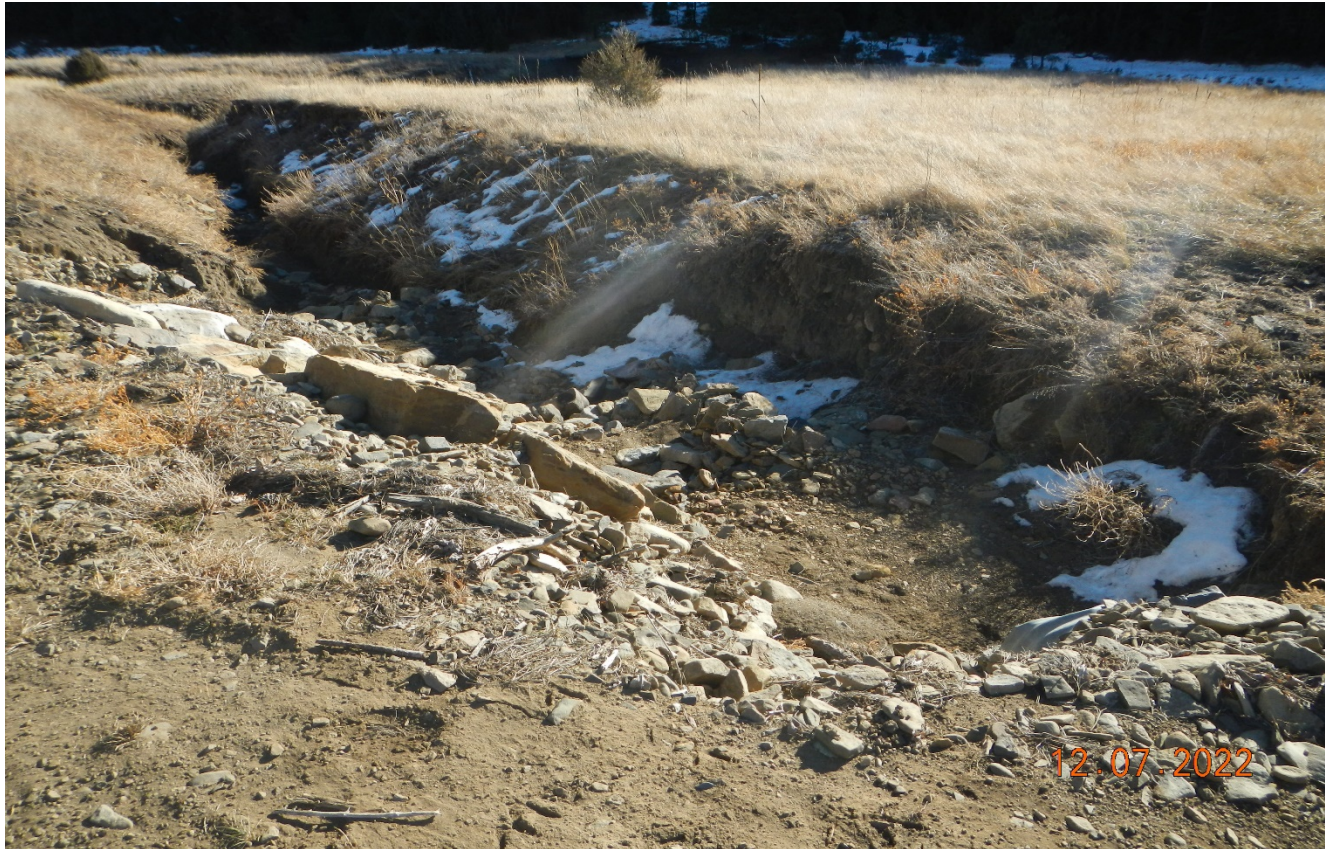
**Photo 2.** Facing toward the culvert outlet. The culvert outlet has eroded and needs to be repaired. Previous corrective action was not completed. BMP's must be installed per good engineering practice. (E.g. Rock outlet protection should include geotextile fabric)

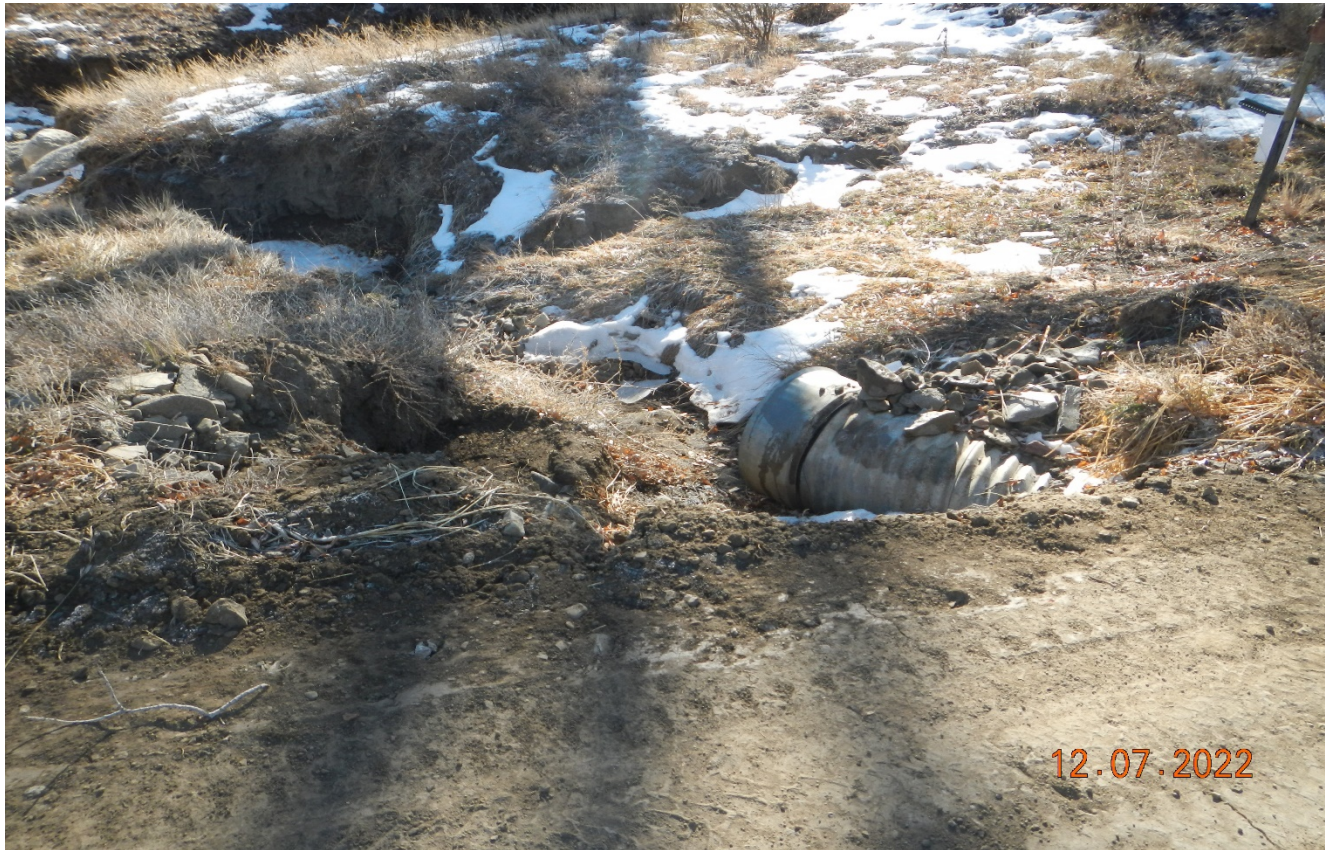
**Photo 3.** The next culvert along the road is also eroded at the culvert outlet with no outlet protection. Previous corrective action was not completed.

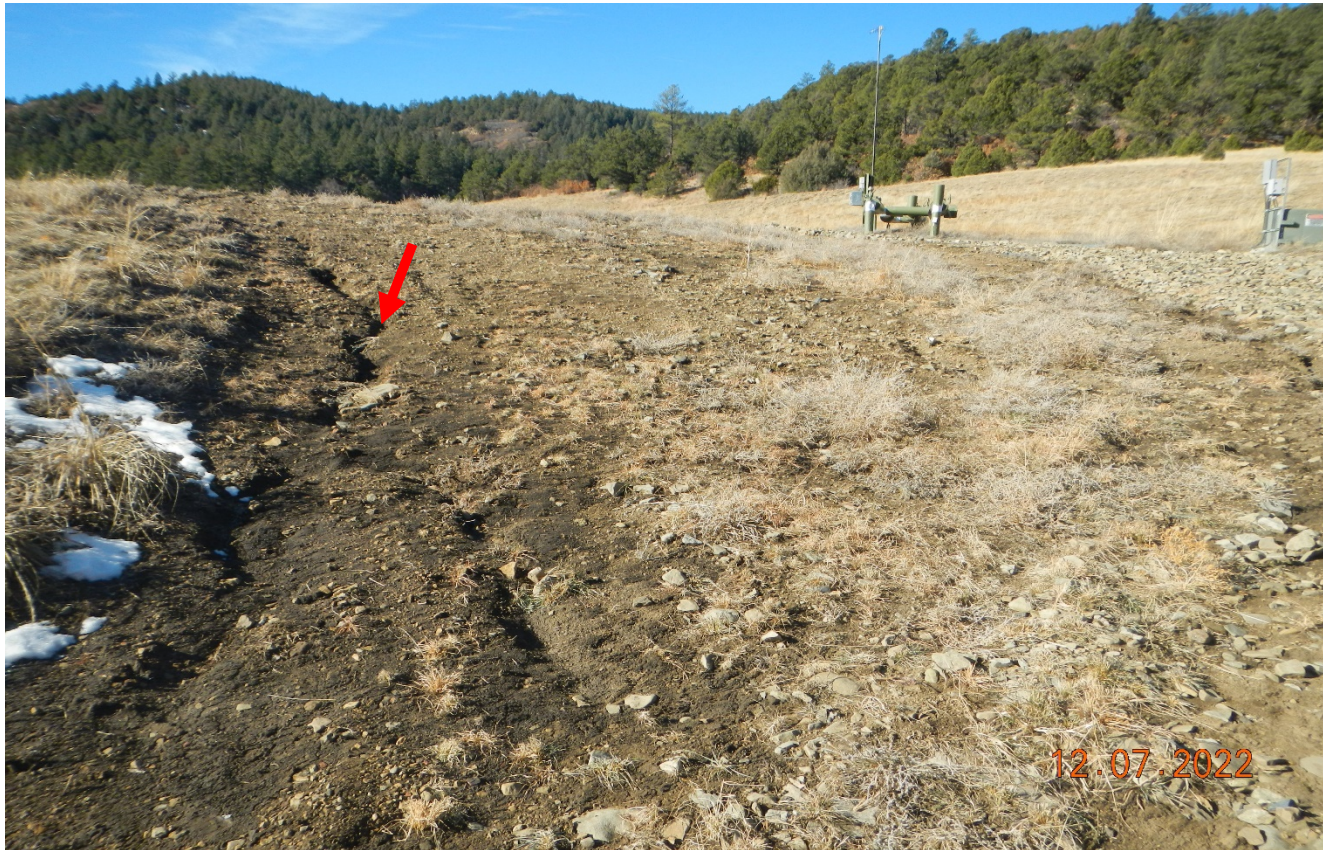
**Photo 4.** Facing southwest at the location. There is erosion occurring off the northeast side of the location. Additional BMP's need to be installed in this area.

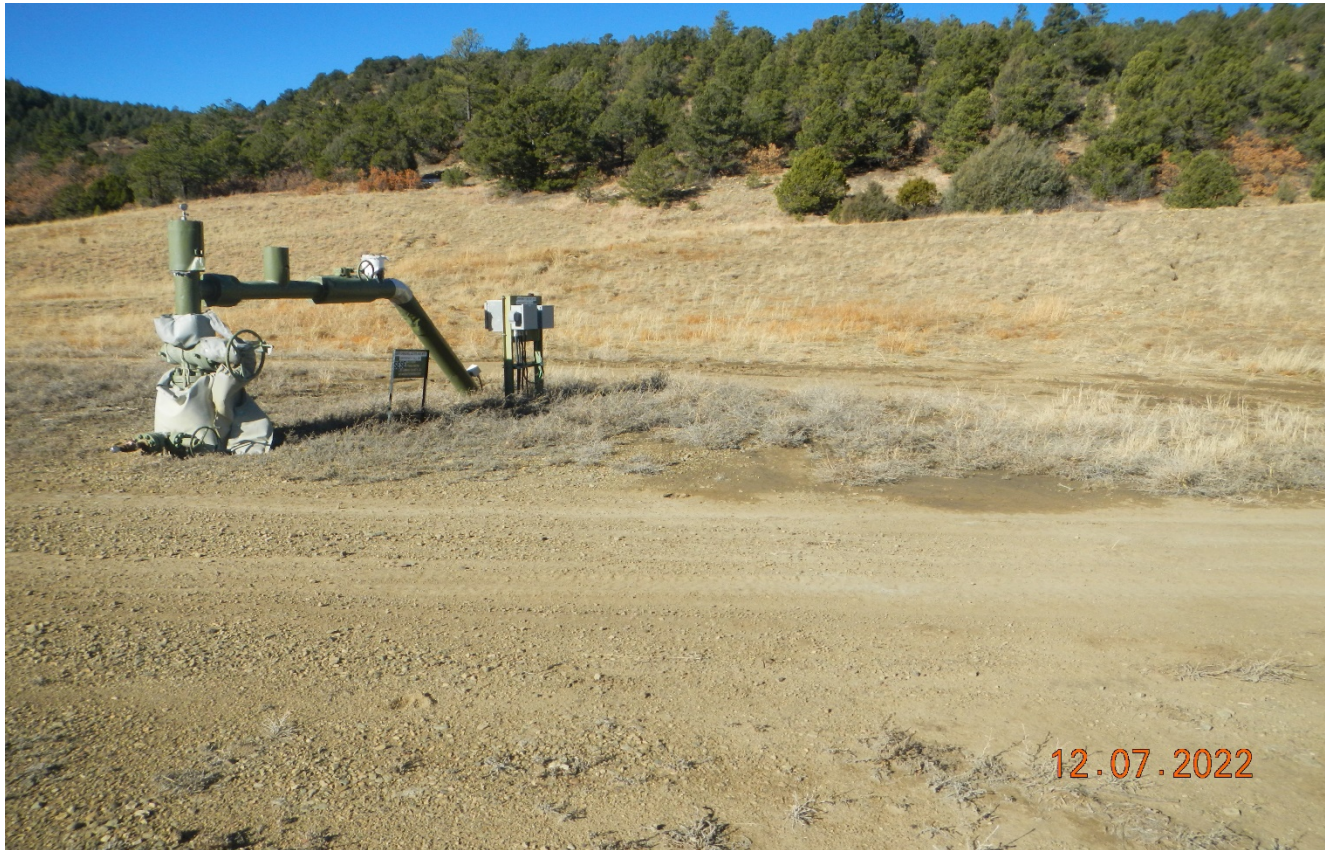
**Photo 5.** Facing northwest toward the wellsite.

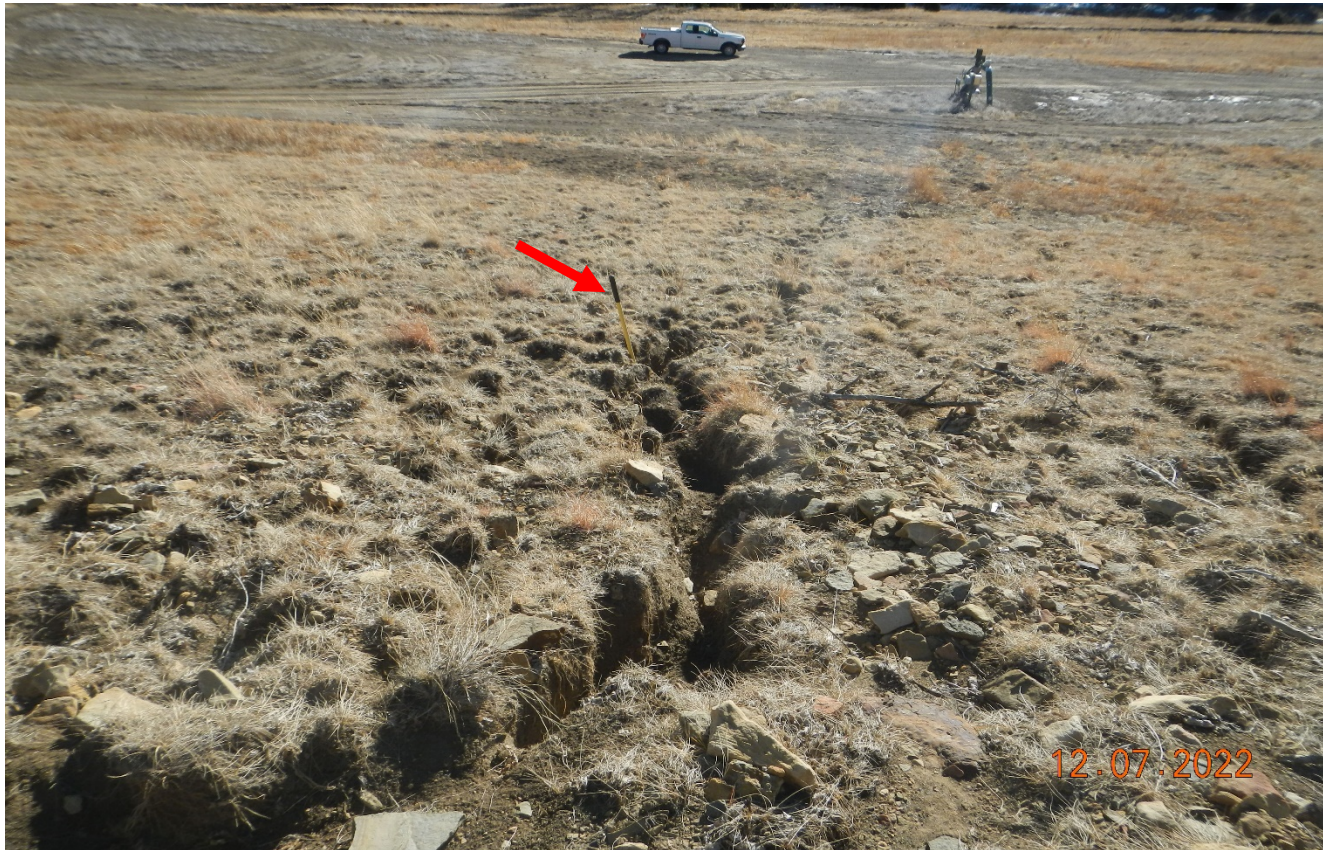
**Photo 6.** Facing east toward the location at the upper cut slope area. Stormwater run-on is causing erosion and is not properly diverted by the perimeter ditch. This area needs to be repaired and stabilized. Previous corrective action is not completed.

Red arrow points to 4.5 ft. shovel placed in the erosion channel.

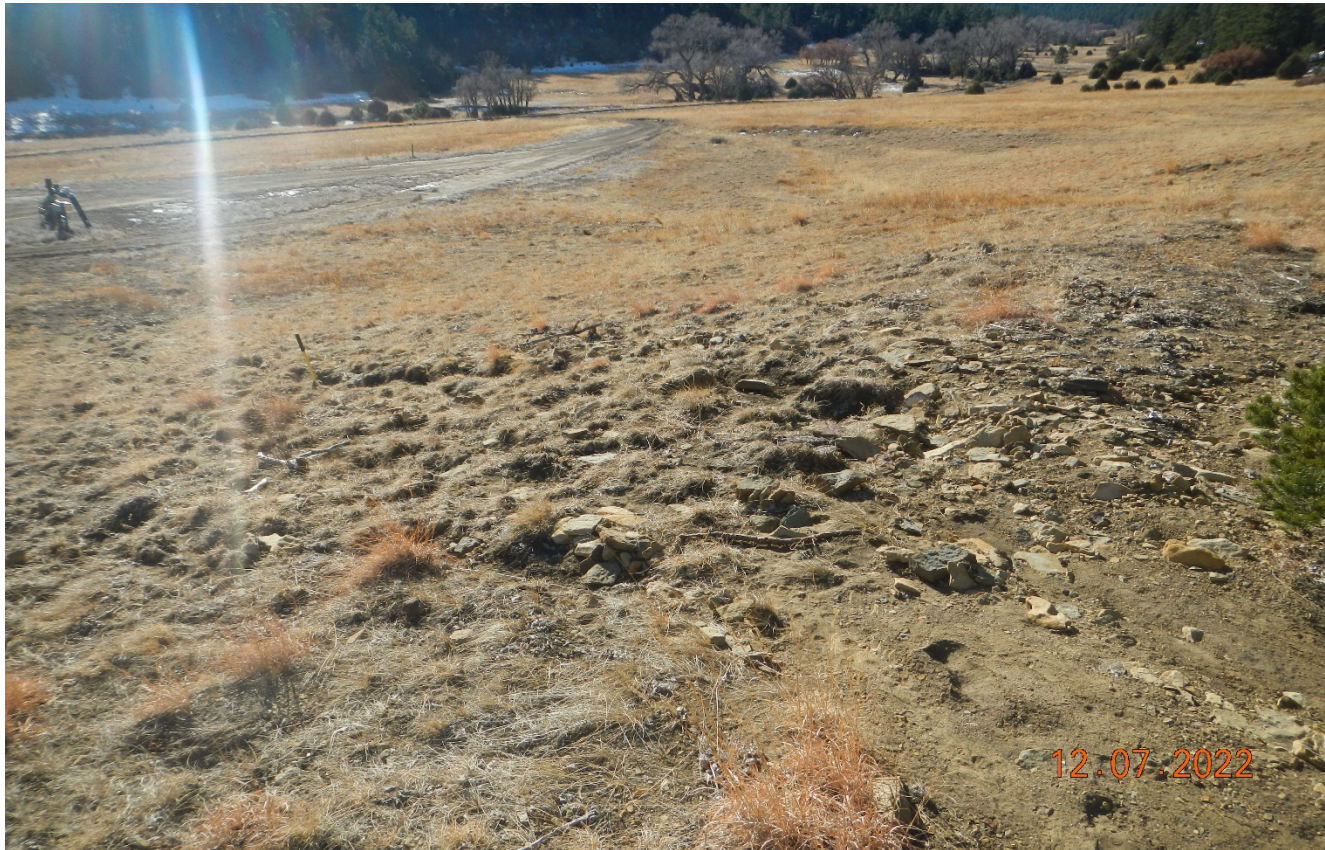
**Photo 7.** Facing south toward the run-on ditch which is filled in with sediment causing erosion of the cut slope. Previous corrective action is not completed.

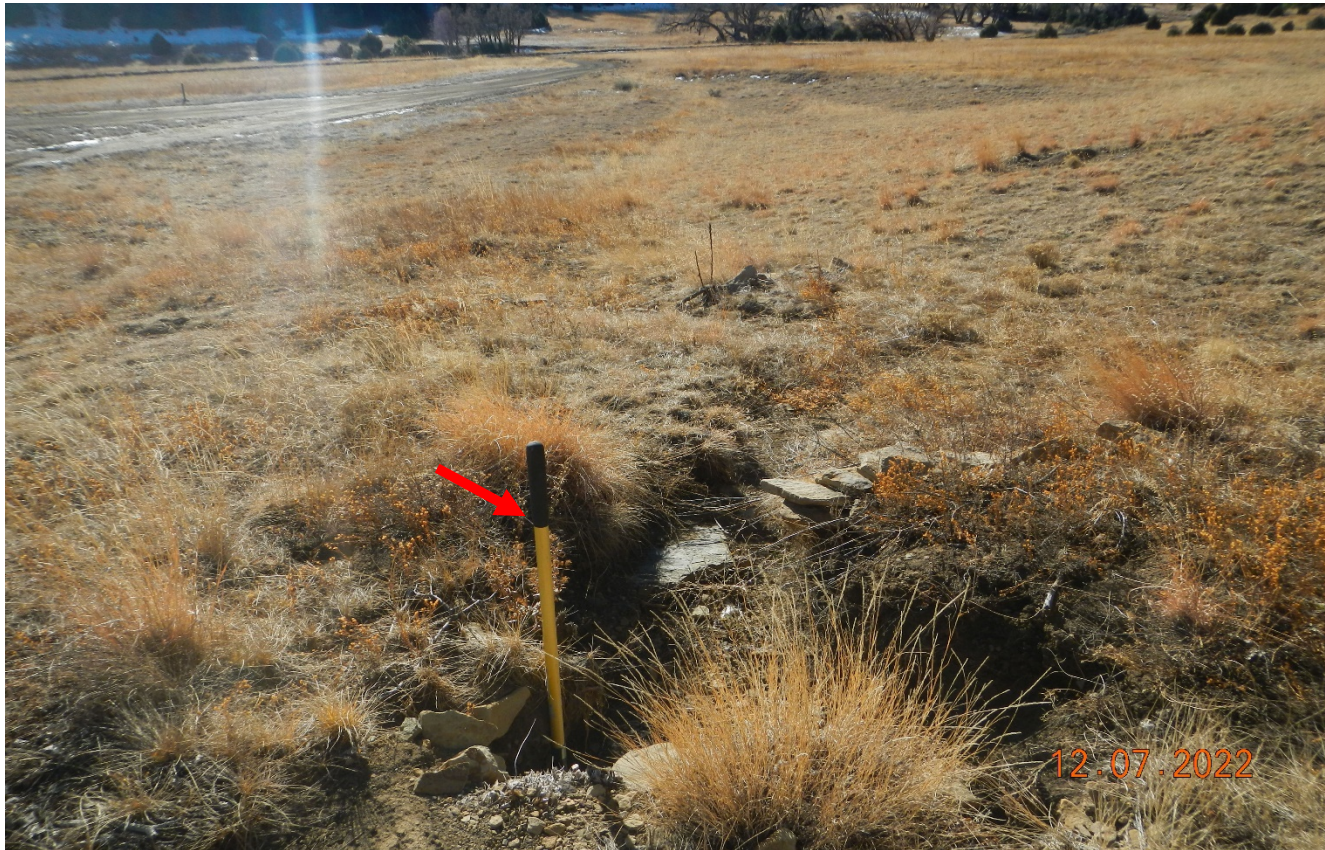
**Photo 8.** There are additional erosion channels along the south side of the location. Previous corrective action is not completed. Red arrow points to 4.5 ft. shovel placed in the erosion channel.
