Construction and Stormwater Inspection

Date: 12/01/2022

Operator: MORNING GUN EXPLORATION - 10656

Inspection Photos
Location Name: Castor 7-59
Location ID: 471039

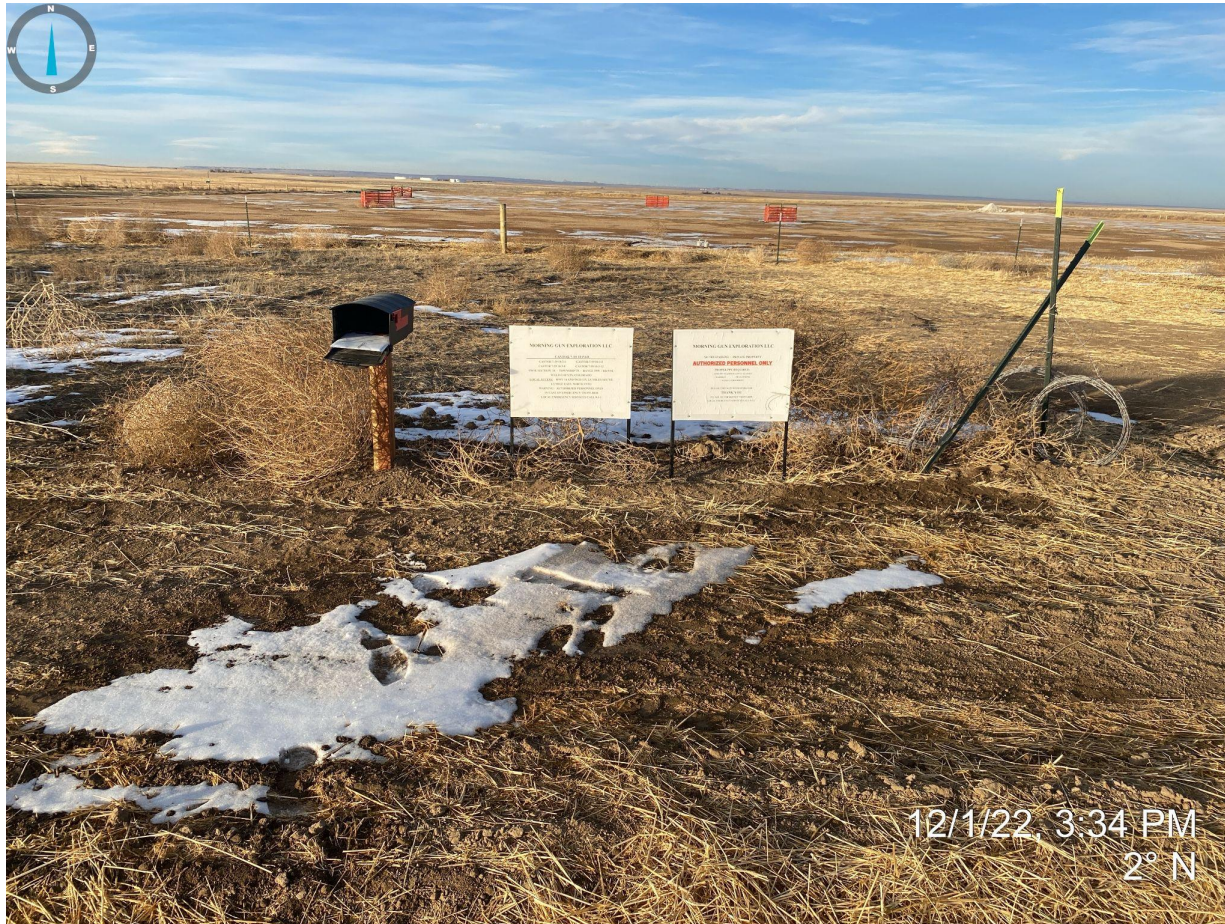
Photo 1. Facing north from entrance to location. Form 2A posted in a conspicuous location.

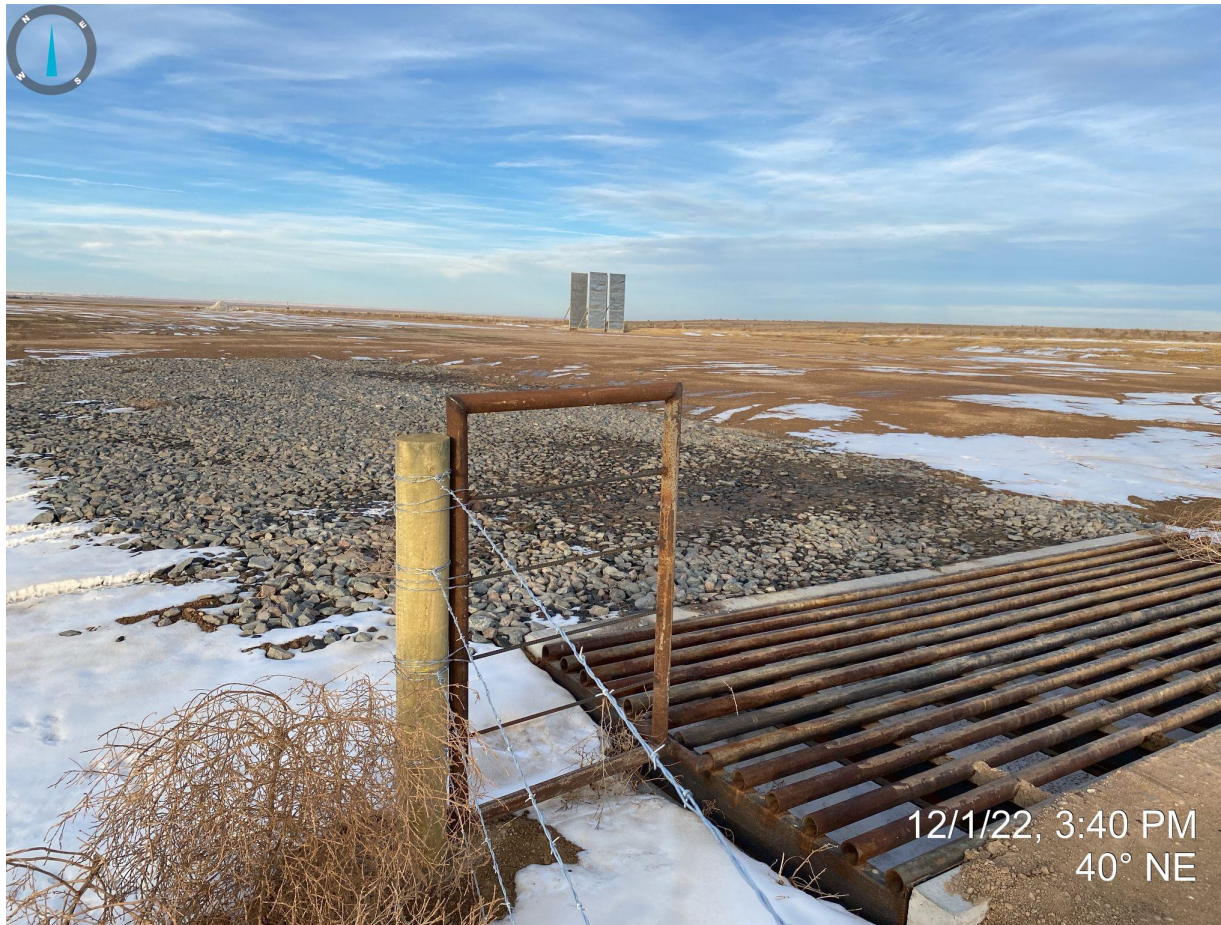
Photo 2. Facing northeast from entrance. Photo illustrates vehicle track out pad installed on location.

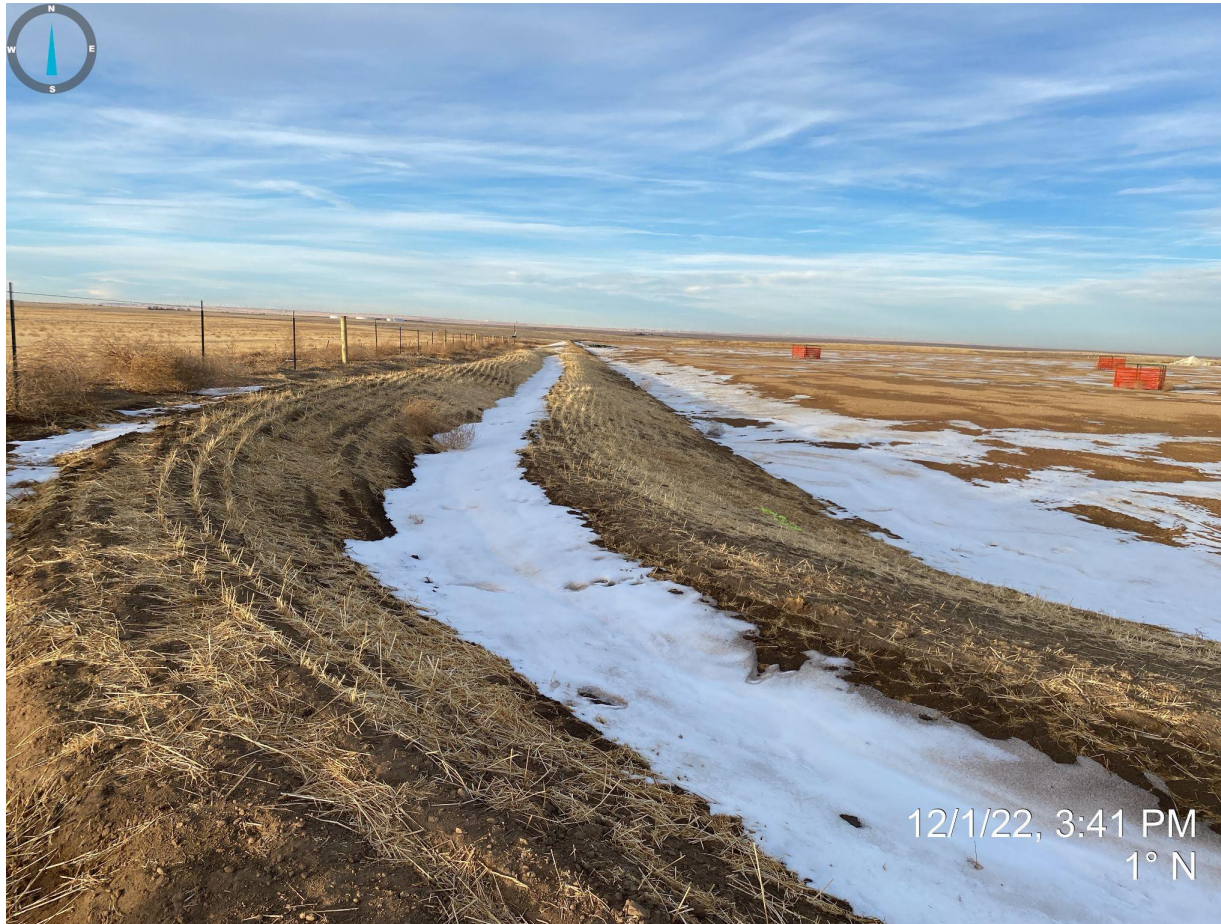
Photo 3. Taken from southwest corner, facing north. Photo illustrates the location has stormwater BMPs (e.g. ditch and berm) installed during the construction phase of the location. It appears the ditch and berm have been temporarily stabilized from wind and water erosion with evidence of drill rows and crimped mulch.

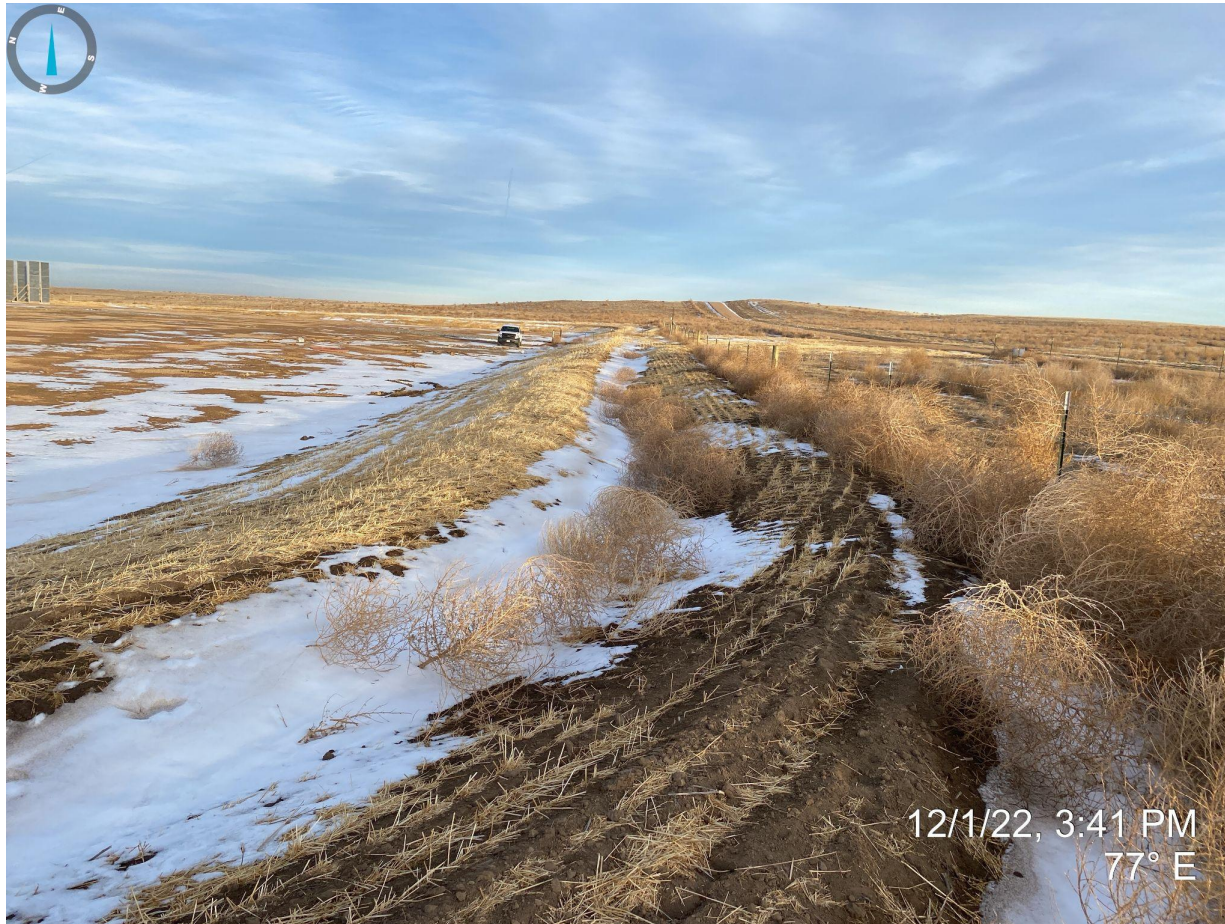
Photo 4. Facing east from the southwest corner. Tumbleweeds located throughout the location are considered debris and need to be removed.

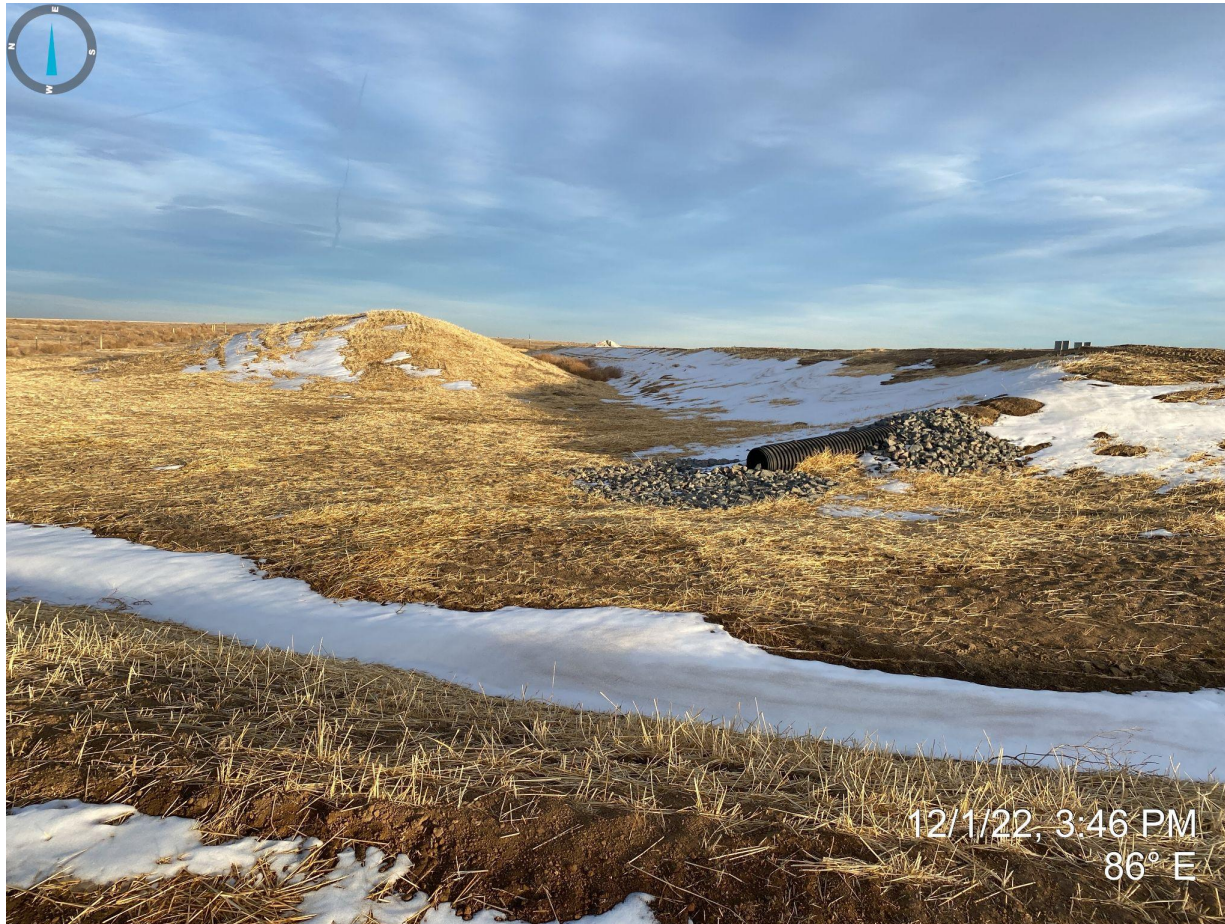
Photo 5. Facing east from the northwest corner of the location. Photo illustrates the topsoil stockpile has been temporarily stabilized with evidence of drill rows and crimped straw/mulch for long-term stabilization.

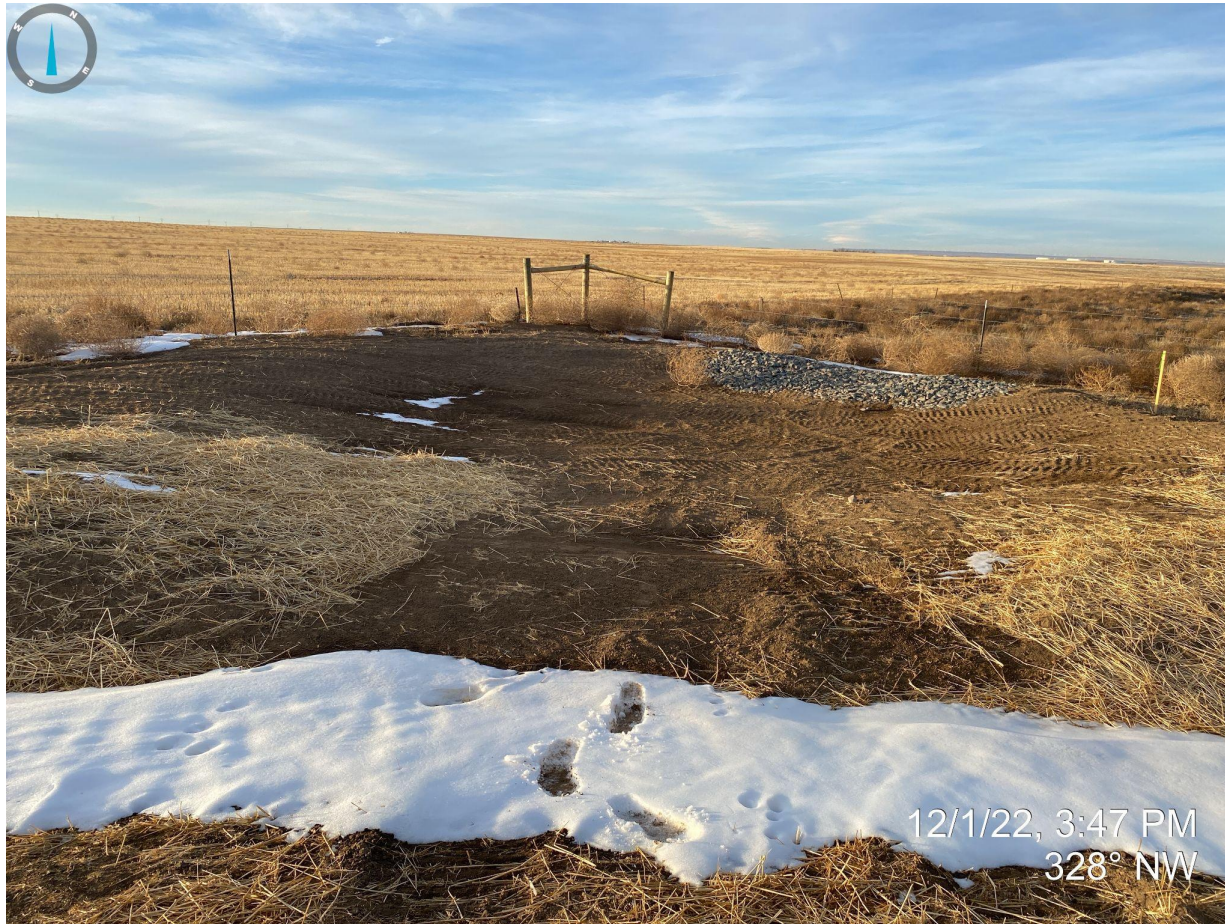
Photo 7. Facing northwest from the northwest corner of the location. Sediment trap appears inadequate in size to handle a 1-hour, 100-year stormwater event as per Weld County guidelines for stormwater management.

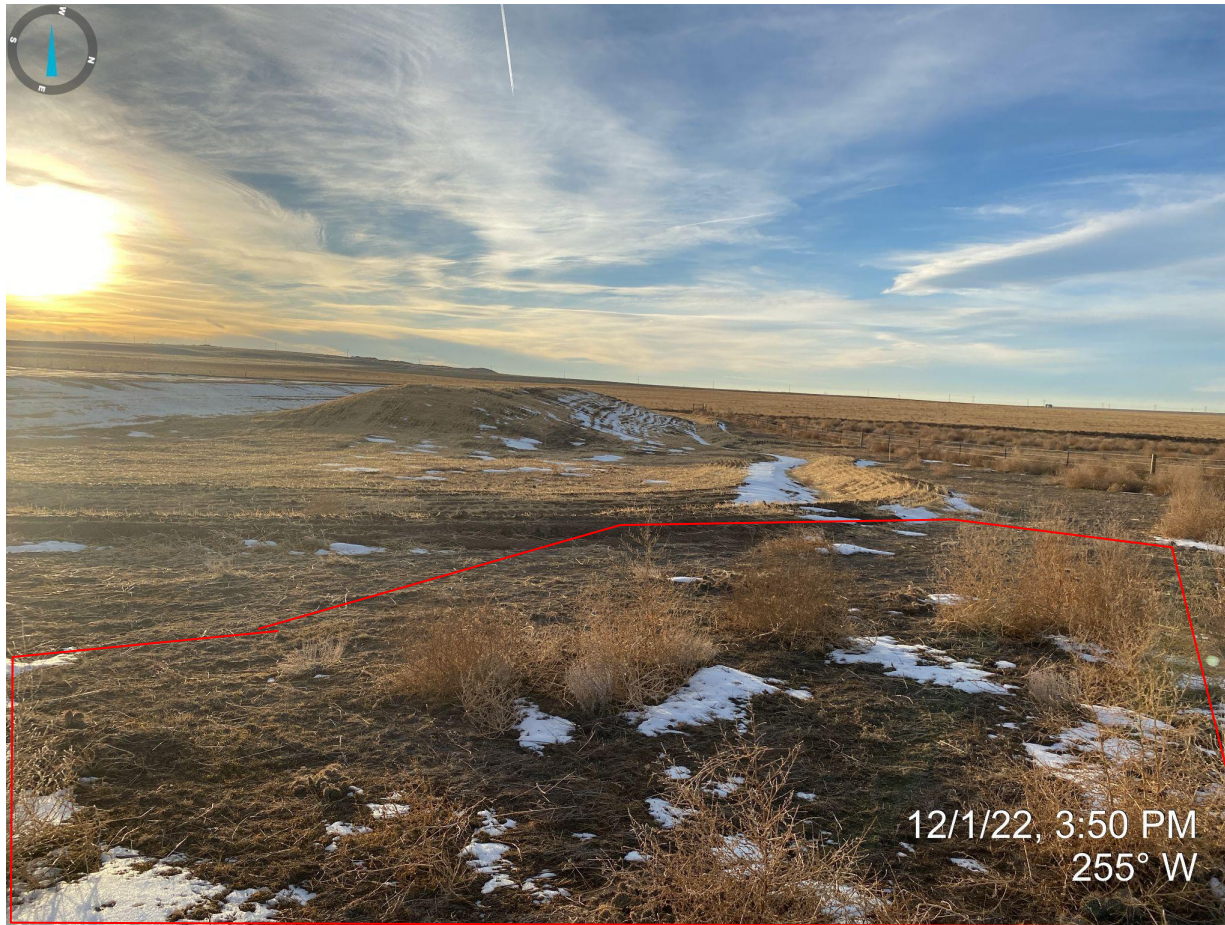
Photo 8. Facing west from the northeast corner of location. Photo illustrates perimeter ditch and berm and topsoil stockpile in background. Undesirable vegetation (e.g. kochia and russian thistle) observed; this is considered debris and needs to be managed/removed.

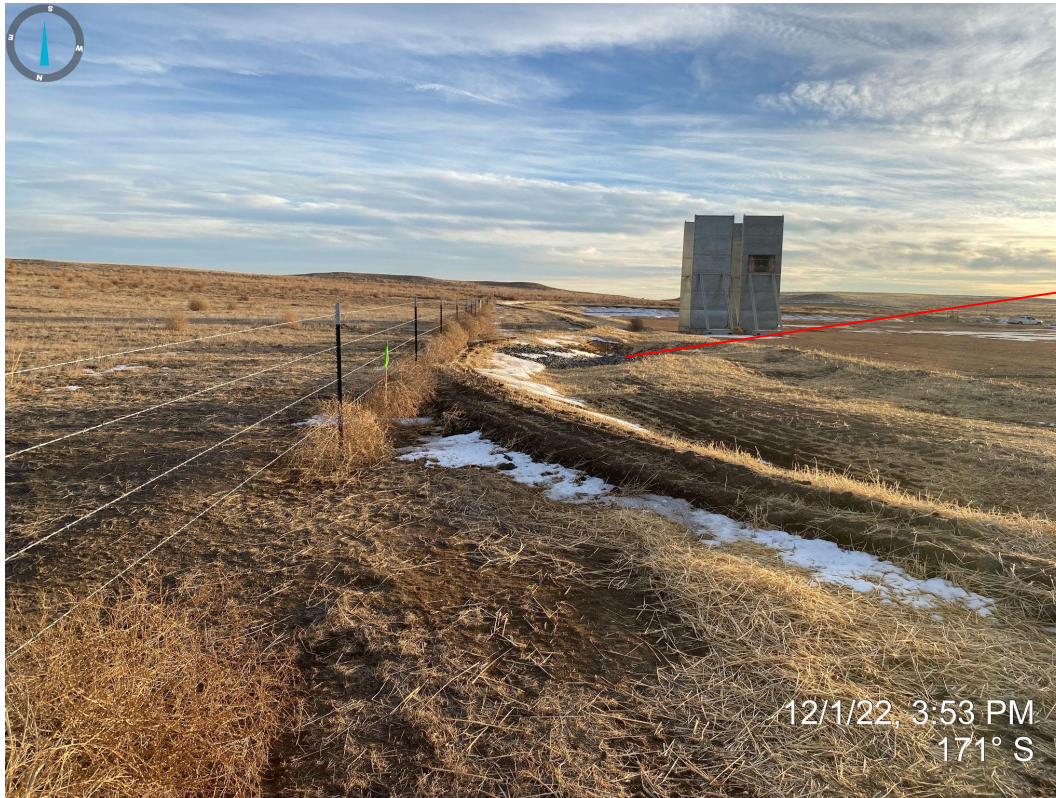
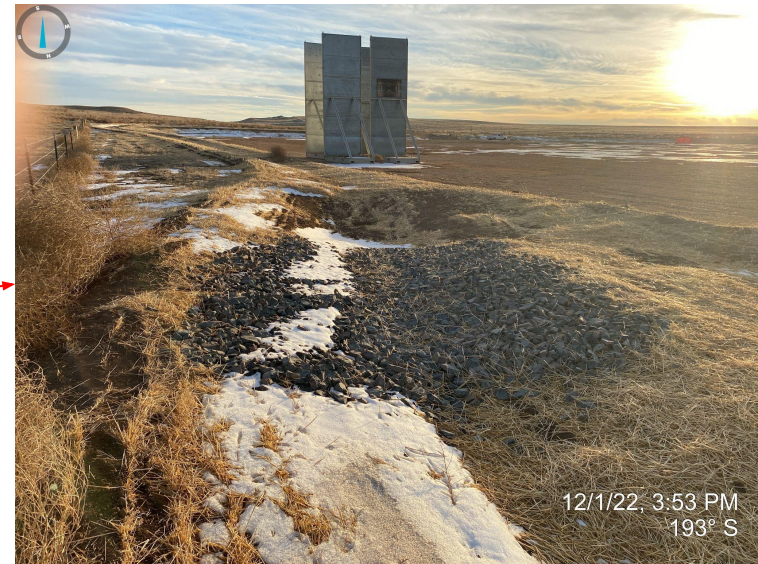
Photo 9. Facing south from the east portion of the location. Photo shows perimeter ditch and berm constructed with smaller sediment trap and outflow protection. Tumbleweeds gathered alongside of perimeter fence are considered debris and need to be removed.

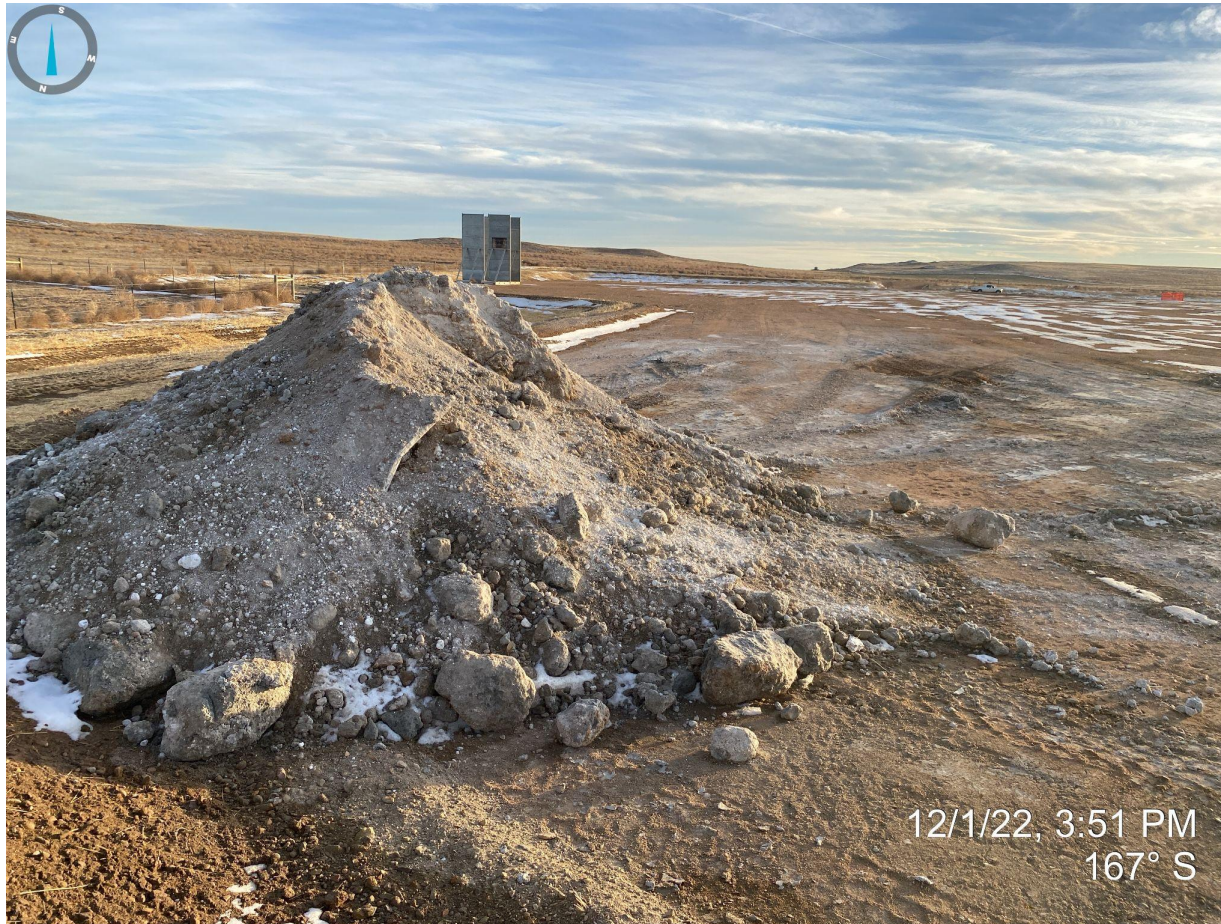
Photo 10. Facing south from the northeast corner of the pad. Photo shows a pile of concrete, without secondary containment, placed immediately adjacent to stormwater ditch and berm. This is considered debris and needs to be removed.

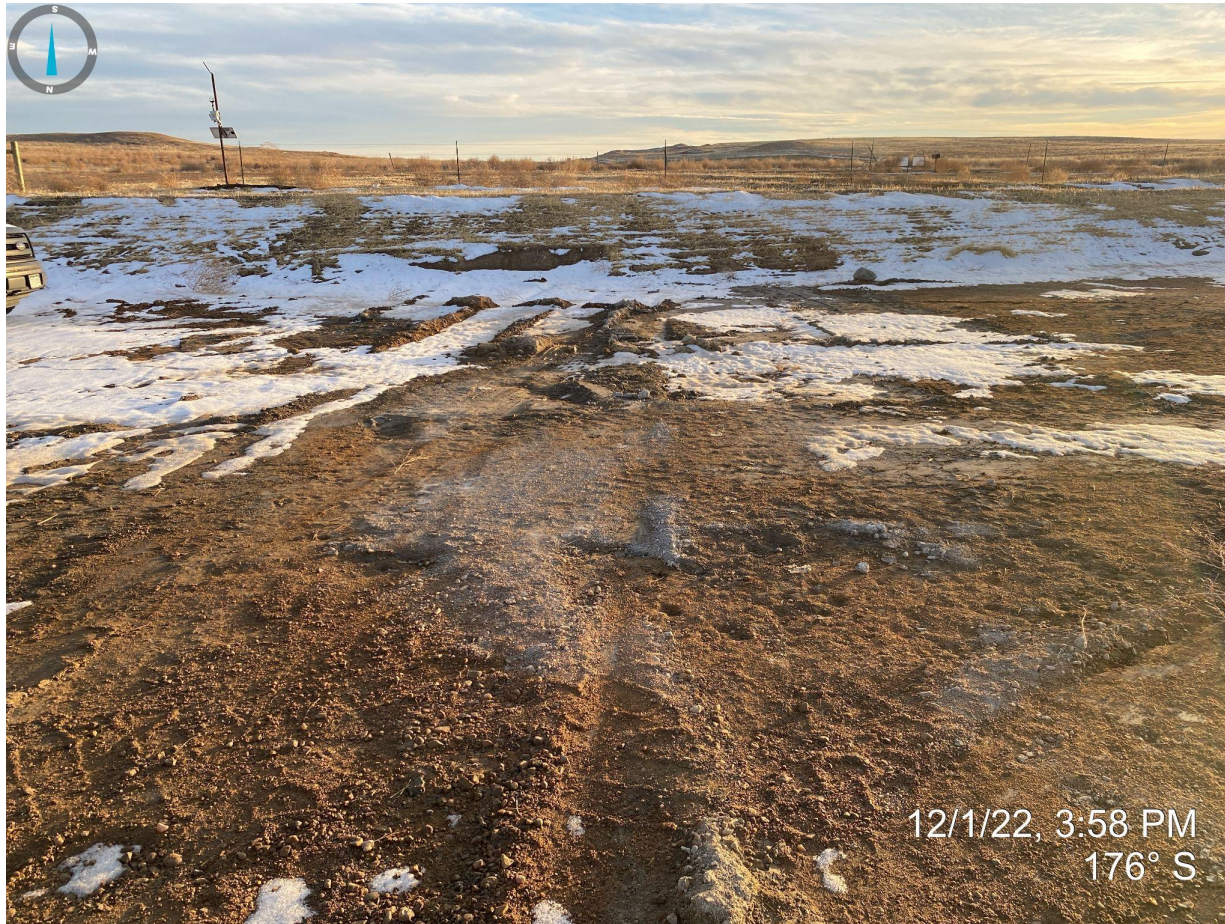
Photo 11. Facing south near the location entrance. Photo illustrates concrete debris/wash-out adjacent to interior ditch and berm. This is considered debris and needs to be removed.
