Inspection Photos

API: 071-07085

Operator: EVERGREEN NATURAL RESOURCES

Inspection Date: 12/12/2022

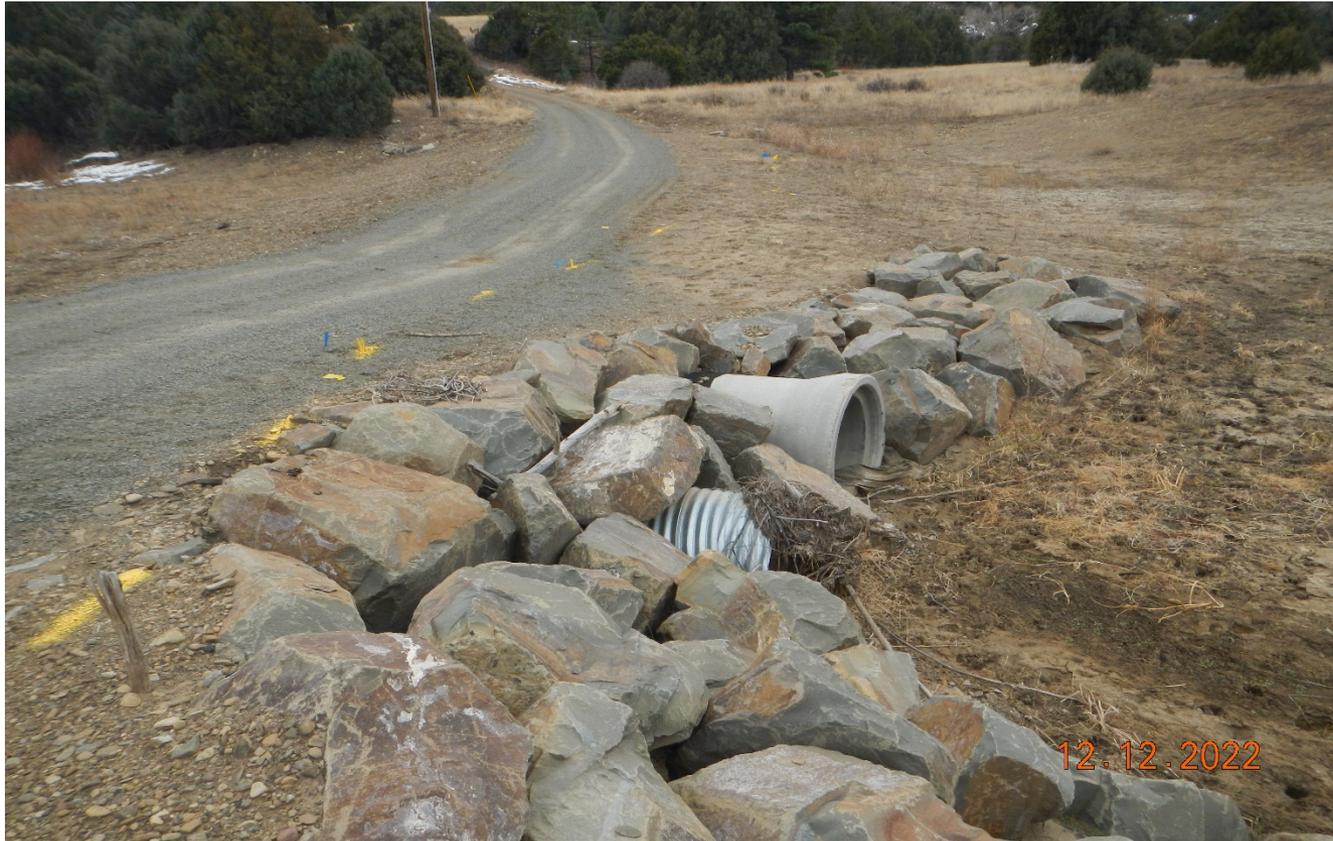
Photo 1. Facing south toward the access road stream crossing. It appears a recent storm event had overtopped the crossing. The two culverts are not sufficient to handle storm events. Previous corrective action not completed.

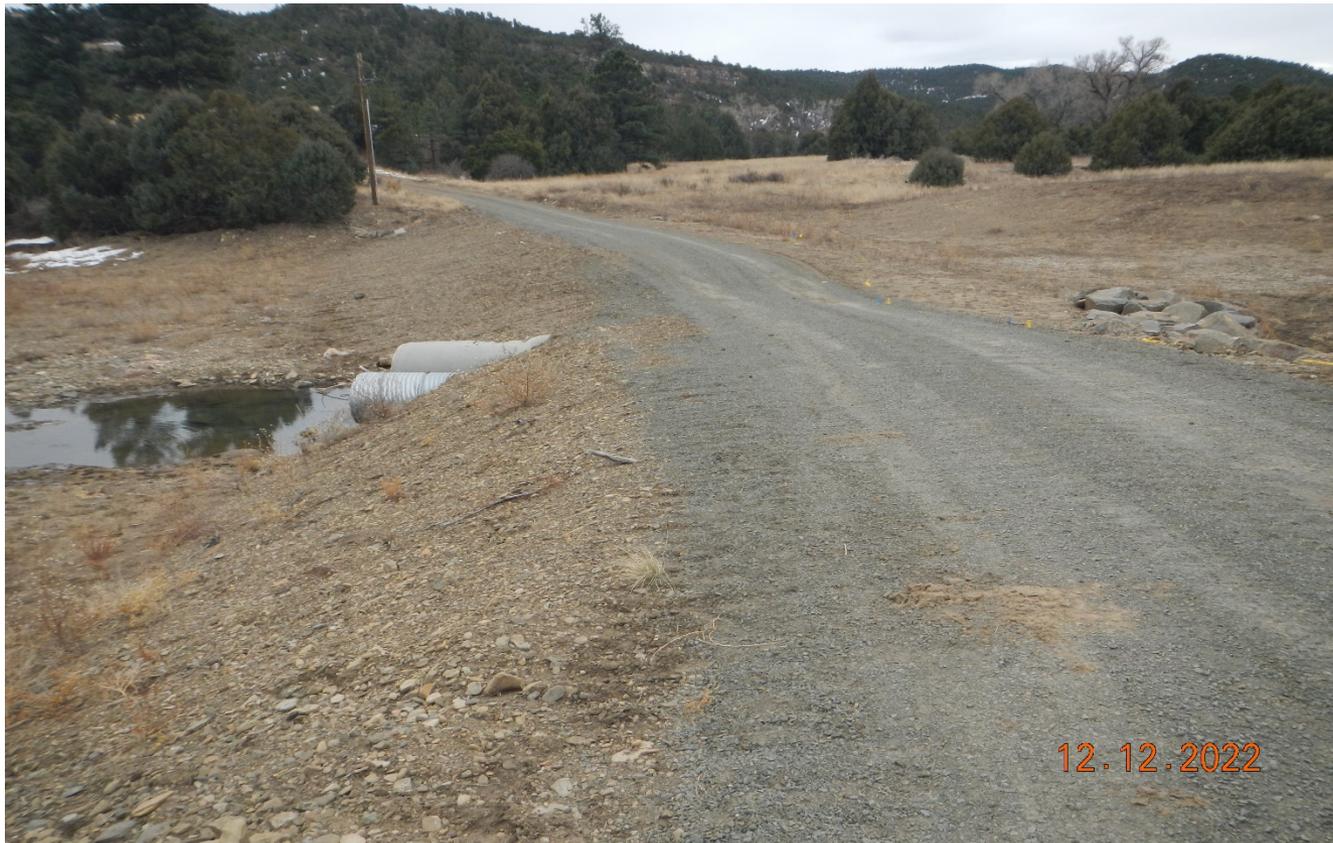
Photo 2. Facing south toward the access road stream crossing outlet side. There is no bank stabilization at the outlet side. Recent dozer work was performed in this area.

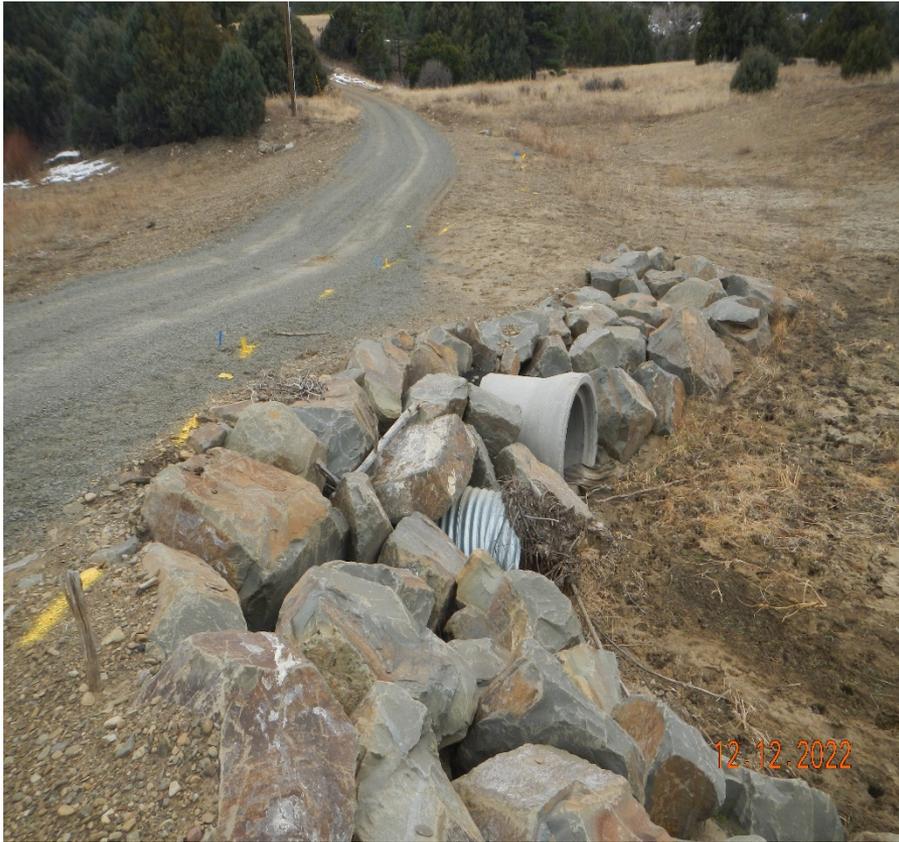
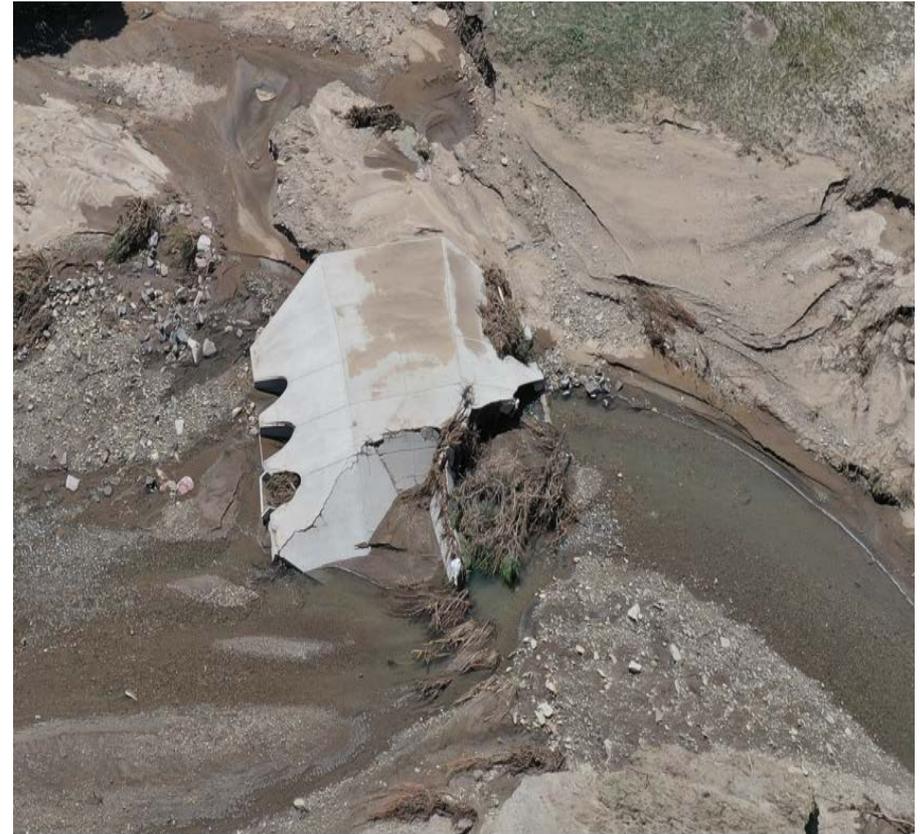
Photo 3. There are two culverts installed at the stream crossing. This appears to be inadequate as the prior cement culvert shown in the photo on the right had 3 large culverts.

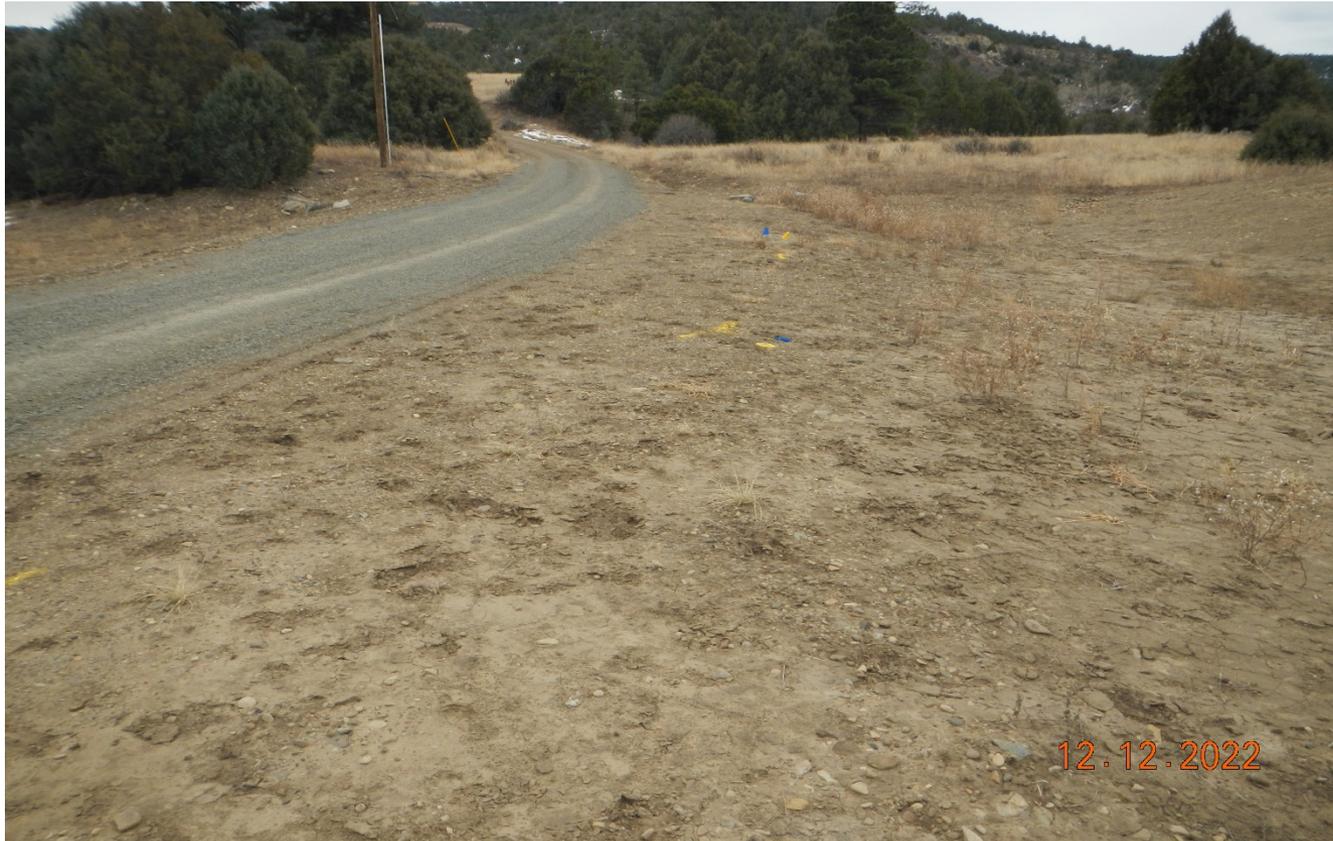
Photo 4. Facing northwest along the side of the access road. All disturbed areas along the road side need to be seeded and stabilized. Previous corrective action not completed.

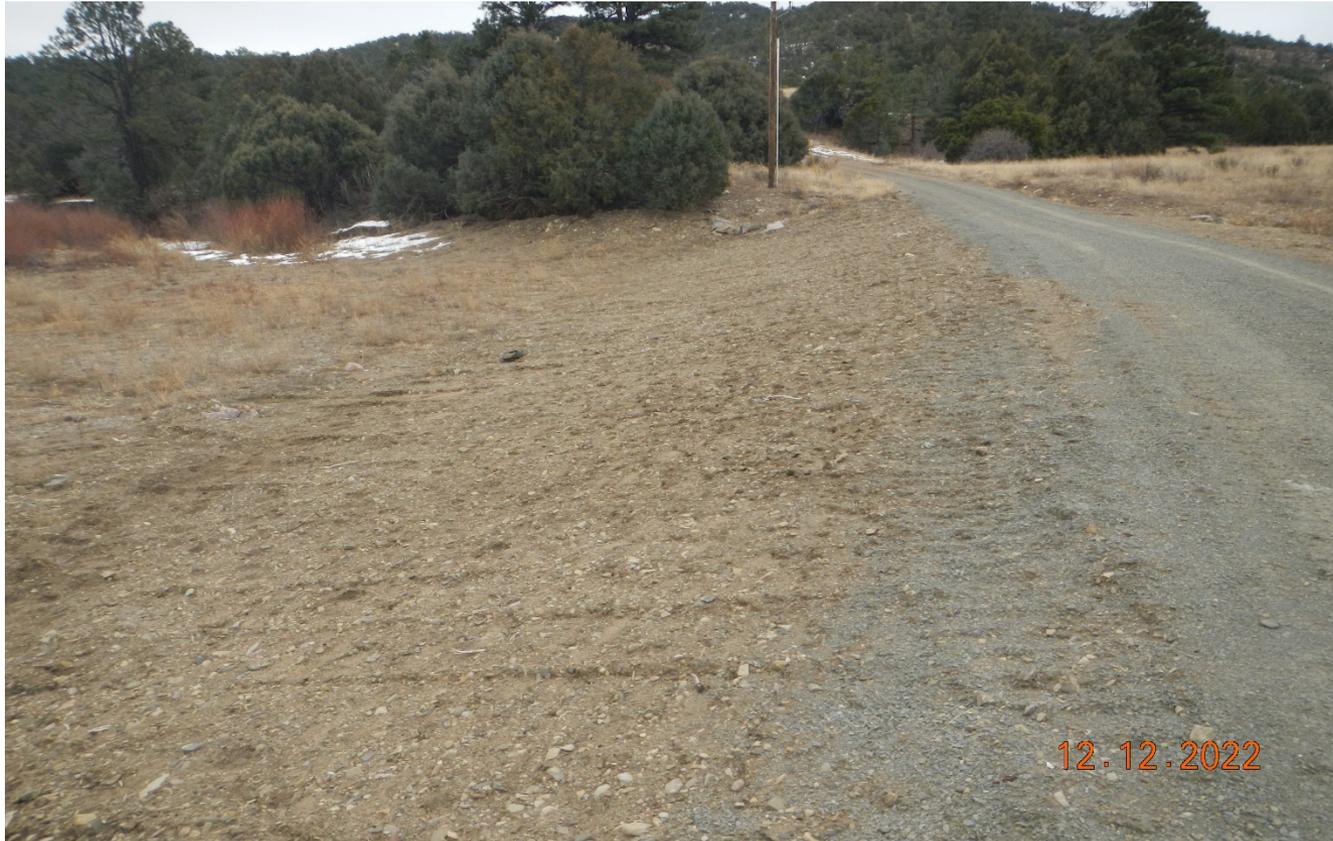
Photo 5. Facing northwest along the side of the access road. All disturbed areas along the road side need to be seeded and stabilized.
