Inspection Photos
Location: Hladky O'Gorman
Facility ID: 480225

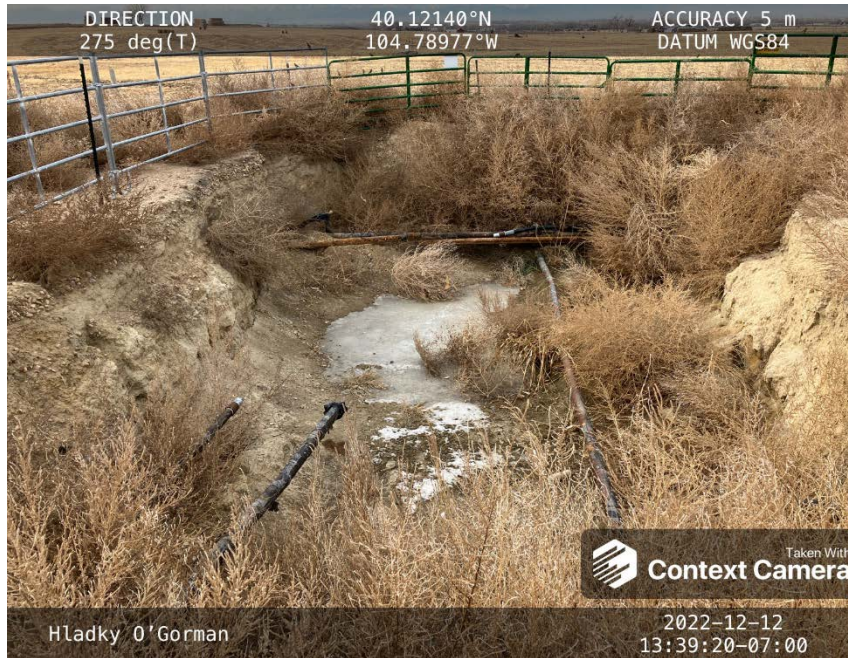
Photo 3 – Weeds overgrown

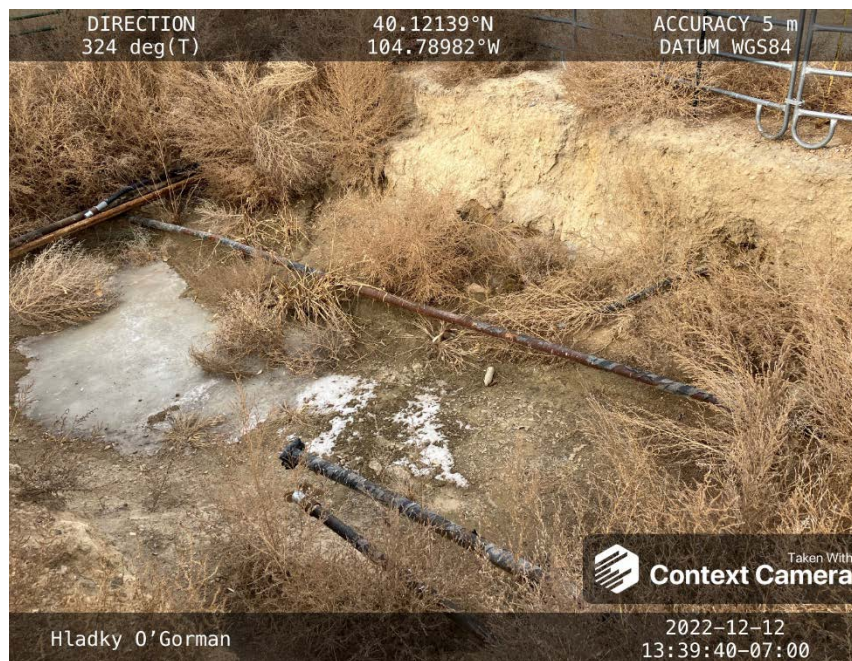
Photo 5 – Frozen groundwater

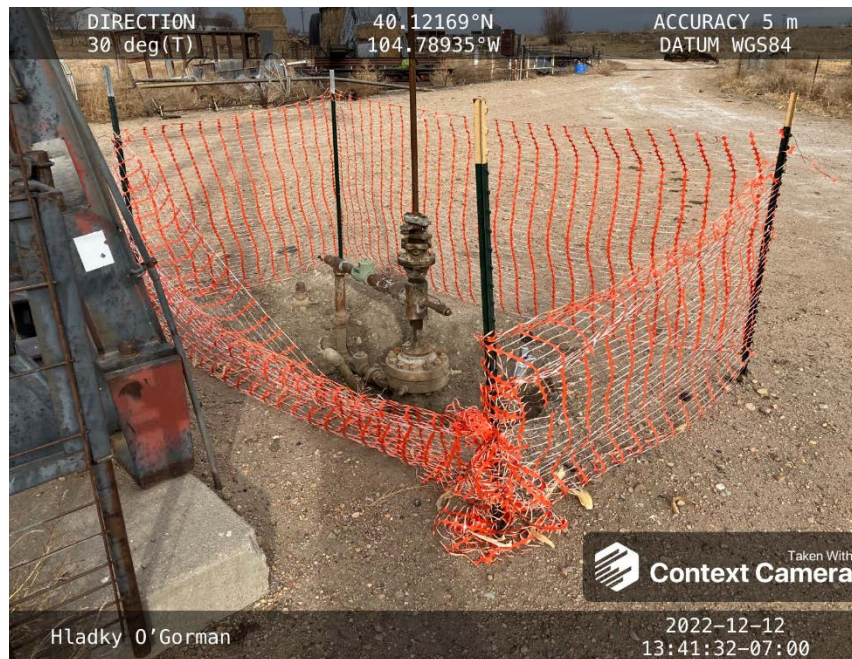
Photo 17 – Inadequate fencing around the excavation

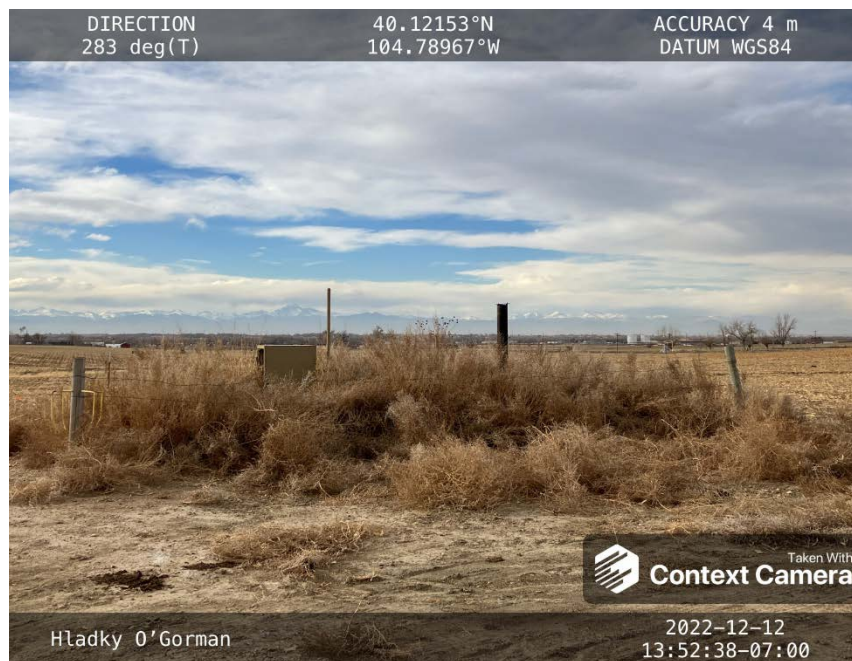
**Photo 23 – Weeds overgrown around separator.
Separator is not visible due to amount of weeds**
