Inspection Photos

API: 061-05138

Operator: WESTERN OPERATING COMPANY

Inspection Date: 12/20/2022

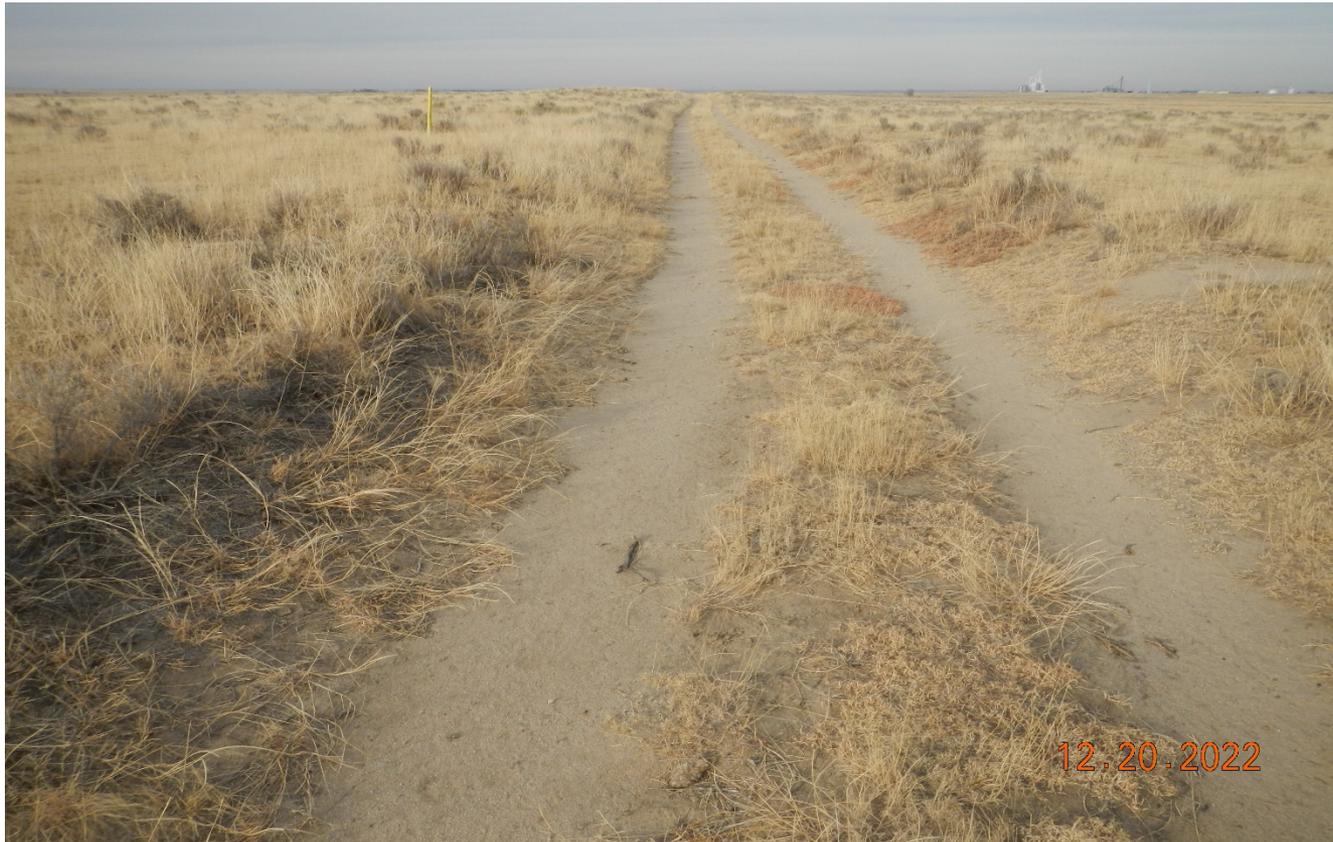
Photo 1. Facing north along the access road which has not been recontoured and reclaimed. Previous corrective action not completed.

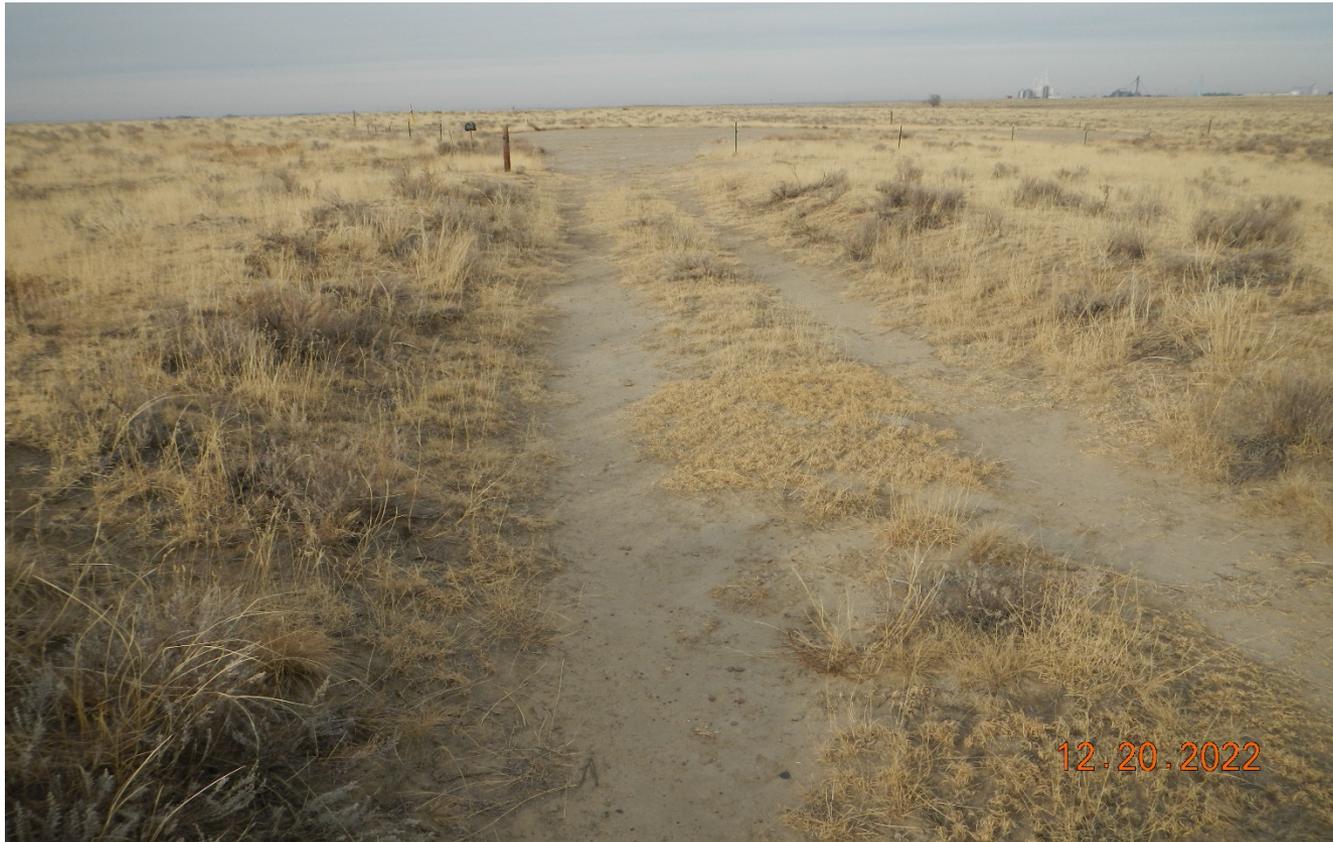
Photo 2. Facing northwest toward the former tank battery site located 300' southwest of the well site. The access road has not been reclaimed.

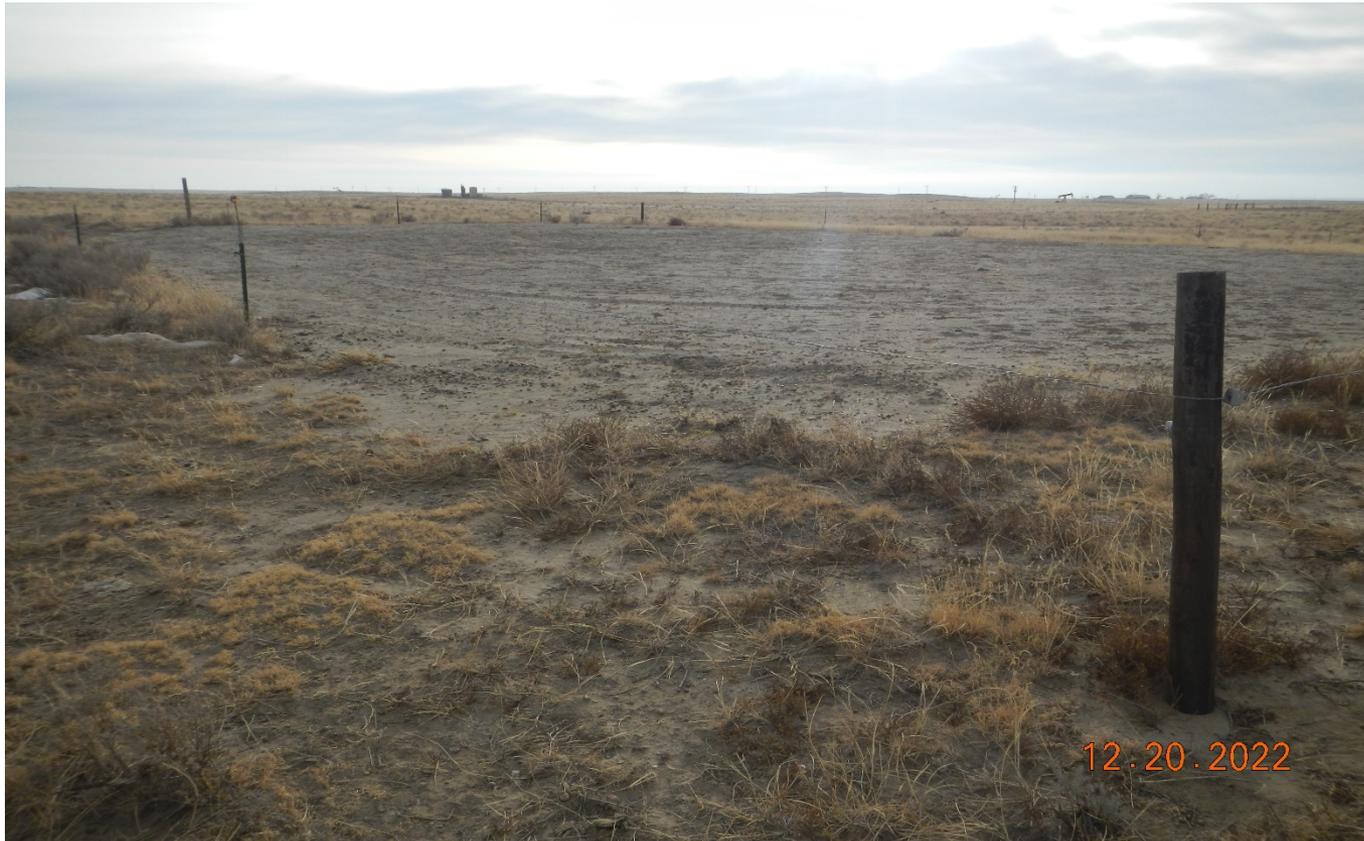
Photo 3. Facing southwest toward the former tank battery site located 300' southwest of the well site. This area has been recontoured and pipe risers have been removed.

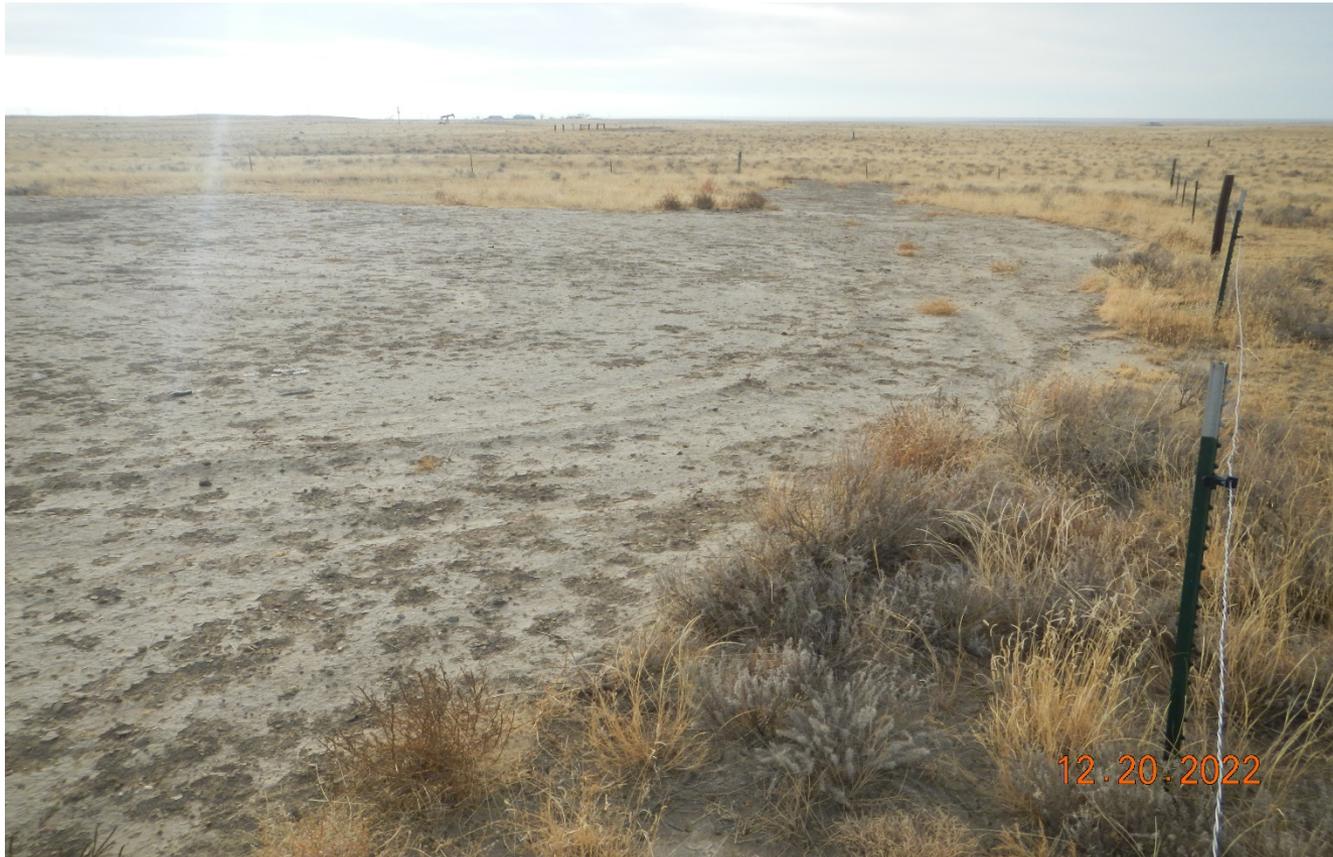
Photo 4. Facing south at the recontoured battery site. There are no stormwater controls installed down gradient and bare soils are susceptible to erosion.

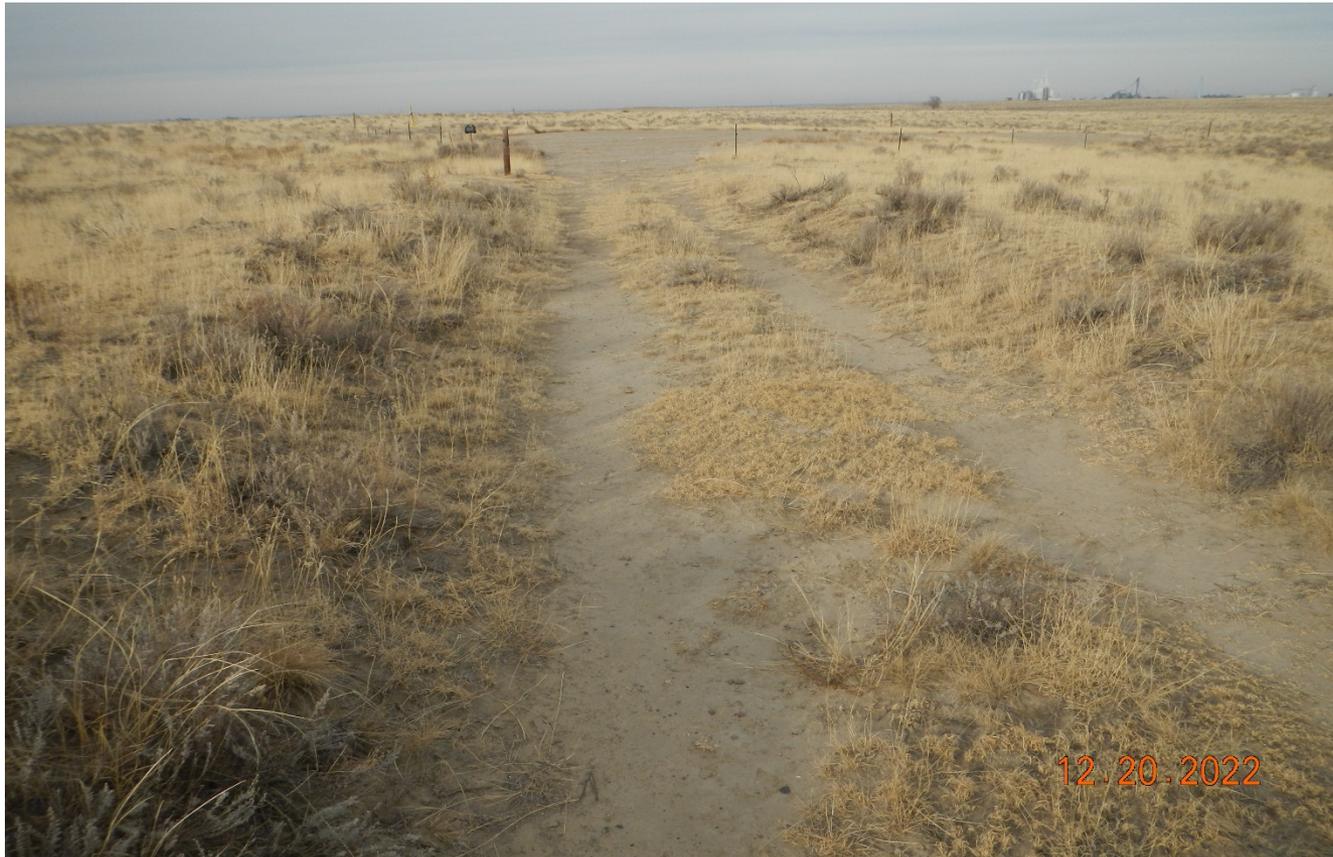
Photo 5. Facing north toward the well site. The access road has not been reclaimed.

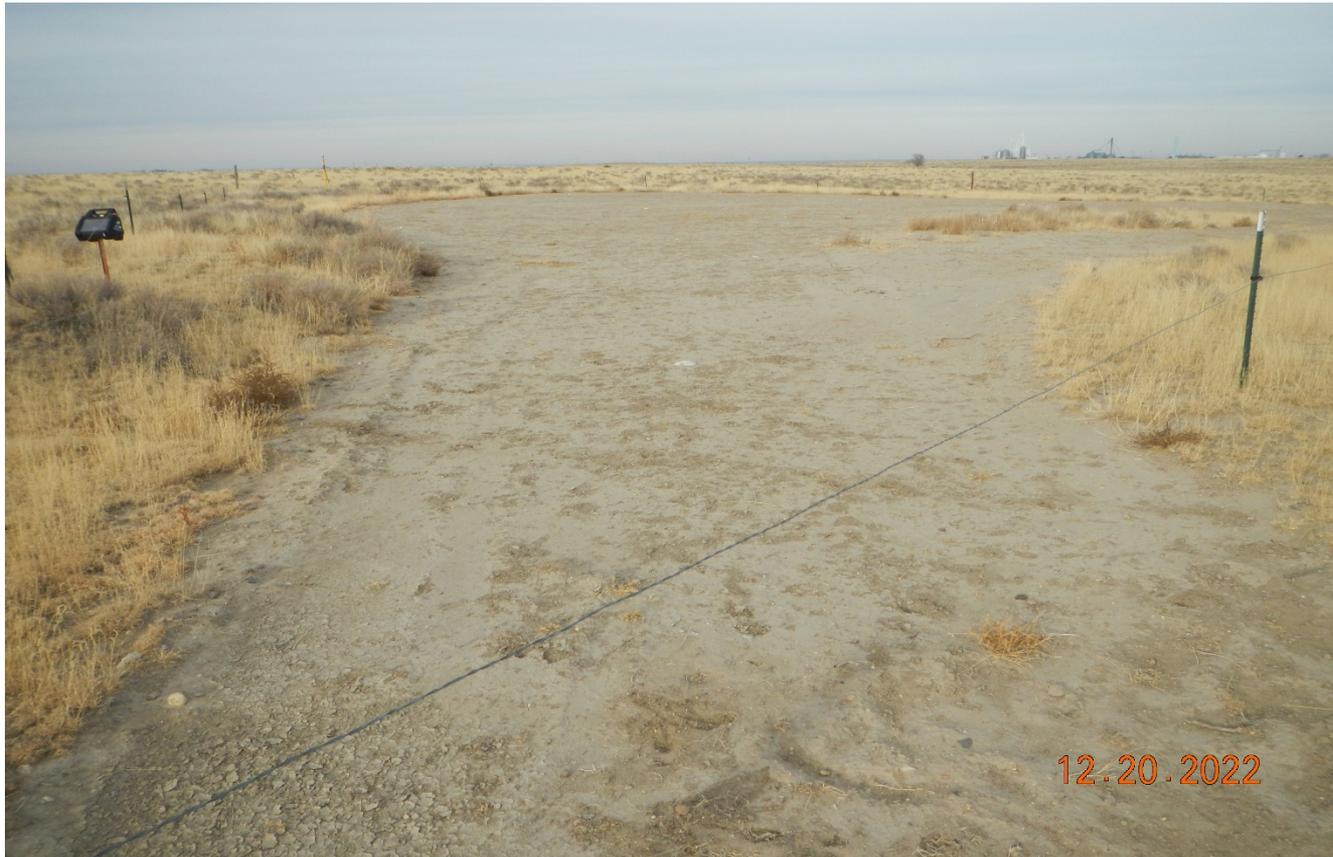
Photo 6. Facing northeast toward the abandoned well site. This area has not been reclaimed. Bare soils that are not stabilized and are susceptible to erosion. This area has been recontoured and decompacted.
