Inspection Photos

API: 061-06844

Operator: JETTA OPERATING COMPANY INC

Inspection Date: 12/21/2022

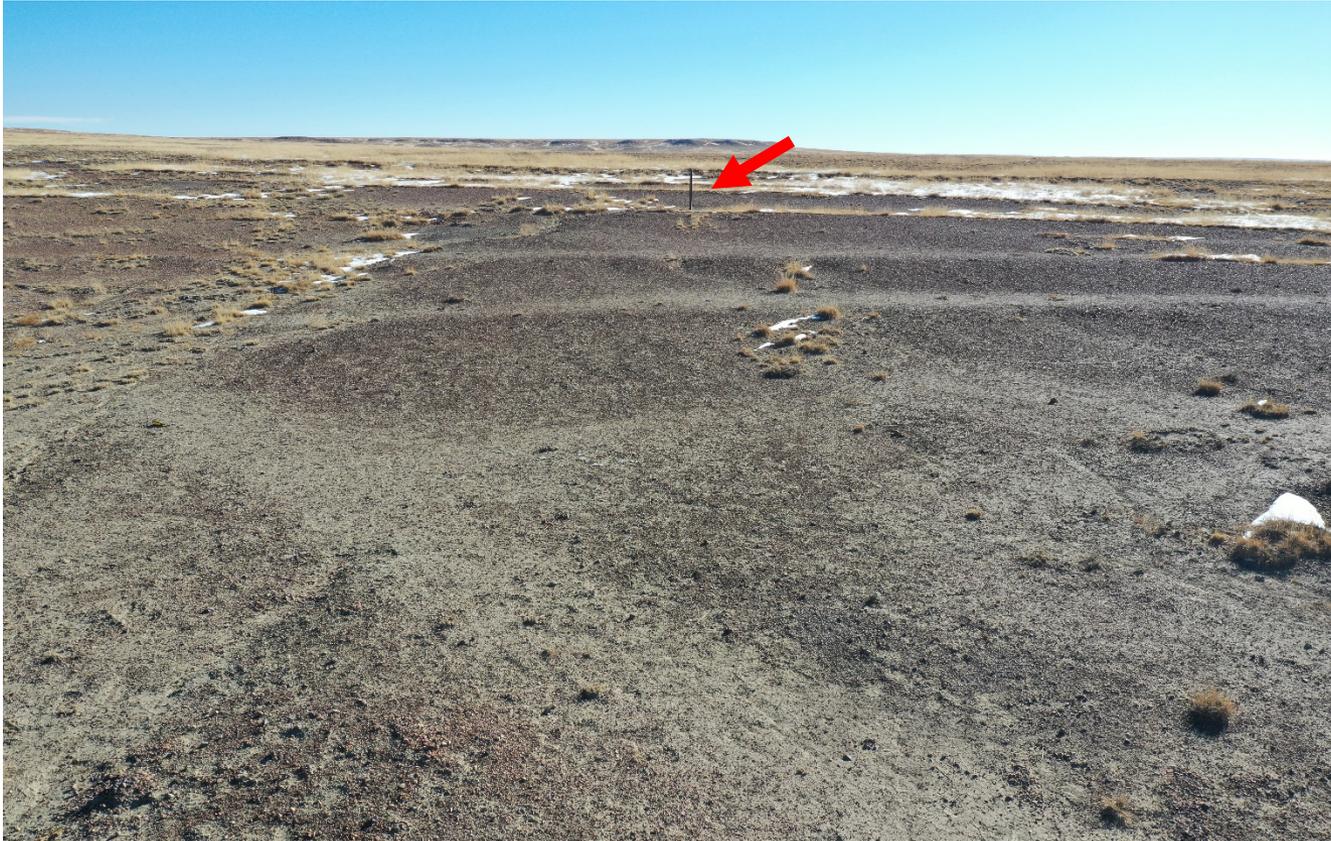
Photo 1. Facing east toward the location. There are areas at the location with no vegetation cover. Red arrow points to the well marker.

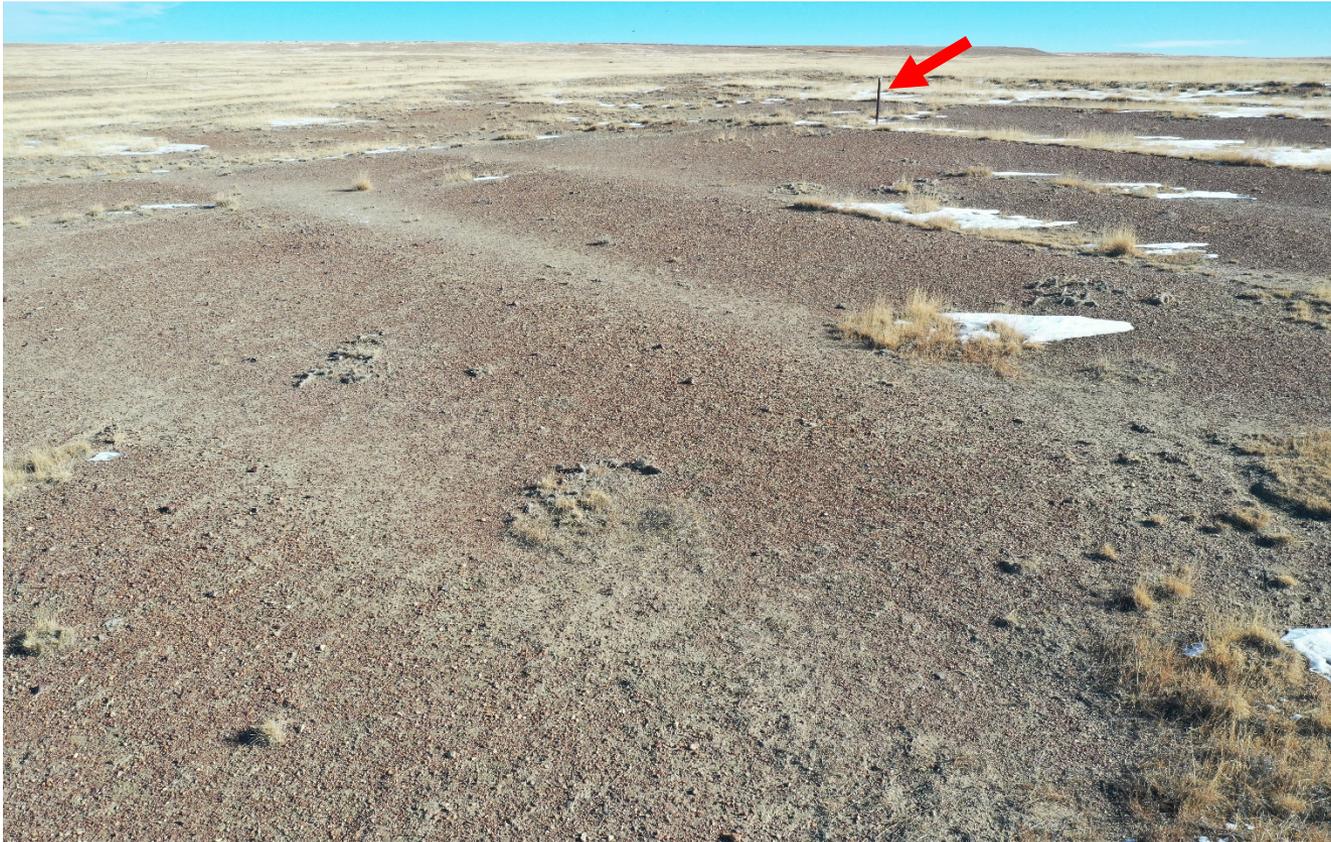
Photo 2. Facing northeast toward the location. There are areas at the location with no vegetation cover. Red arrow points to the well marker.

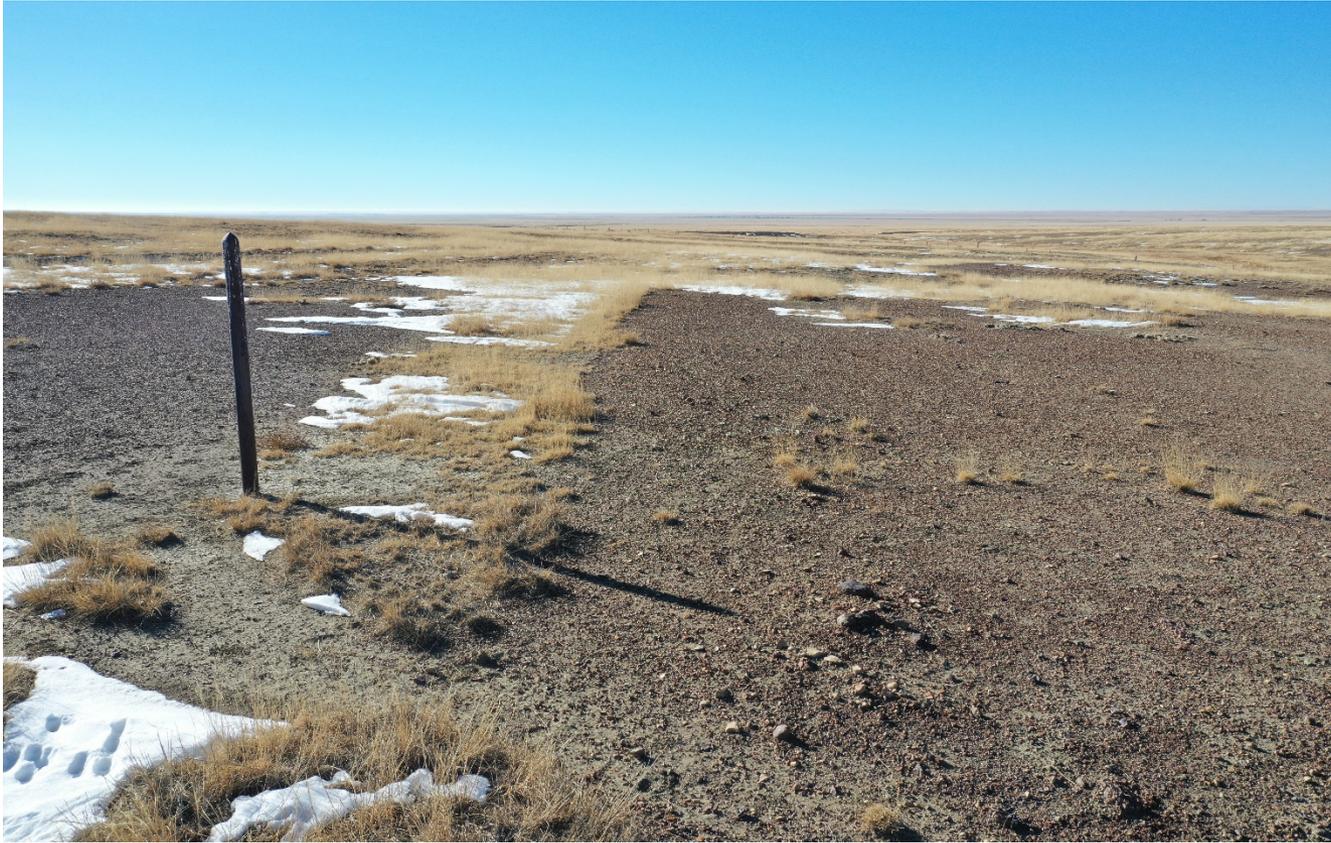
Photo 3. Center of the location facing south.

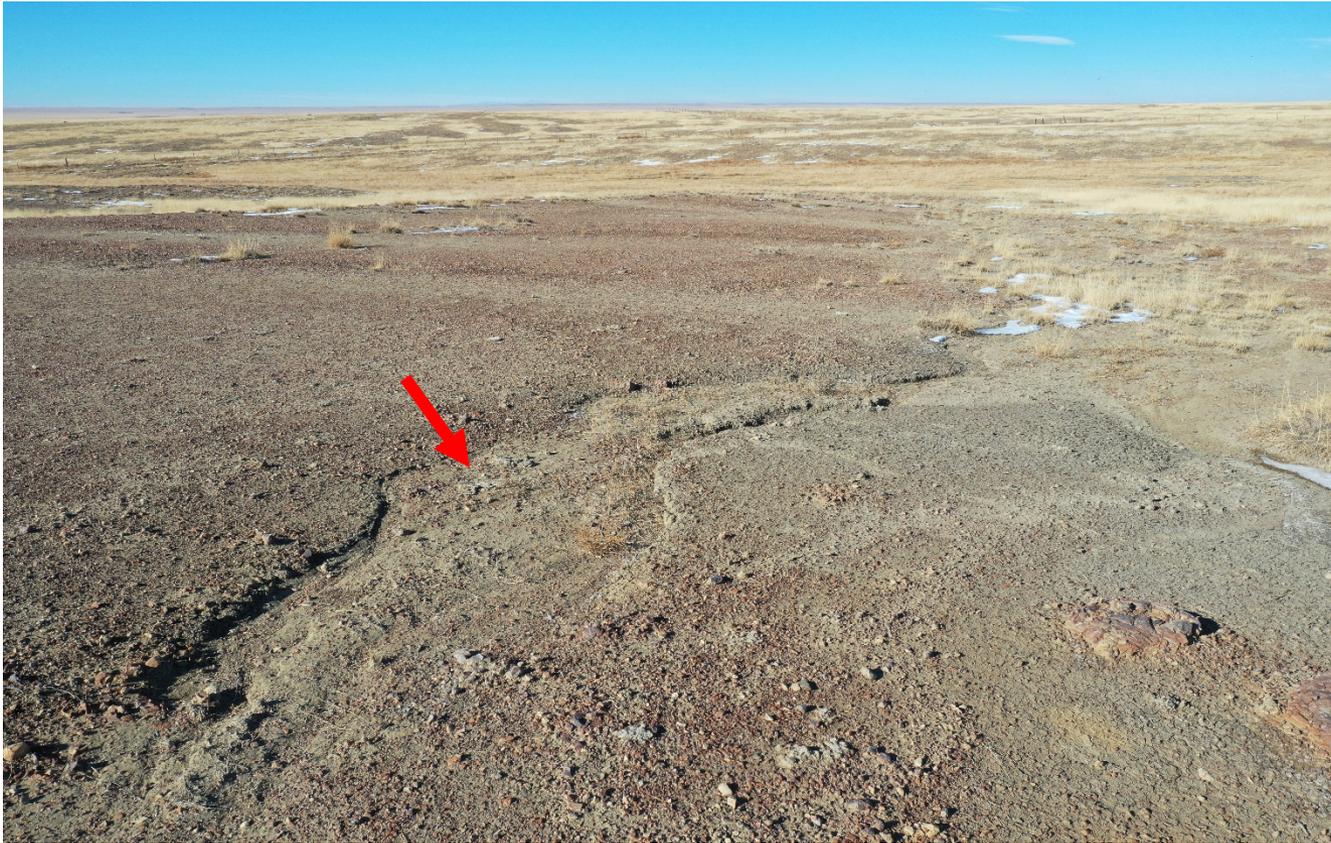
Photo 4. Center of the location facing west. There is erosion beginning to occur in this area shown at red arrow.

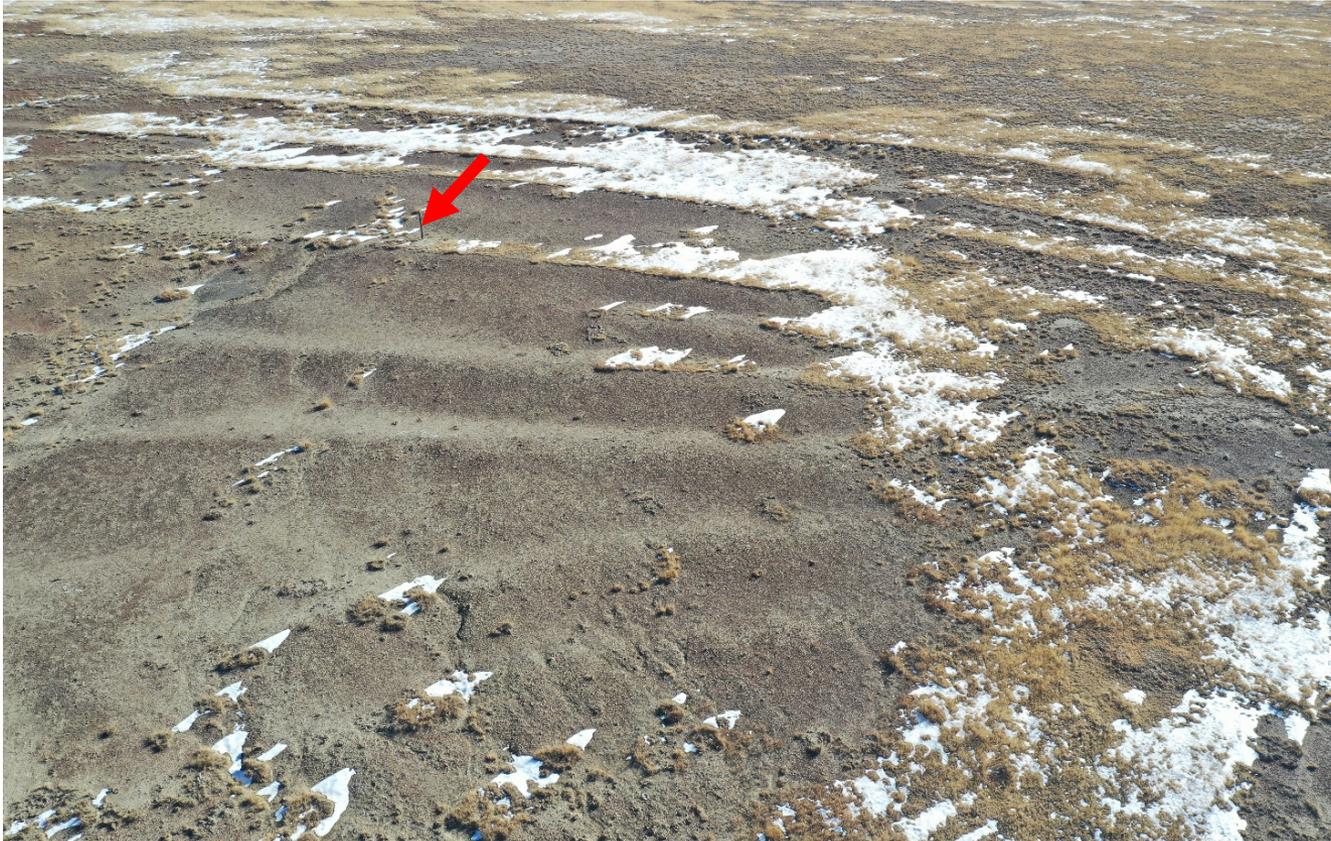
Photo 5. Drone aerial photo facing down east toward the location which shows mostly bare soils with no vegetation establishment. Red arrow points to the well marker.

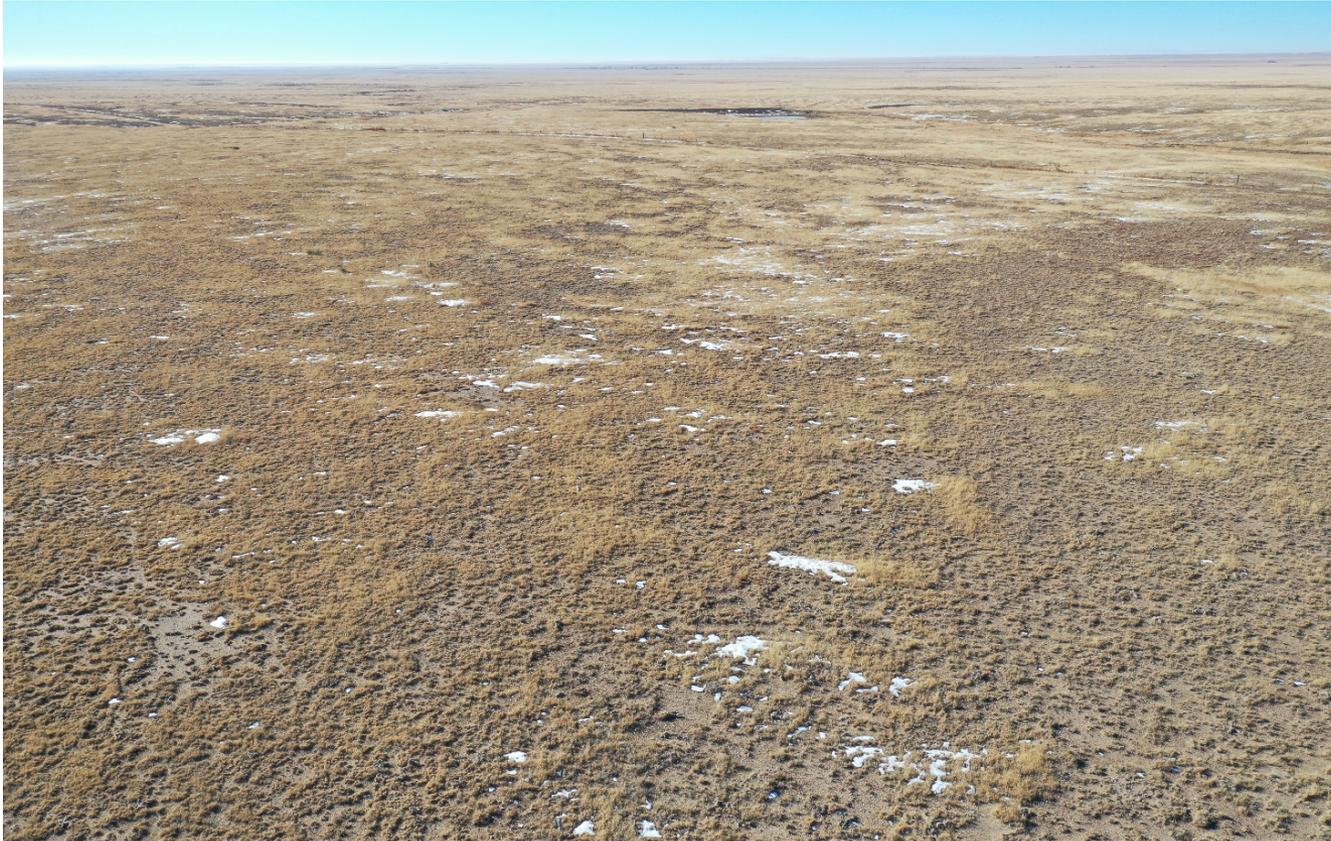
Photo 6. Facing south toward the surrounding undisturbed reference area consisting of a uniform native vegetation cover.
