Final Reclamation Inspection

Operator: PDC ENERGY INC - 69175

Location ID: 309667

Inspection Photos
Location Name: Hergenreder 13-33U
Location ID: 309667

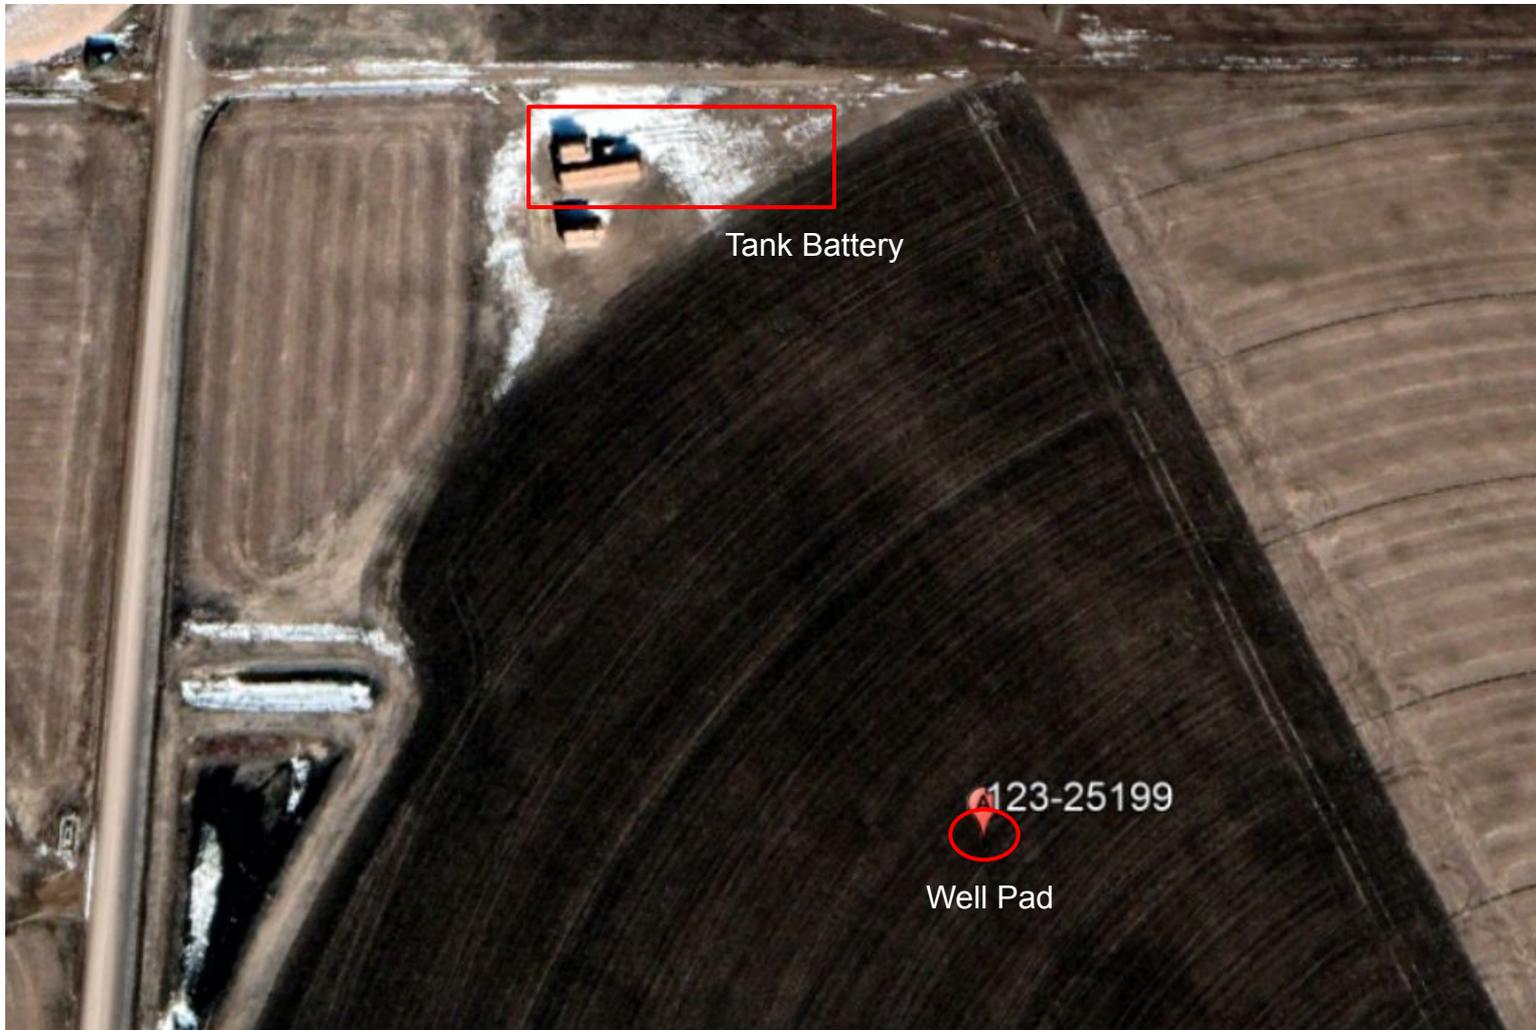
Photo 1. 2020 aerial imagery of the well pad and tank battery. Note: could not identify access road from historical imagery.

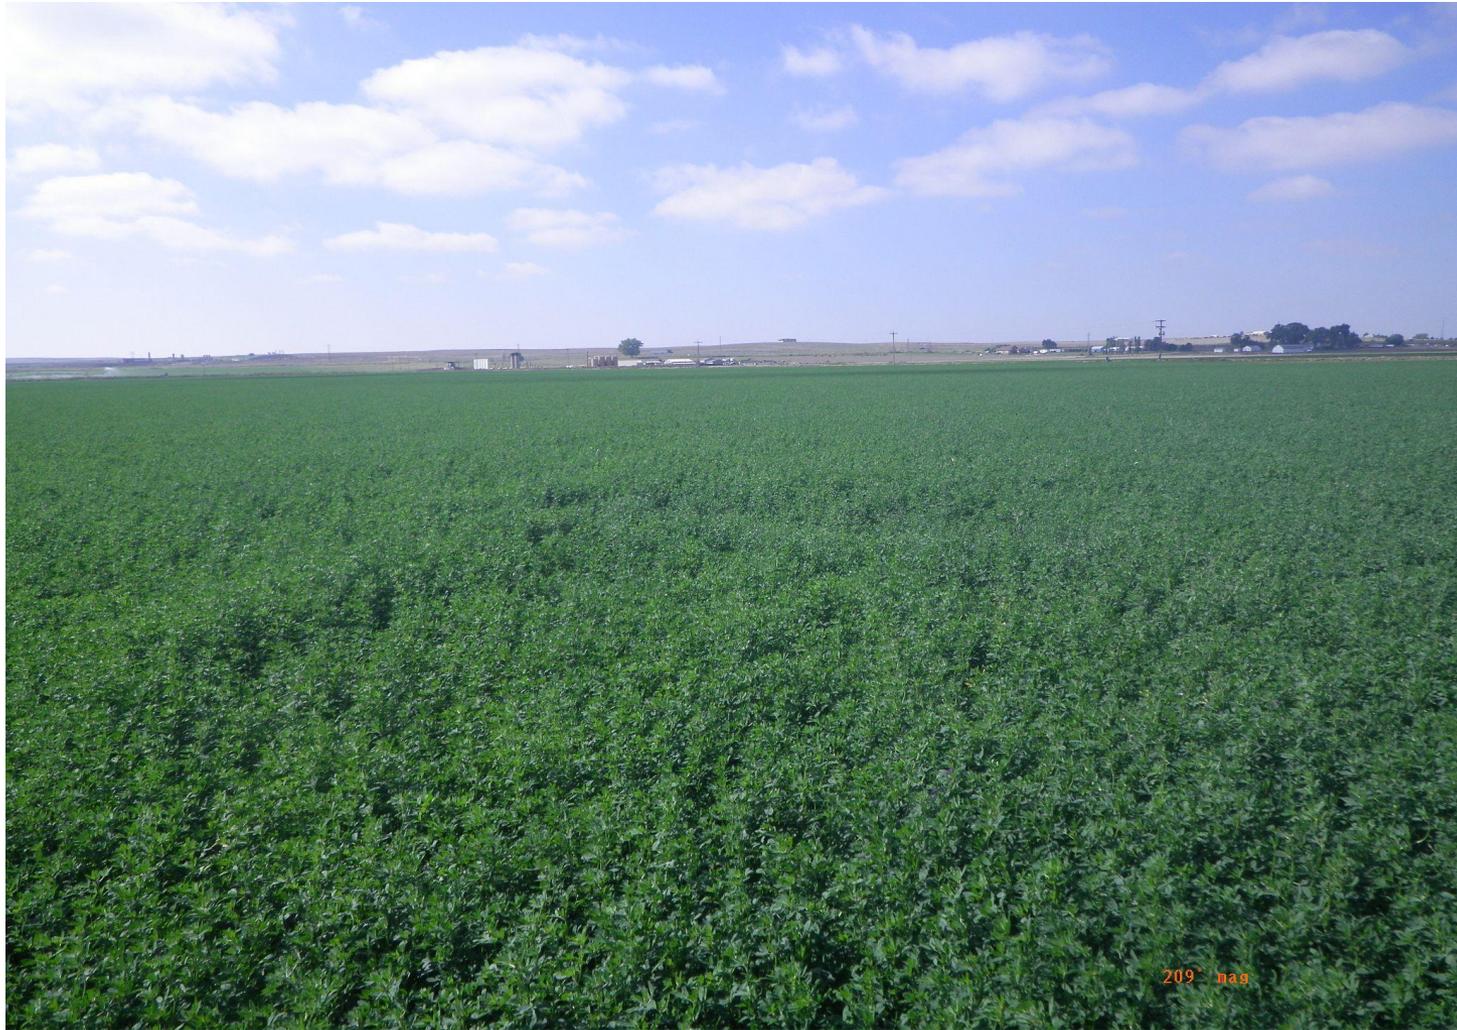
Photo 2. Overview photo of the well pad taken at ground level from the northern edge facing south.

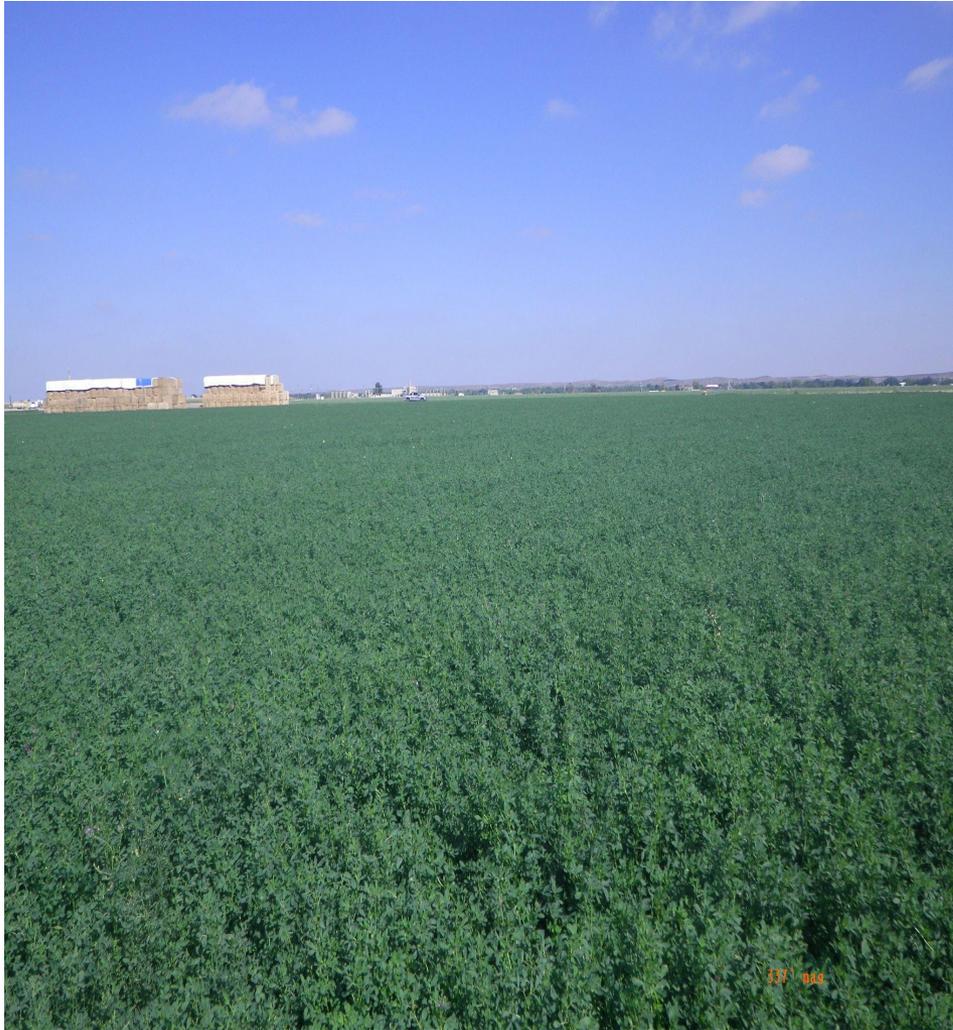
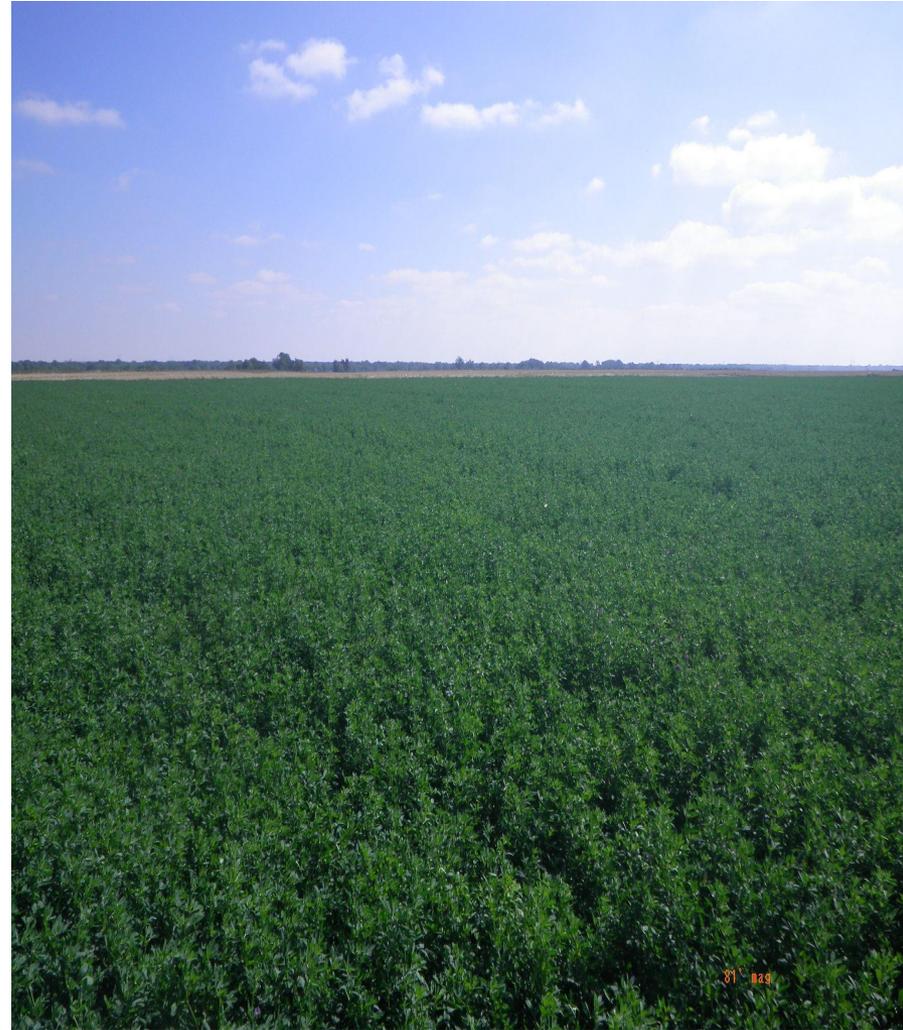
Photo 3. Cardinal photos taken from the middle of the well pad. Left photo facing north, right photo facing east.

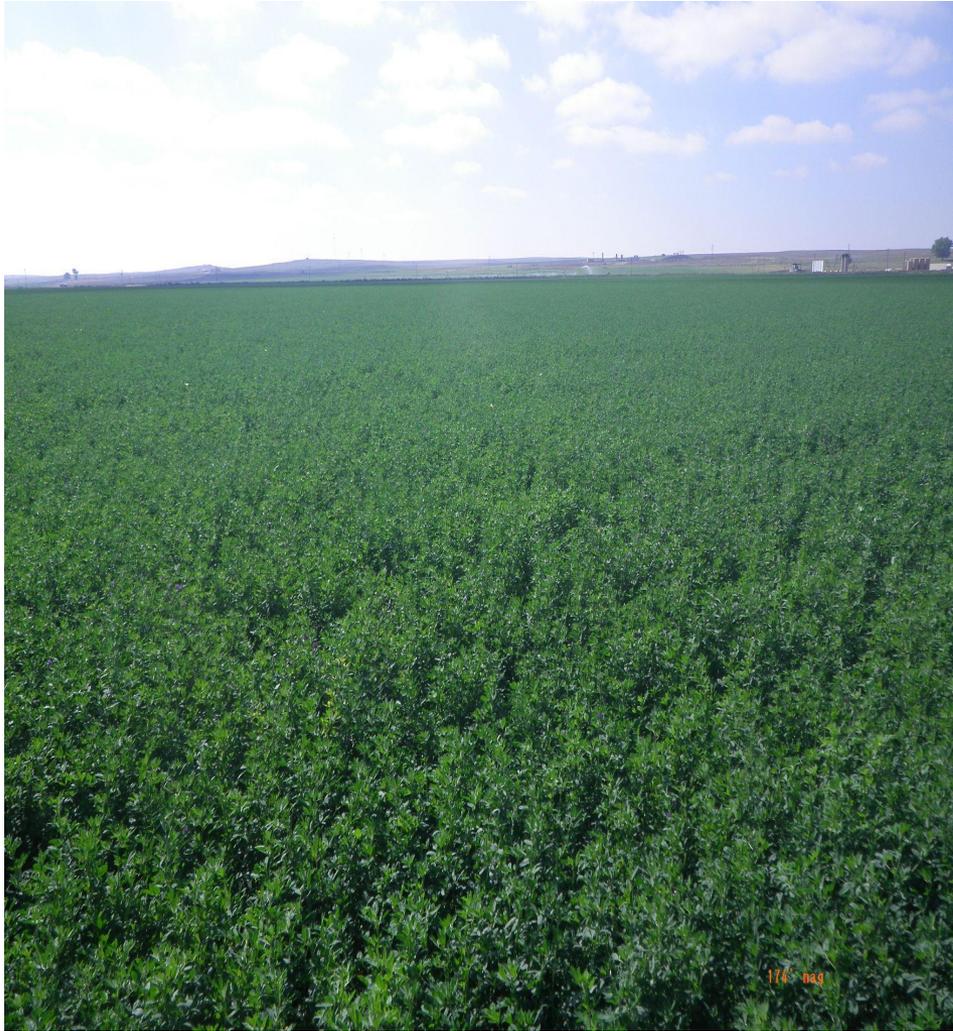
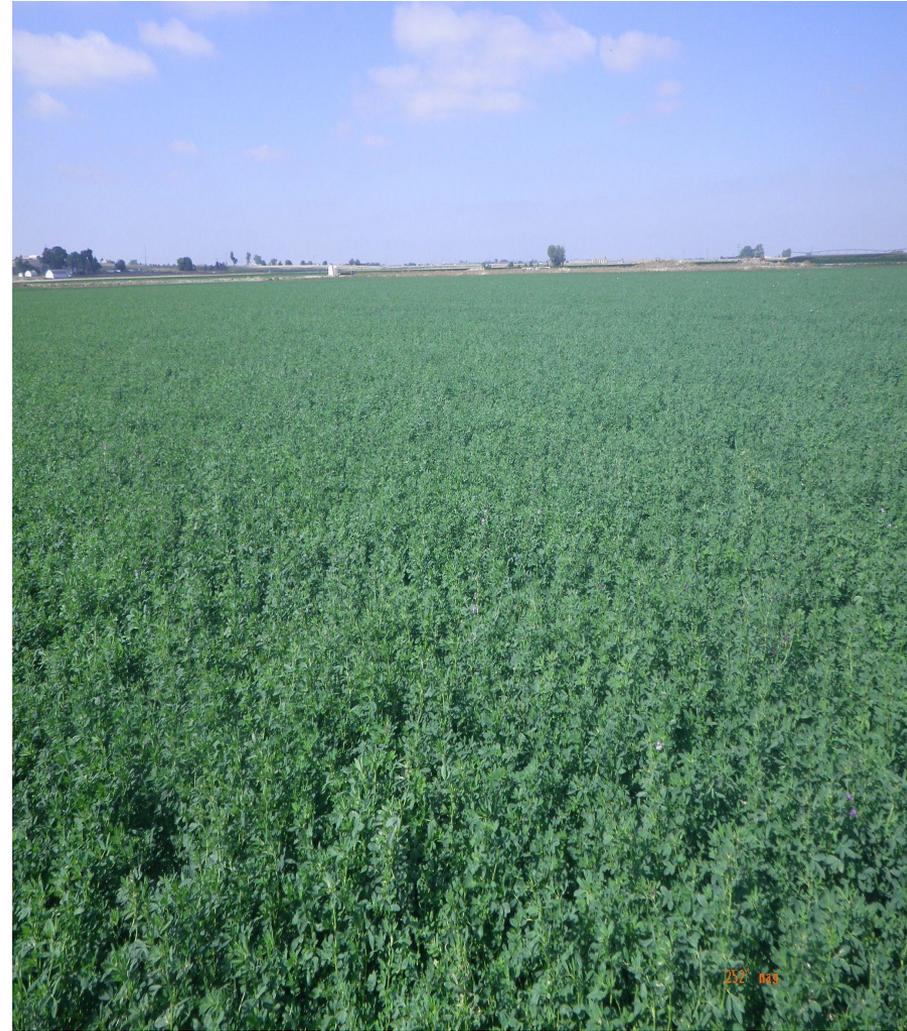
Photo 4. Cardinal photos taken from the middle of the tank battery. Left photo facing south, right photo facing west. Note: well pad appears consistent with adjacent crop reference area (see photo 5).

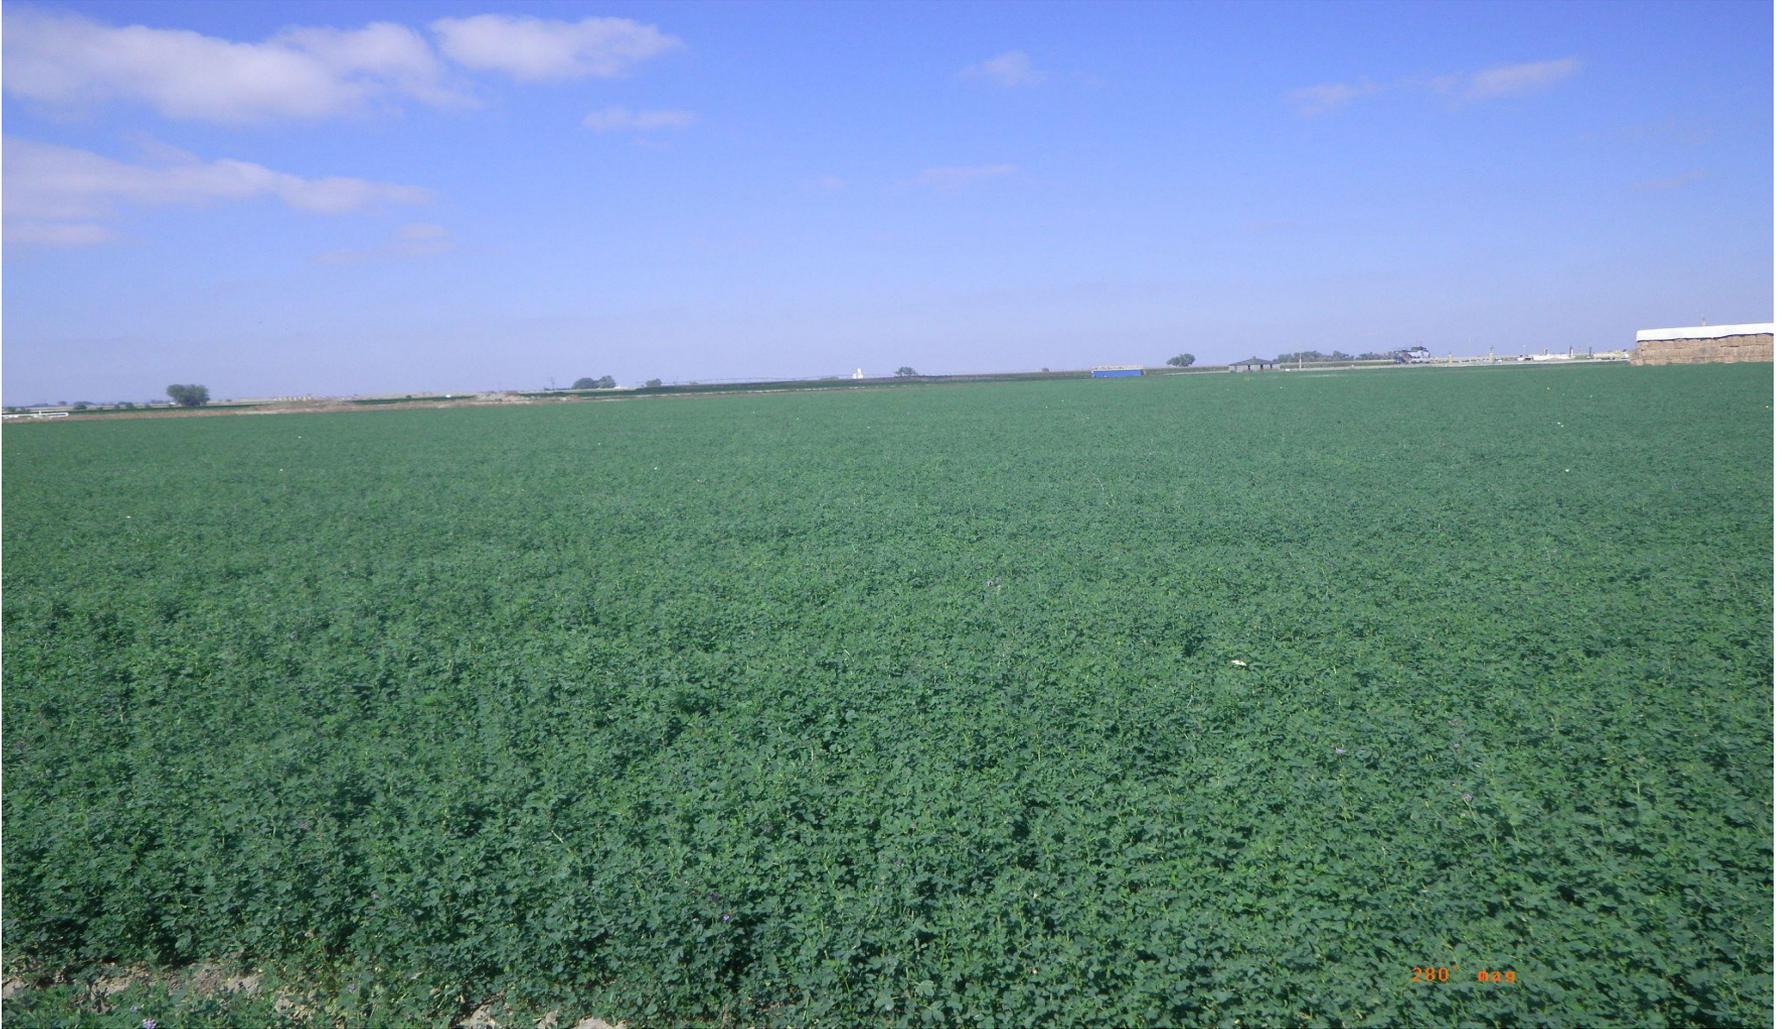
Photo 5. Well pad reference area.

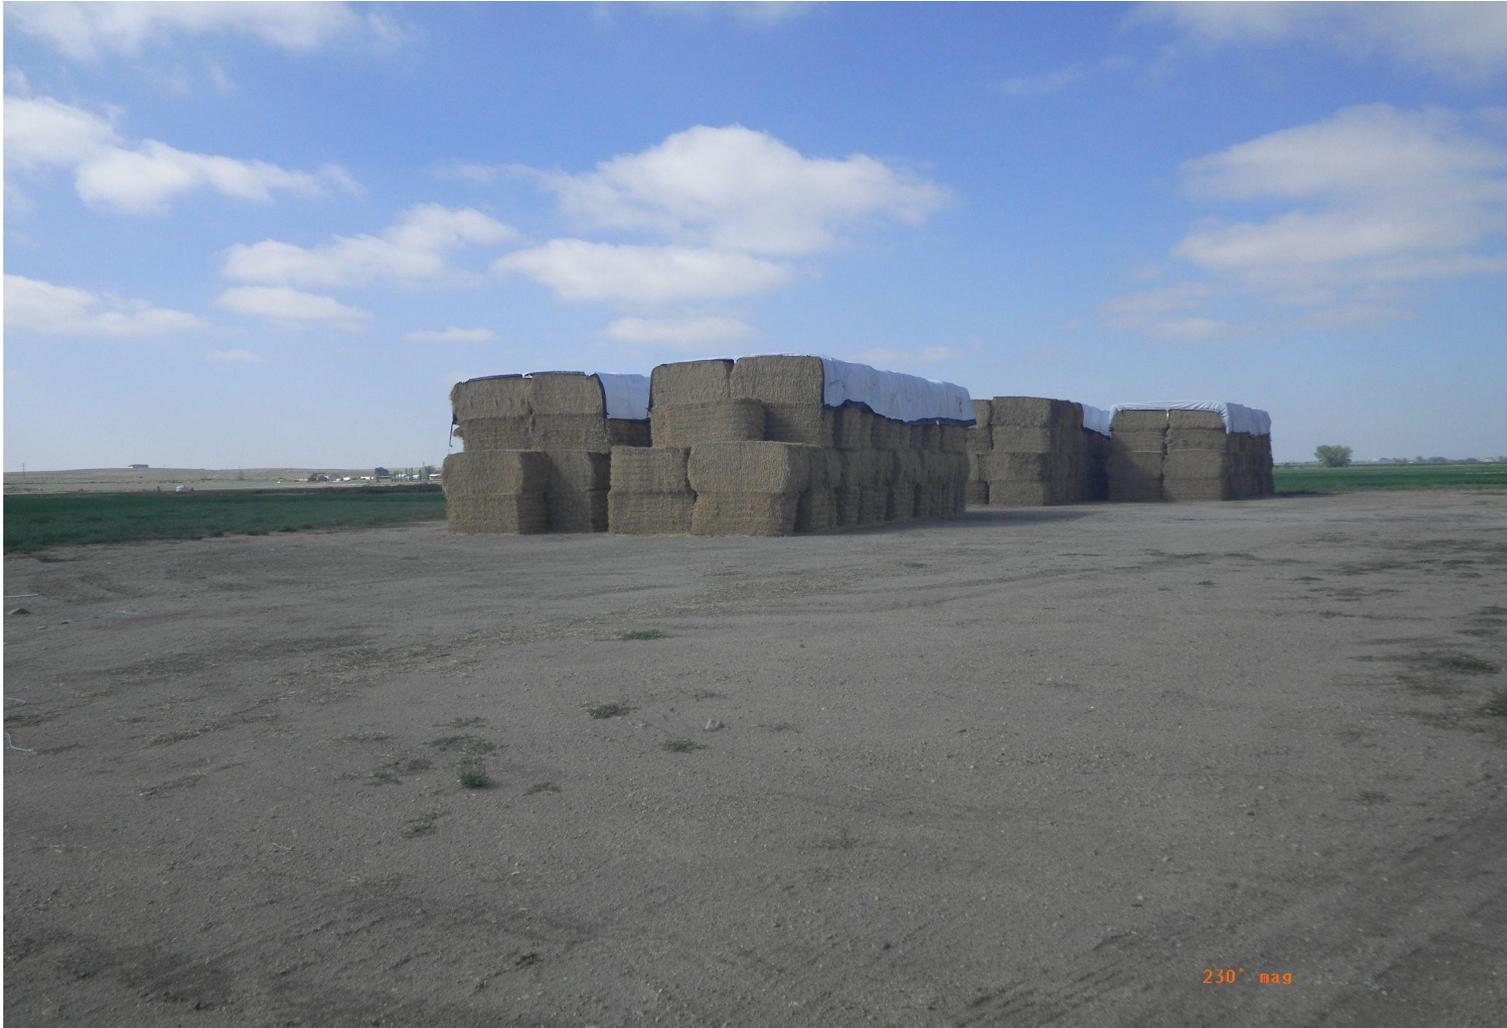
Photo 6. Overview photo of the tank battery. Note: gravel remains throughout the disturbance and is being used for hay storage.
