Inspection Photos

API: 071-07862

Operator: EVERGREEN NATURAL RESOURCES

Inspection Date: 12/28/2022

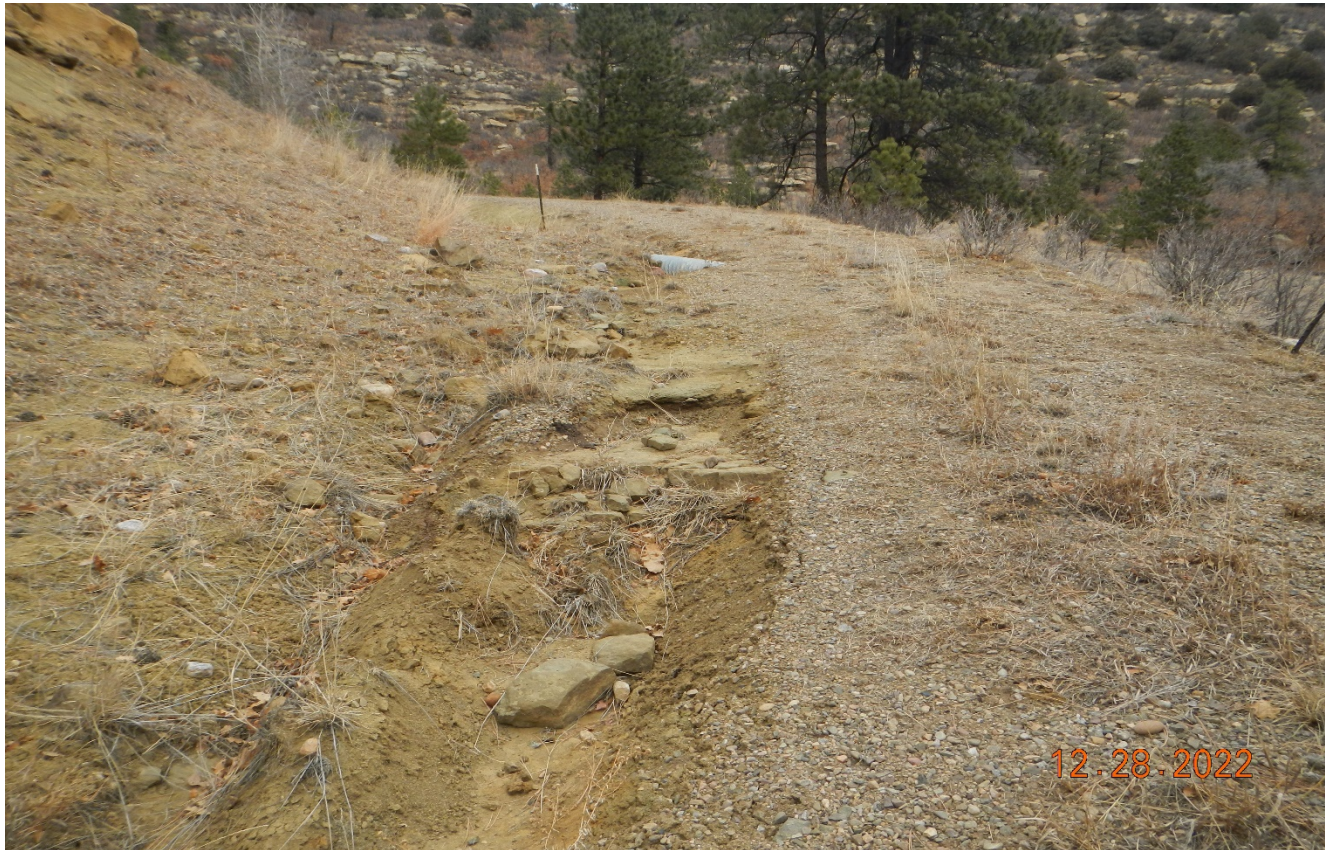
Photo 1. Facing north along the access road. Stormwater is bypassing the culvert causing erosion down the road. Previous corrective action was not completed.

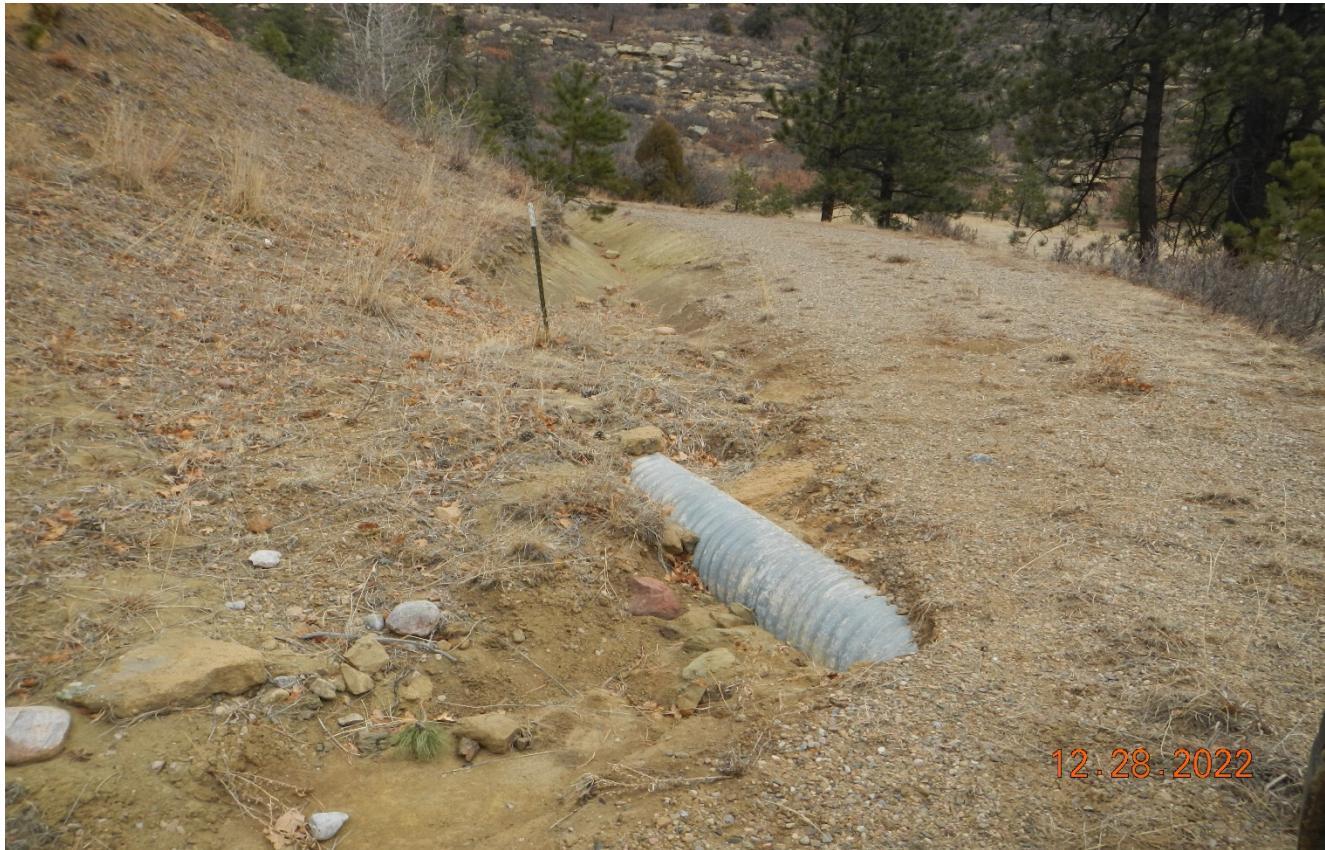
Photo 2. There is erosion along the road side that needs to be repaired and stabilized. Previous corrective action was not completed.

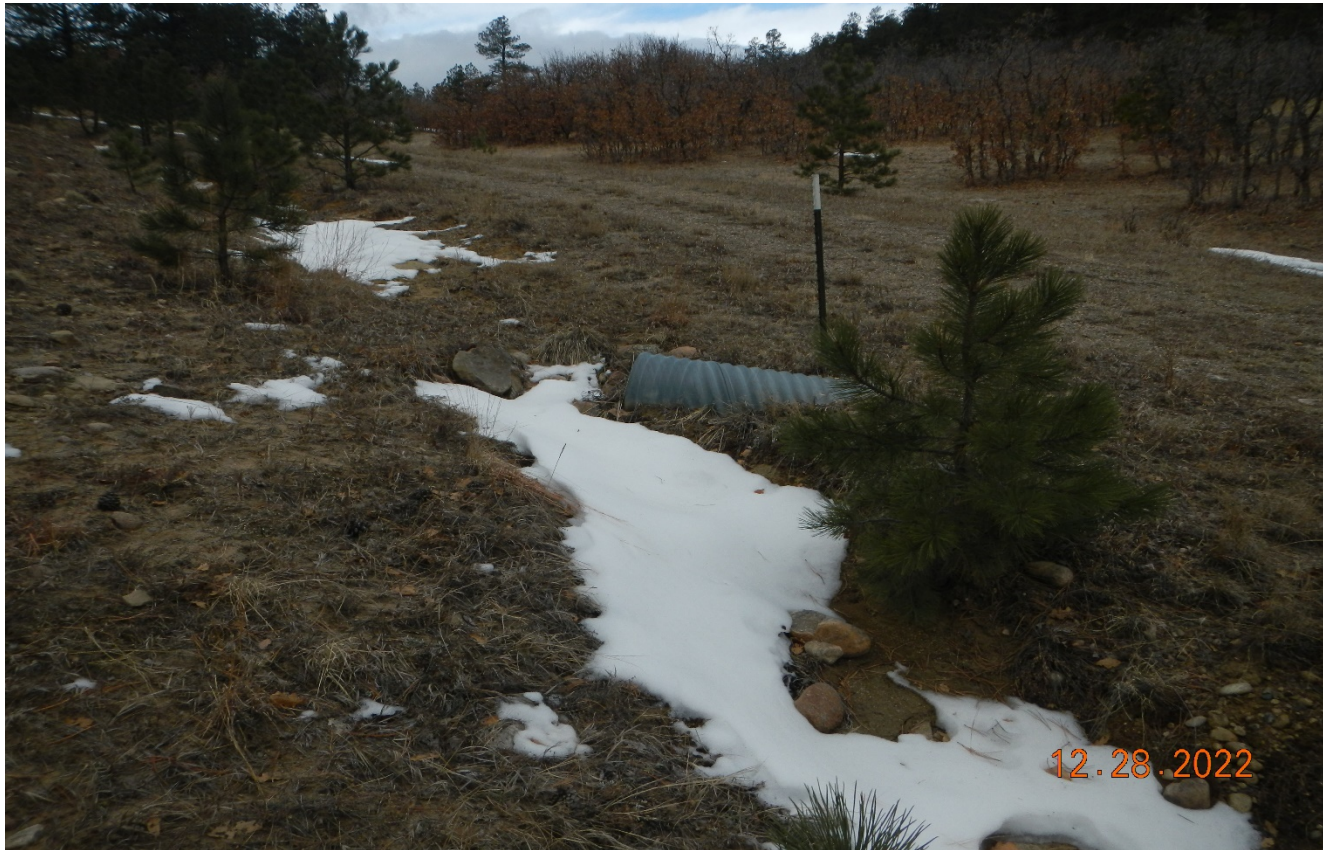
Photo 3. Further up the road is a culvert where stormwater is bypassing. This needs to be dug out to allow stormwater flow.

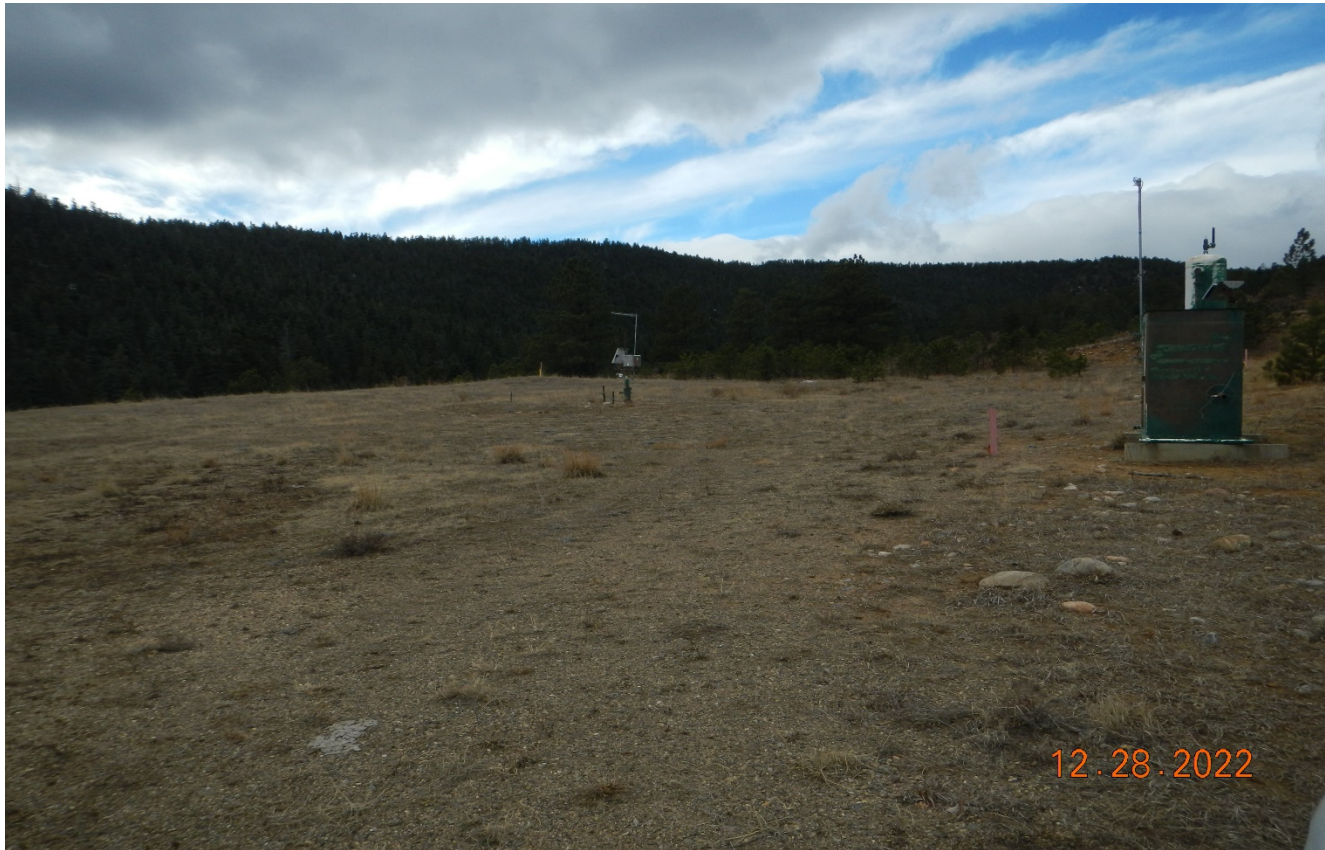
Photo 4. Facing southwest toward the well site.

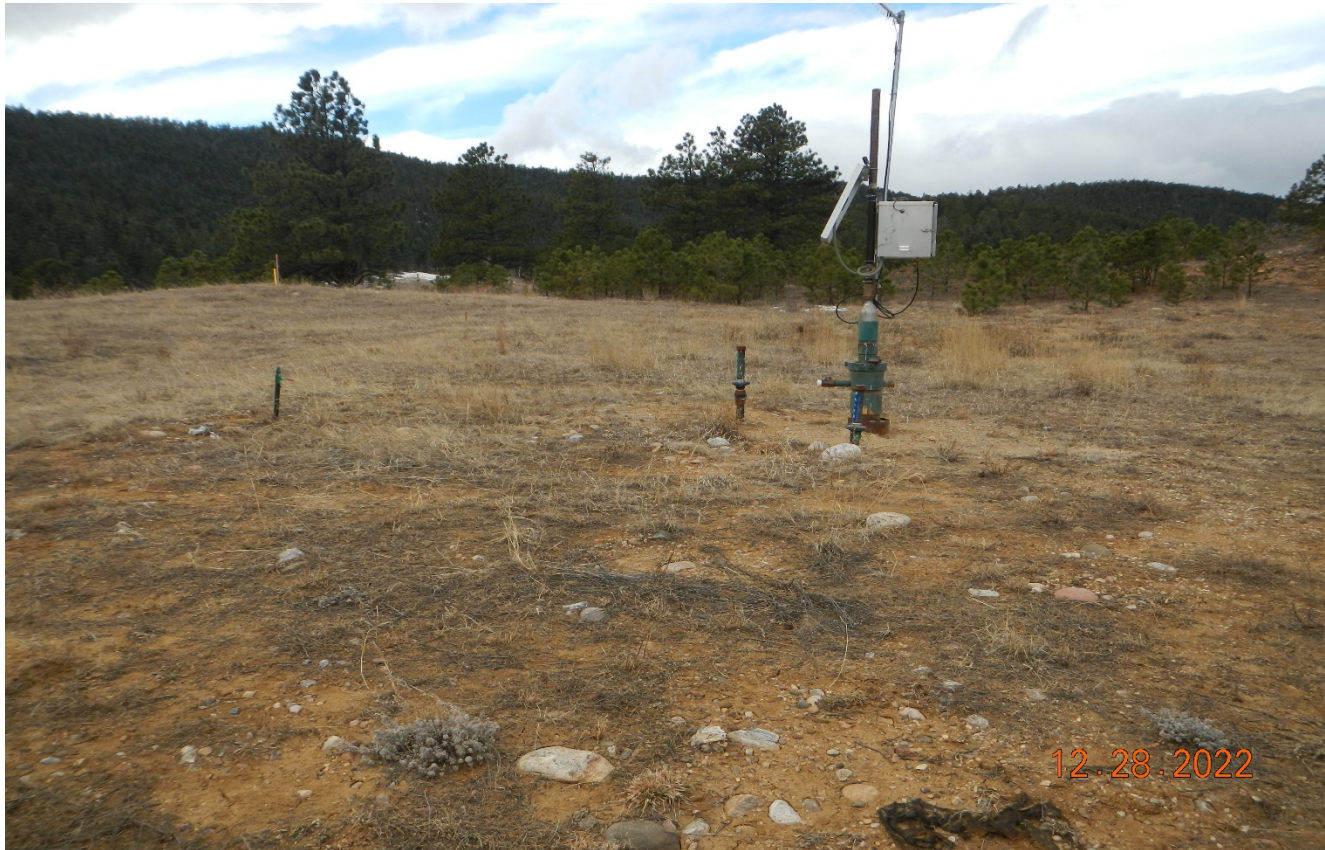
Photo 5. Facing toward the well. The 3 risers have been capped and labeled.
