Inspection Photos

12/27/2022

Operator: LARAMIE ENERGY LLC #10433

Location #452807

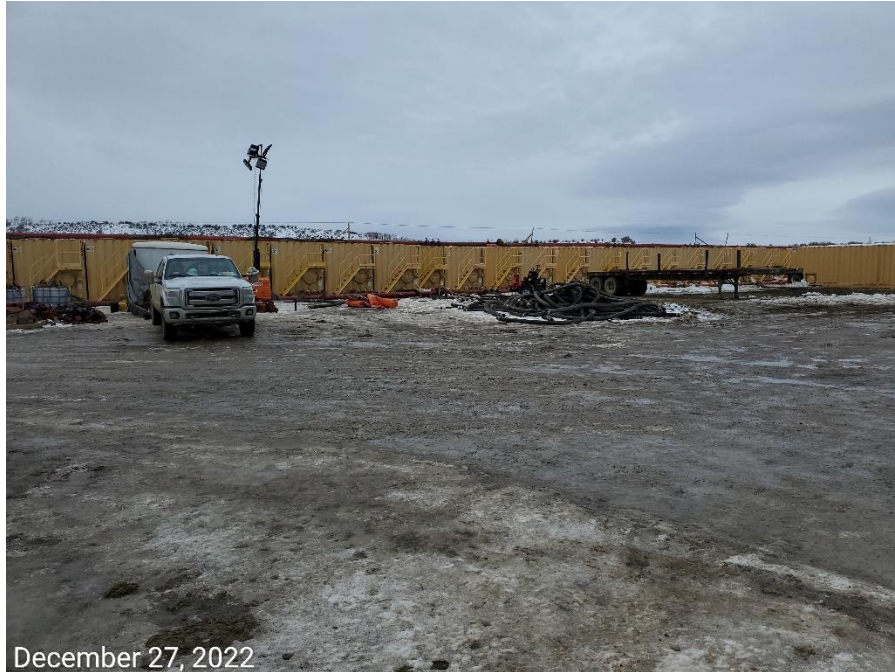
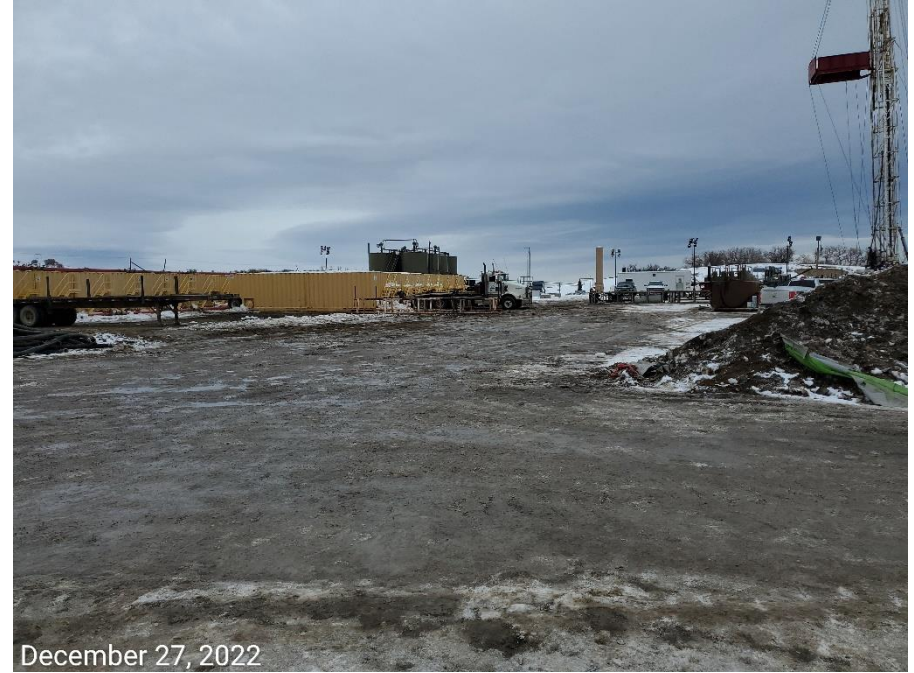
Photo 1: Photos 1-2 taken from the south end of the Location. Photos provide an overview of the location from west, northwest, northeast to east.

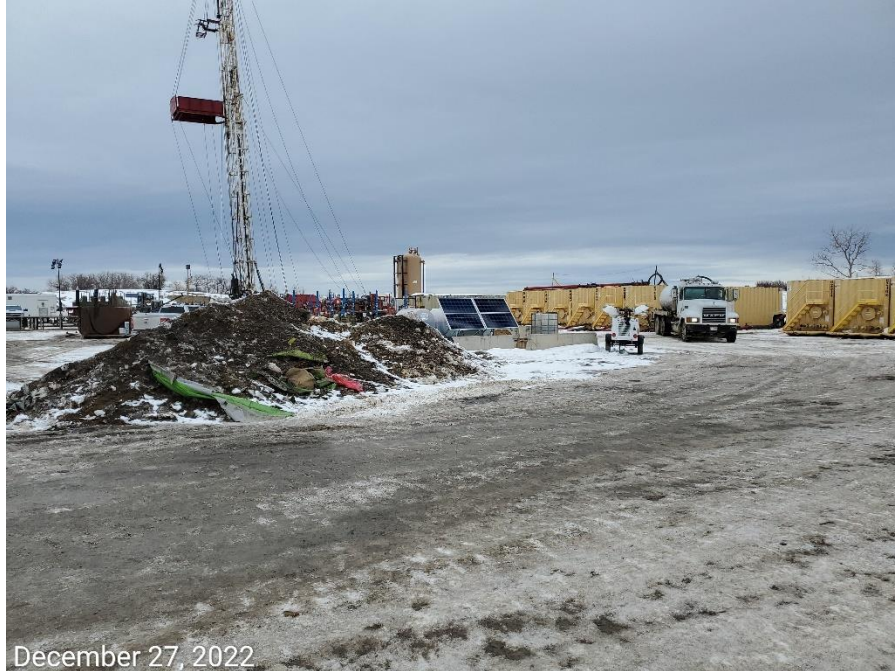
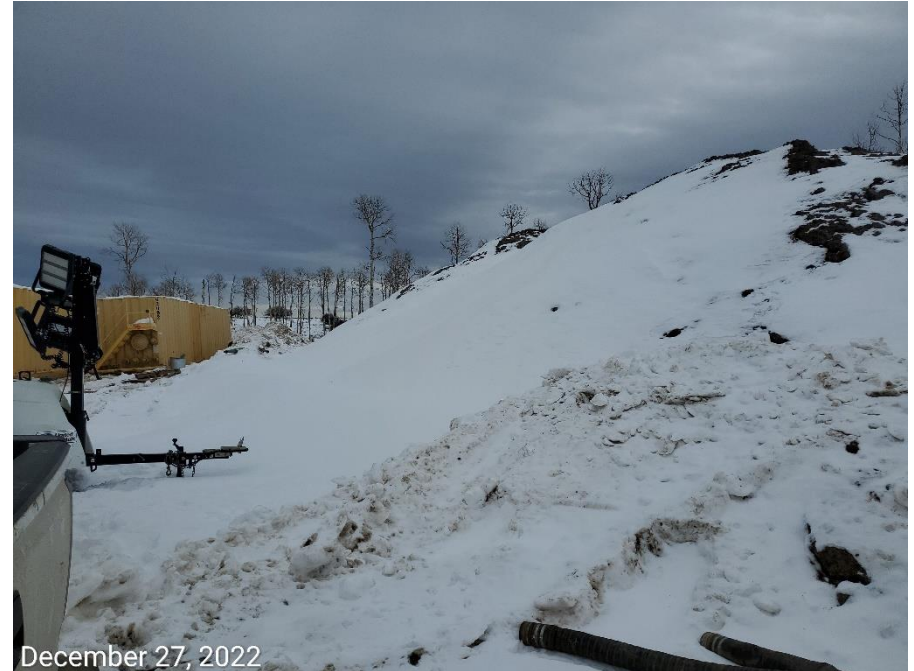
Photo 2: See comment under photo 1.

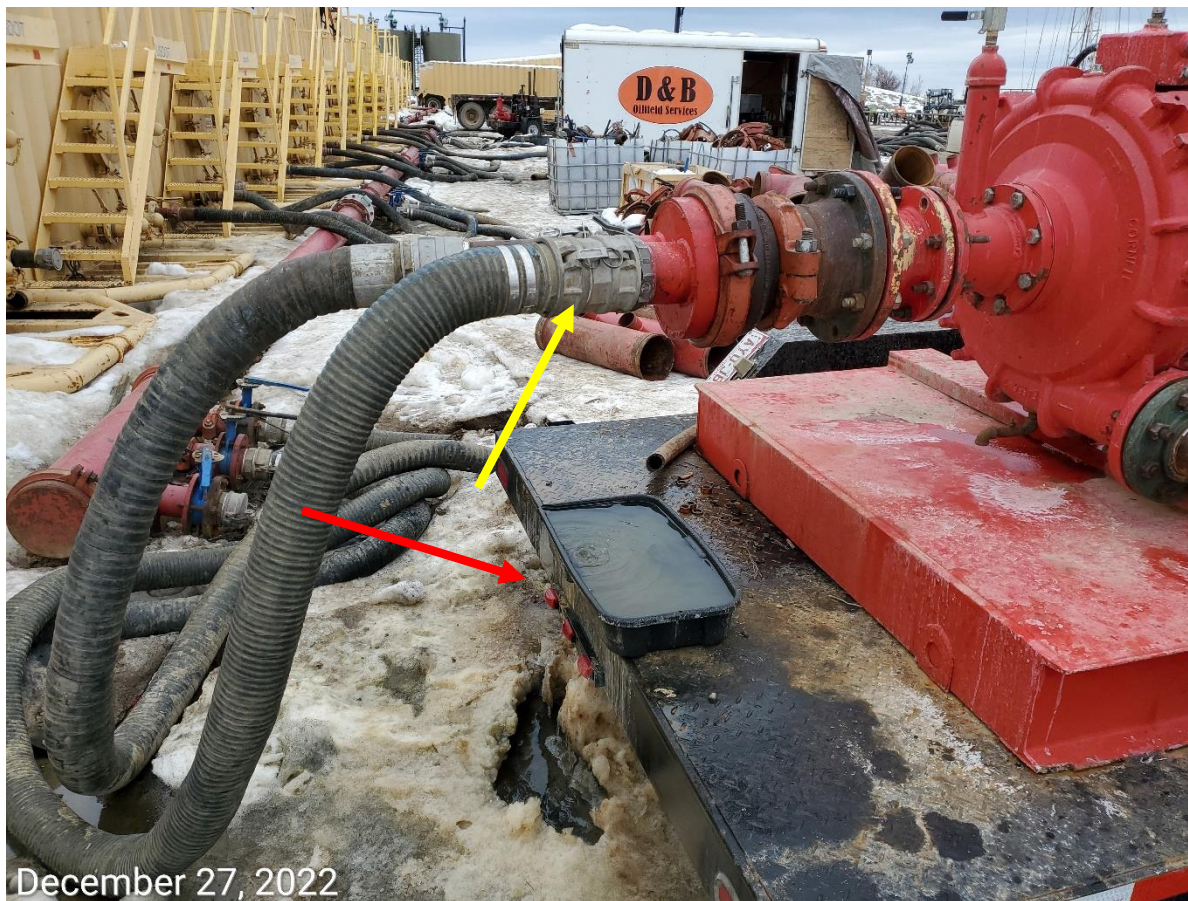
Photo 3: Photo shows pump equipment on the southwest end of the location. Fluids were observed spilling/releasing from equipment (yellow arrow). Operator appears to have placed a shallow container beneath leak point of pump in attempt to contain fluids- fluids observed spilling over container (red arrow). Secondary containment at pump is also not in proper functioning condition/inadequate to contain a spill or release

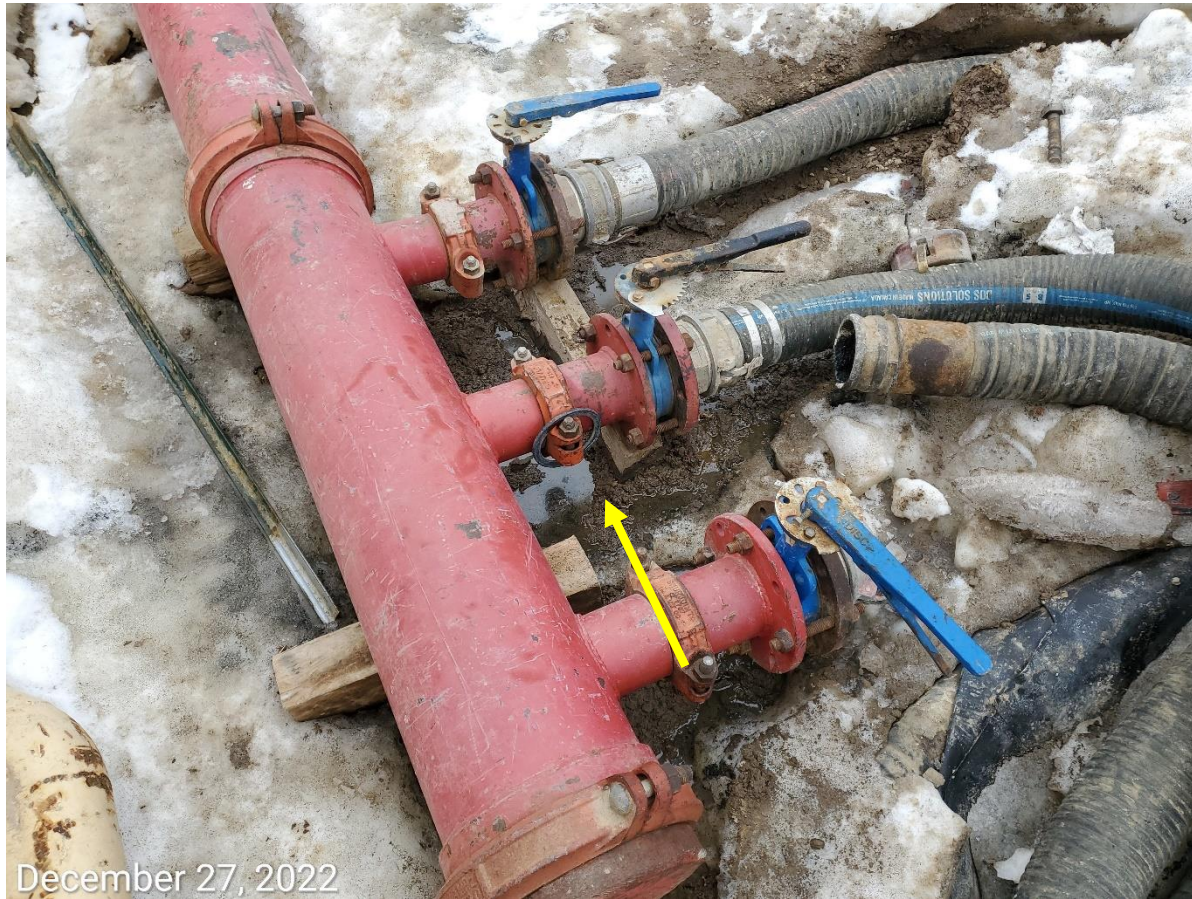
Photo 4: Photo shows connection points at pipes adjacent to the produced water tanks on the southwest end of the Location. Fluids were observed releasing onto the pad surface.

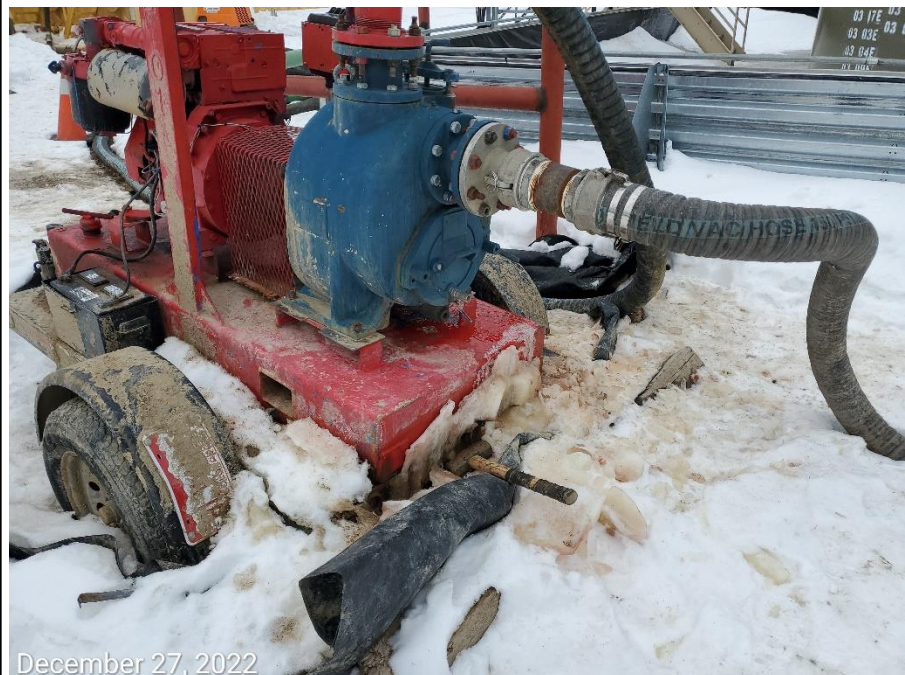
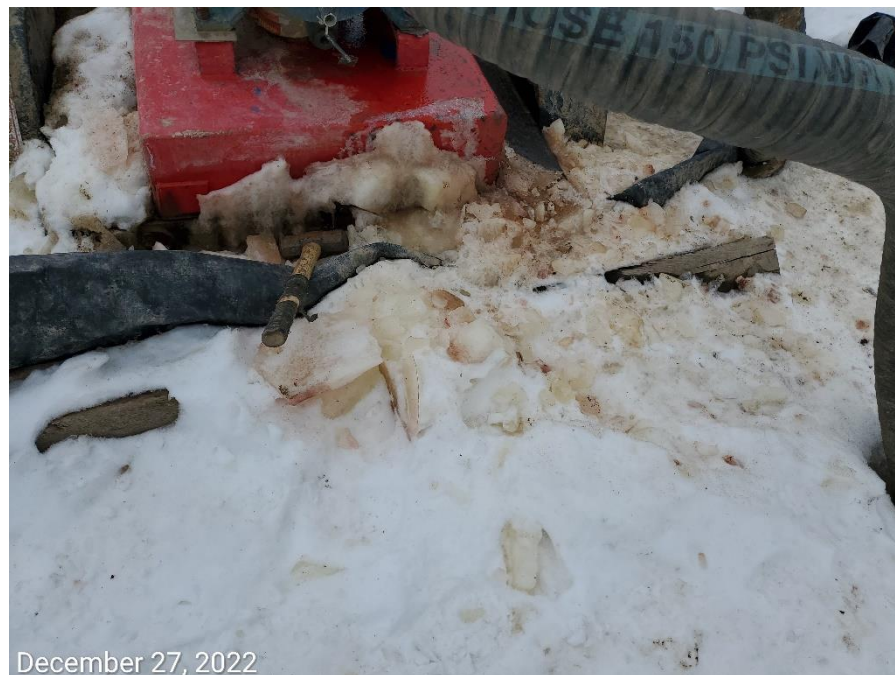
Photo 5: Photo taken from pump on the northwest end of the Location. Snow and Ice observed below the connection point of the pump appears to be impacted, and contained a red discoloration. Impacts require removal/clean-up. Secondary containment at pump is not in proper functioning condition/inadequate to contain a spill or release

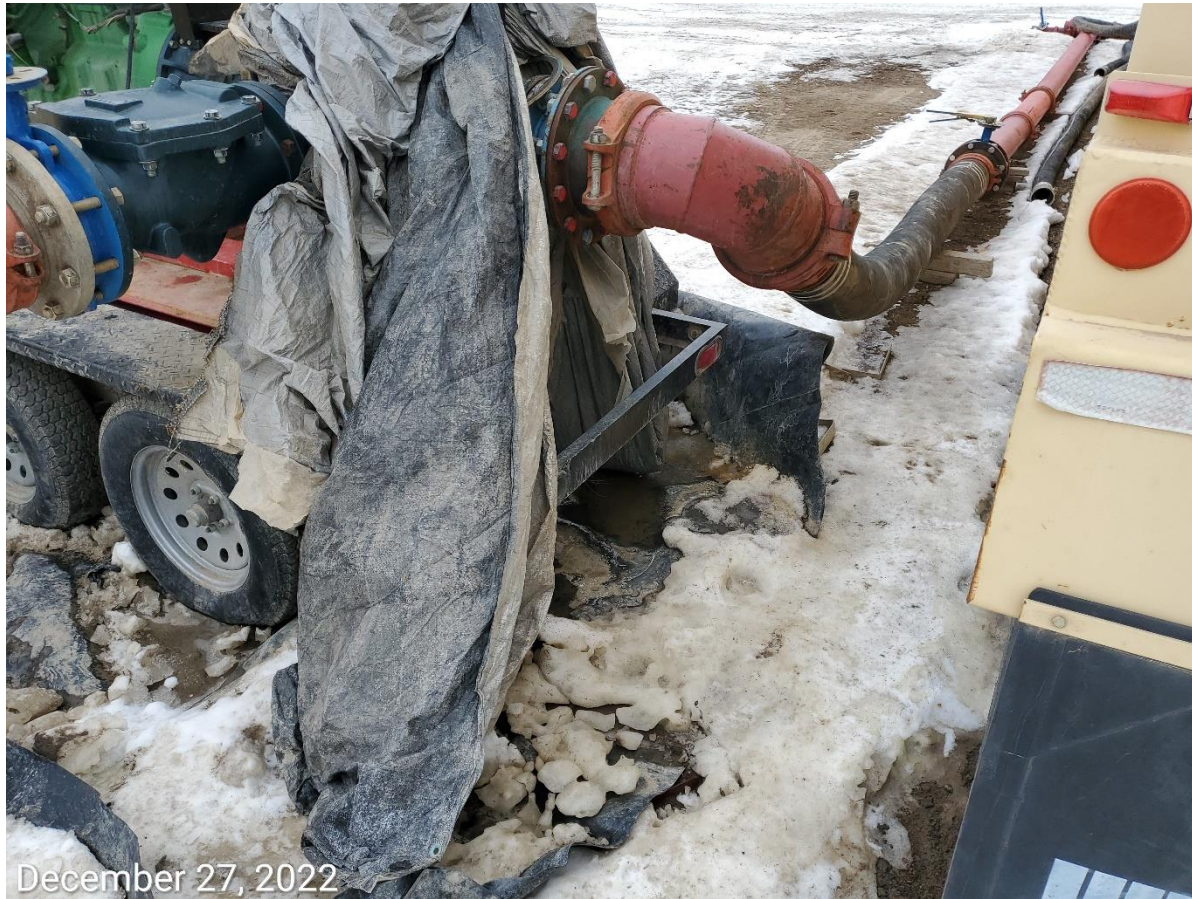
Photo 6: Photo taken from the pump observed on the east end of the Location. Photo shows secondary containment at pump is not in proper functioning condition/inadequate to contain a spill or release

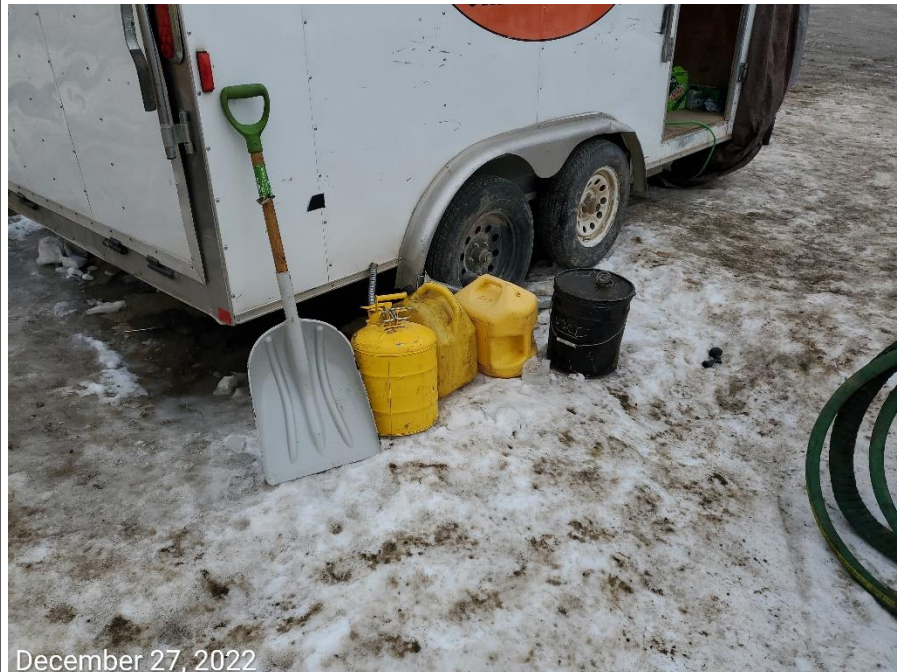
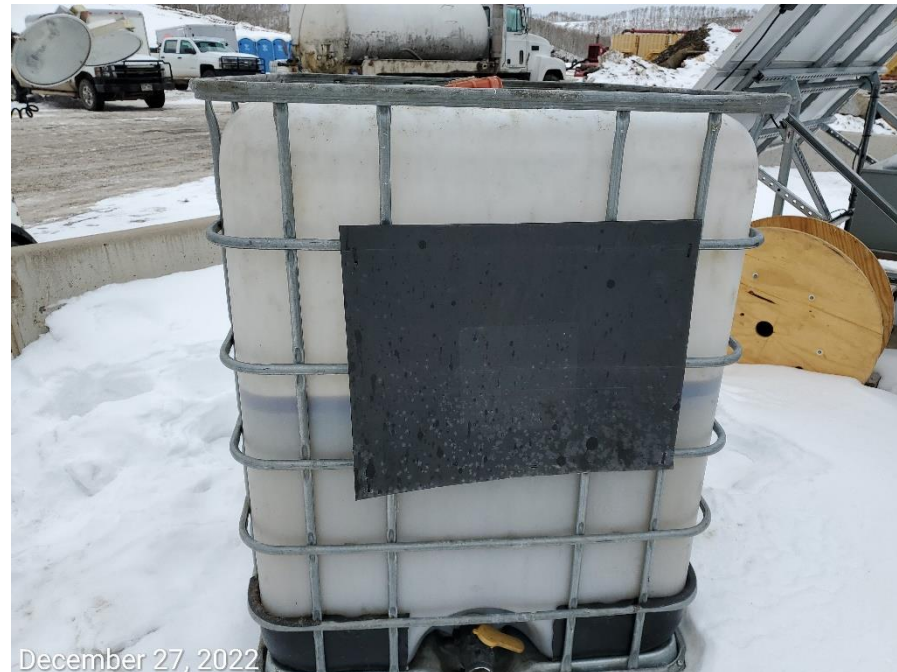
Photo 7: Photos provide examples of containers/buckets/totes observed on the Location missing BMPs to prevent or contain a spill. Photo right also example of totes observed on Location missing content identification labelling information.

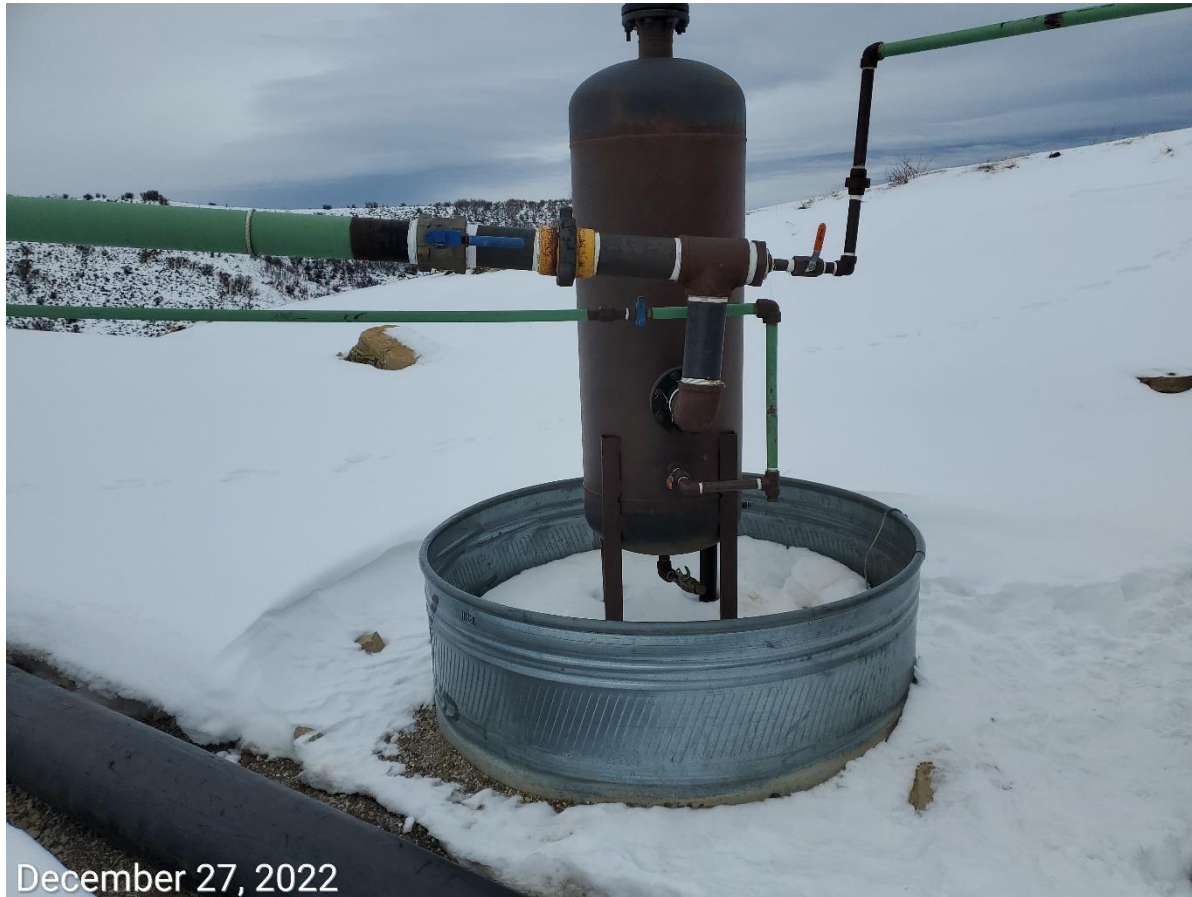
Photo 8: Photo shows wildlife protection devices missing from containment BMP.

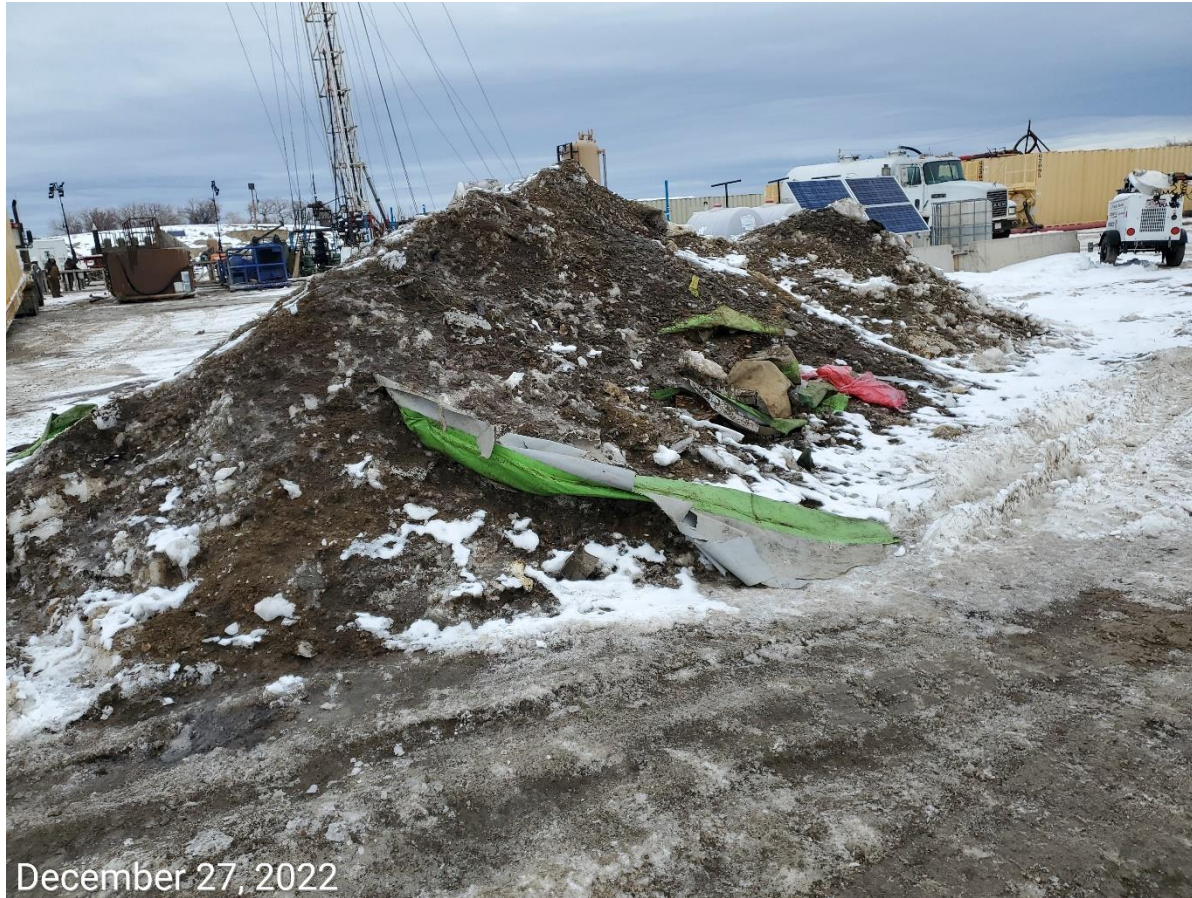
Photo 9: Photo shows what appears to be various tarp or liner material within a snow/dirt pile. Material is considered debris and required removal and proper disposal.
