# Interim Reclamation and Stormwater Inspection

Operator: KP KAUFFMAN COMPANY INC - 46290

Location ID: 450344

Inspection Photos  
Location Name: Boxer 25, 26, 29 Battery  
Location ID: 450344

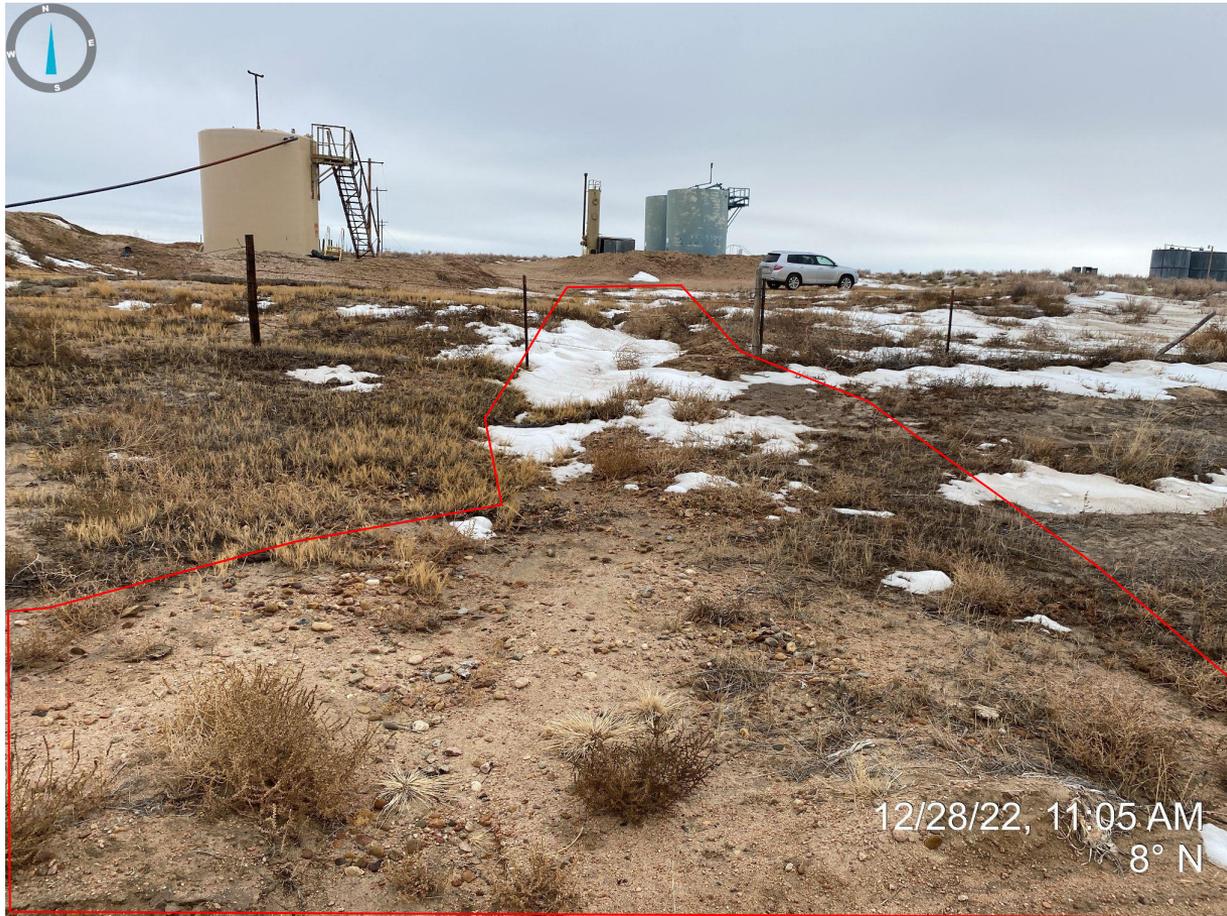
**Photo 1.** Facing north from access road. Photo illustrates gully erosion occurring on location and recent sediment laden stormwater migrating off location, outlined in red.

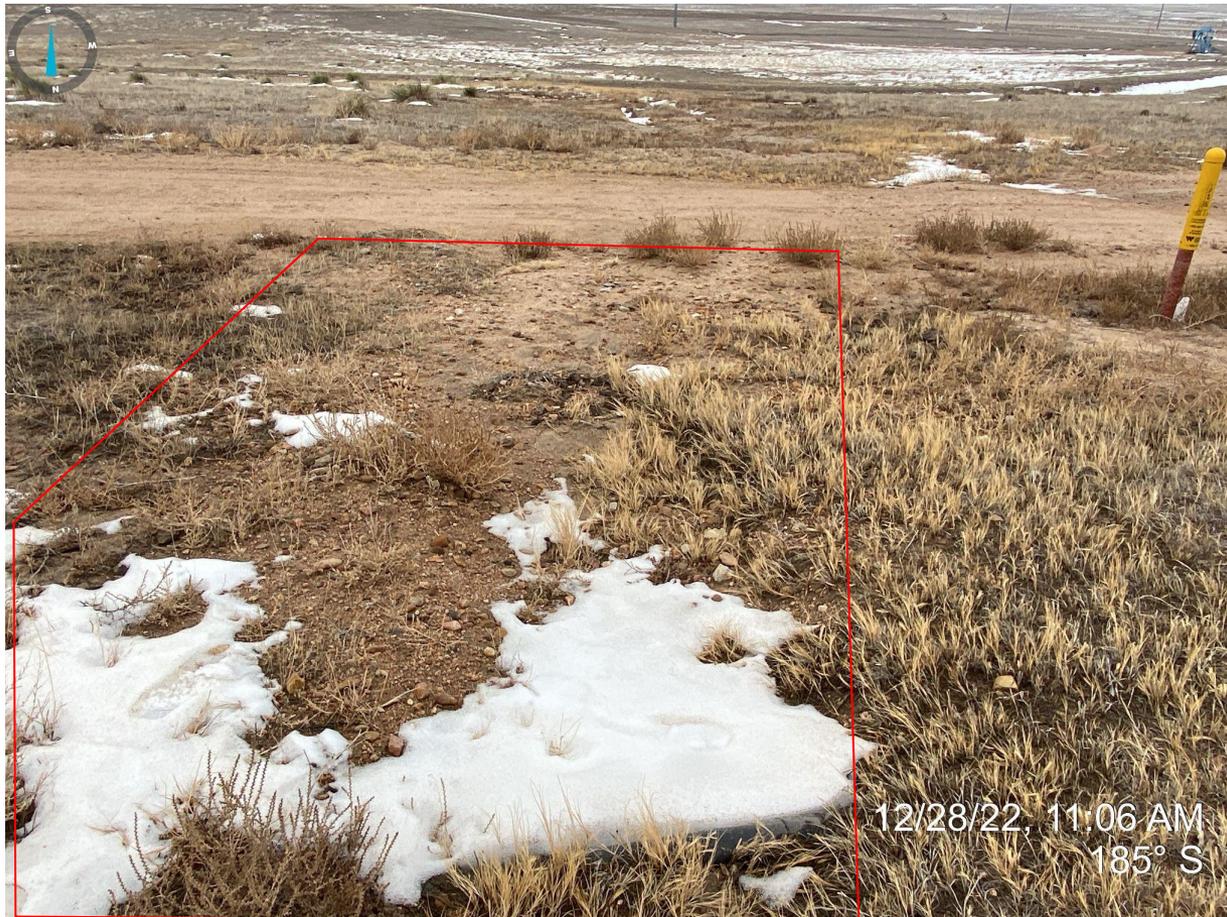
Photo 2. Facing south, see comments in Photo 1.

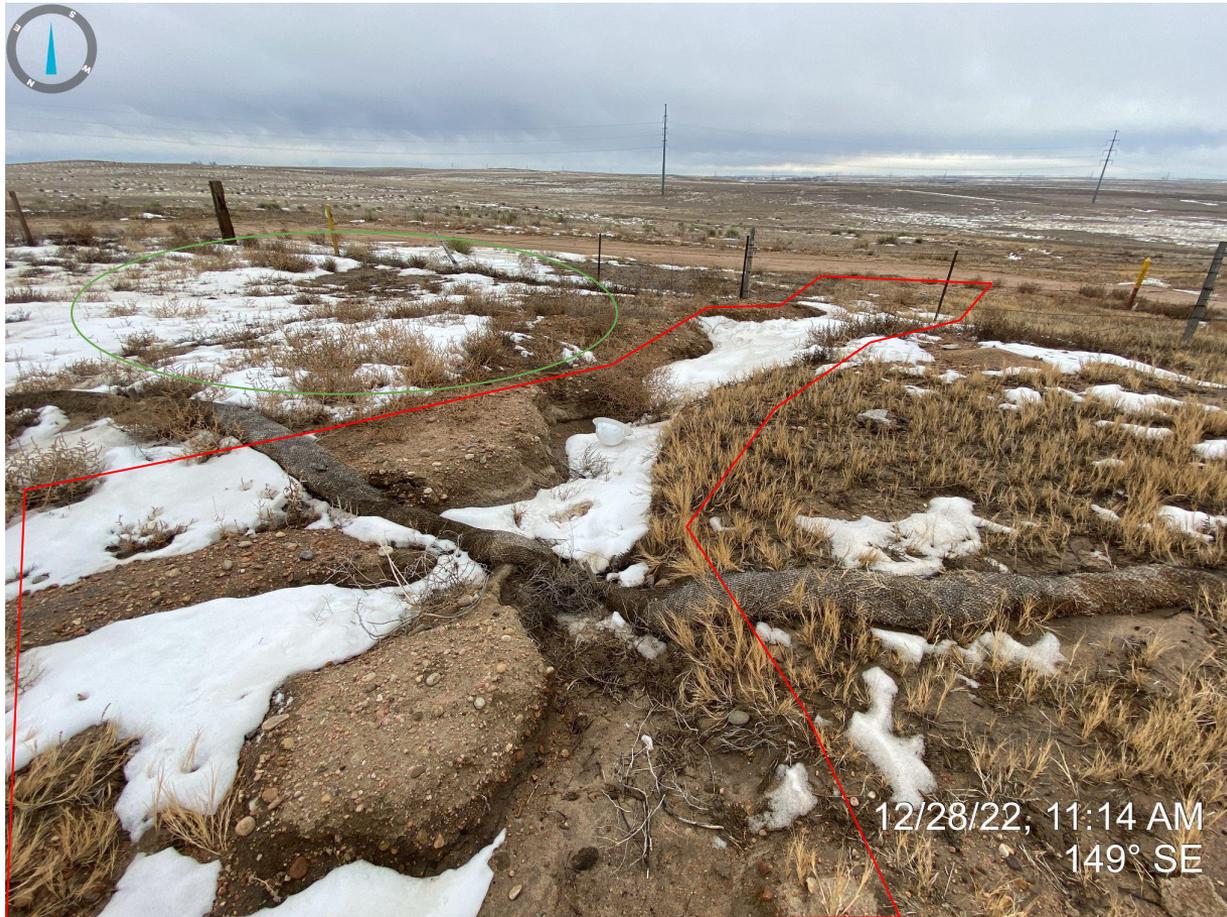
**Photo 3.** Facing southeast from location, near produced water pit. Photo illustrates gully erosion resulting from inadequate stormwater BMPs; e.g. degraded and improperly installed straw wattles. Also pictured, presence of russian thistle and kochia observed, outlined in green. Stormwater BMPs need to be installed and maintained in order to prevent further erosion and degradation to adjacent lands.

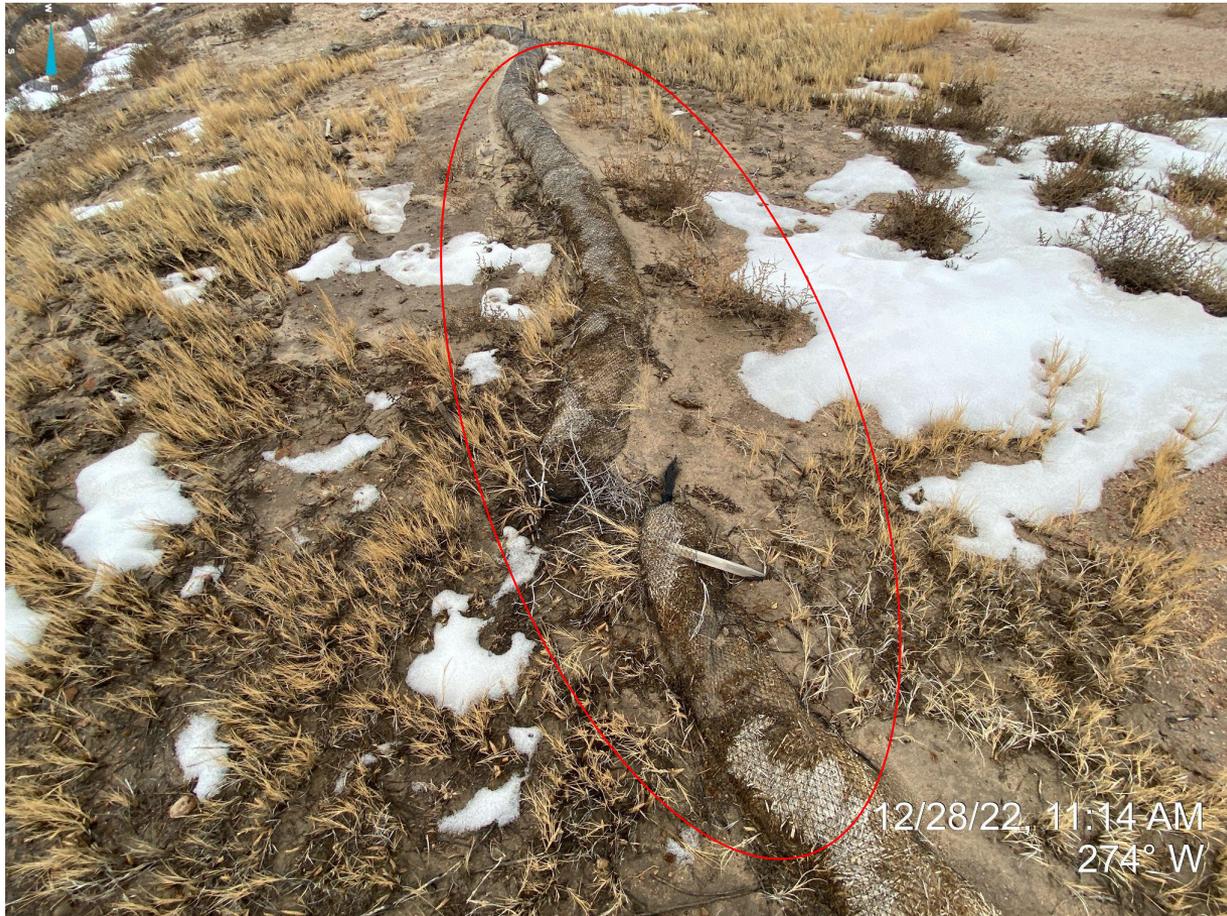
**Photo 4.** See comments in Photo 3.

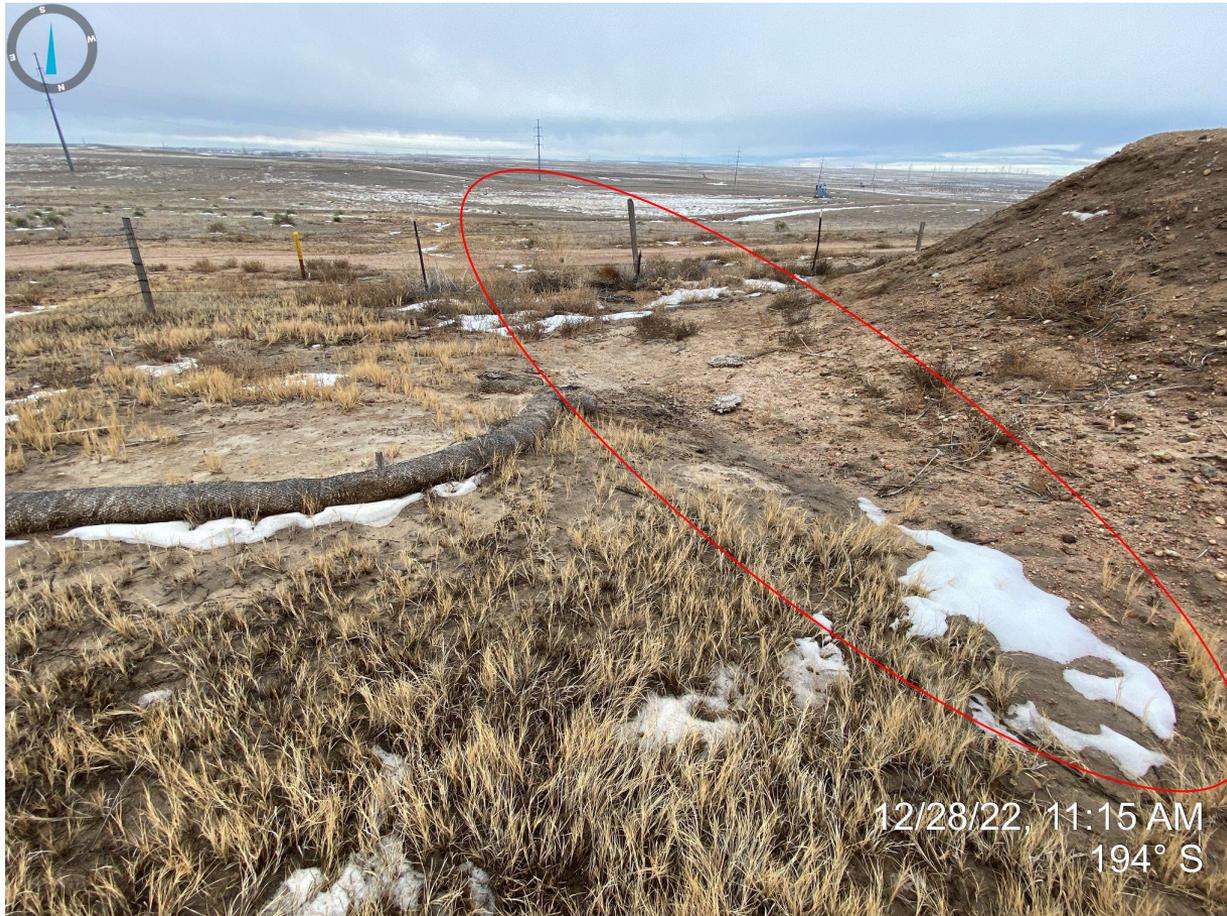
Photo 5. See comments in Photo 3.

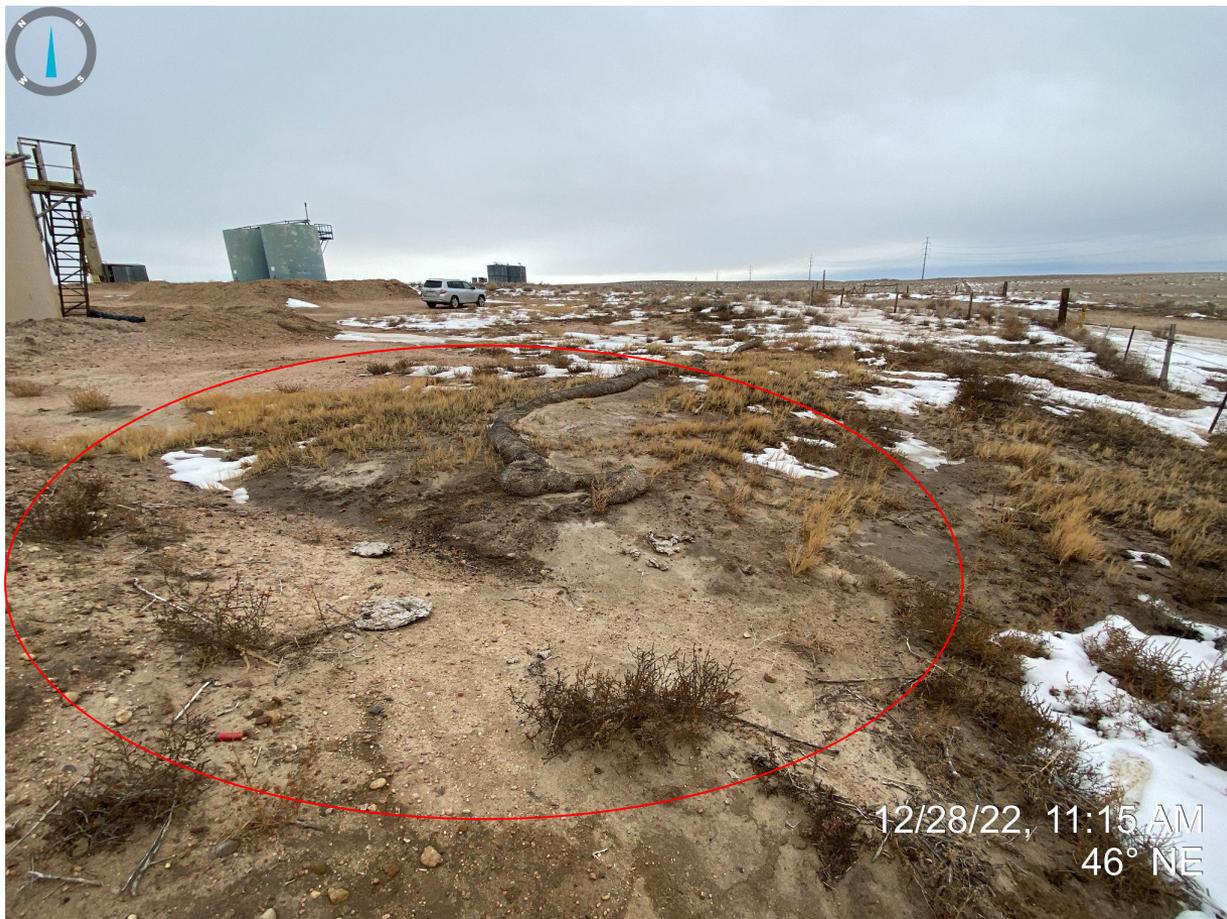
Photo 6. See comments in Photo 3.

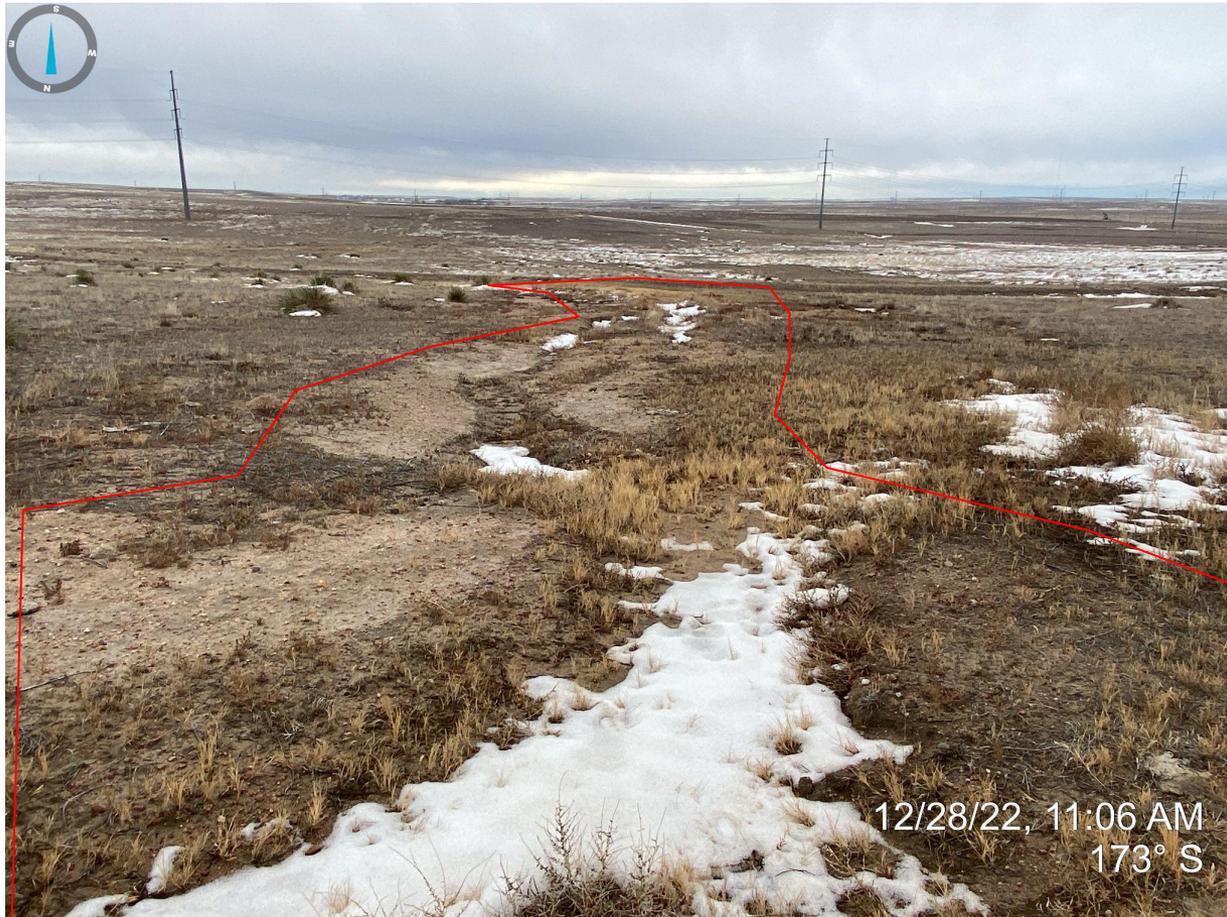
**Photo 7.** Facing south from access road. Photo illustrates salt kill impacted area with gully erosion evident. No stormwater BMPs to help stabilize the eroded area observed during this inspection.

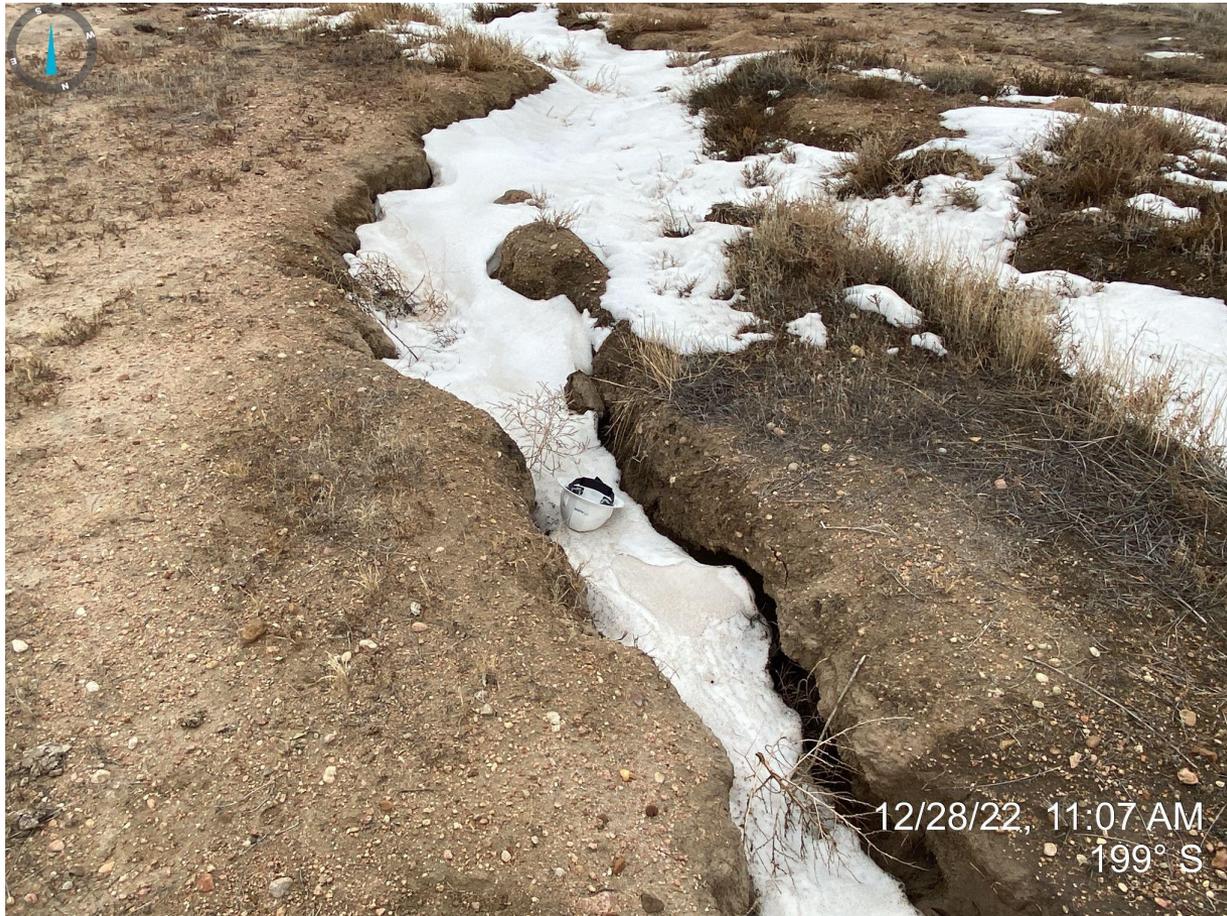
**Photo 8.** Taken approximately 175' from the access road, facing south. Gully was approximately 10" deep to top of snow cover, possibly deeper under the snow; hard hat for scale.

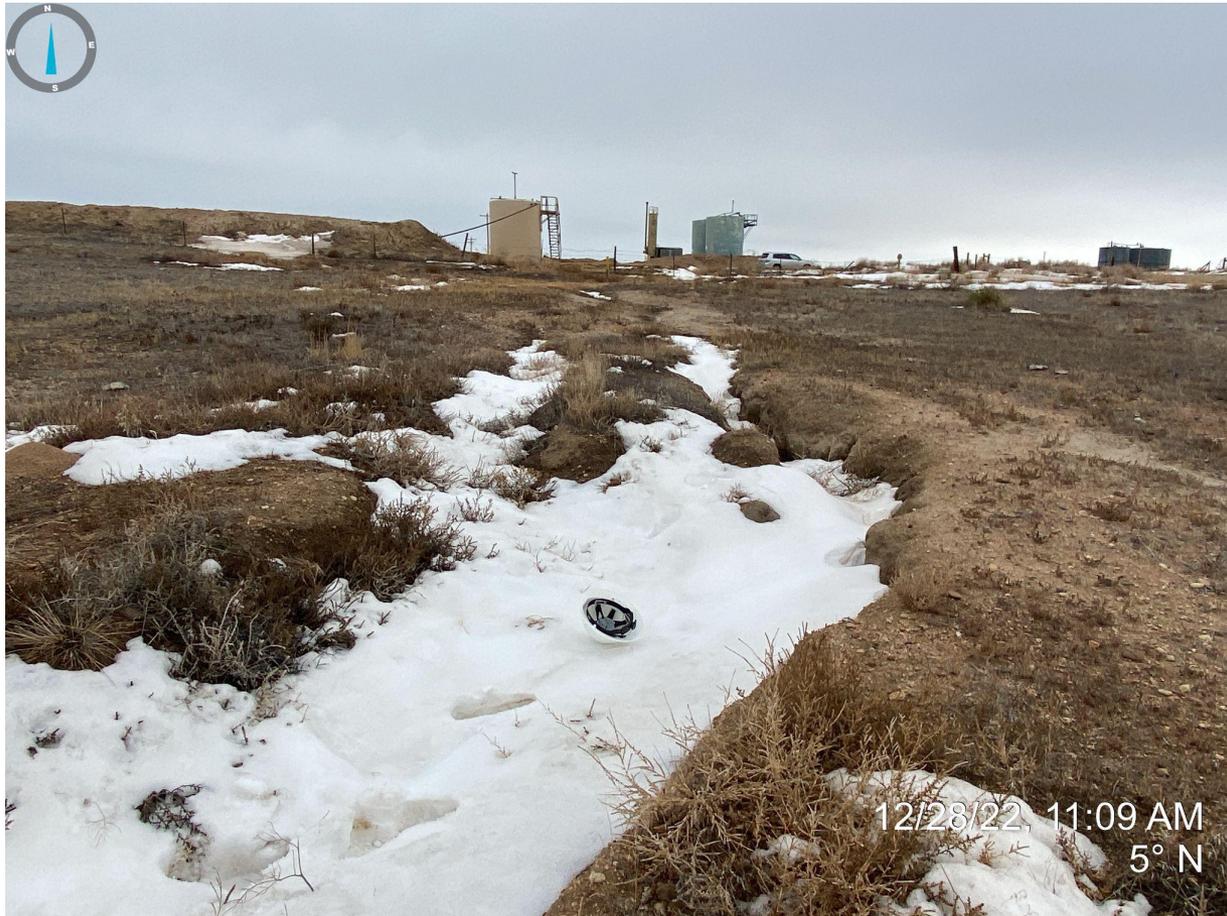
**Photo 9.** Facing north, see comments in Photos 7 and 8.

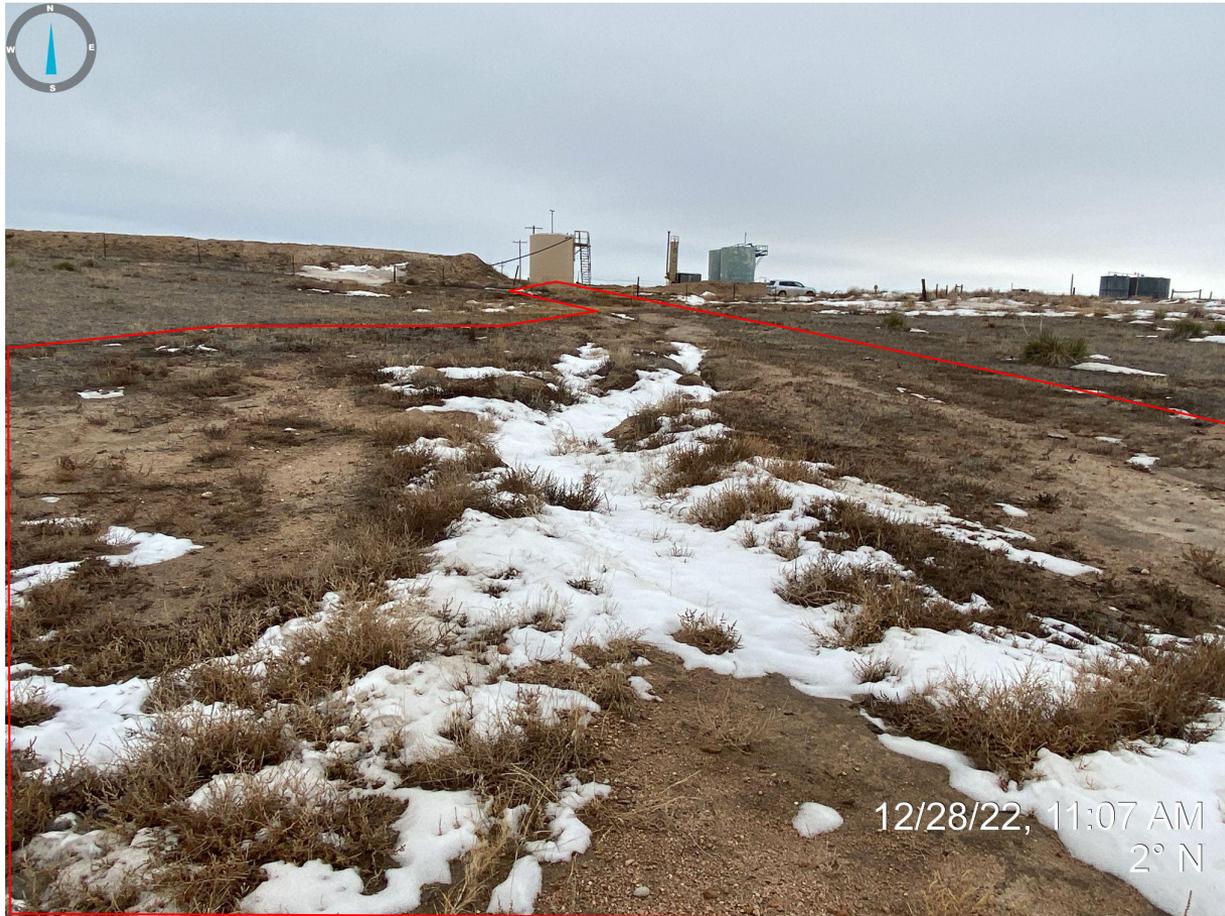
**Photo 10.** Facing North, approximately 200' from access road. Photo illustrates gully erosion within the salt kill area, with evidence of undesirable vegetation (e.g. russian thistle and kochia) that was not observed in other areas outside of the salt kill (e.g in the reference area).

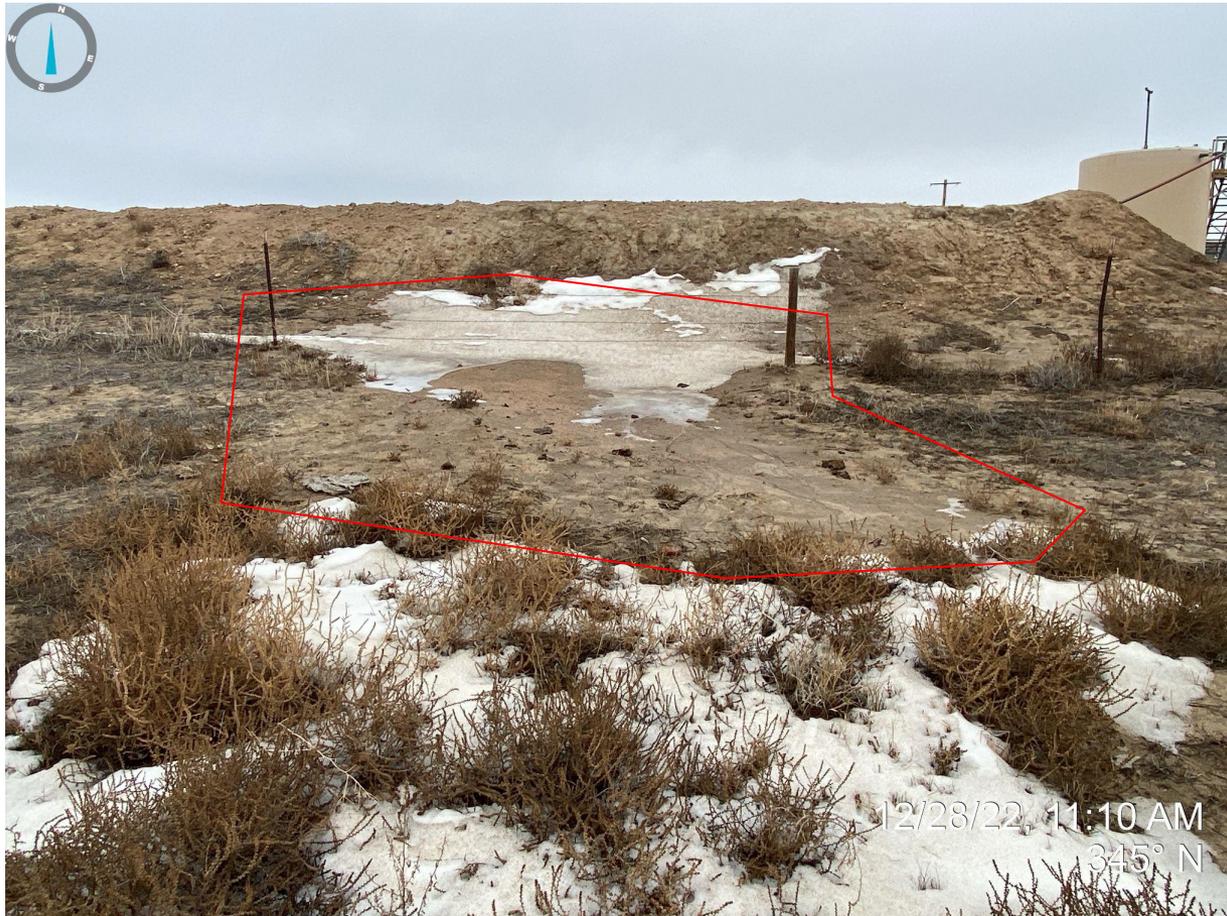
**Photo 11.** Taken from the access road, facing north. Photo illustrates presence of undesirable vegetation, and off-location sediment transport, outlined in red. Snow cover is likely concealing further evidence of sediment transport.

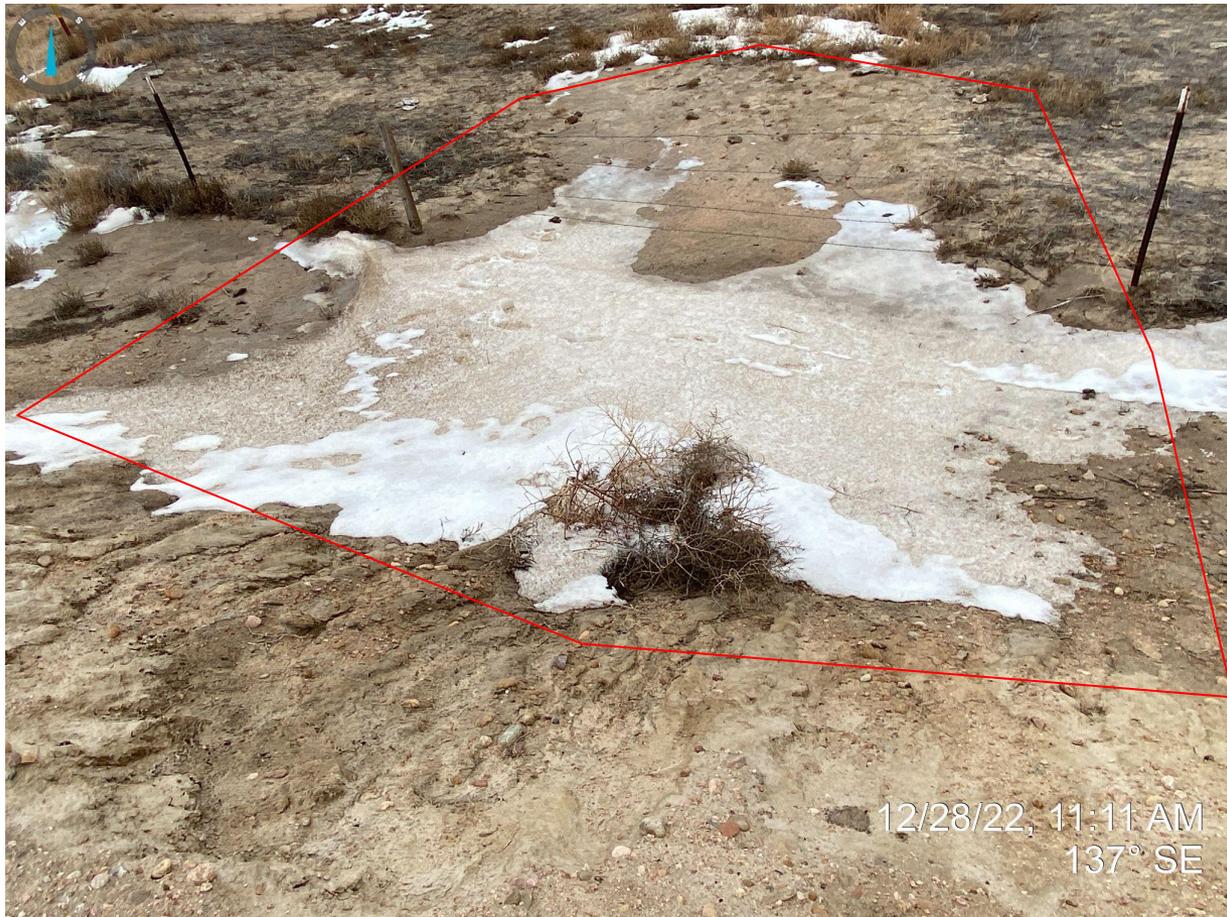
**Photo 12.** Facing southeast, see comments in Photo 11.

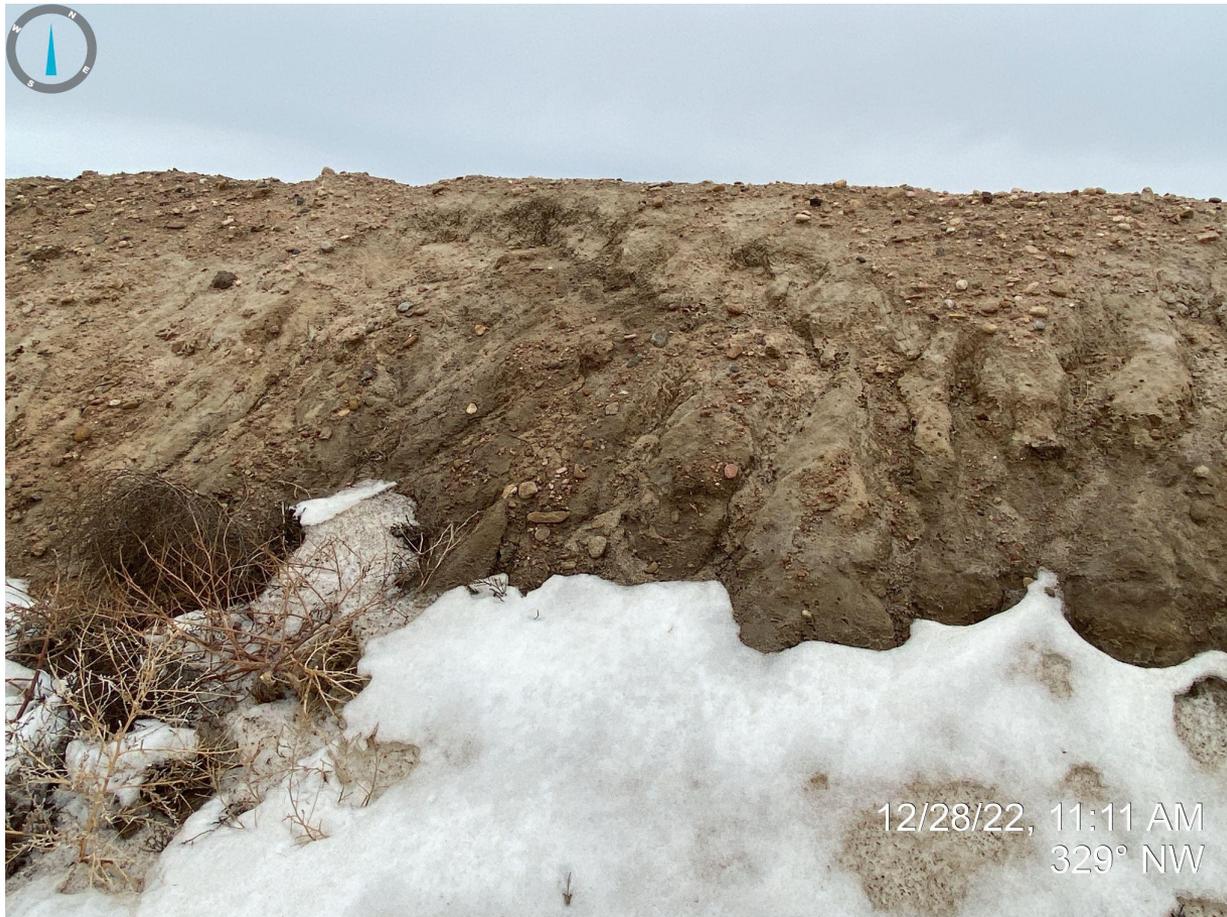
**Photo 13.** Facing northwest. Photo illustrates close up of unstabilized pit walls that were comprised of unconsolidated material, evidence of rill erosion, and almost vertical in shape.

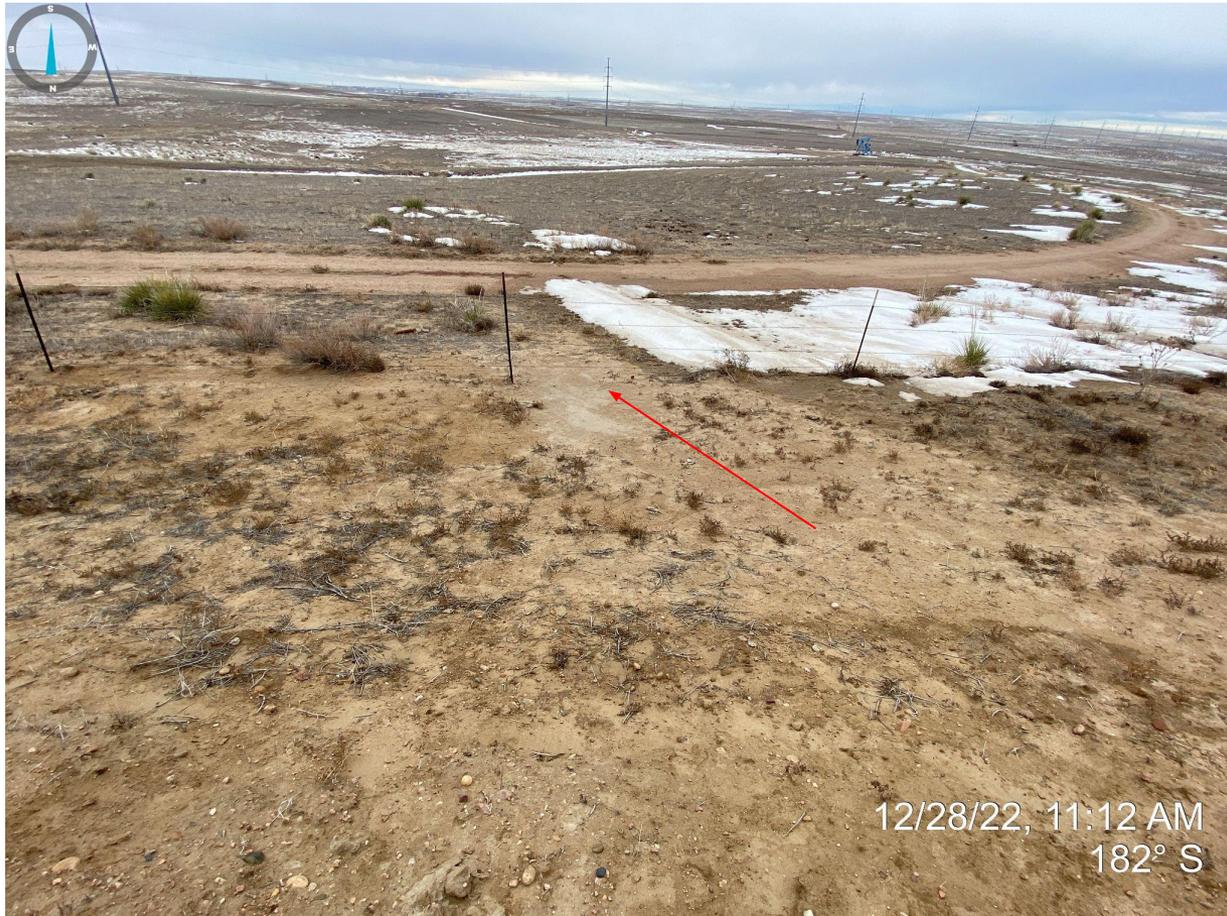
**Photo 14.** Facing south from the southwest corner of the produced water pit. Photo illustrates evidence of recent sediment transport off location, red arrow.

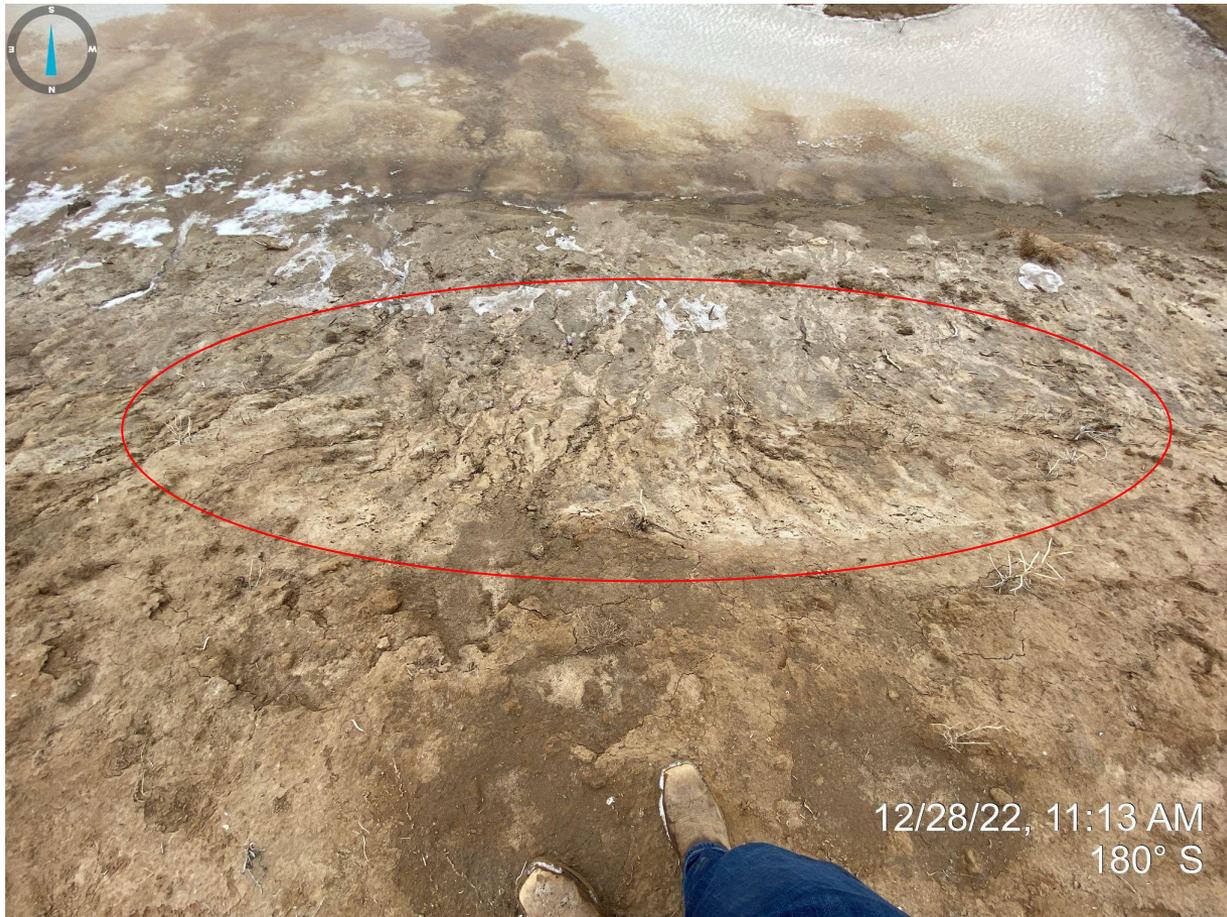
**Photo 15.** Facing south from northern pit wall. Photo illustrates evidence of rill erosion on the inside pit wall.

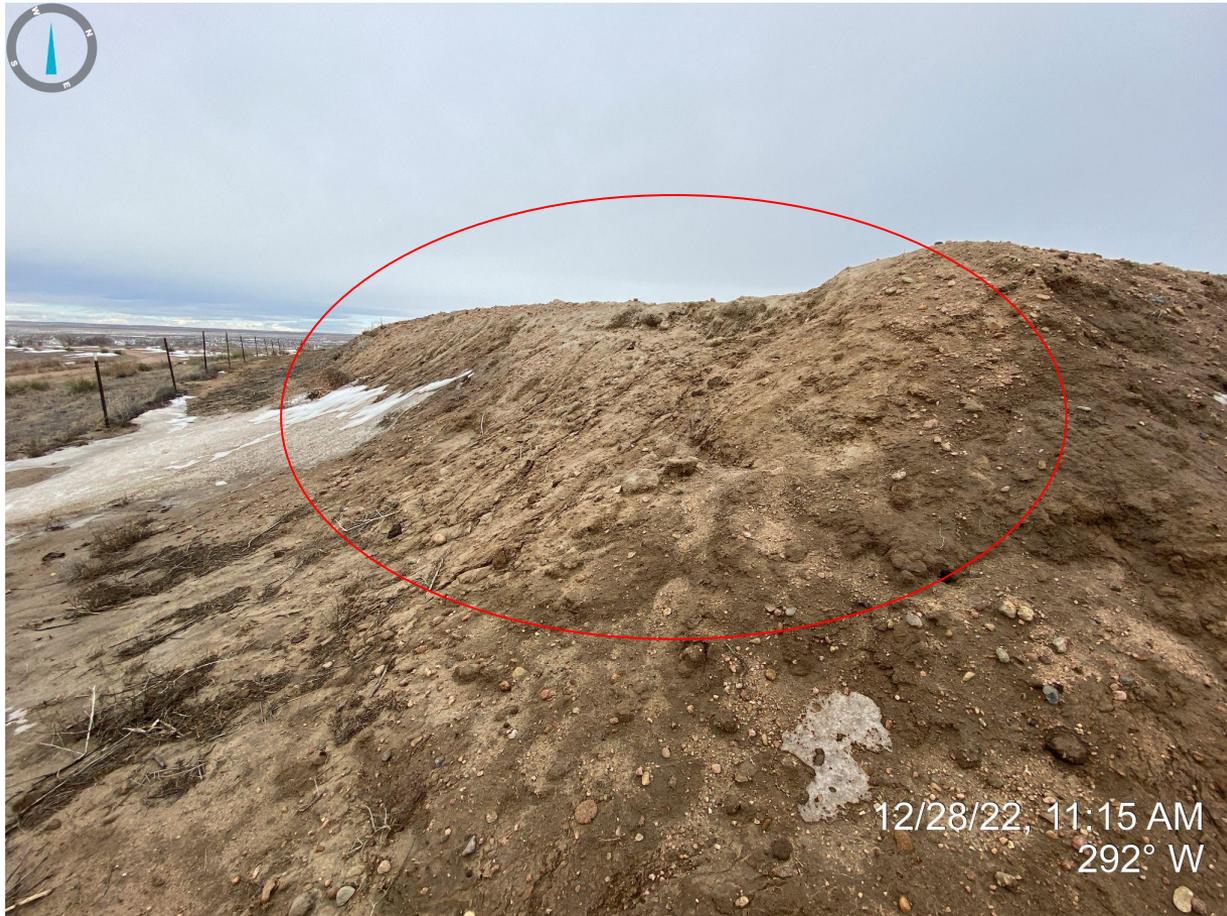
**Photo 16.** Facing west from the southeast corner of the pit. Photo illustrates unstabilized pit wall with evidence of rill erosion, vertical shape and unconsolidated material that is susceptible to further erosion.

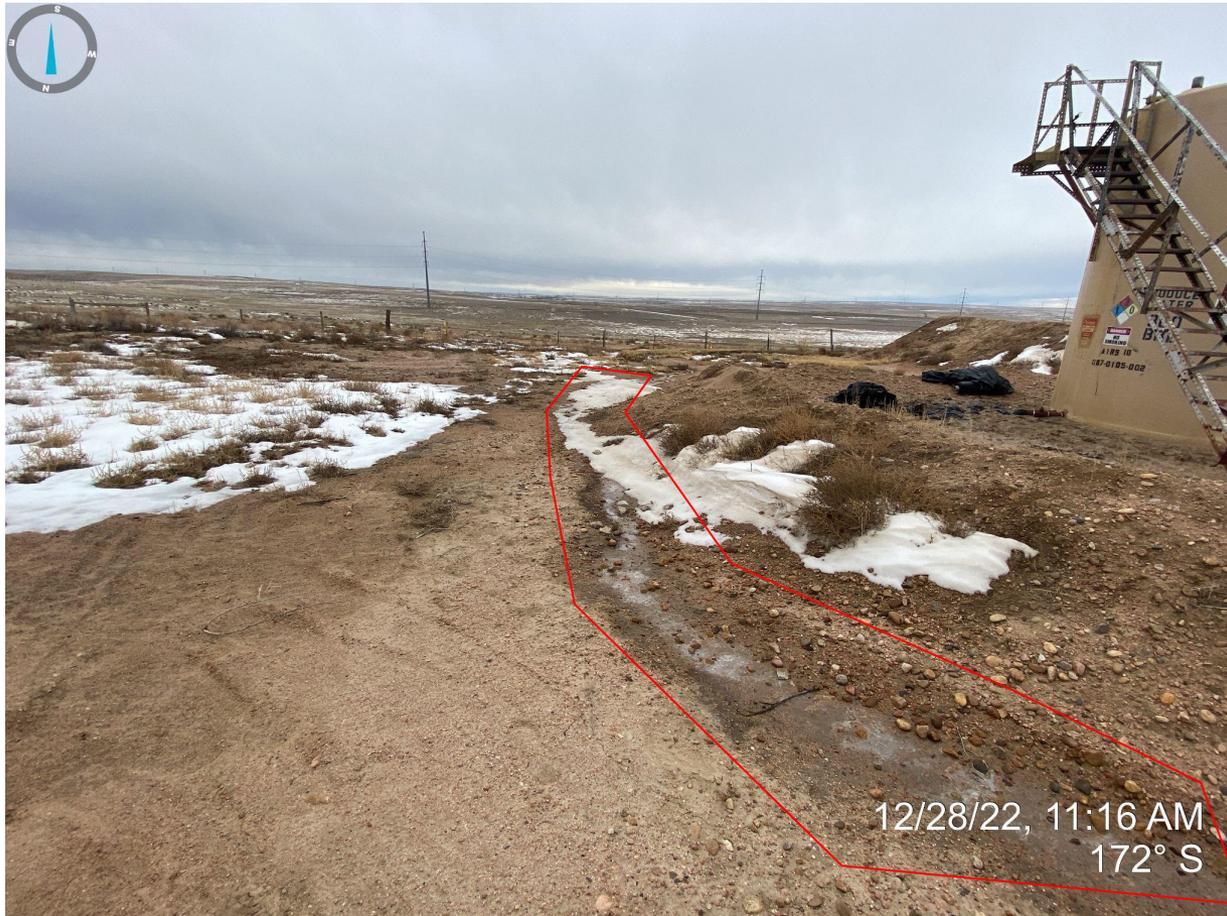
**Photo 17.** Facing south near the produced water tank. Picture shows evidence of rill/gully erosion occurring on the location with no apparent stormwater BMPs being implemented.

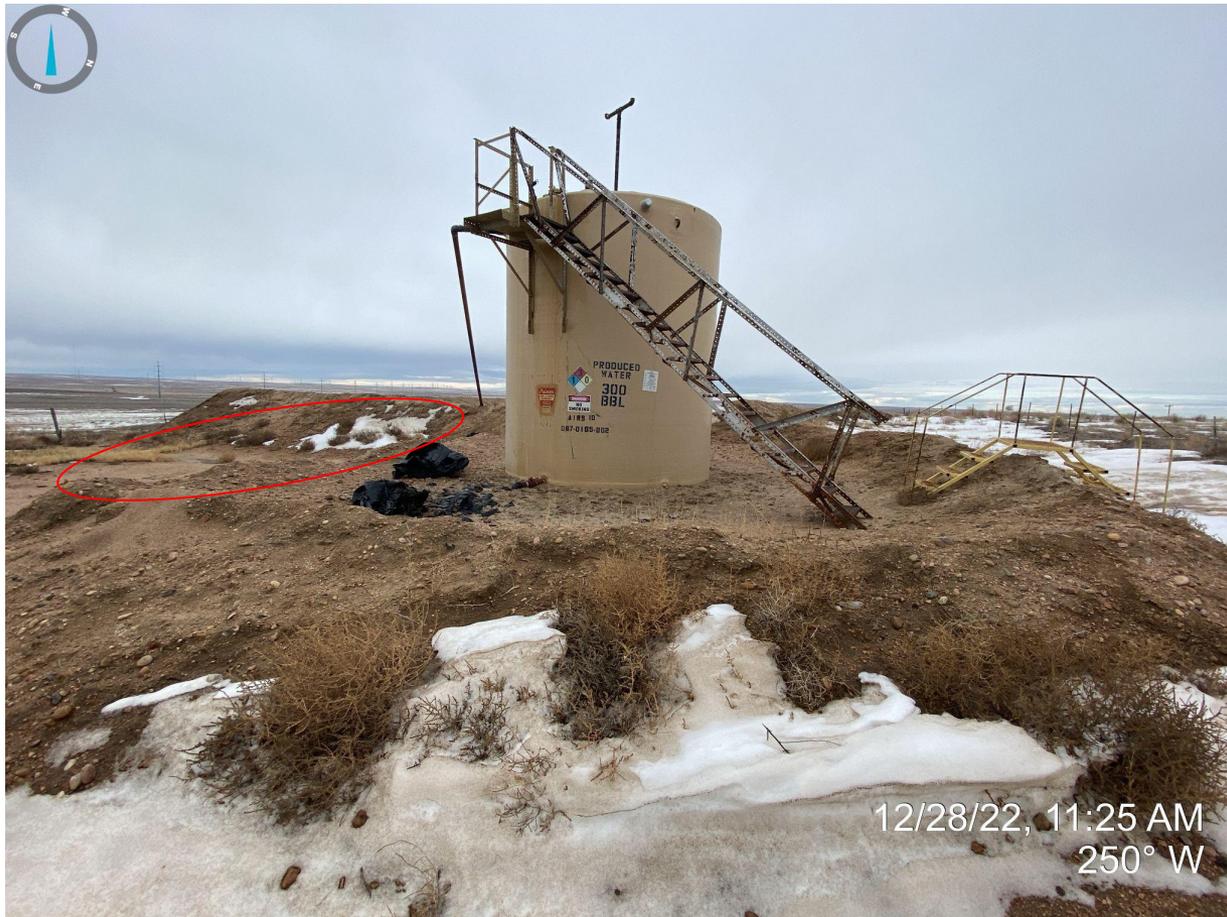
**Photo 18.** Facing west towards produced water tank. Photo illustrates no emergency contact information posted at facility, evidence of undesirable vegetation (e.g. russian thistle and kochia), debris (plastic liner), and a breached earthen berm with inadequate free board.

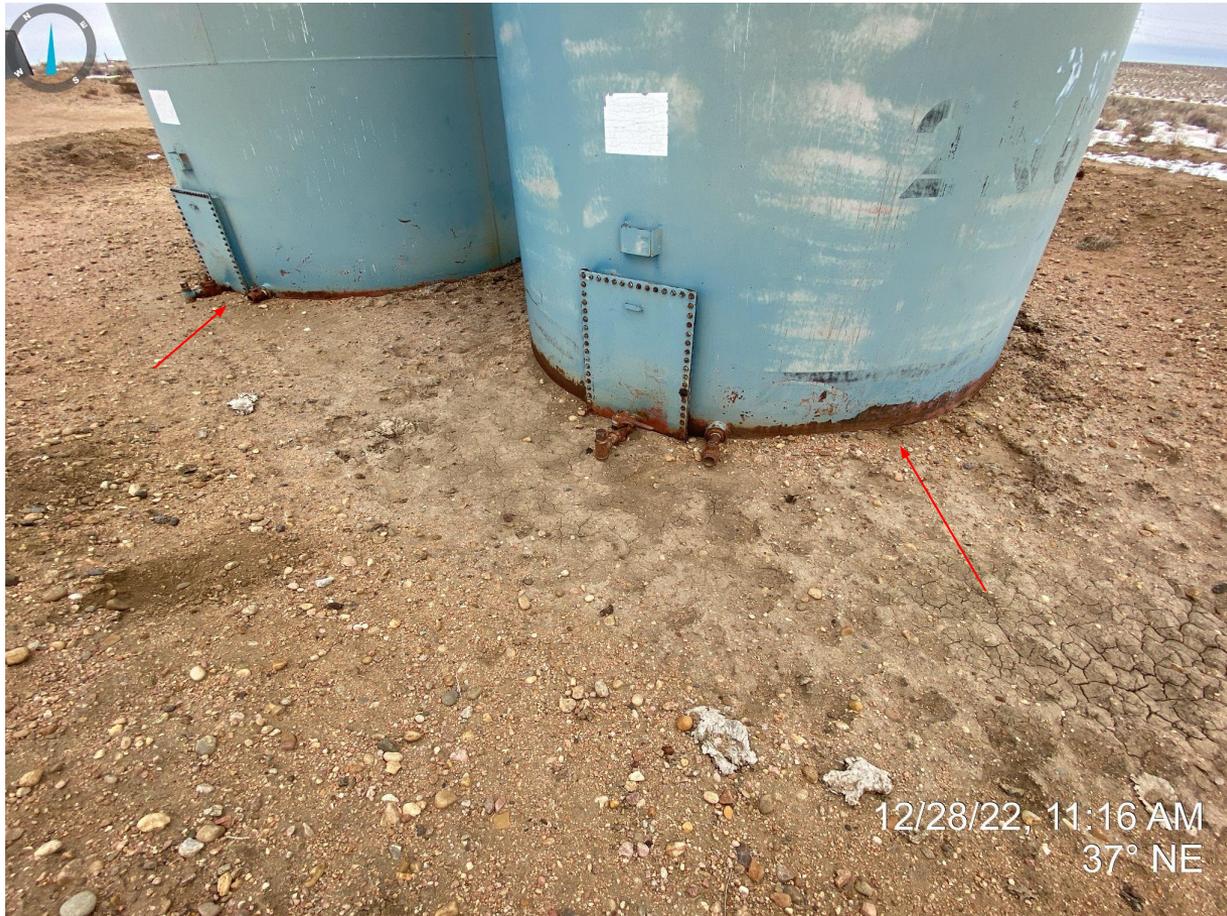
**Photo 19.** Facing northeast at crude tank battery facility. Photo illustrated pitted/rusted tank bottoms.
