# Interim Reclamation and Stormwater Inspection

Operator: KP KAUFFMAN COMPANY INC - 46290

Location ID: 450344

Inspection Photos  
Location Name: Boxer 25, 26, 29 Battery  
Location ID: 450344

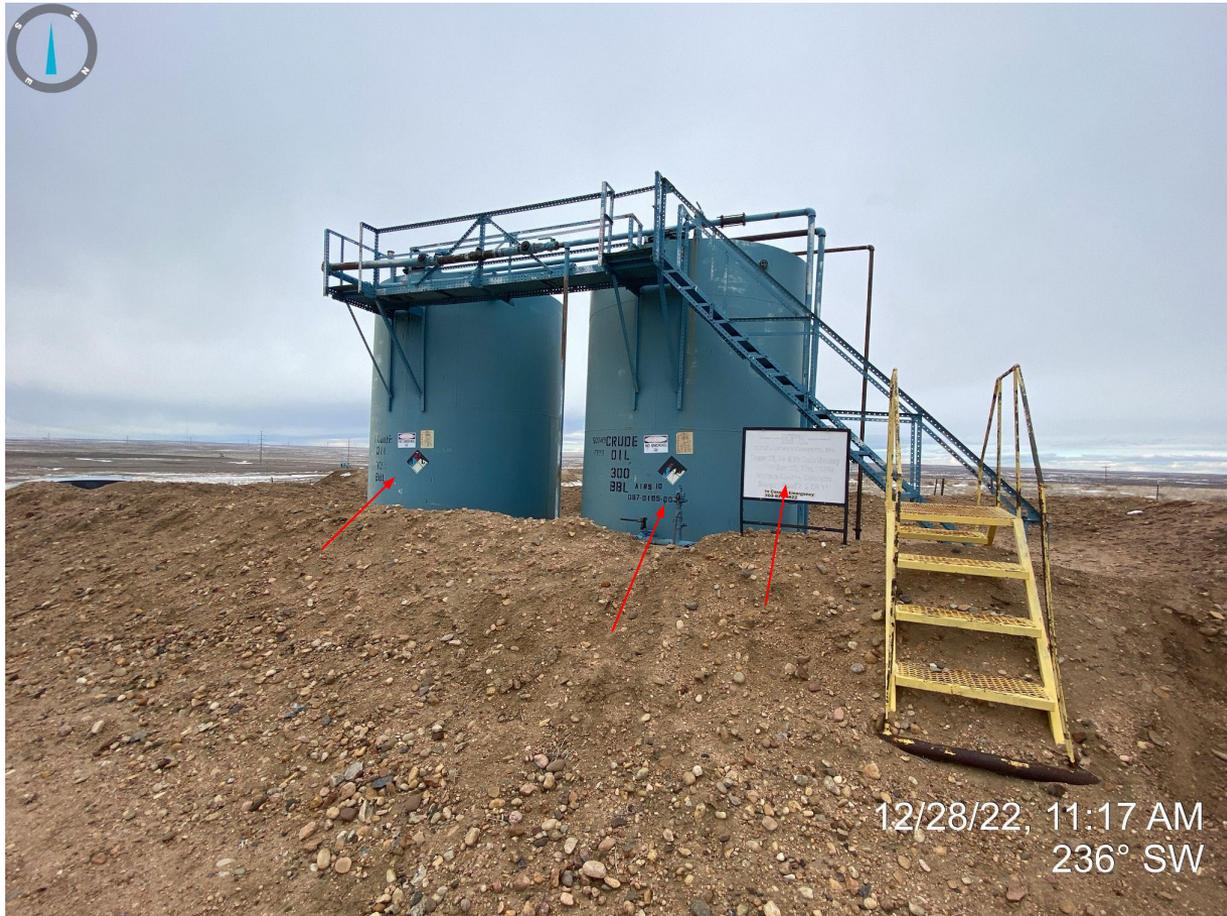
**Photo 20.** Facing southwest at tank battery. Photo illustrates the sign at the facility is illegible and faded, and faded/torn hazmat placards on tanks.

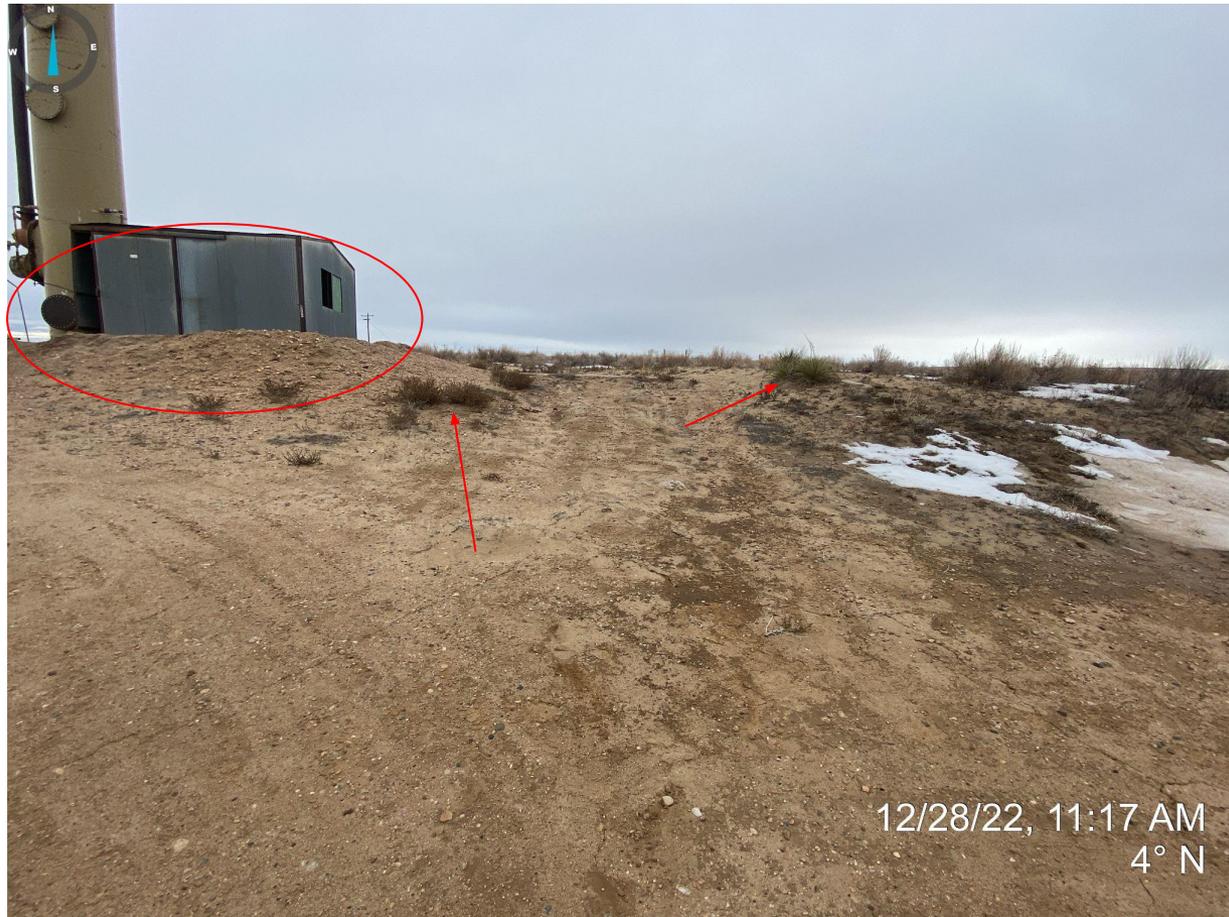
**Photo 21.** Facing north from the northern portion of the location, near heater treater. Photo illustrates presence of undesirable vegetation (e.g. russian thistle and kochia) and absence of sign posted at facility.

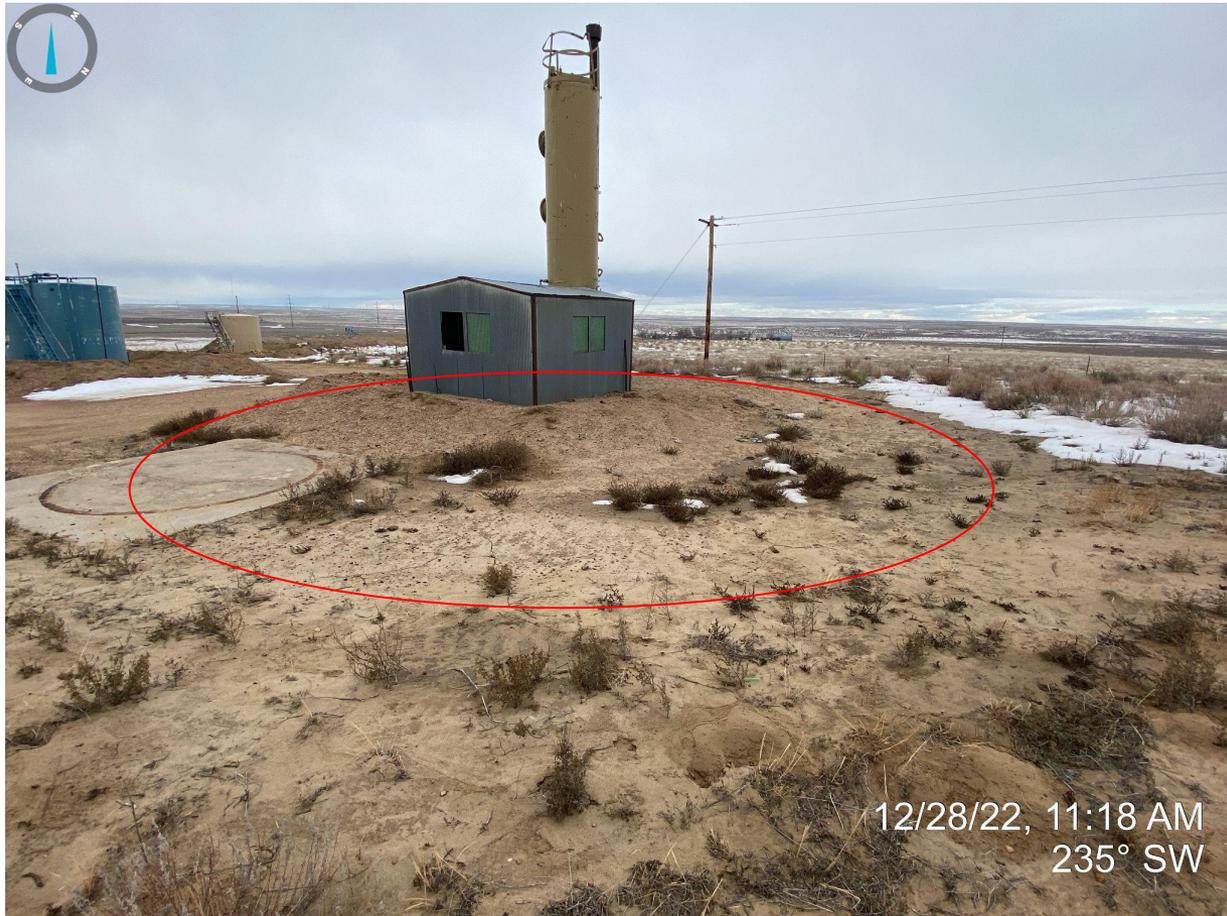
**Photo 22.** Facing southwest. See comments in Photo 21.

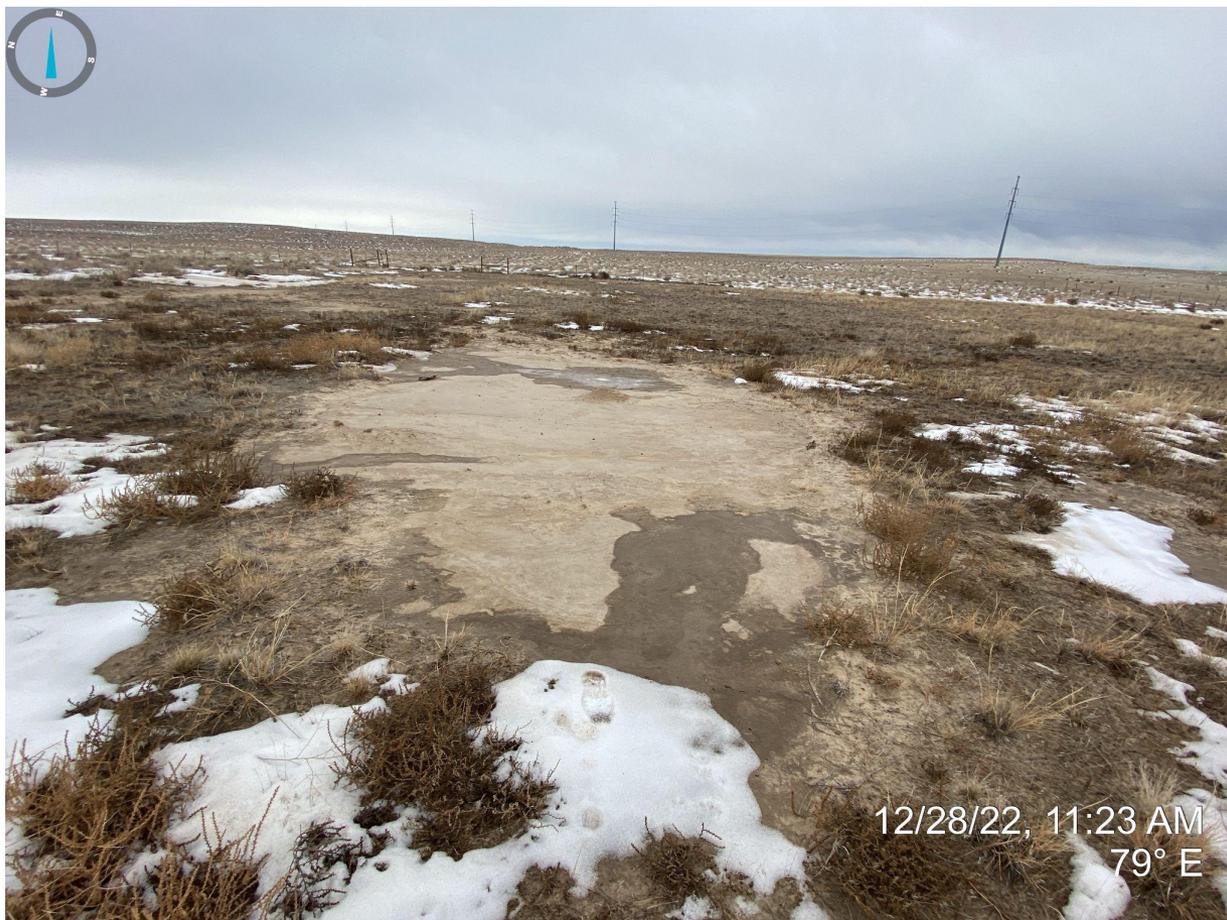
**Photo 23.** Facing east near the former Boxer East Skim Pit. Photo illustrates an area approximately 10' x 30' in size that is void of any vegetation, possibly a result of salt impacted soils. This area will need to be investigated and properly remediated in order to close the former skim pit (#102702).

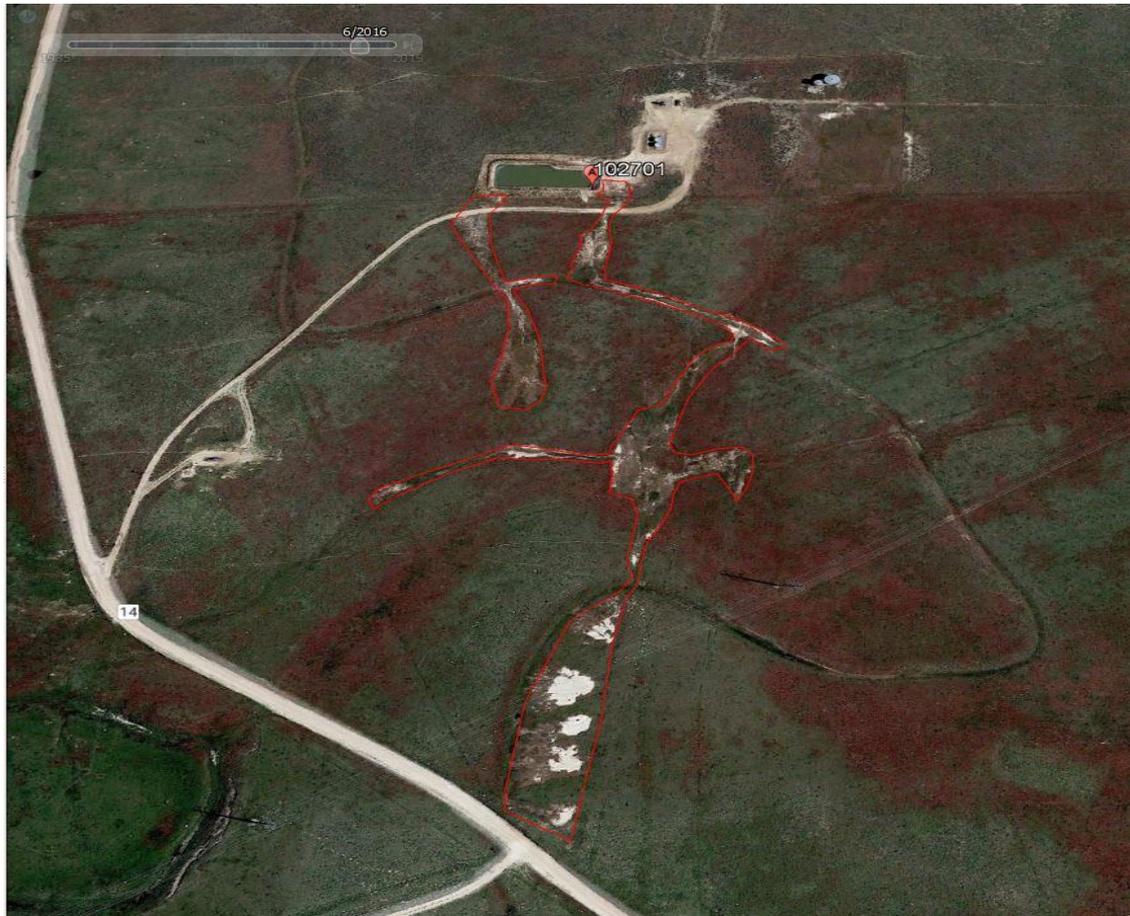
**Photo 24.** Google Earth aerial imagery taken circa 2016 illustrating the extent (outlined in red) of the salt kill impacted area. The Operator shall delineate the horizontal and vertical extent of the salt kill area and provide that information in a Supplemental Form 27.
