Inspection Photos

API: 055-06295

Operator: PETROGLYPH OPERATING CO

Inspection Date: 1/6/2023

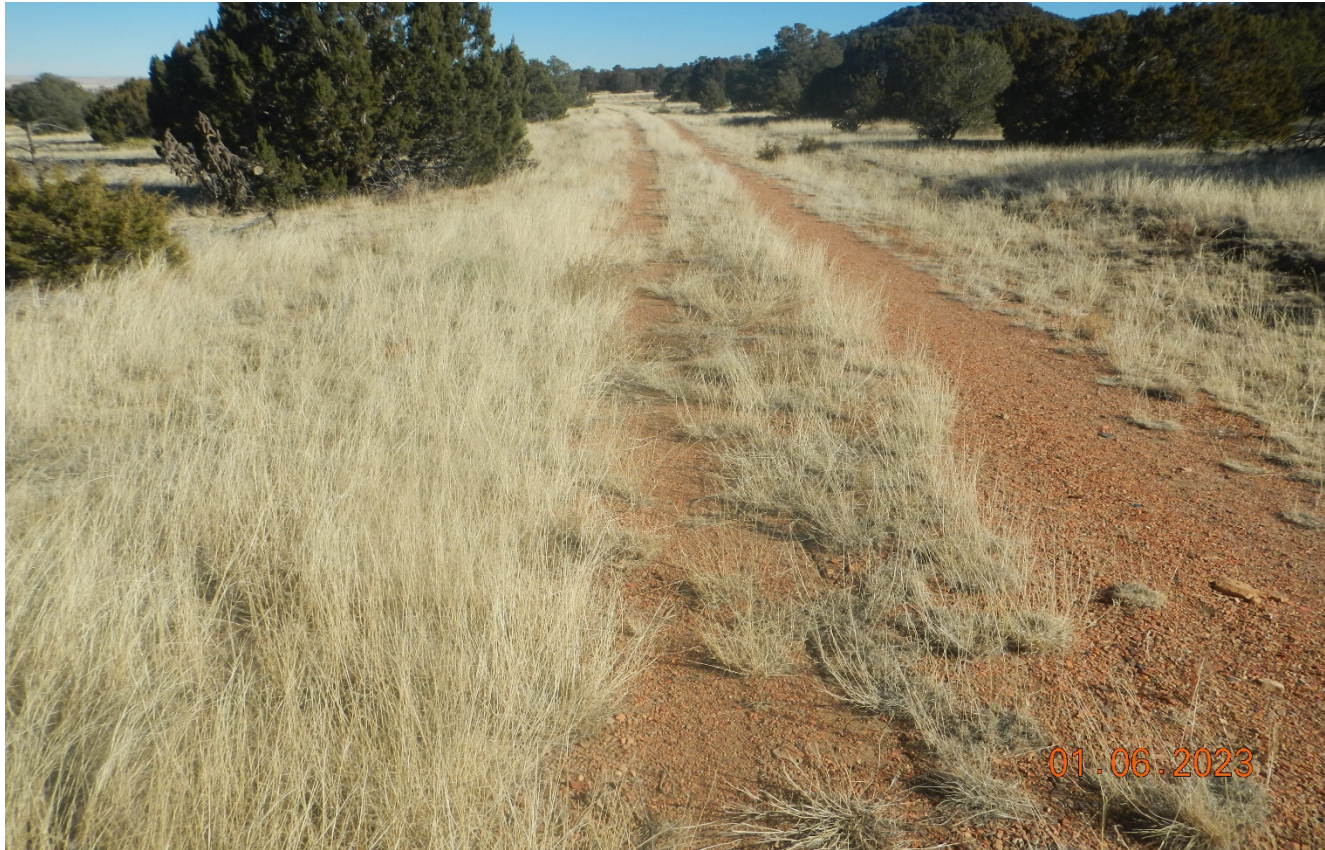
Photo 1. Facing east along the two track access road which was not reclaimed.

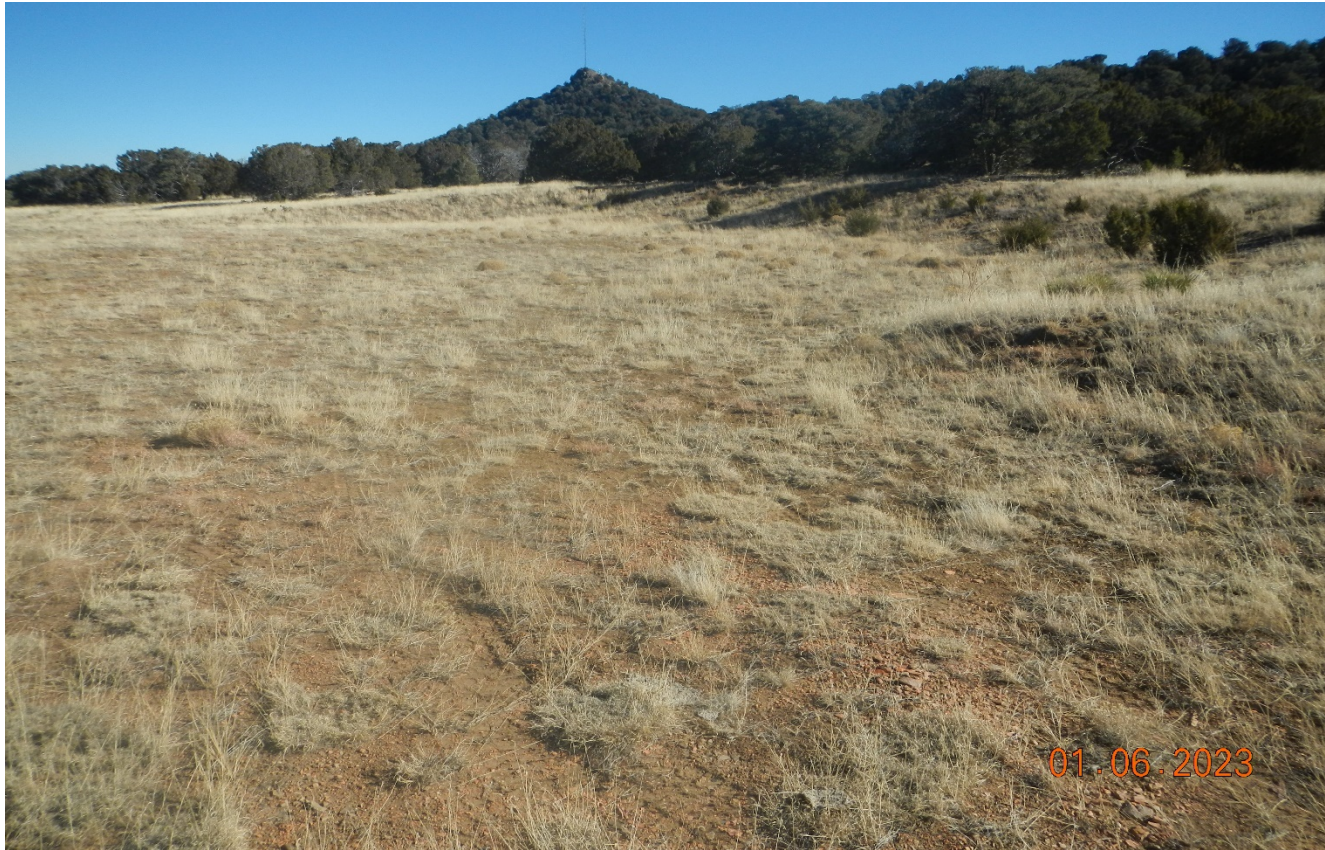
Photo 2. Facing southeast toward the location.

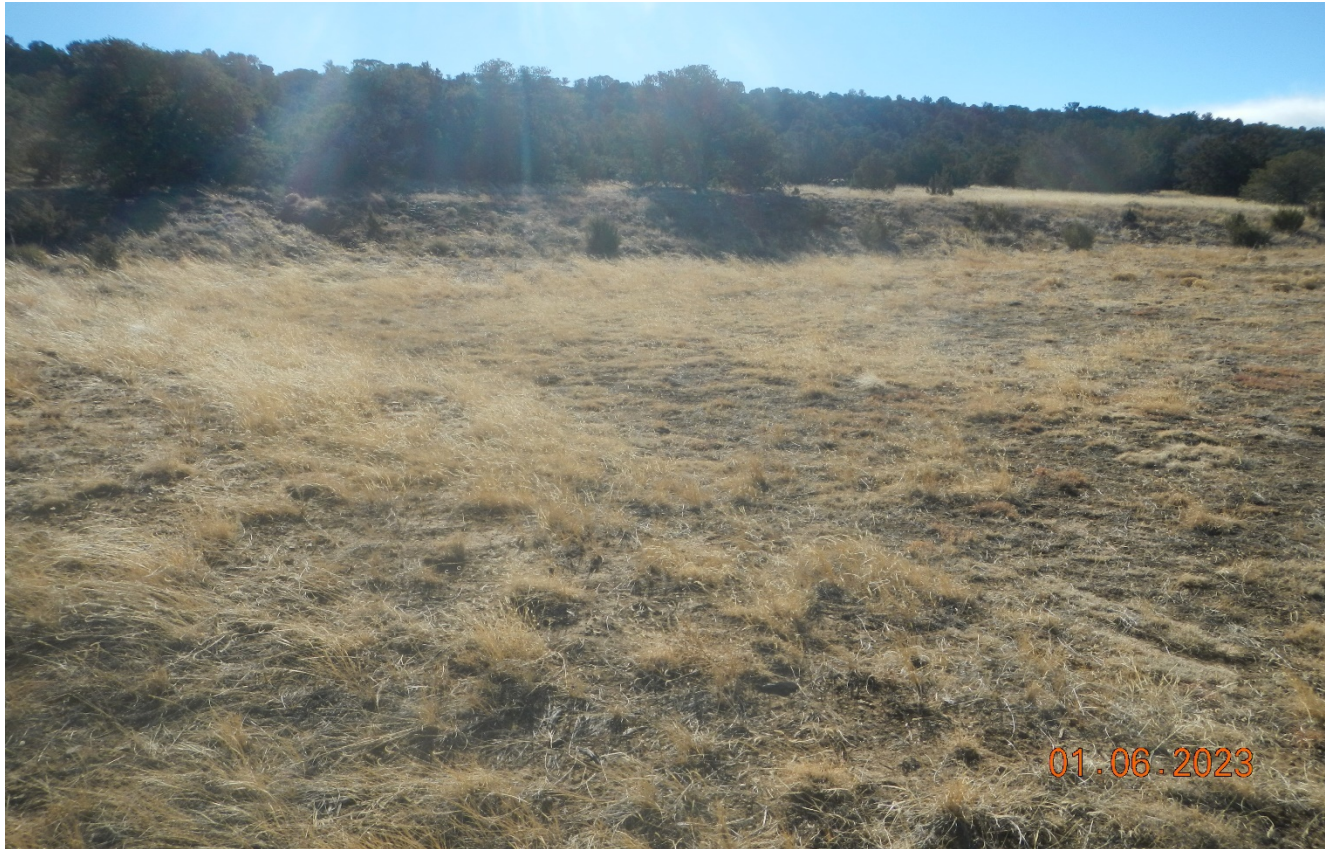
Photo 3. Facing South toward the cut slope of the location.

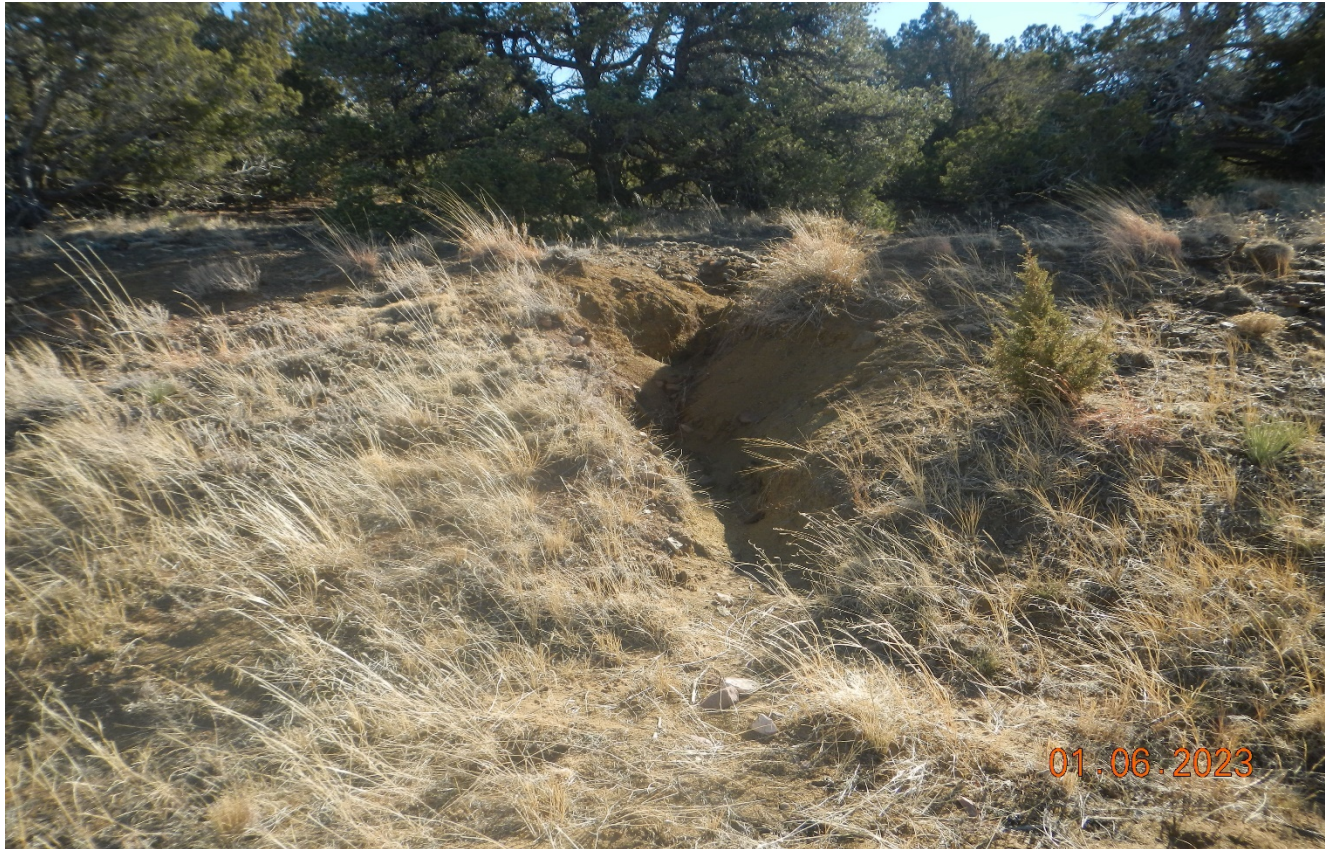
Photo 4. There is an erosion channel along the cut slope which was not repaired since previous inspection.

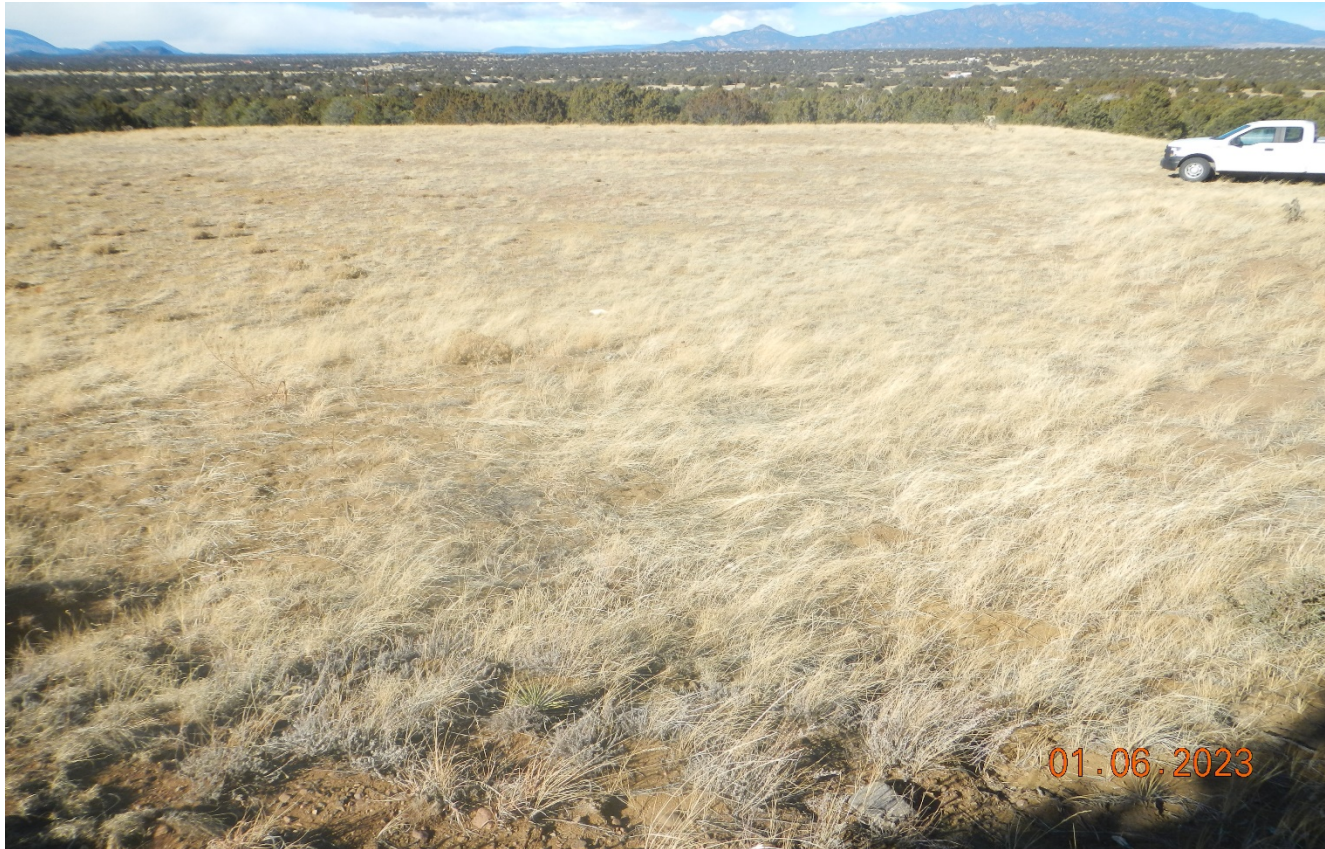
Photo 5. Facing northwest toward the location.
