# Inspection Photos

API: 009-06449

Operator: INVESTMENT EQUIPMENT LLC

Inspection Date: 1/10/2023

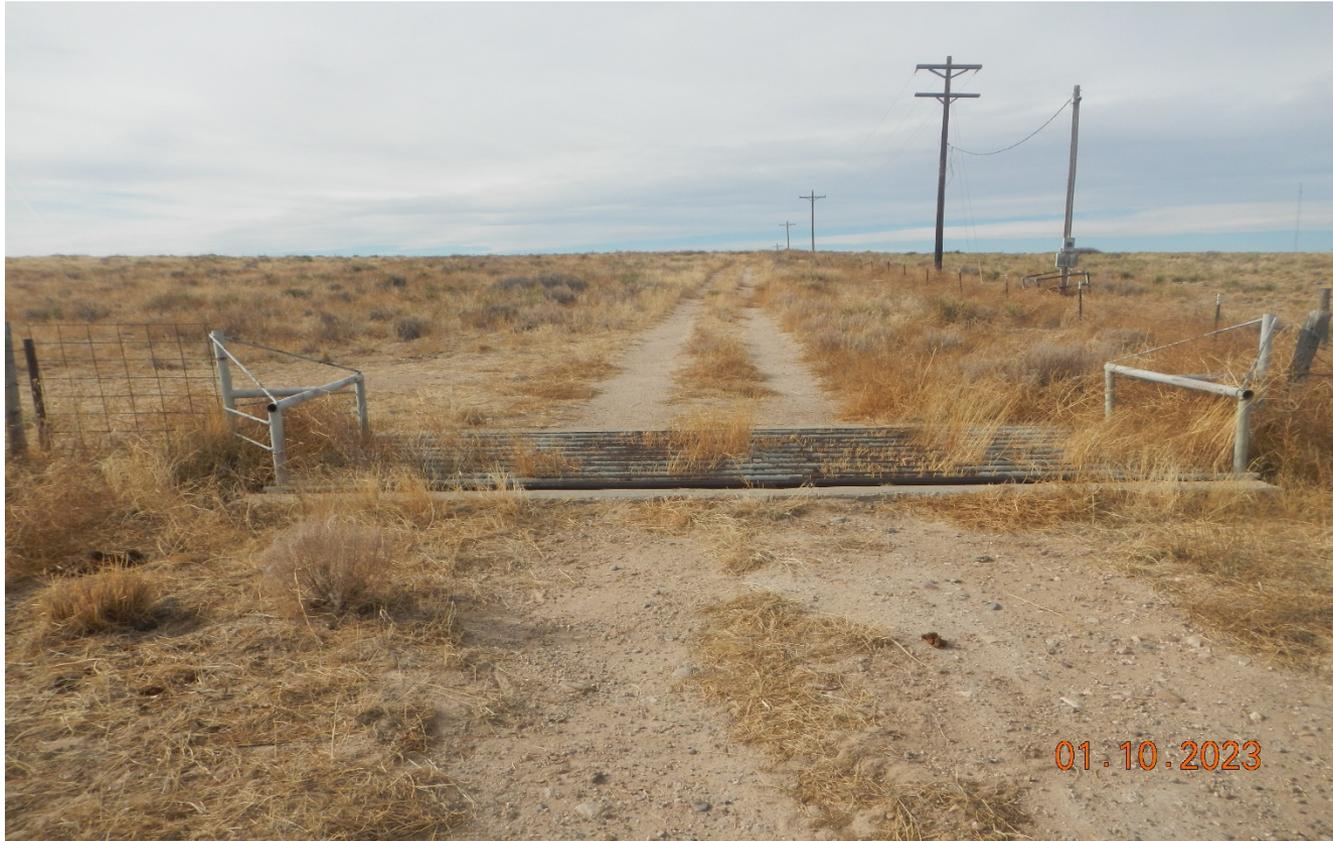
**Photo 1.** Facing west at the beginning of the access road. The cattle guard has not been removed and the road is not reclaimed.

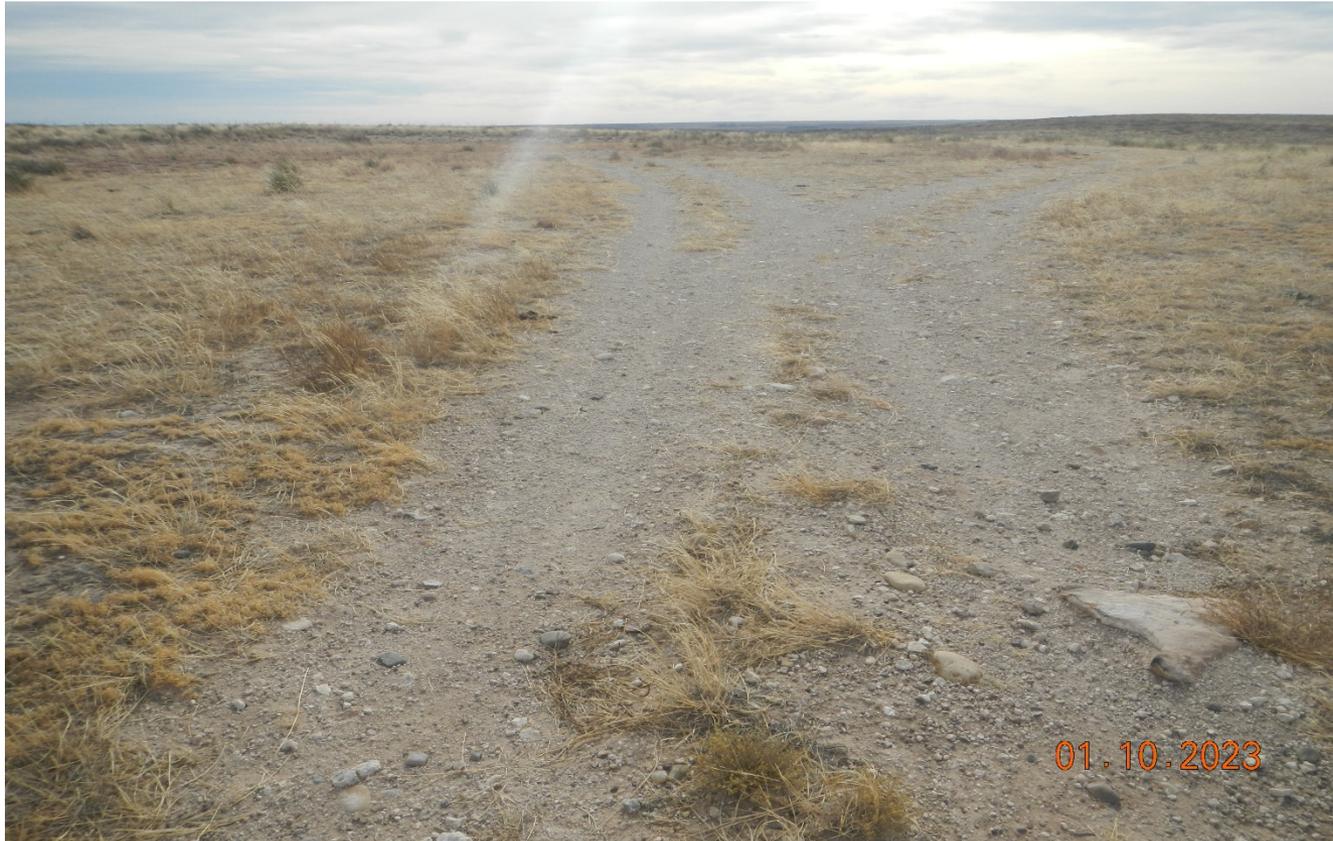
**Photo 2.** Facing south toward the location which has not been reclaimed.

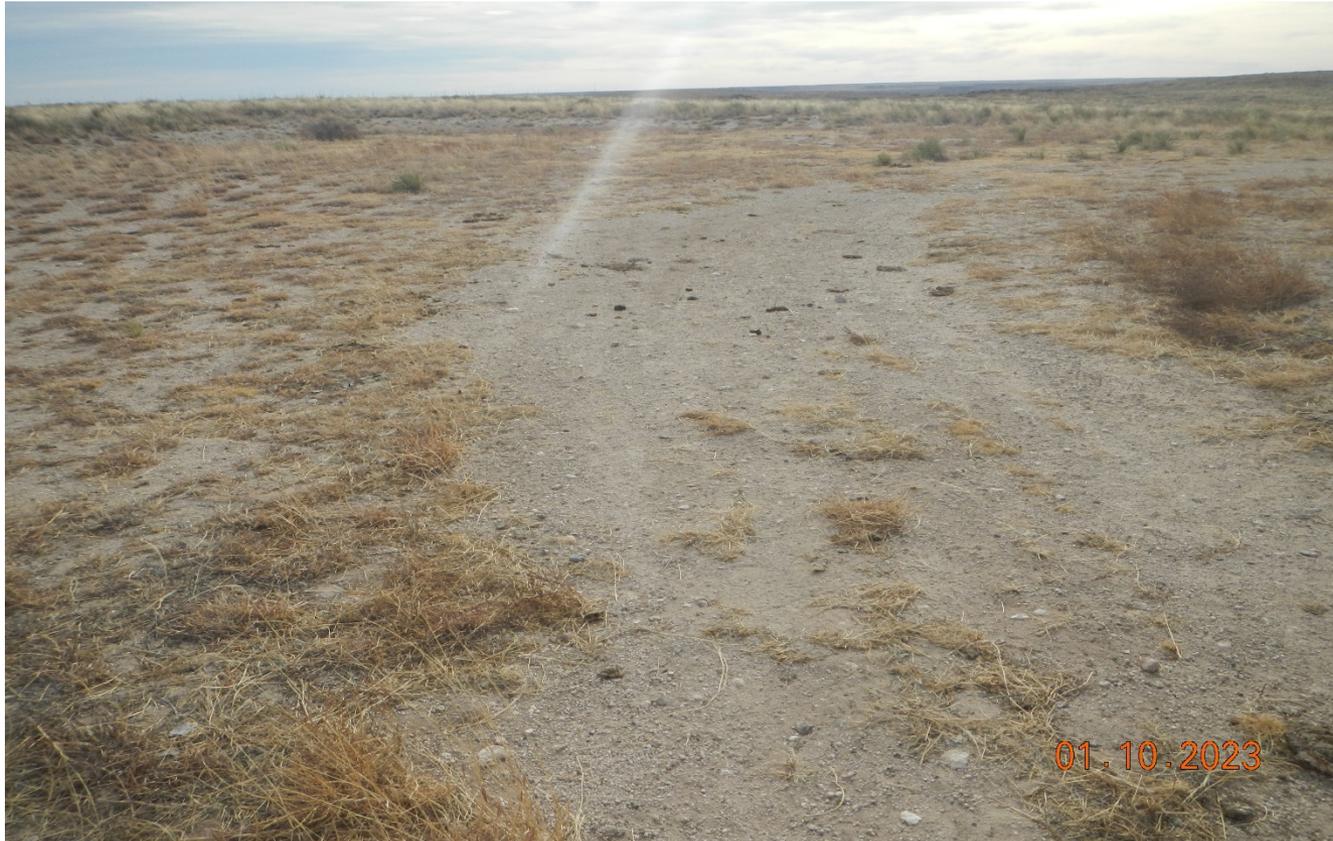
**Photo 3.** Facing southwest toward the location. There is compacted soil where the road remains.

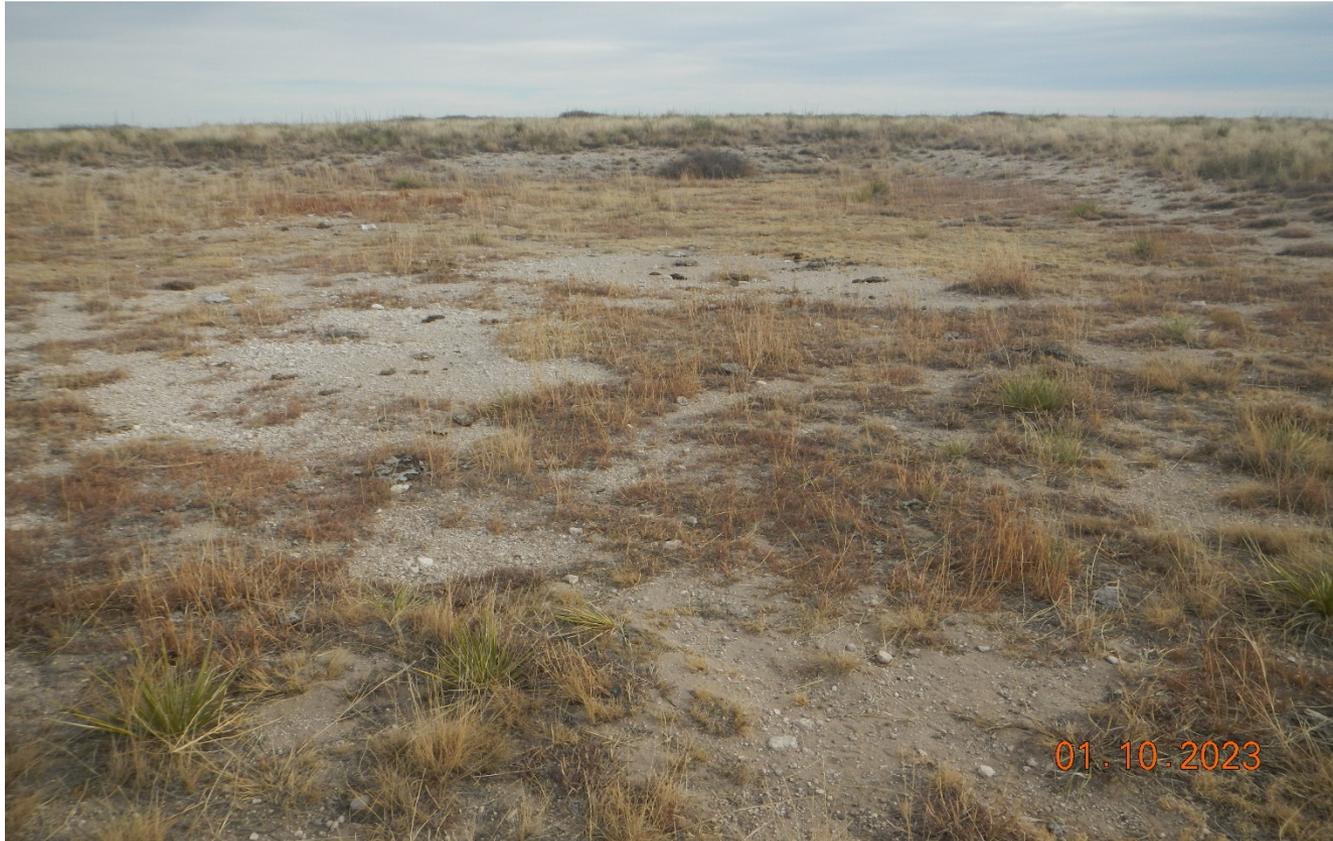
**Photo 4.** Facing east at the location.

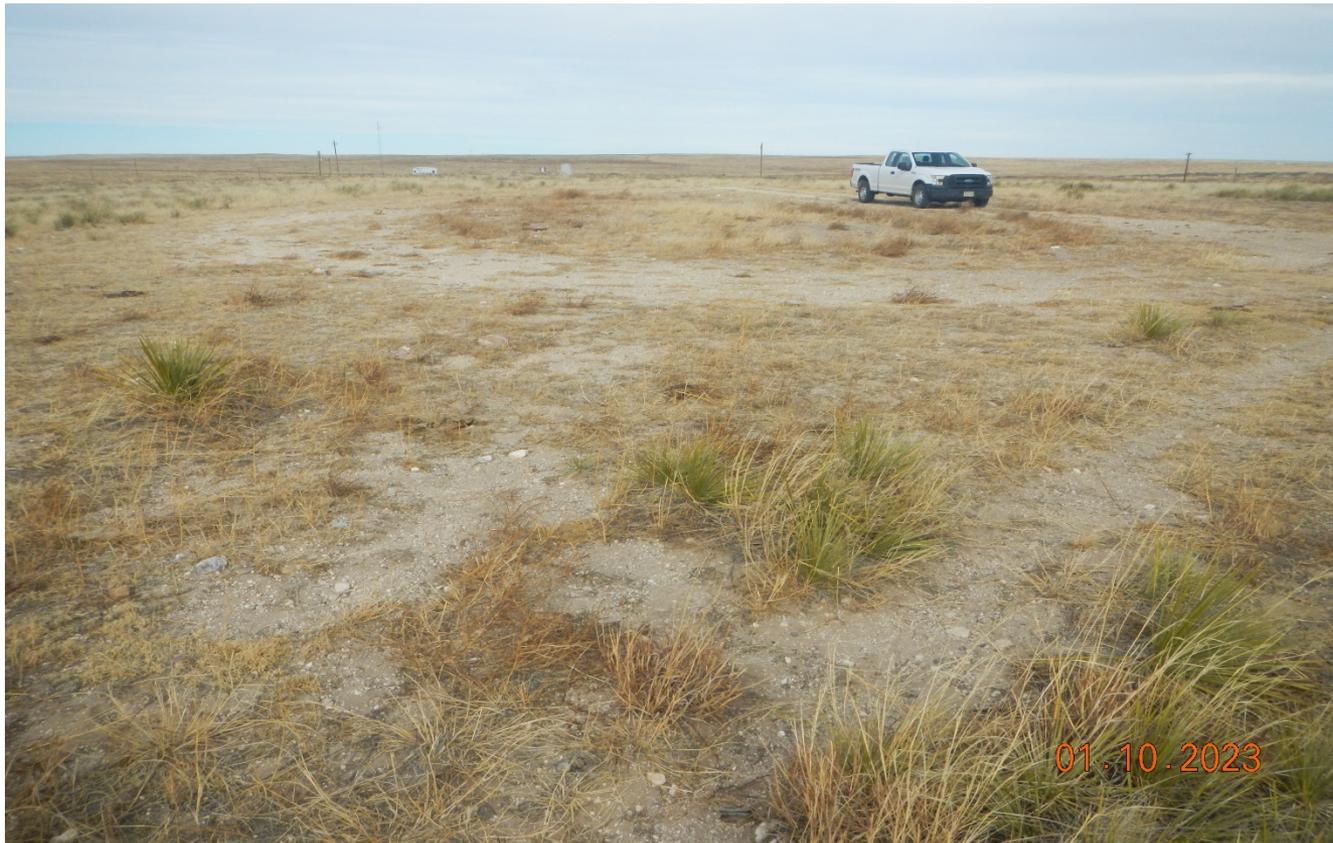
**Photo 5.** Facing north at the location.
