Inspection Photos

Location Name: TEP ROCKY MOUNTAIN LLC DEVER-66S92W /18SWSE

Location ID: 311676

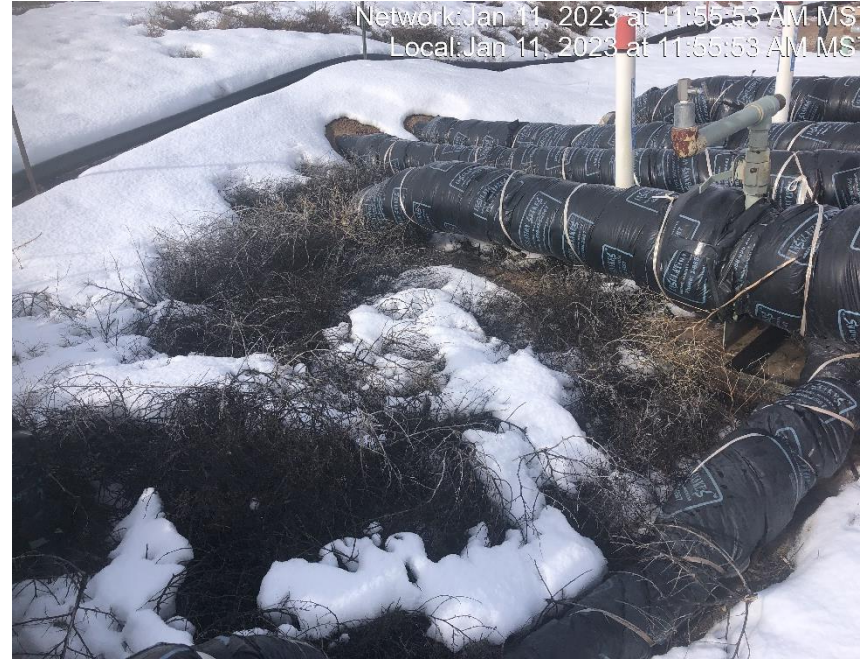
Photo #8752 Undesirable plant species on location.

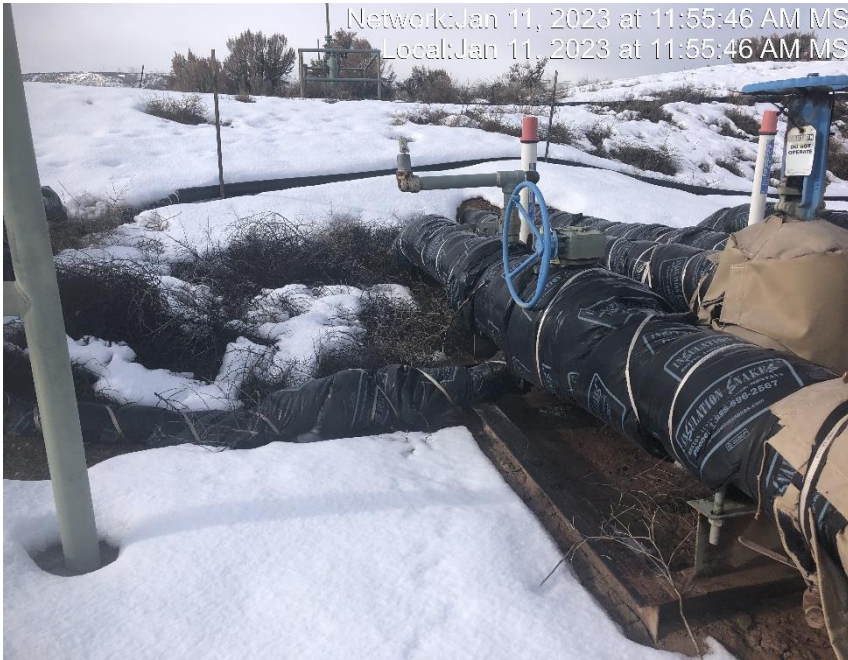
Photo #8753 Undesirable plant species on location.

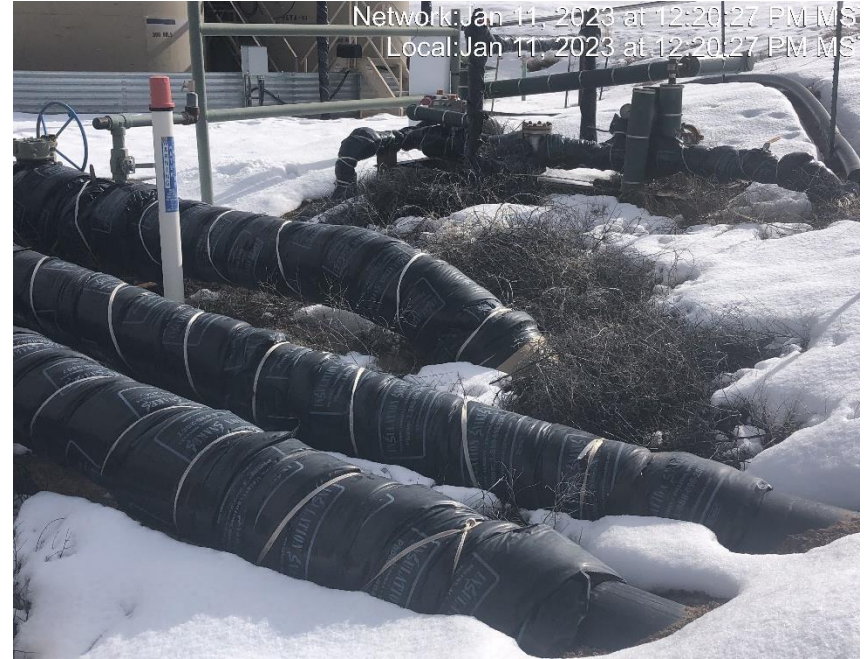
Photo #8771 Undesirable plant species on location.

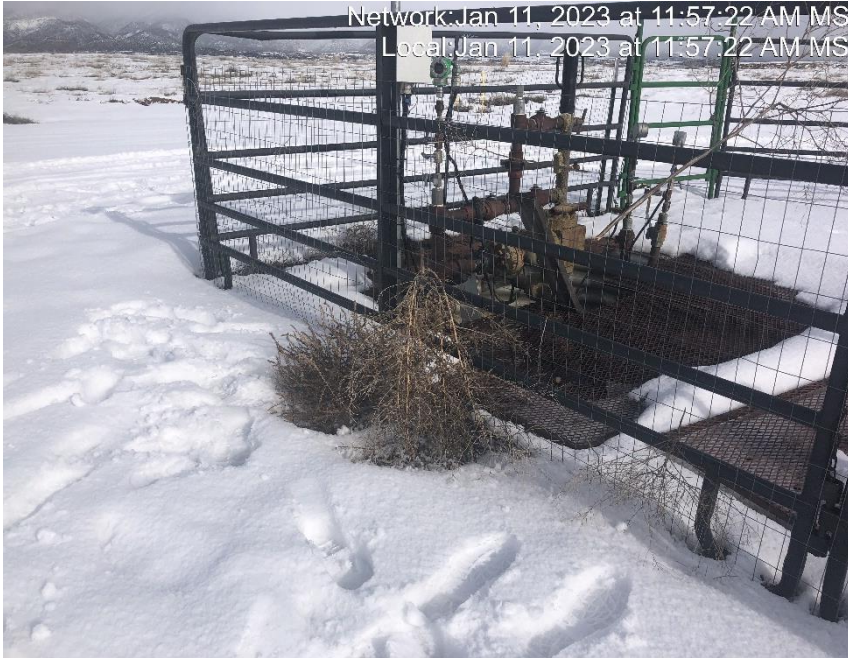
Photo #8756 Undesirable plant species on location.

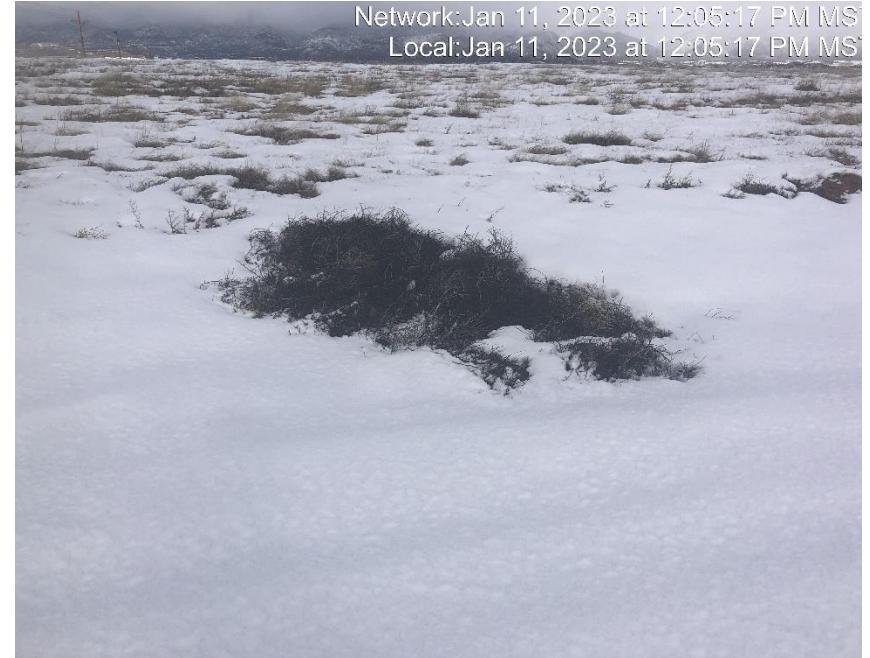
Photo #8757 Undesirable plant species on location

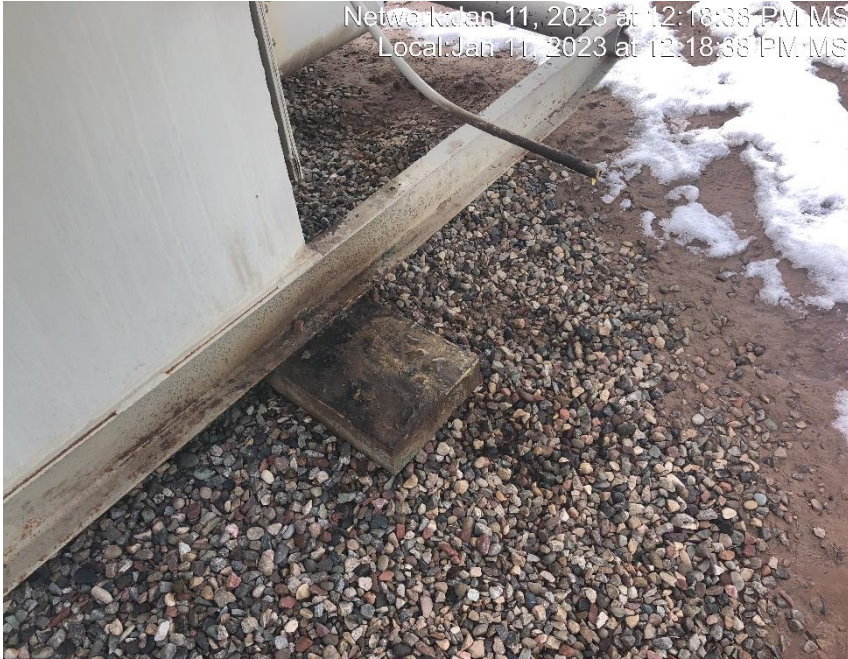
Photo #8763 Stained soils and gravel on location.

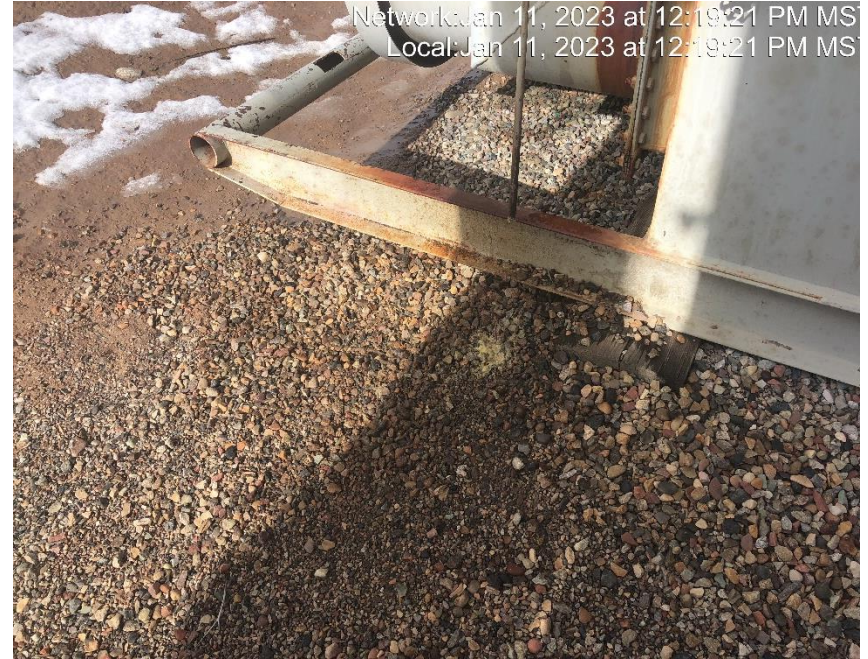
Photo #8766 Stained soils and gravel on location.

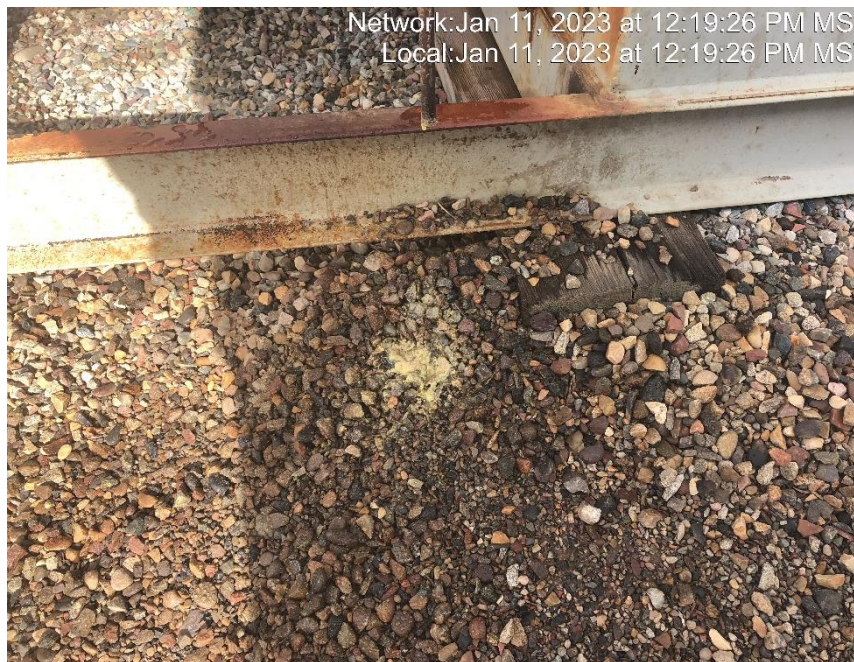
Photo #8767 Stained soils and gravel on location.

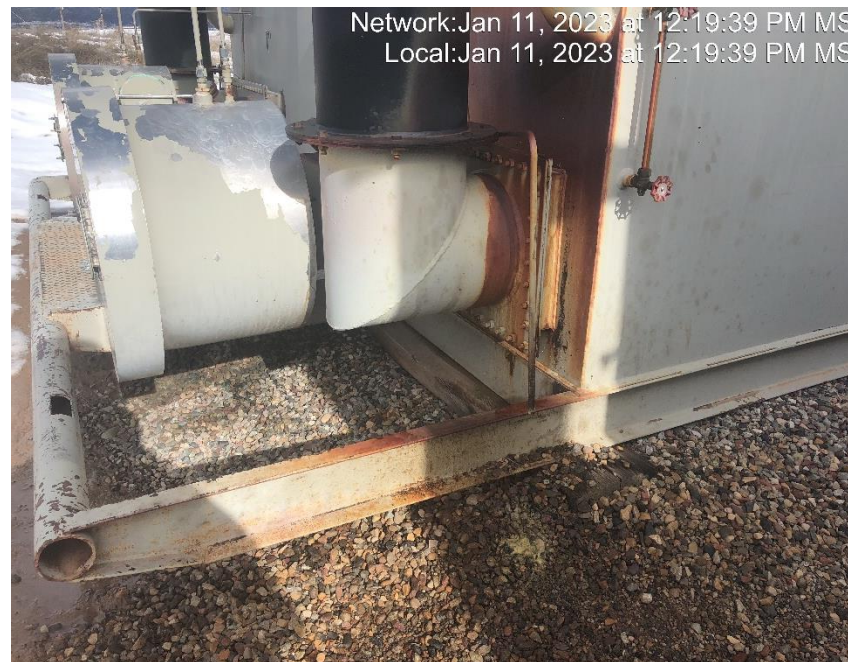
Photo #8768 Stained soils and gravel on location.

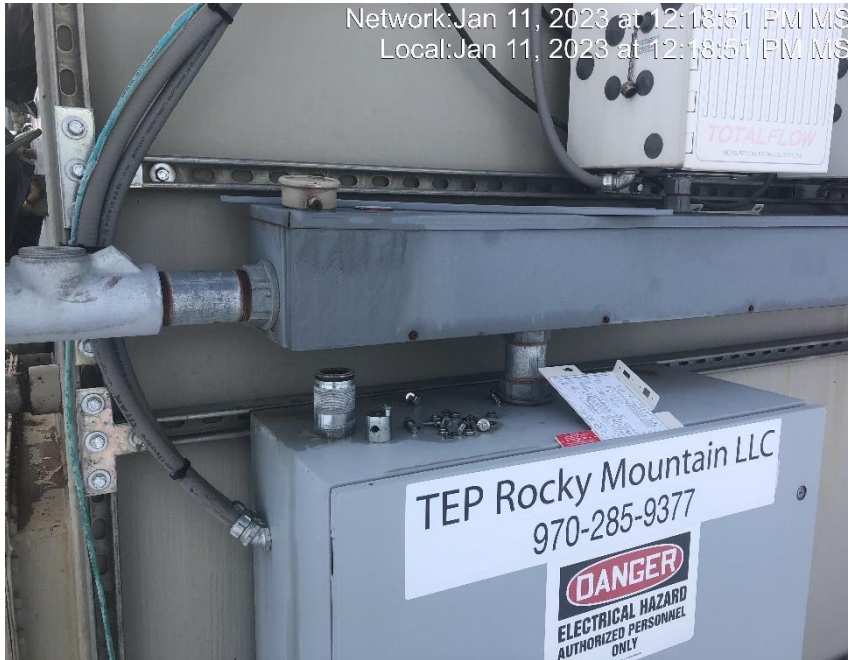
Photo #8764 Multiple places with unused equipment.

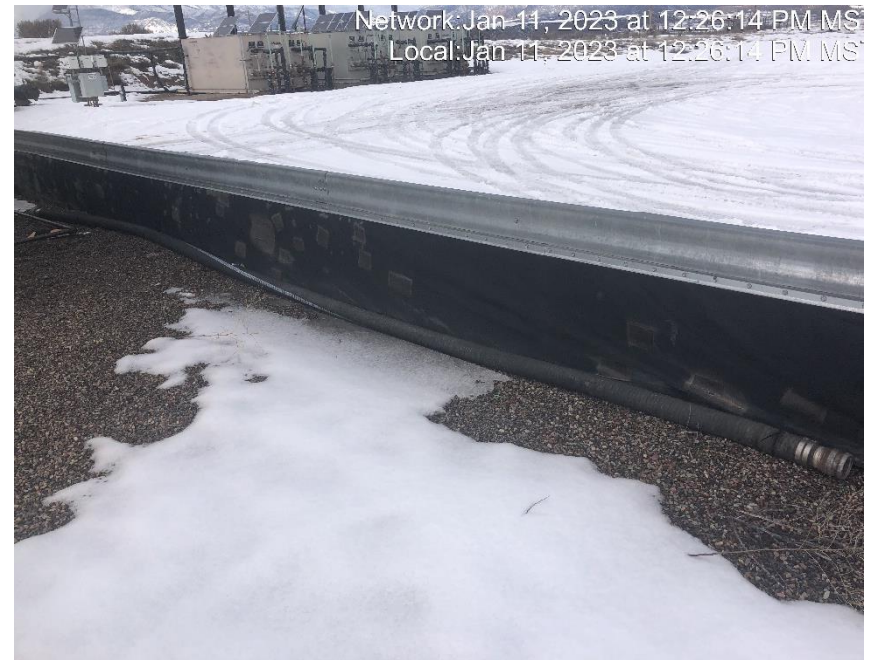
Photo #8779 Multiple places with unused equipment.

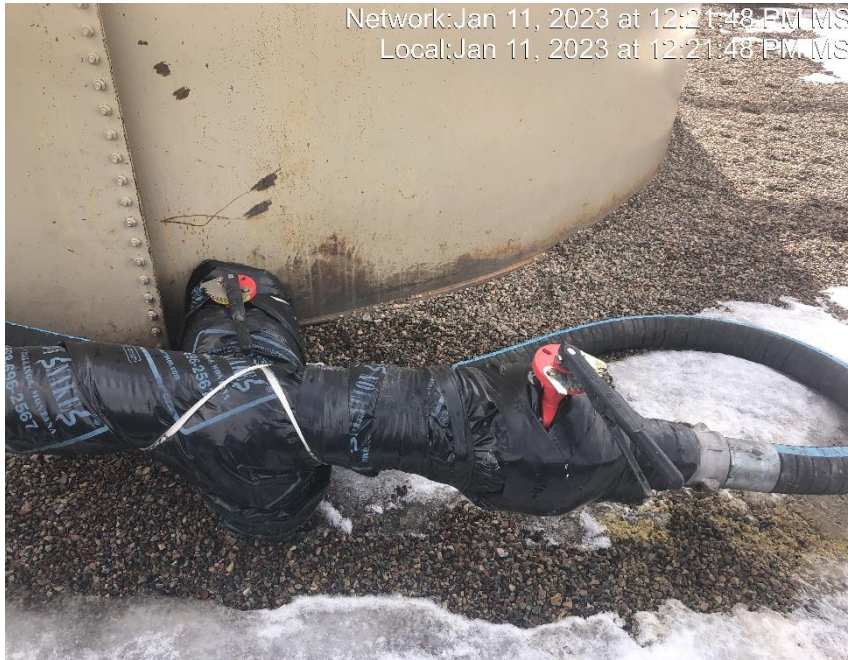
Photo #8775 Drain valves open with stained gravel under valve and hose.

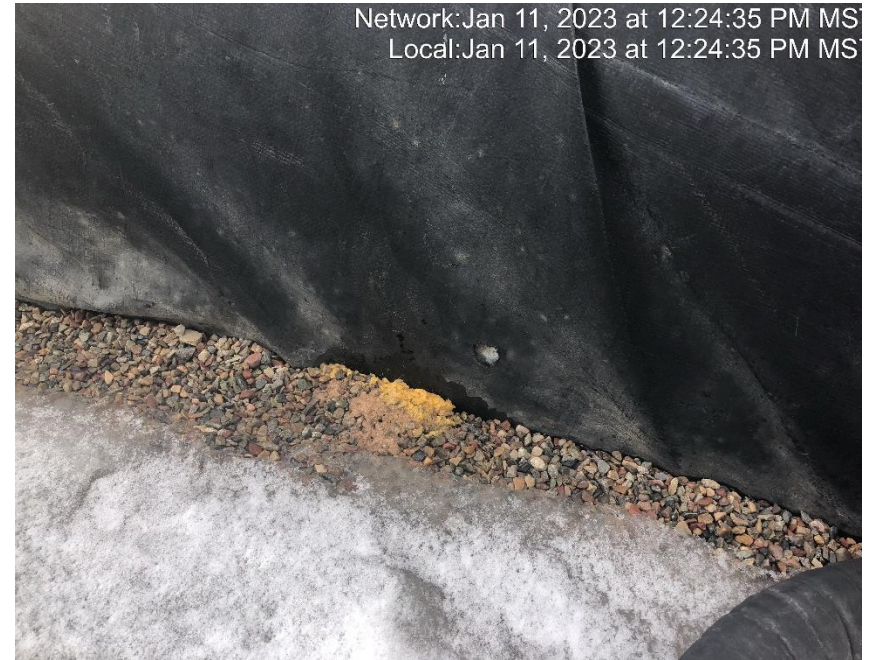
Photo #8776 Hole in secondary containment and stained gravel.

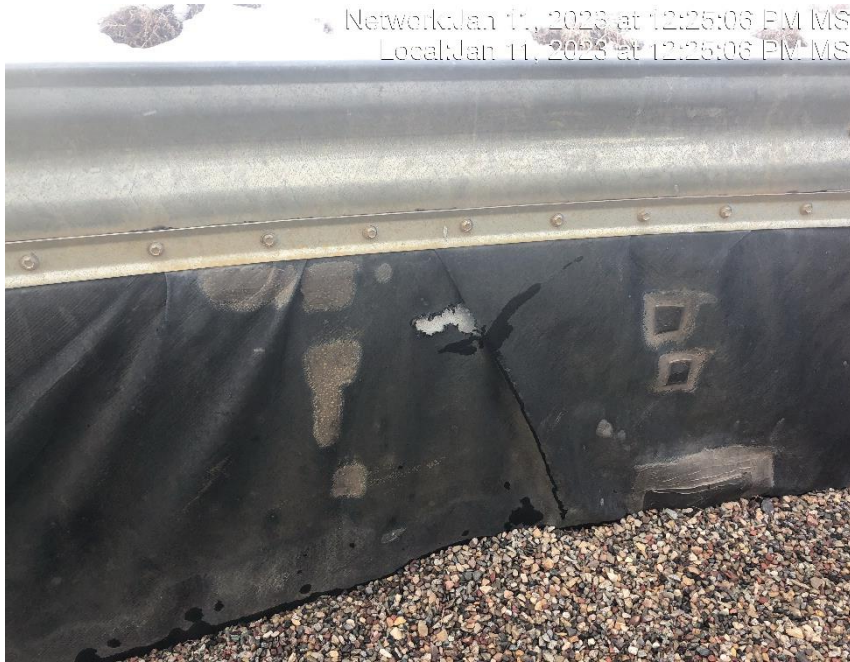
Photo #8777 Multiple holes in tank containment.

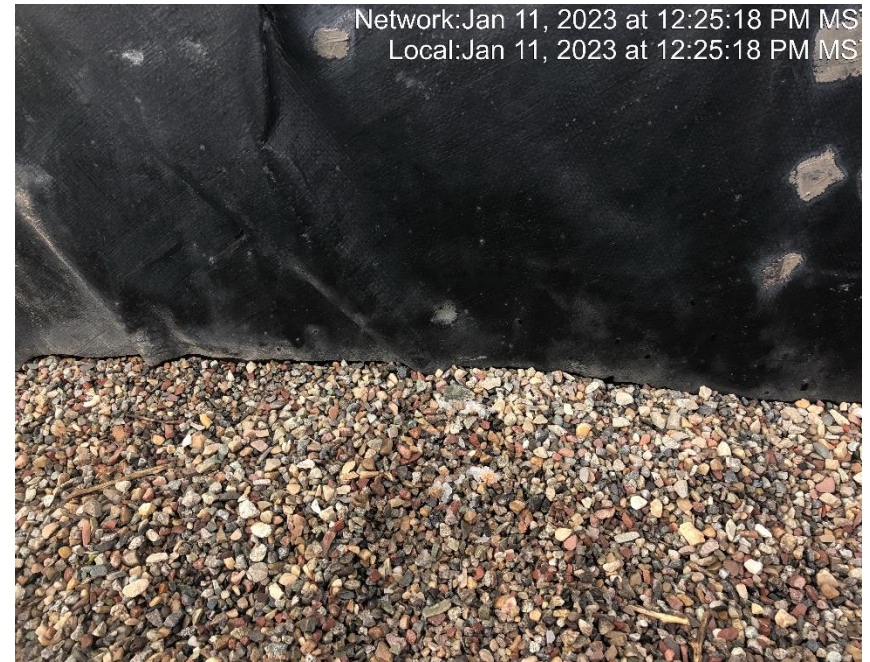
Photo #8778 Multiple holes in tank containment.

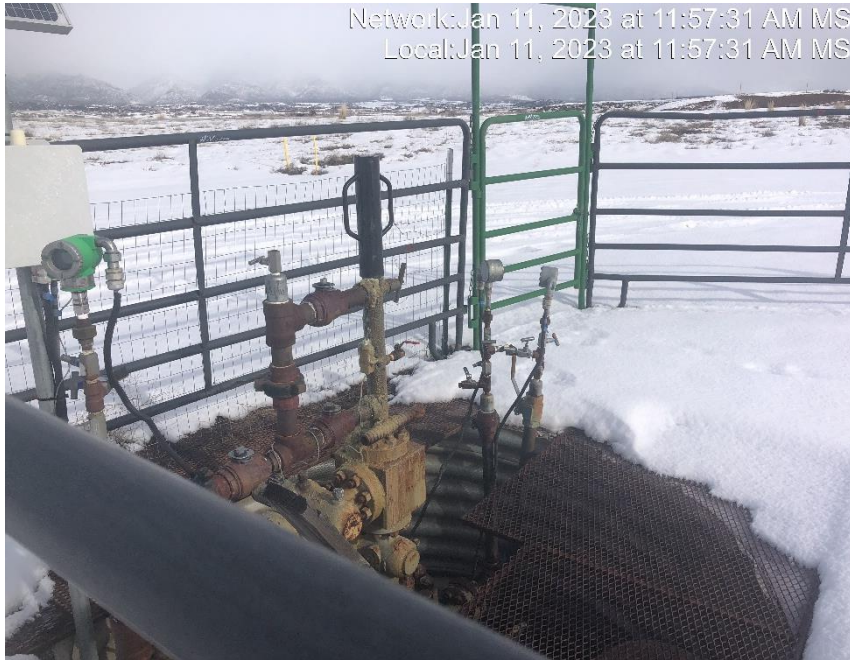
Photo #8757 Dever A12 Wellhead leaking.

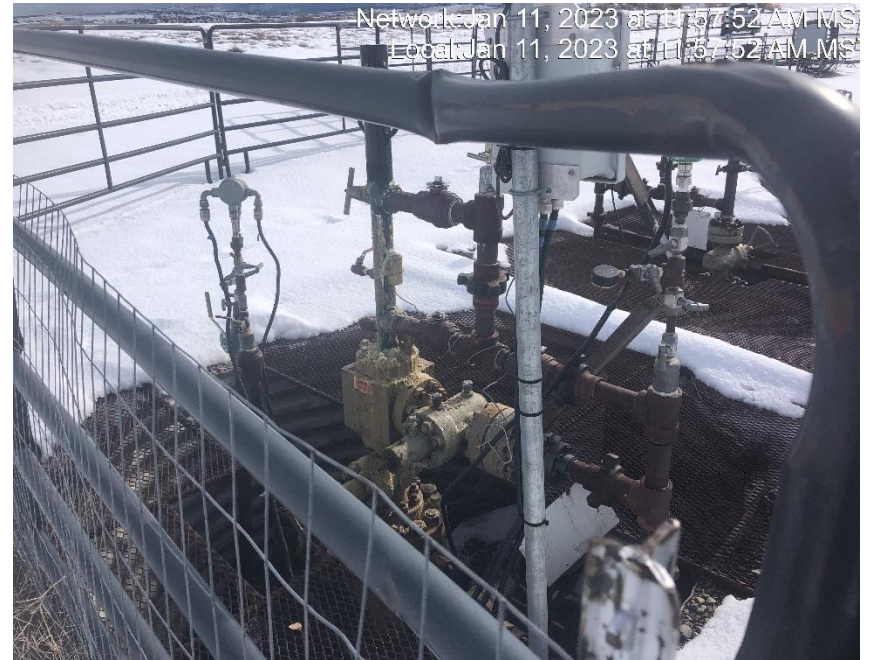
Photo #8758 Dever A12 Wellhead leaking.
